**PRODUCT CAMPAIGN BULLETIN**

**APPLICABILITY:** 2004-2005 Subaru Impreza, WRX, STI

**SUBJECT:** Takata Front Passenger Air Bag Inflator Replacement

**NUMBER:** WQR-53R

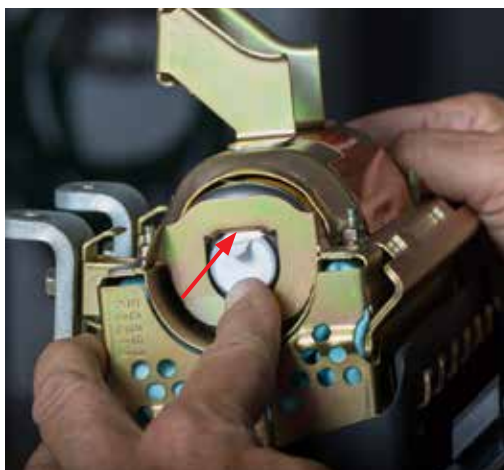
**STEP 9-** Install the new inflator into the mounting bracket with the harness connector end going in first toward the mounting bracket. Make sure the “D-shaped” portion of the inflator harness connector boss aligns with the “D-shaped” portion of the hole in the end of the mounting bracket as shown below. When properly installed, the end of the inflator will be seated tight against the mounting bracket. Do not peel the white harness connection dust cover at this time.

**Inflator properly seated against mounting bracket (NO GAP)**

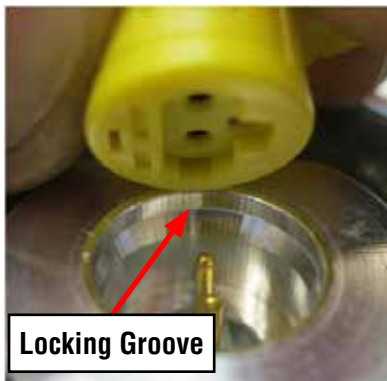
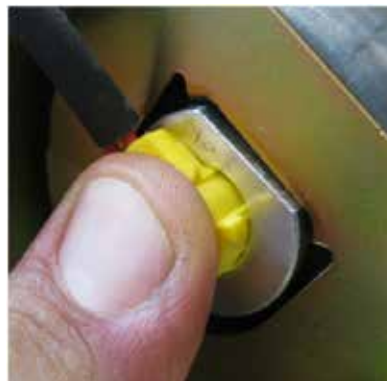
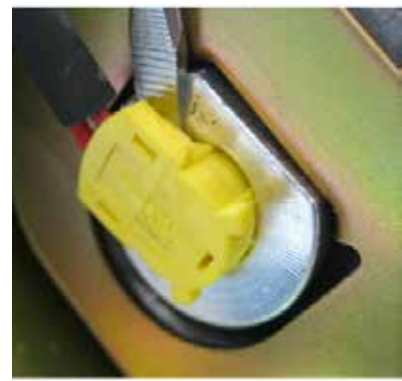
**STEP 11- VERY IMPORTANT:** When connecting the new harness to the inflator, the harness **MUST** be routed toward the module's mounting brackets as shown in the photo below. Peel off the white dust cover and **CAREFULLY** align the 2 inflator pins with the female terminals of the harness connector as shown in the sequence below. Once pin alignment is confirmed, push down firmly to engage the connector's 2 locking tangs into the locking groove of the connector boss. Confirm the connector is fully locked by prying up **LIGHTLY** with a small flat-blade screwdriver.
