**PRODUCT CAMPAIGN BULLETIN**

**APPLICABILITY:** 2004-2005 Subaru Impreza, WRX, STI

**NUMBER:** WQR-53

**SUBJECT:** Takata Front Passenger Air Bag Inflator Replacement

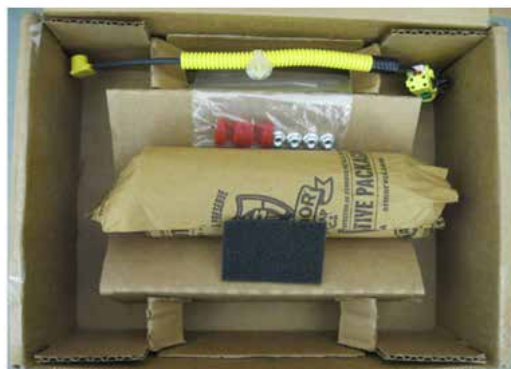
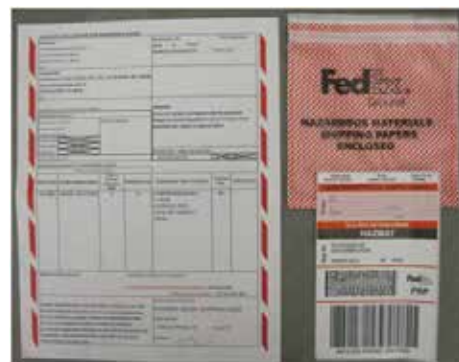
- Open the Kit Box and confirm all the necessary components are included:
  - 4 Self-Locking nuts
  - New Inflator (yellow tape applied to one end to identify it as the replacement part)
  - New Inflator Harness
  - Electro-Tap (red shorting crimp connector)
  - 1 ½” X 2 ¼” piece of self-adhesive Sponge Tape
  - Shipping Declaration document, FedEx document pouch and return shipping label

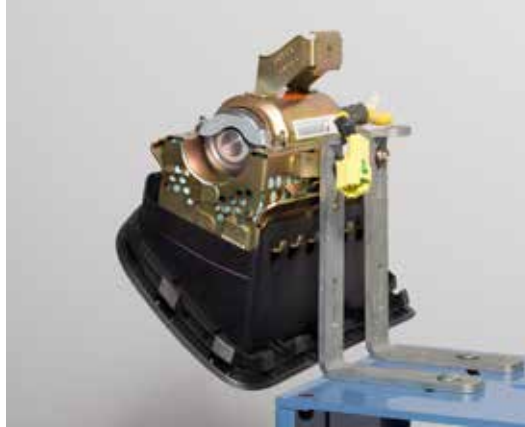
- **IMPORTANT:** The removed airbag module must be mounted to the Airbag Deployment Fixture (part number J-39401-B) as shown in the photo below to better secure it during the inflator and wiring harness component replacement procedures. Always perform this work in an area away from others to reduce chances of inadvertent injury should any deployment occur. Take your surroundings into account to avoid possible hazards should inadvertent deployment occur or sources of static or other electricity that could potentially induce such a deployment.

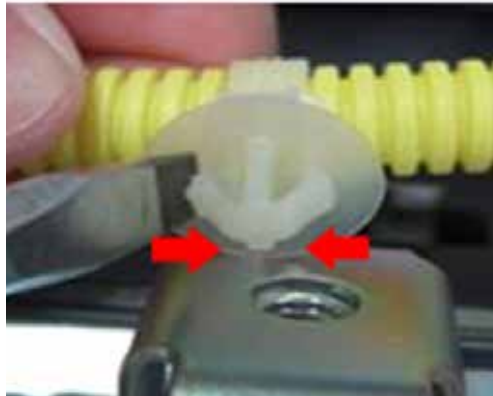
**STEP 2-** Peel the Sponge Tape and remove the harness clip from the retainer bracket by pushing the tangs inward with a flat-blade screwdriver as shown below. Always remove any Sponge Tape adhesive residue from the airbag mounting bracket using mild solvent on a clean shop cloth. **CAUTION:** Never use any silicone-based products for this purpose.

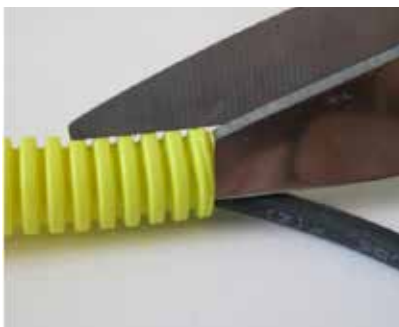
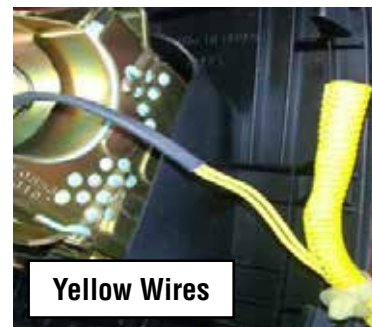
**STEP 3- CAREFULLY** cut the yellow harness cover enough (approximately 2 inches) to expose the 2 red or yellow wires inside and provide enough room to install the Electro-Tap (shorting) connector using a wire cutter or scissor (no knives or razors). **TAKE YOUR TIME AND BE CAREFUL TO NOT CUT THE 2 WIRES!**

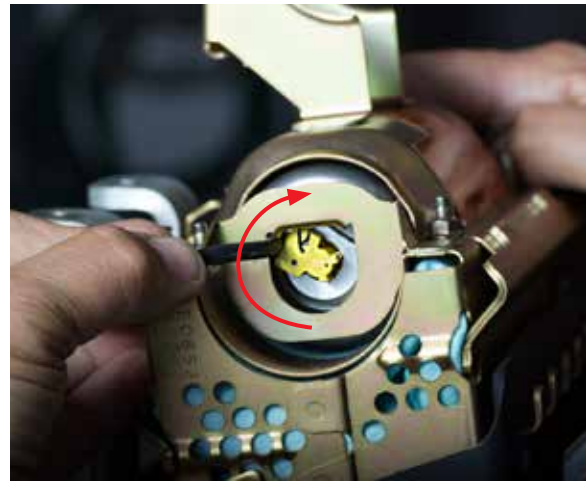
**STEP 7-** With the stopper plate removed and the other 2 self-locking nuts loosened, unseat the inflator off the mounting bracket end plate then rotate it slightly **CLOCKWISE** to make it easier to remove as shown in the photo to the right. Slide the inflator out of its mounting while feeding the cut off portion of the wiring harness through the “D-Shaped” hole in the end of the mounting bracket.

Place the removed original air bag inflator in the “cradle” of the Kit Box insert.

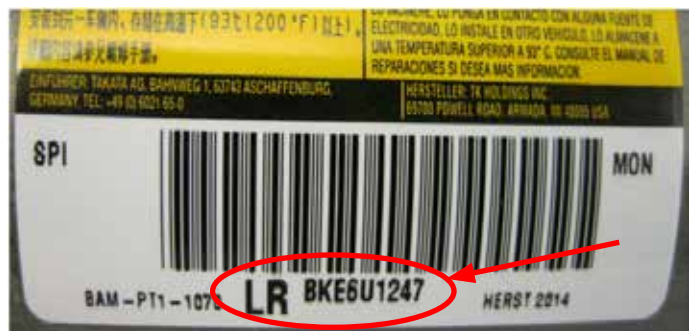
**STEP 8- VERY IMPORTANT:** Record the **FedEx Shipper Receipt Number** (located at the top of the return shipping label included with the new inflator) and the **11-digit alphanumeric serial number for both the new and the removed inflators** on the hard copy of the Repair Order. This information will be required for completion of the Part Return Notice which will be forwarded by the retailer to the PCC. The new serial number is also a requirement for claim entry.

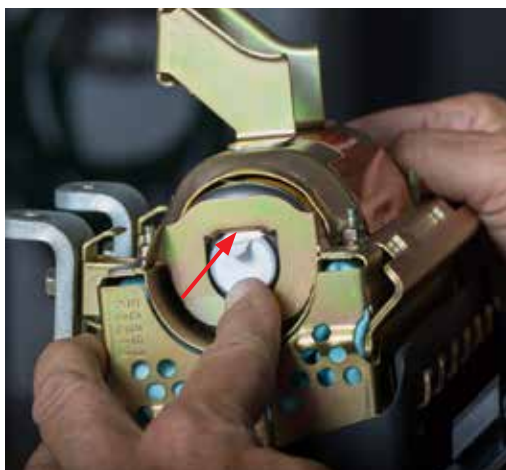
**STEP 9-** Install the new inflator into the mounting bracket with the harness connector end going in first toward the mounting bracket. Make sure the “D-shaped” portion of the inflator harness connector boss aligns with the “D-shaped” portion of the hole in the end of the mounting bracket as shown below. When properly installed, the end of the inflator will be seated tight against the mounting bracket. Do not peel the white harness connection dust cover at this time.

**Inflator properly seated against mounting bracket (NO GAP)**

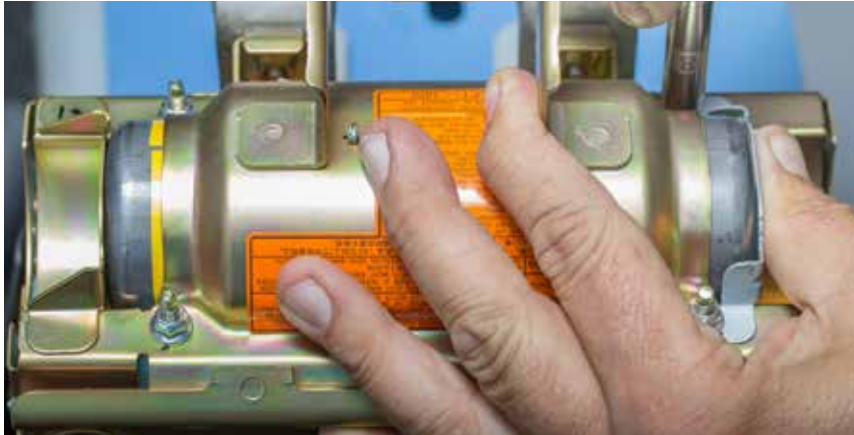
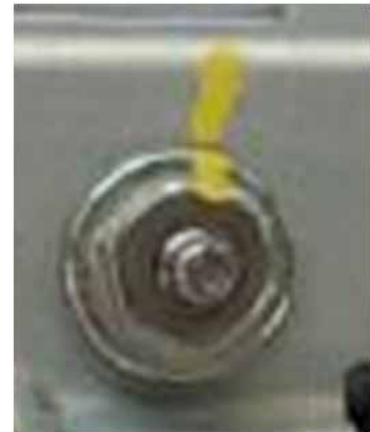
**STEP 10-** As shown below, install but do not fully tighten 2 of the NEW self-locking nuts while holding the stopper plate tight against the inflator. Remove the nuts still installed on the mounting bracket and replace them with 2 NEW self-locking nuts. Once all 4 NEW nuts are in place, torque to 31 - 38 inch pounds in the sequence shown below. Use a marker to mark the nuts after torquing indicating they have been fully tightened.

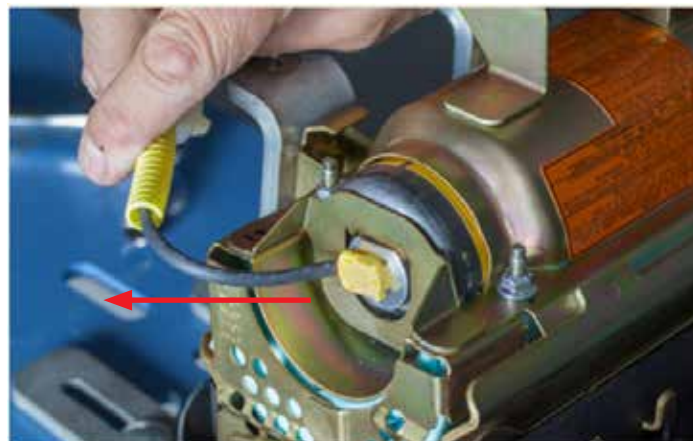
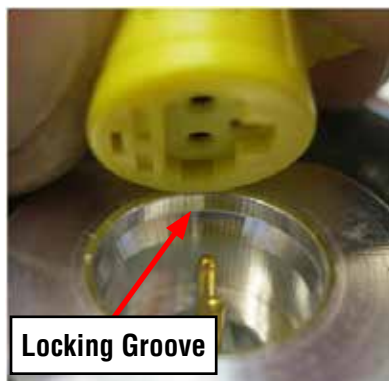
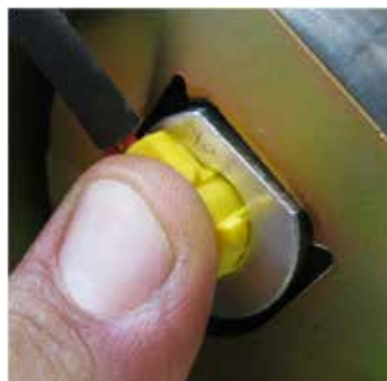
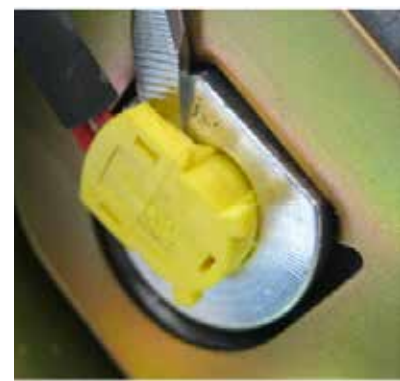
**STEP 11- VERY IMPORTANT:** When connecting the new harness to the inflator, the harness **MUST** be routed toward the module's mounting brackets as shown in the photo below. Peel off the white dust cover and **CAREFULLY** align the 2 inflator pins with the female terminals of the harness connector as shown in the sequence below. Once pin alignment is confirmed, push down firmly to engage the connector's 2 locking tangs into the locking groove of the connector boss. Confirm the connector is fully locked by prying up **LIGHTLY** with a small flat-blade screwdriver.

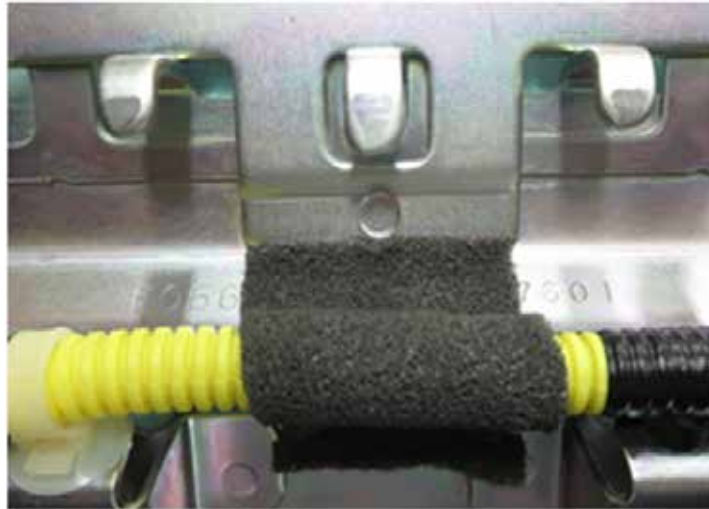
**STEP 13-** Peel the adhesive backing and install the new Sponge Tape onto the yellow harness tube first then adhere it to the airbag mounting bracket as shown in the illustrations below.

**IMPORTANT:** The Sponge tape must be installed more than half-way around the yellow harness tube.
