IMPORTANT SAFETY RECALL

Airstream Interstate

NHTSA Recall Number 15V-336

Transport Canada Recall Number 2015-218

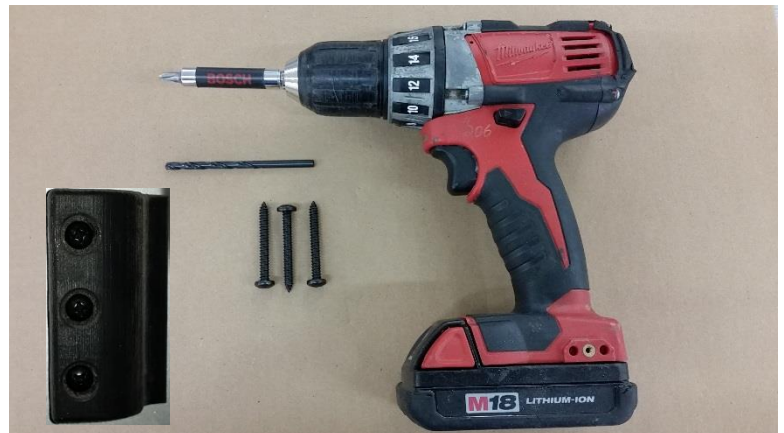
Airstream Interstate 2015/2016 Model Year

Step 1: Installation of the sliding door stop on 2015/2016 Airstream Interstates.

The repair is to attach a block/stop on the vehicle's sliding door, which keeps the sliding door from shutting if the screen door is closed. See attached repair procedure.

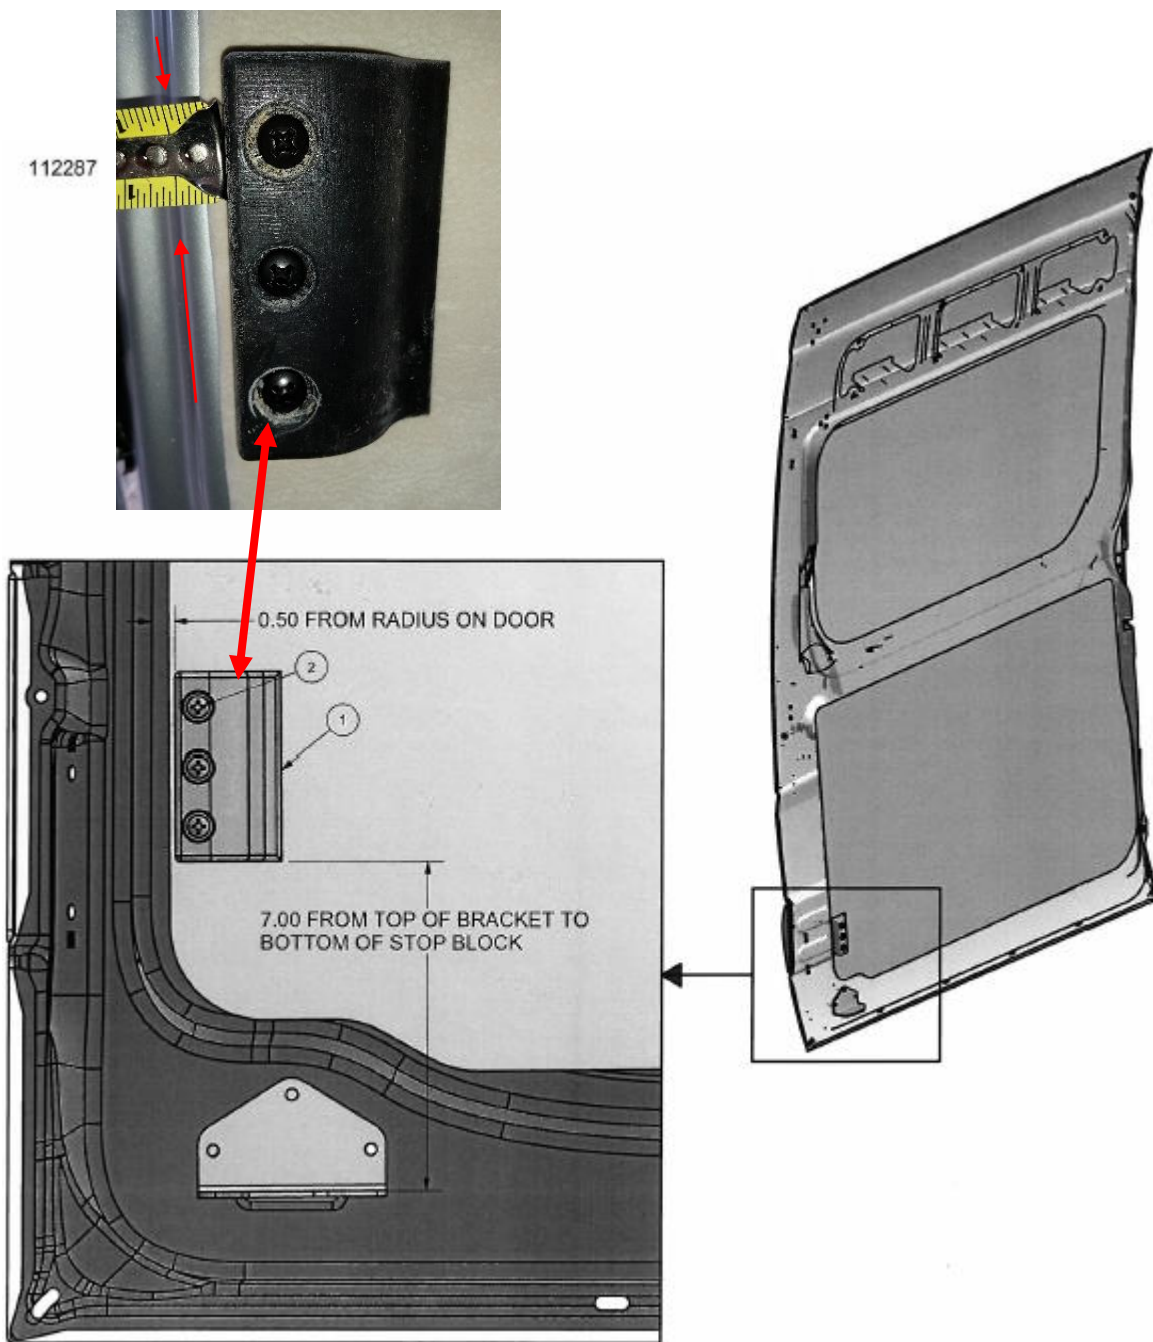
Measure in $\frac{1}{2}$ " from side radius and 7" up from sliding door bracket. Using your $\frac{3}{16}$ " bit drill out the three holes using the stop as your template

Shut the screen door. Once screen is closed, verify that the sliding door will no longer latch. The door will not shut if installed properly.

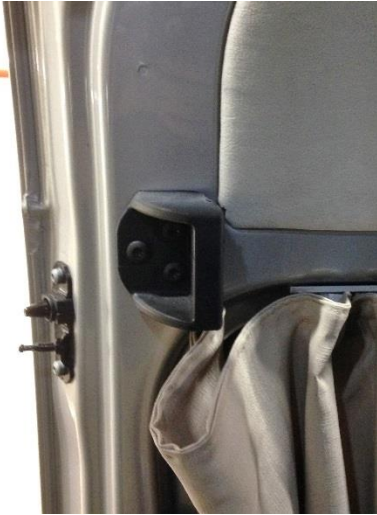
On certain 2015, they may be two sliding door stops from Mercedes that will need removed. If these are still installed you will simply need to remove the fastener to take these off. Once removed you will need to reinstall the fasteners that were used holding them on.

You will need a T14 tip to remove the three fasteners
