SAFETY RECALL BULLETIN

SUBJECT: ABS HYDRAULIC UNIT – SAFETY RECALL CAMPAIGN – REVISED			No: SR-15-004REV
			DATE: July, 2015
			MODEL: 2006-09 Eclipse and Eclipse Spyder
CIRCULATE TO:	<input checked="" type="checkbox"/> GENERAL MANAGER	<input checked="" type="checkbox"/> PARTS MANAGER	<input checked="" type="checkbox"/> TECHNICIAN
<input checked="" type="checkbox"/> SERVICE ADVISOR	<input checked="" type="checkbox"/> SERVICE MANAGER	<input checked="" type="checkbox"/> WARRANTY PROCESSOR	<input checked="" type="checkbox"/> SALES MANAGER

This bulletin supercedes SR-15-004, issued July, 2015, to clarify the repair procedure. Changes are italicized and indicated by ◀.

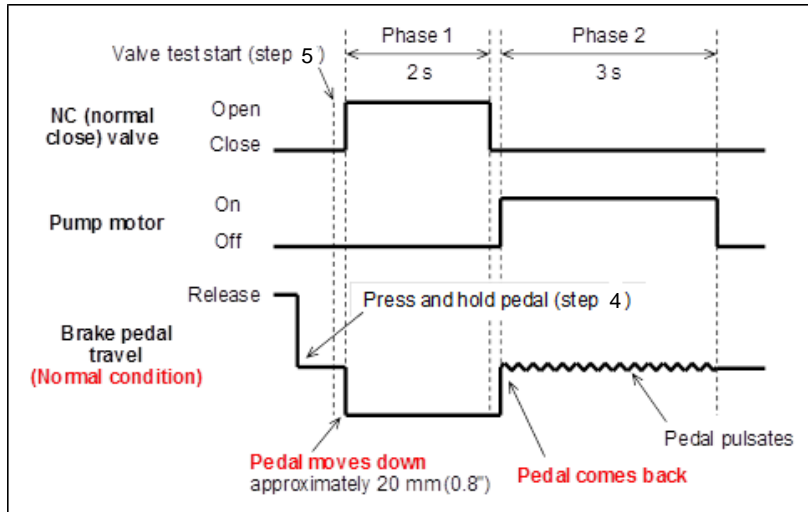
6. The valve test will begin. The brake pedal's behavior should follow the chart below.

Phase 1: NC (Normal Close) valve open

The valve will open right after the valve test starts.

- If the brake pedal **moves down**, the hydraulic unit is **normal**.
- If the brake pedal **doesn't move down**, the hydraulic unit is **not normal**.

Phase 2: Pump motor on

The pump motor will run approximately 2 seconds after the valve test has started.

- If the brake pedal **comes back up**, the hydraulic unit is **normal**.
- If the brake pedal **doesn't come back up**, the hydraulic unit is **not normal**.

a. If Phase 1 or Phase 2 brake pedal behavior is **not normal**, ABS hydraulic unit replacement is required. Refer to the applicable service manual, Group 35B: ABS --> Hydraulic Unit --> Removal and Installation. Once the ABS Hydraulic Unit is replaced, proceed directly to the **BRAKE FLUID REFERENCES** section.

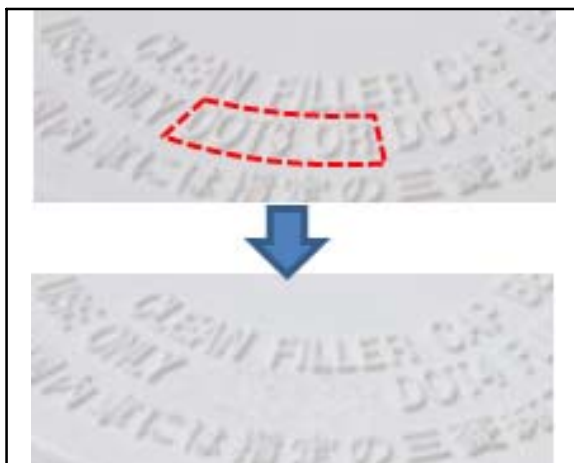
1. Reinstall all four wheels and lower the vehicle. Torque specification for the wheel nuts is 73 ± 7 ft-lb (98 ± 10 N-m).
2. Remove the brake fluid cap from the reservoir.
3. With a carving knife or similar tool, scrape off the wording of “DOT 3 OR” from the brake fluid warning description which is embossed on the top surface of the cap.
4. Remove scraped residue from the top and bottom side of the reservoir cap.
5. Reinstall the cap to the brake fluid reservoir.

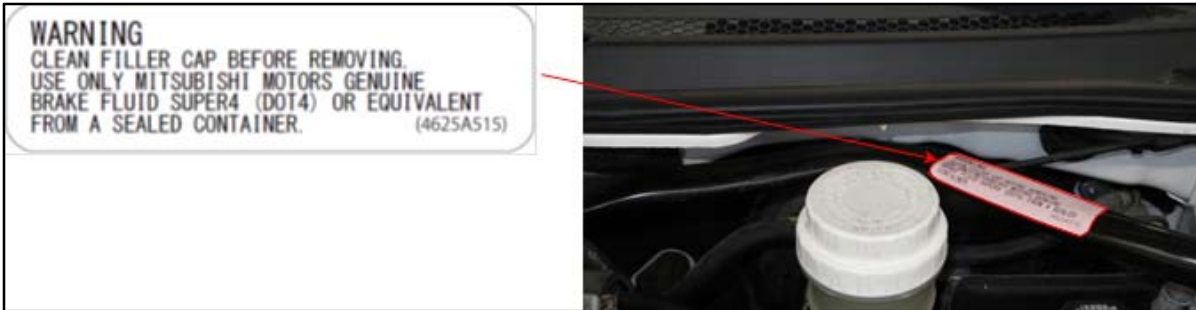
6. If the vehicle is equipped with a front strut tower brace, adhere the English brake fluid warning label on the strut tower brace as shown.

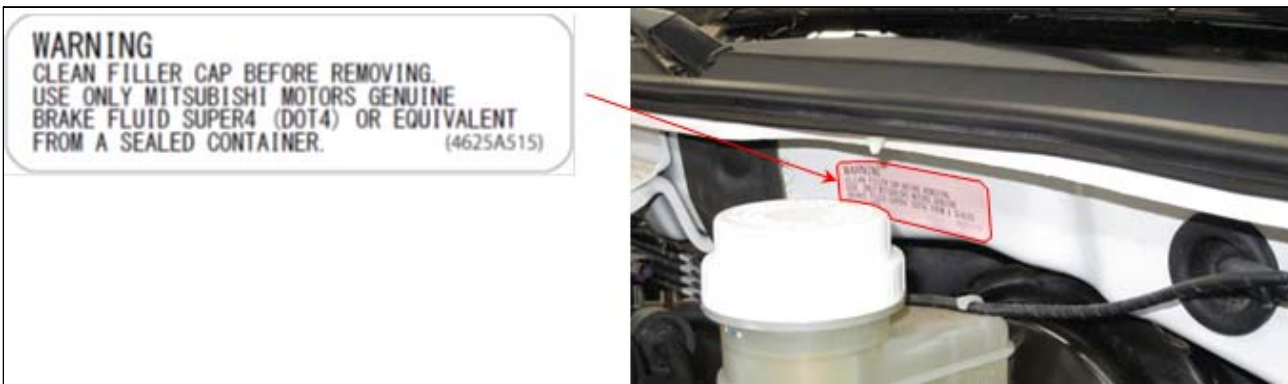
7. If the vehicle is not equipped with a front strut tower brace, adhere the English brake fluid warning label on the dash panel as shown.

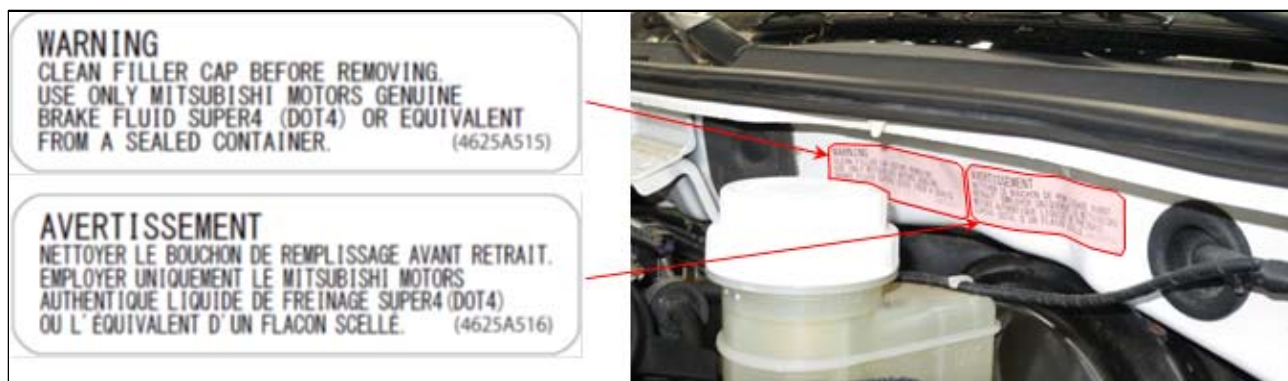
9. If the vehicle is not equipped with a front strut tower brace, adhere the English and French brake fluid warning label on the dash panel as shown.
