April 28, 2016

02517 Version 4

## Safety Recall: Front Passenger's Airbag Inflator Can Be Over-Pressurized

Replace the passenger's airbag inflator, then return the original, undeployed inflator as directed.

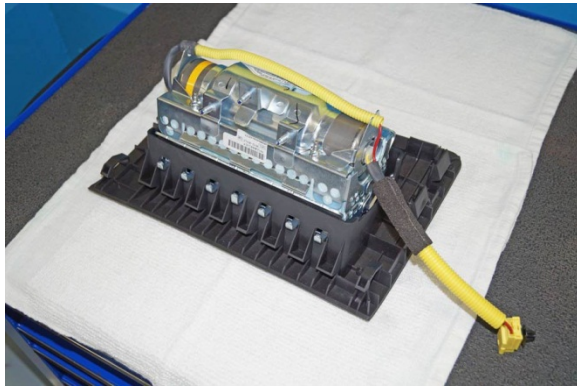
3. Remove the front passenger's airbag. Refer to the service repair information.
  4. Place the airbag, face-down, on a clean shop towel.

- The orientation of the airbag is critical because if the inflator is installed incorrectly, the harness will be too short when you reinstall the airbag.
- The brackets between the various models are similar but may differ from the example shown.

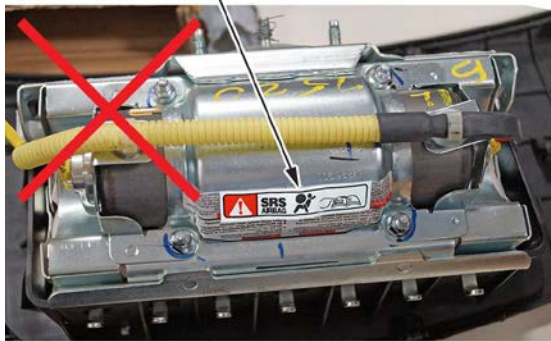
**NON-STANDARD SAFETY LABEL**

- If there is nothing unusual about the airbag or the inflator, go to step 6.
- If there are any unusual markings, like an incorrect label or a model year written in marker, the airbag and inflator may not be the correct airbag and/or inflator for the vehicle or it may be a counterfeit part. For more information about counterfeit airbags, you can refer to [safercar.gov](http://safercar.gov), enter keywords **MANAGING COUNTERFEIT**, and select **Recommended Dealer Guidance for Managing Counterfeit Air Bags** from the list. **If you suspect that the airbag or inflator is counterfeit, do not continue this procedure.** Contact your DPSM for assistance.

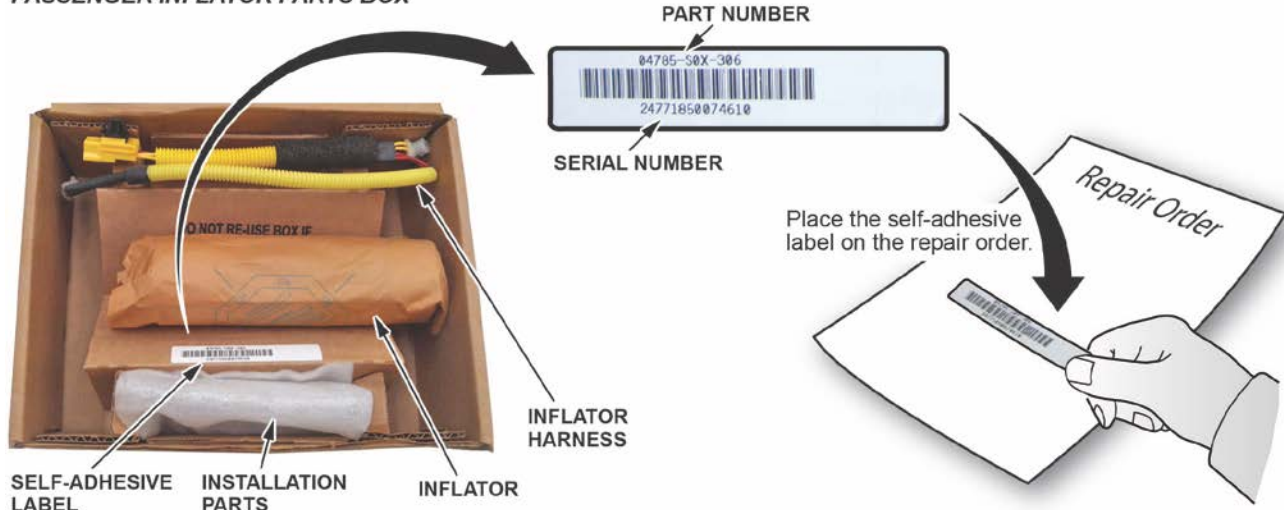
**PASSENGER INFLATOR PARTS BOX**

6. Peel the label located inside the inflator box from its backing and attach it to the RO. For the warranty claim to be paid, the **replacement inflator part number that you received** must be included in the warranty claim.

- The replacement part number is printed on the top part of the label and the serial number is printed on the bottom. **Make sure you attach the label to the RO and give it to the warranty clerk.**
- There may also be a colored sticker located in the kit; ignore it because it is not used.
- Not all inflator kits have a label included. In those cases, write the serial number and part number from the side of the inflator box on the RO. The part number always starts with 047.

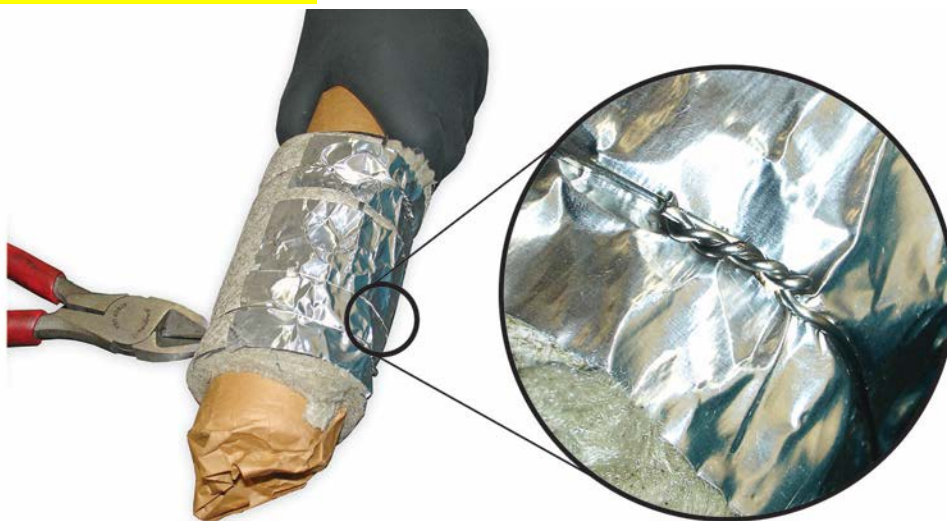
- Wear disposable gloves and protective glasses. The insulation is not toxic or dangerous, but some people may be sensitive to the insulation.
- Dispose of the insulation and wrapping paper to avoid getting the insulation dust/fibers on you or the airbag assembly.
- Do not reuse the insulation or wrapping paper. You do not need to wrap the inflator being removed from the vehicle when it is returned.
- Cut the wires off from the opposite side from where they are tied (twisted) together.

NOTE: Do not cut the insulation.

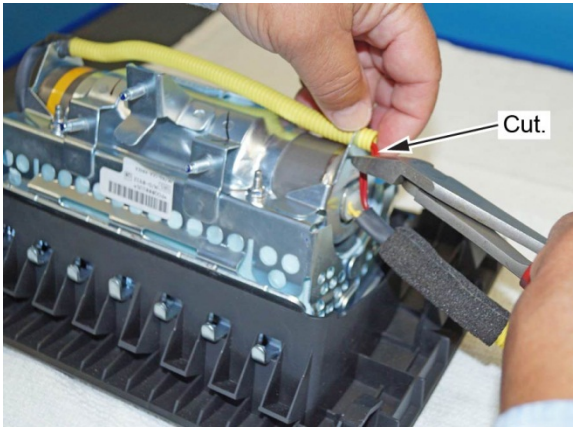
NOTE: **You must cut and short the wires** as indicated to prevent accidental deployment.

- Cut the red wires as shown.

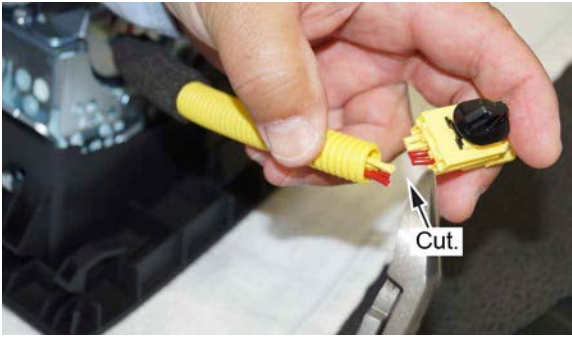
- Cut all four wires to remove the connector.

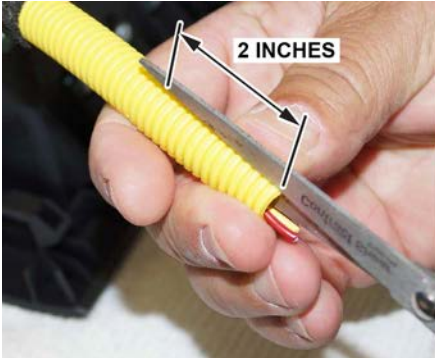
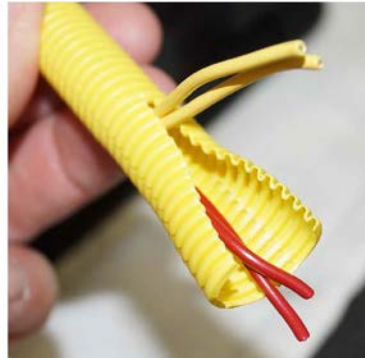
- Cut about 2 inches of the corrugated tube, then pull out the yellow wires.

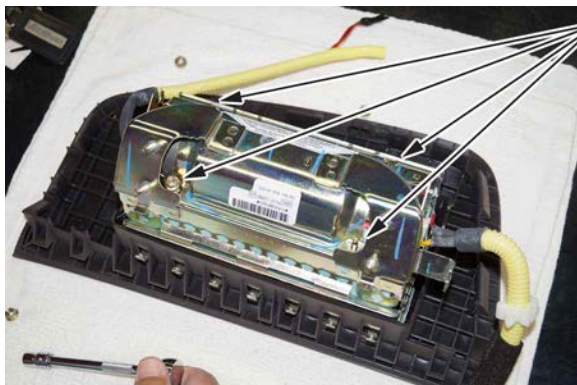
INFLATOR NUTS

11. Remove the four inflator nuts.

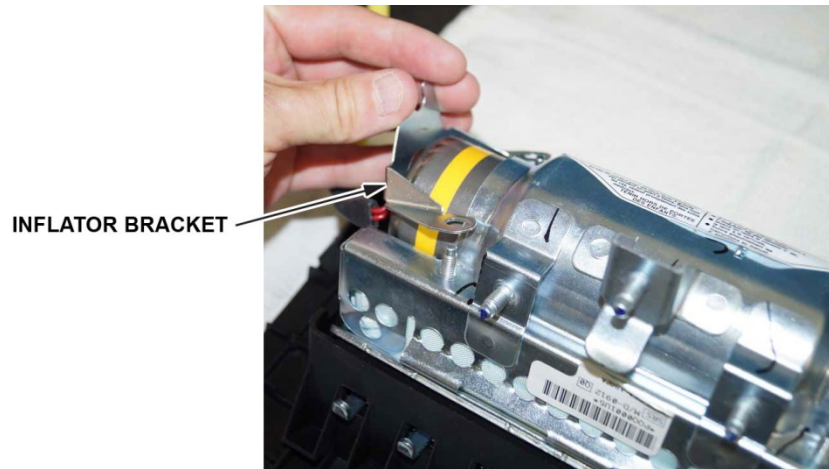
12. Remove the inflator bracket.

NOTE: You can only remove one of the brackets, as the other is welded to the airbag housing.

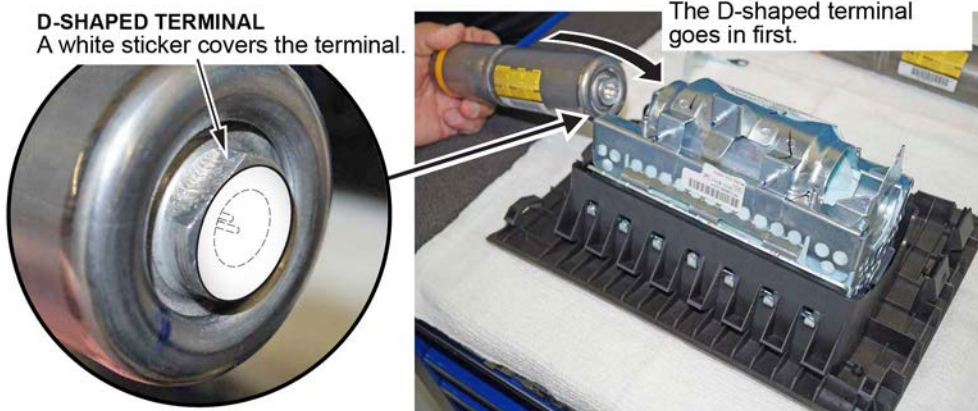
- One connector looks like a “D” whereas the other connector is a circle. Make sure you insert the “D” shaped terminal into the airbag first.

NOTE: There is a yellow band marking on the circle side.

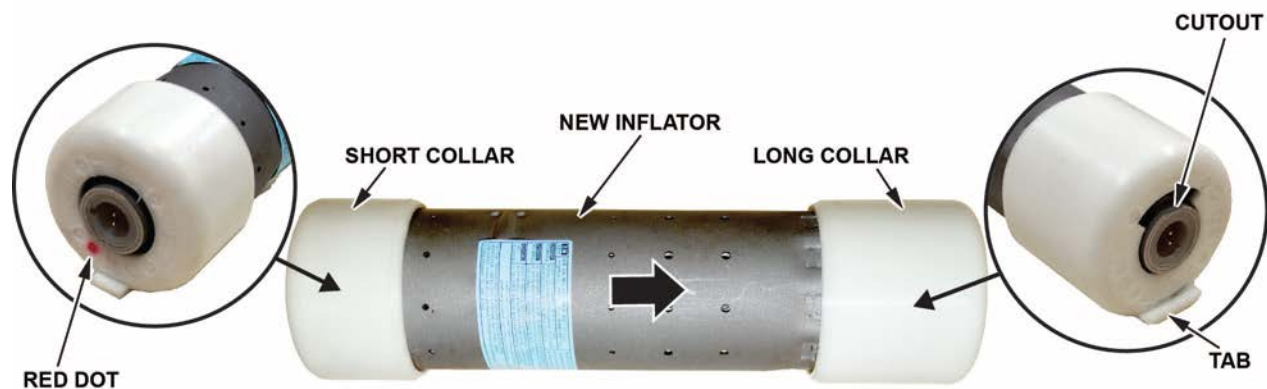
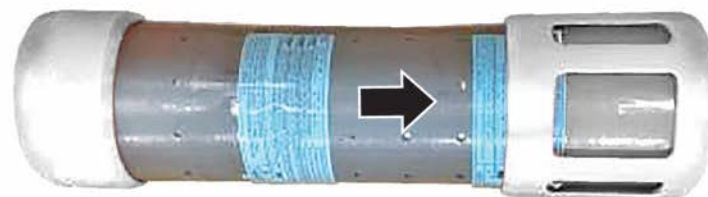
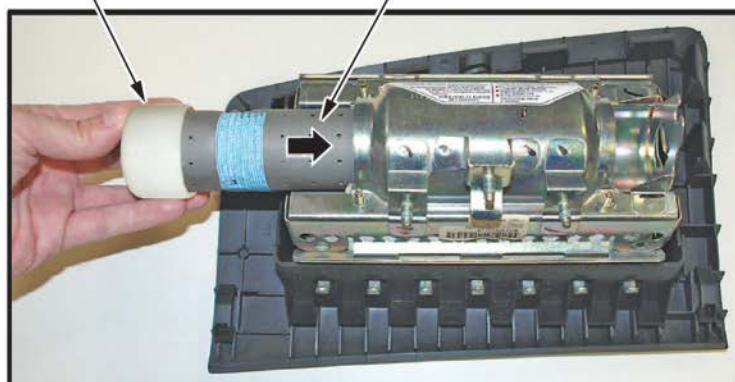
- One side of the inflator has a longer collar, a longer tab, a plastic cutout, and a small flat spot on the connector. The other side has a shorter collar, a shorter tab, and a red dot. Make sure you insert the end with the longer collar into the airbag first.

(Part number ending with 318 appears slightly different.)

The inflator installation is directional.

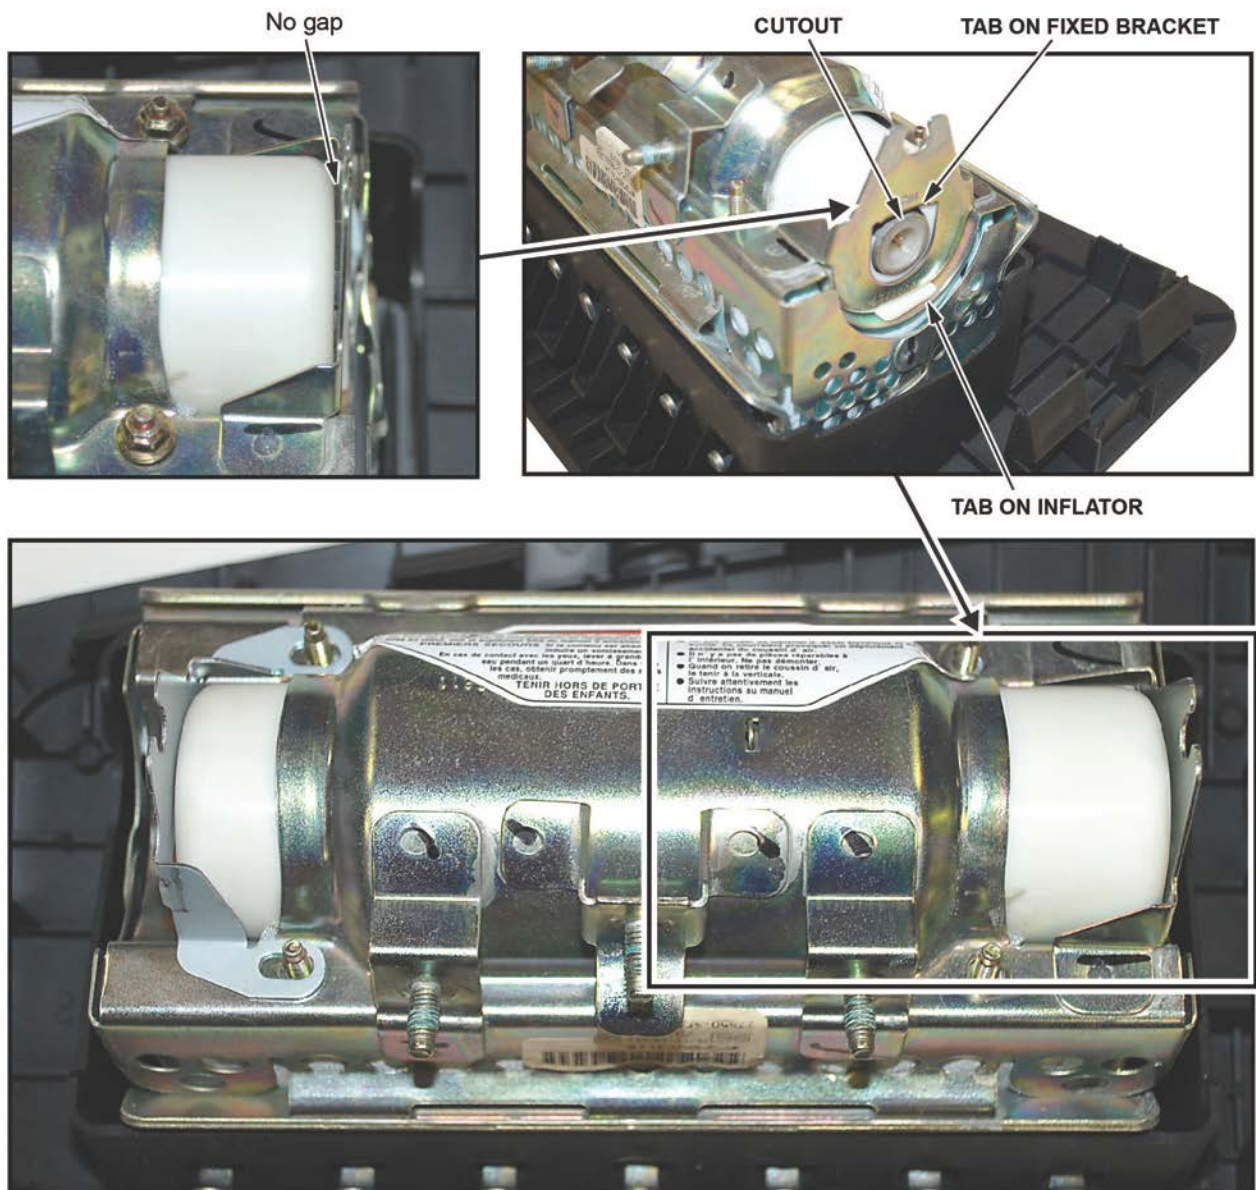
#### FIXED BRACKET END

- Slide the inflator in until the plastic cutout and the small flat spot align with the tab on the bracket. There should be no space or gap between the inflator and bracket.

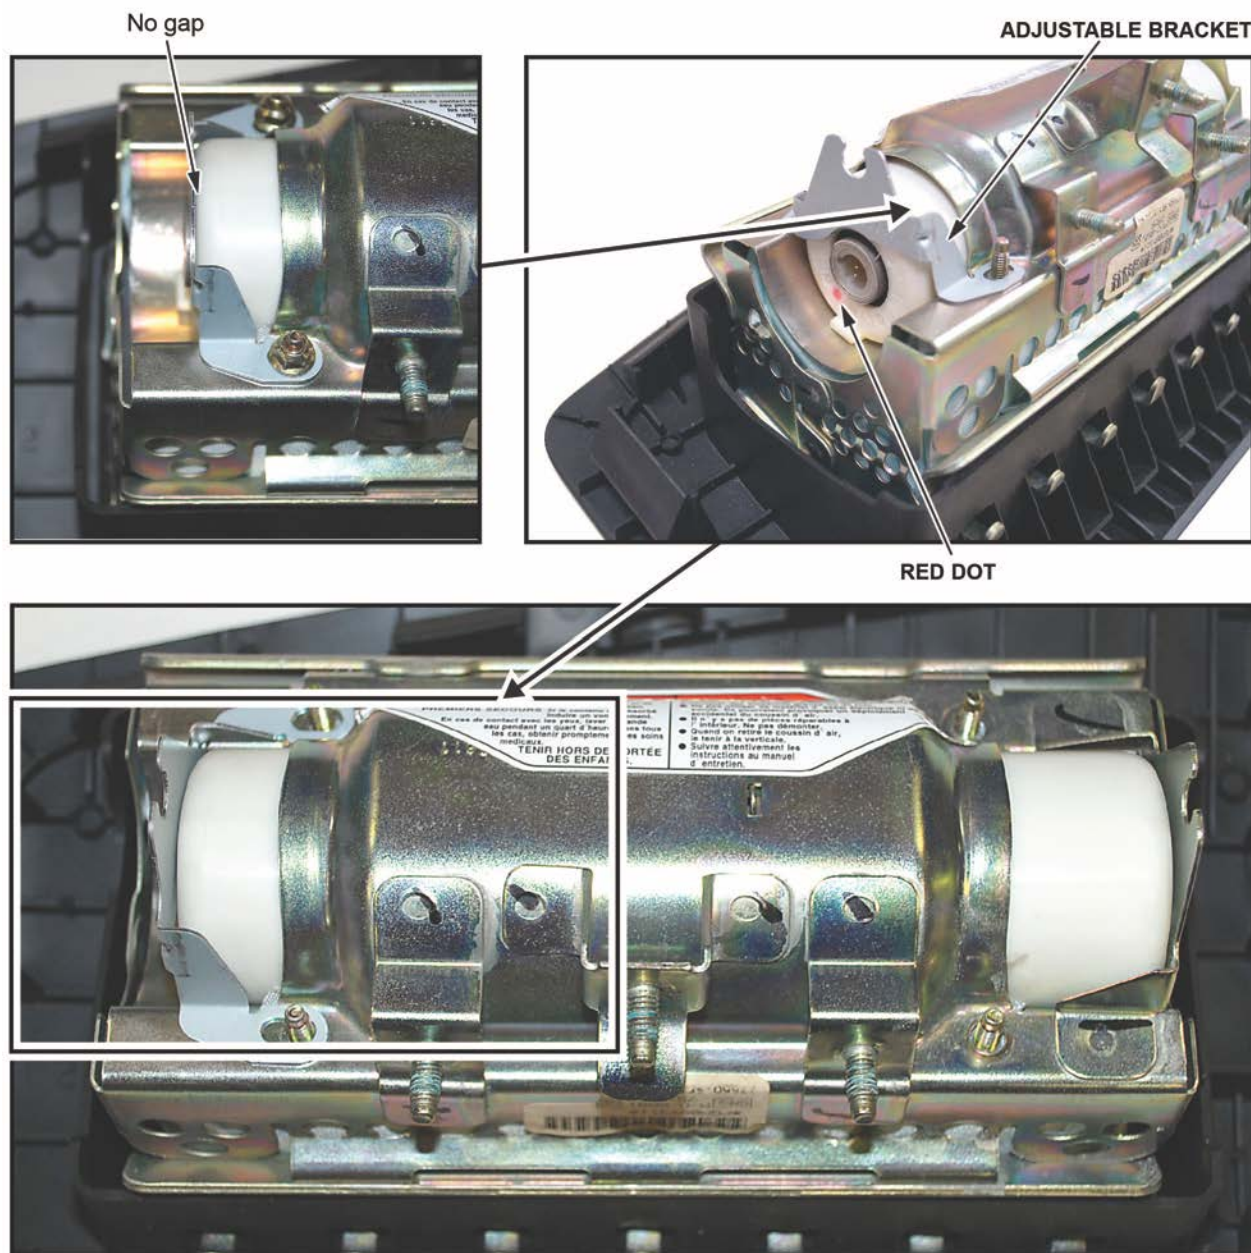
#### ADJUSTABLE BRACKET END

- Install the bracket included in the kit onto the airbag module. There should be a red dot visible on the end of the plastic connector. There should be no space or gap between the inflator and bracket.

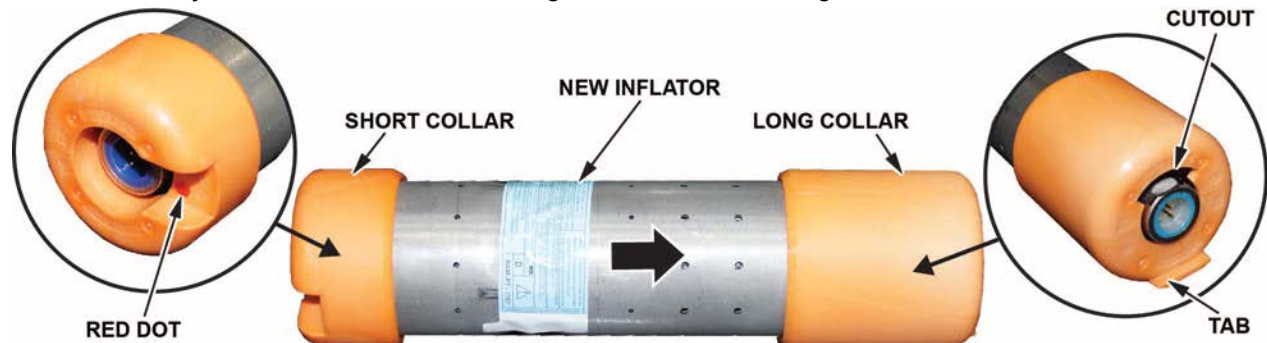
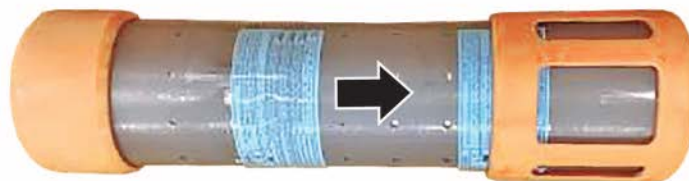
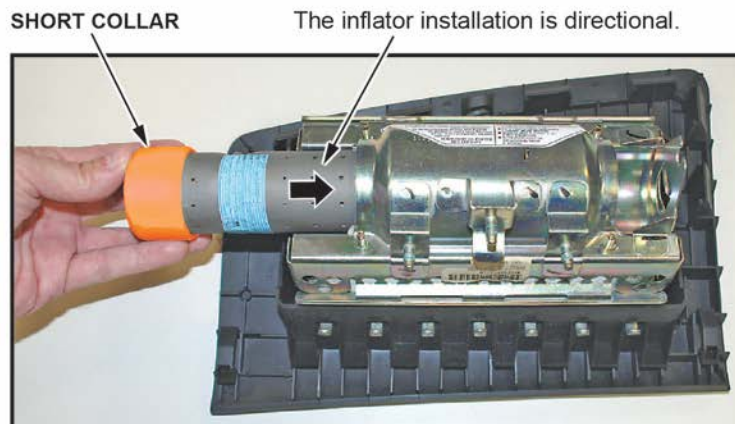
- Collars on this inflator are orange, not white. One side of the inflator has a longer collar, a tab, a plastic cutout, and a small flat spot on the connector. The other side of the inflator has a shorter collar, no tab, and a red dot. Make sure you insert the end with the longer collar into the airbag first.

(Part number ending with 315 appears slightly different.)

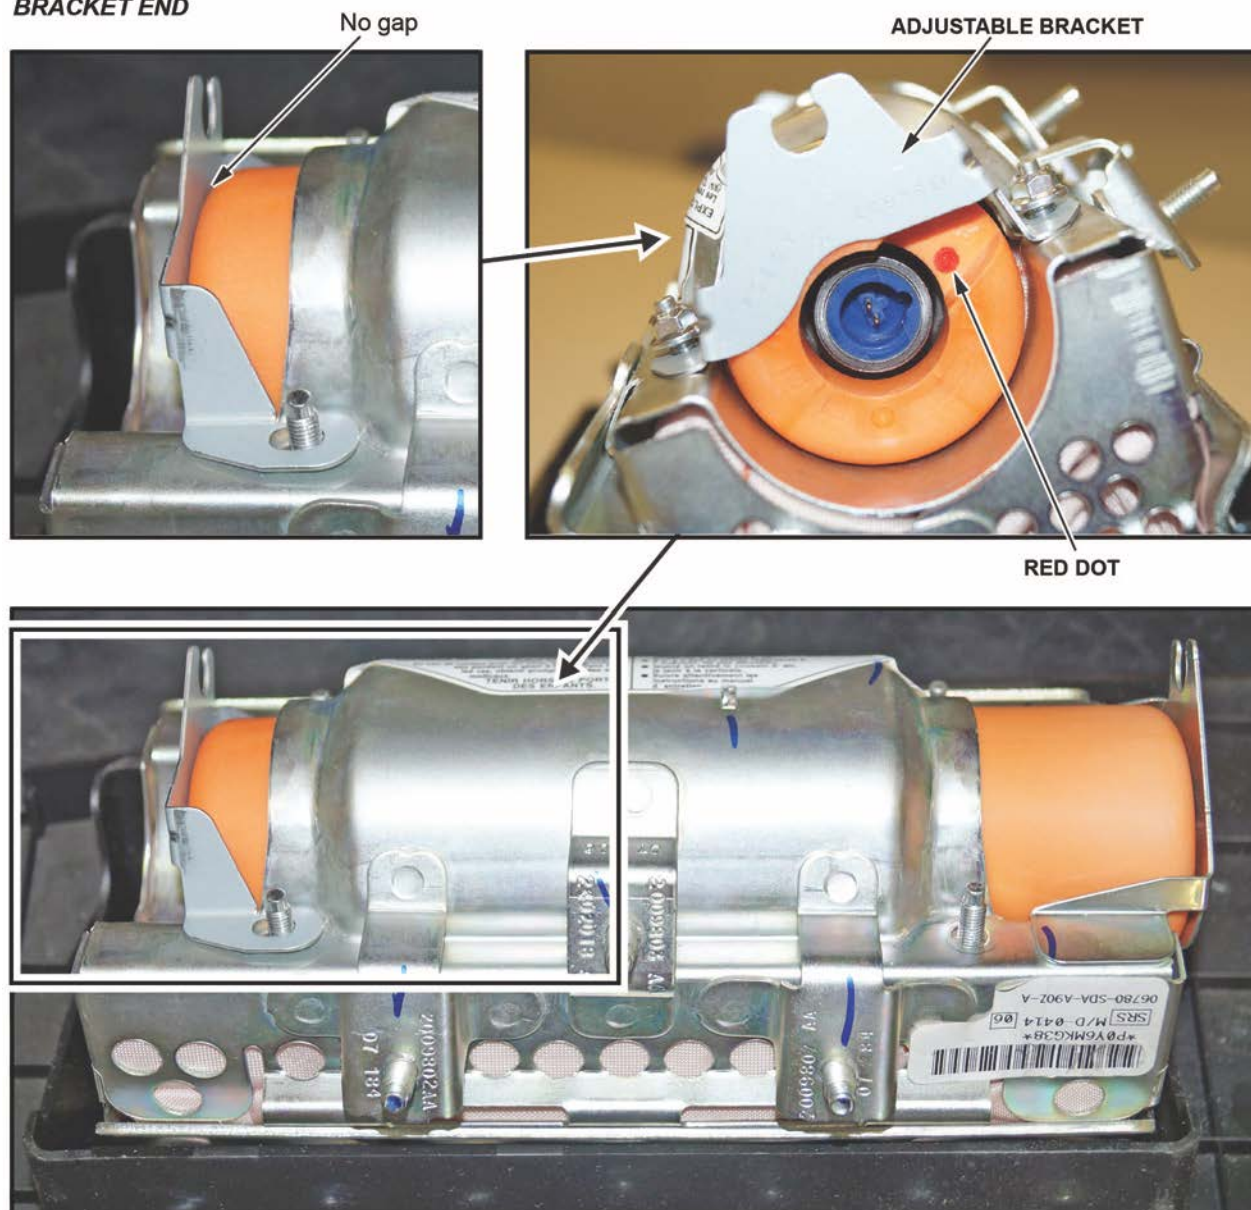
**ADJUSTABLE  
BRACKET END**

- Install the bracket included in the kit onto the airbag module. There should be a red dot visible on the end of the plastic connector. There should be no space or gap between the inflator and bracket.

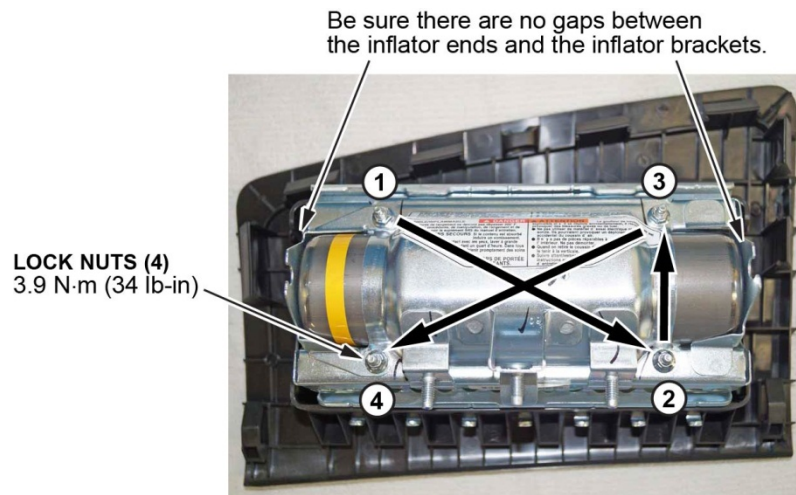
15. Install the new 5 mm locknuts and torque them in sequence to **3.9 N•m (34 lb-in)**.

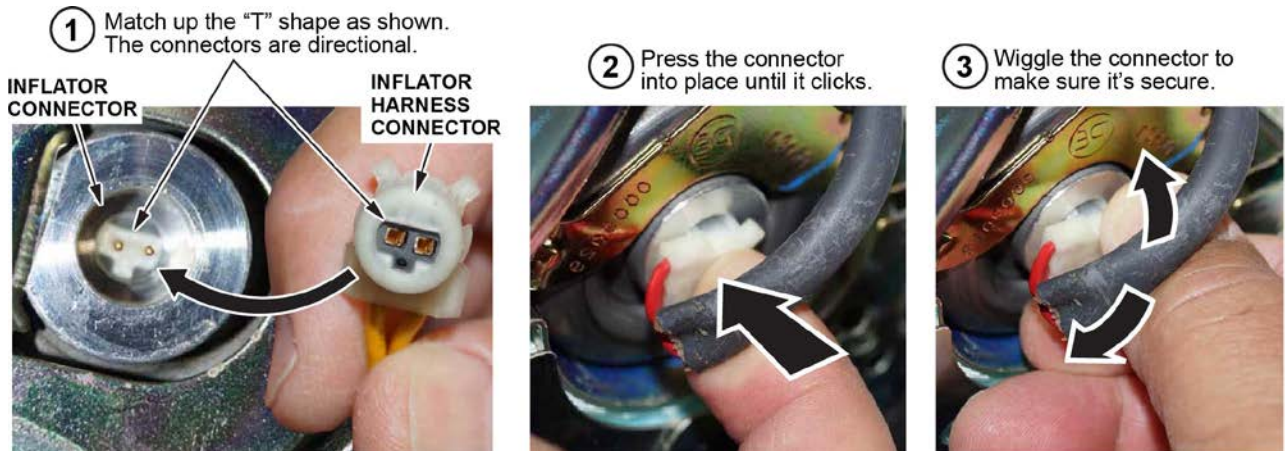
- Connect the two connectors. Align the “T” shape in the inflator harness connector with the T-shaped inflator connector, then press the connector into place.

- After you hear each connector click, wiggle it to make sure it is secure.

NOTE: If the connector is not properly aligned, it will come out.

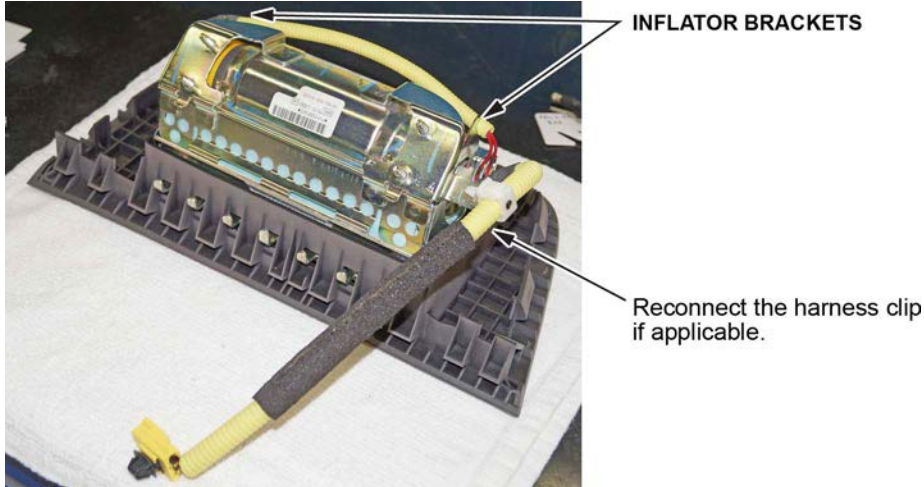
18. Connect the harness to the inflator brackets.

- Insert the side without the shrink wrap tubing first. Insert the harness at the third “valley” in the corrugated tube.
- Insert the side of the harness with the shrink wrap tubing into the inflator bracket. Make sure the harness is securely inserted and that it does not sag.

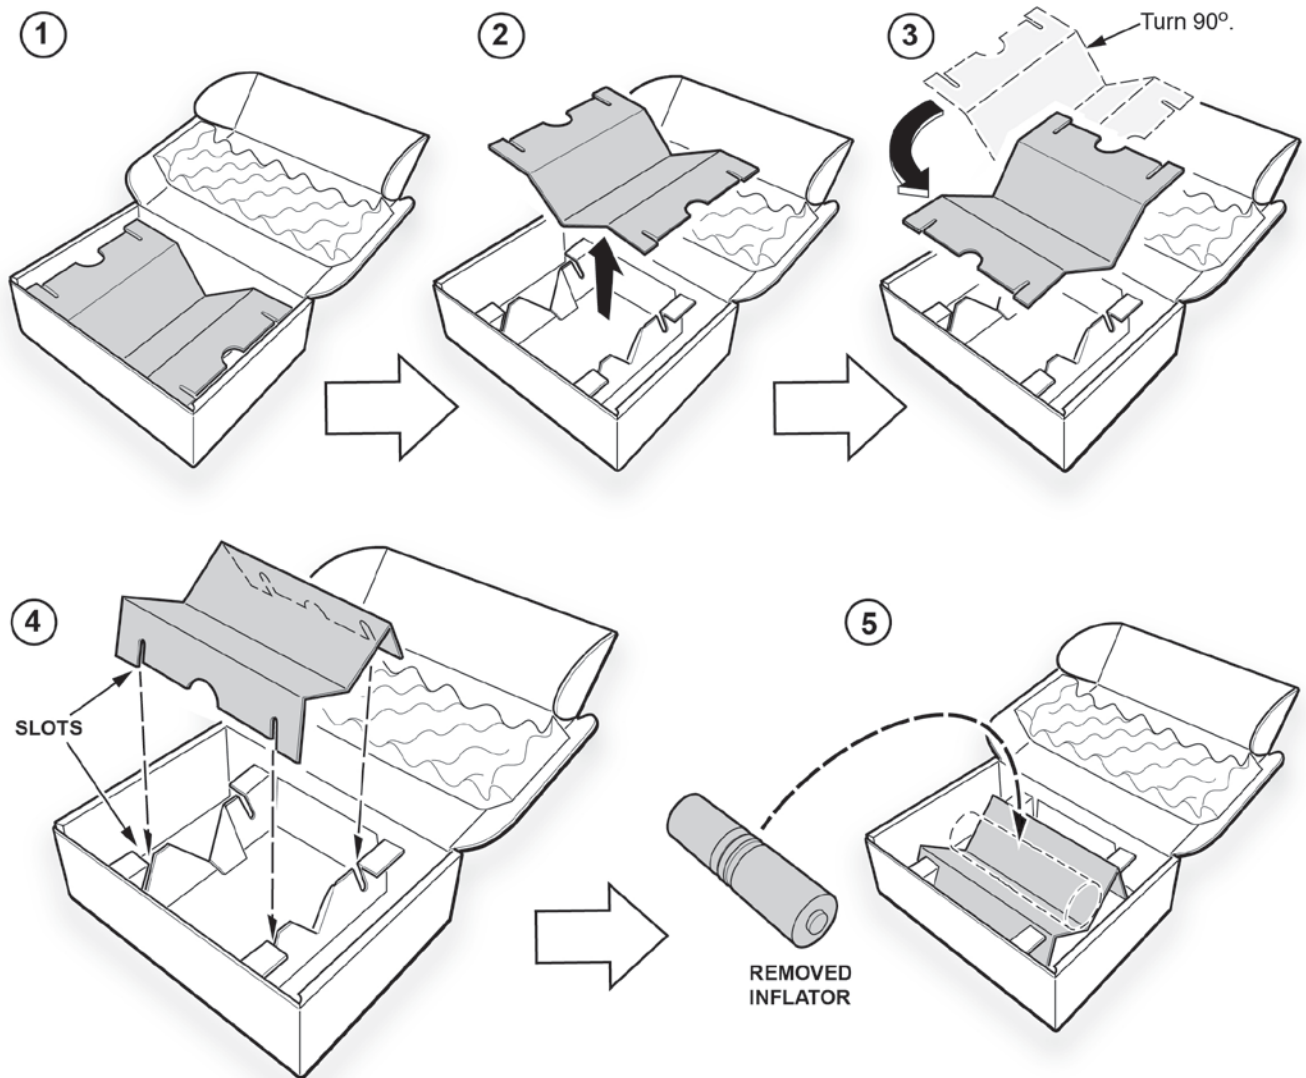
23. For boxes where the inflator came with shipping insulation (part number ends with 305 or 308): Remove the cardboard insert and turn it 90 degrees. Then insert the cardboard into the slots as shown.

- **Do not reuse the shipping insulation.**
- The cardboard insert needs to be adjusted to send back the original inflator otherwise the original inflator removed from the vehicle will rattle around and may be rejected by the courier.
