02518 Version 1

## Safety Recall: Front Passenger's Airbag Inflator Can Be Over-Pressurized

Year	Model	Trim	VIN Range
2003	MDX	ALL	Check the iN VIN status for eligibility

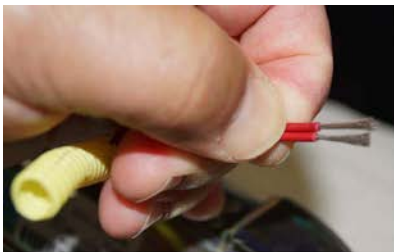
- Strip away about 1 inch of the wire insulation, then twist the wires together.

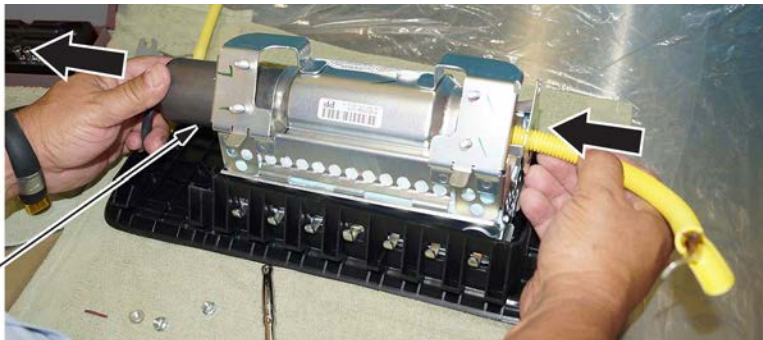
7. Remove the inflator by pushing it out.

INFLATOR  
Do not reuse.

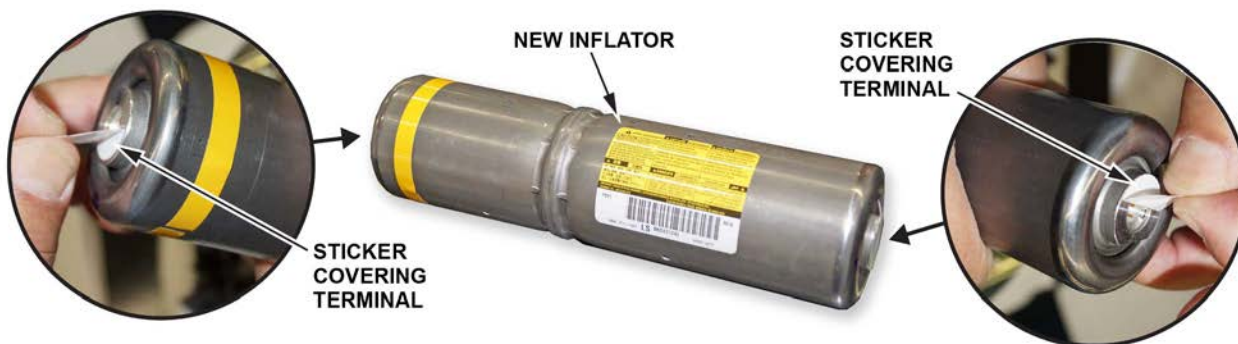
10. Remove the stickers covering the terminals on both sides of the new inflator.
