Safety Recall

Code: 47M3

Subject	Brake Line Fitting Torque
Release Date	June 09, 2015
Affected Vehicles	U.S.A.: 2015 MY Passat <i>Check Campaigns/Actions screen in Elsa on the day of repair to verify that a VIN qualifies for repair under this action. Elsa is the <u>only</u> valid campaign inquiry & verification source.</i> <ul style="list-style-type: none">✓ Campaign status must show "open."✓ If Elsa shows other open action(s), inform your customer so that the work can also be completed at the same time the vehicle is in the workshop for this campaign.
Problem Description	A brake line connection at the rear left (driver side) wheelhouse may have been improperly torqued during vehicle production. This may cause some brake fluid seepage and cause the brake line to become loose over time. If this happens, it could result in reduced braking performance in one brake circuit, potentially leading to an extended stopping distance and increasing the risk of a crash.

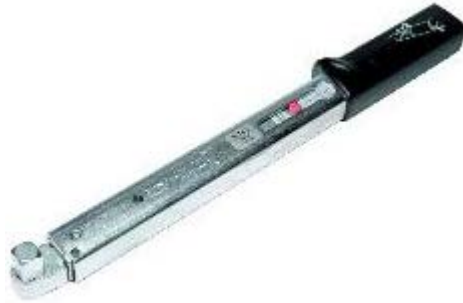
- Torque Wrench - 1331

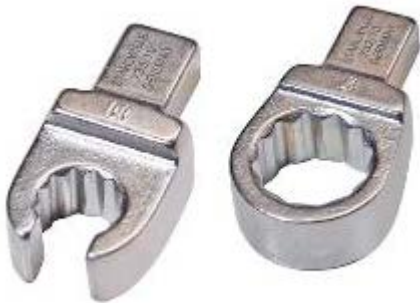
- Torque Wrench 1331 Insert – 11mm Ring Wrench

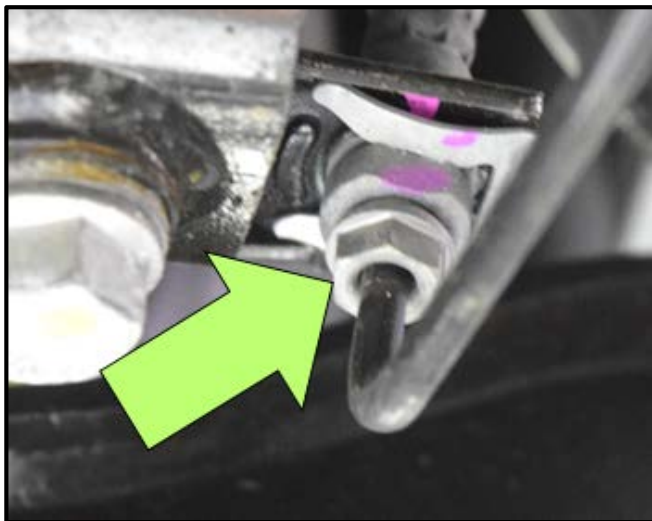
Section B – Torque Left Rear Brake Line Fitting

- Raise the vehicle on an appropriate hoist.
- Locate the brake line fitting between the left rear (driver) brake hose and the steel brake line <circle>.

- Counter-hold the brake hose flange, and torque the fitting <arrow> to **14 Nm** using Torque Wrench 1331 (or equivalent) and the 11mm ring wrench insert (or equivalent).
- Lower the hoist.

If a fluid leak is detected at this fitting, the fluid level in the brake fluid reservoir must be inspected and, if necessary, topped off.
