**Technical Service Bulletin**

**15-01-030**

**SONATA (LFA)**

**SUBJECT:** FRONT PASSENGER SEAT BELT BUCKLE COVER REPLACEMENT  
(RECALL CAMPAIGN 130)

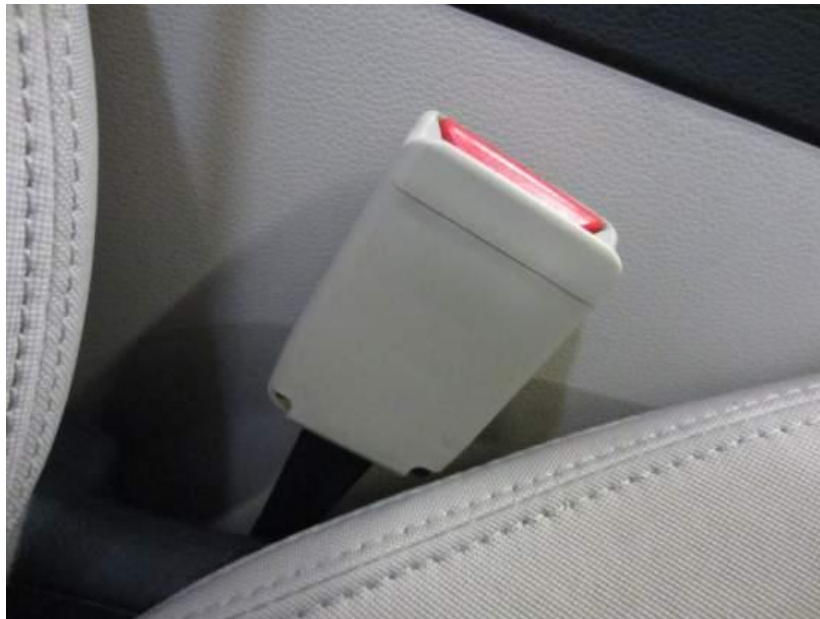
**Description:** On certain 2015MY (LFA) Sonata vehicles the passenger side seat belt buckle may jam when forcibly inserting the seat belt "tongue" into the buckle at an angle, preventing the front passenger from fastening the seat belt. The front passenger's seat belt warning lamp will illuminate if the front passenger seat belt is not buckled while the seat is occupied.

This condition does not result in partial latching of the belt, and does not affect the driver or rear passenger seat belt buckles.

This bulletin provides the service procedure to inspect the passenger seat belt buckle and install a new seat belt buckle lower cover (As needed).

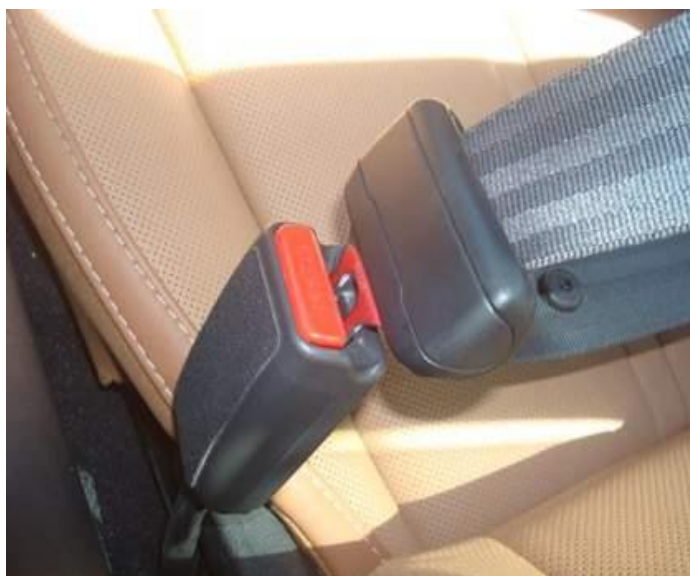
- Inspect the passenger side seat belt by inserting the tongue into the seat belt buckle. Ensure that the seat belt “tongue” fully engages the buckle and locks into place.
  - ***If Not*** – replace the seat belt buckle using the procedures outlined in the appropriate shop manual.
  - ***If Yes*** – Proceed to step 2 and replace the seat belt buckle lower cover.

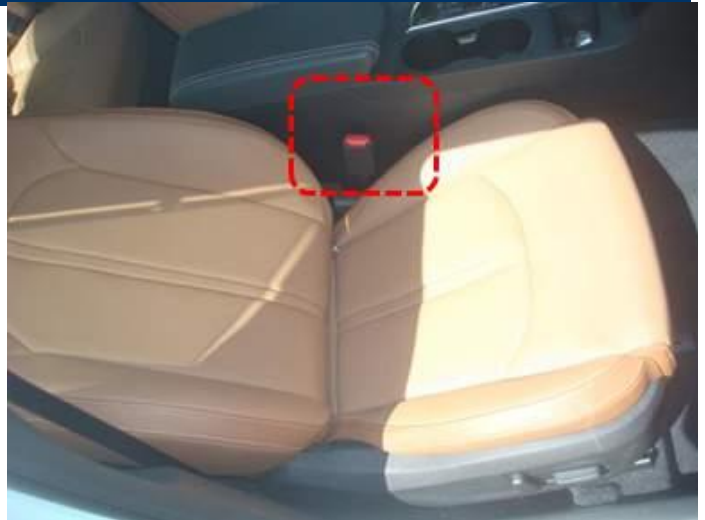
2. Lower the front passenger seat to the lowest position and tilt the seat back to the most reclined position to gain access to the front passenger seat belt buckle.

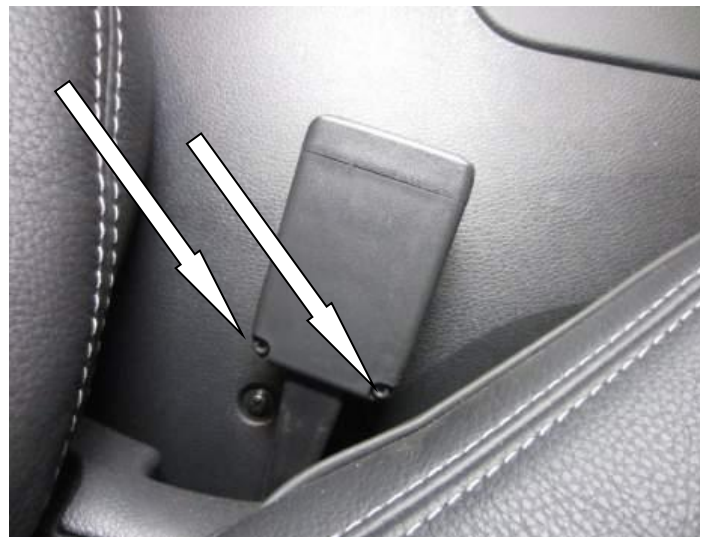
3. Carefully remove the two screws from the lower buckle cover using a Torx Driver (Size: T10H).

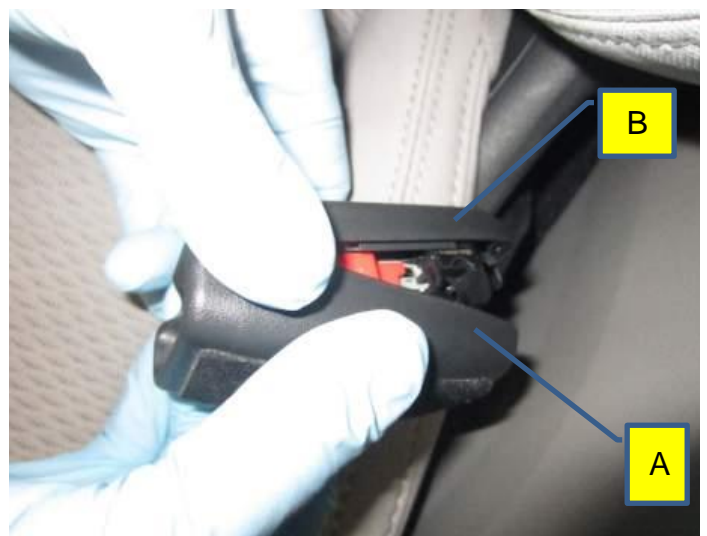
4. Carefully remove the “upper” buckle cover (A) by holding the “lower” cover (B) with one hand in place. Using the other hand, place a finger at the rear edge of the “upper” cover and lift the “upper” cover up and away from the buckle.

**Upper cover must be removed first or damage to the upper cover can occur.**

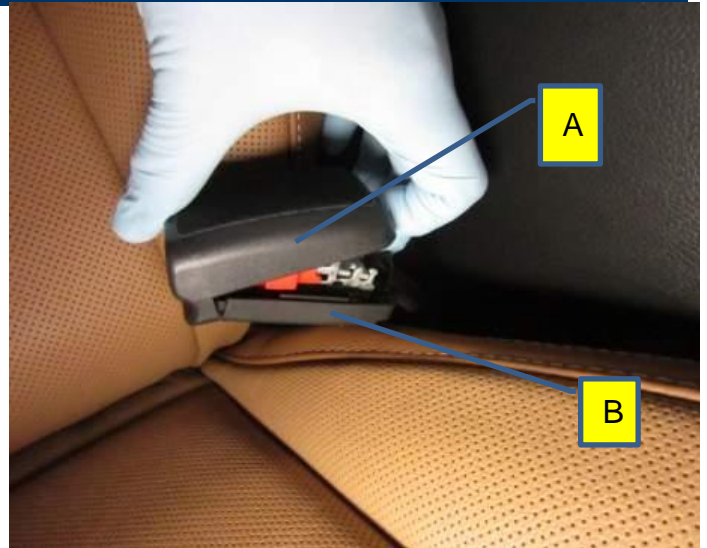
5. This shows the "Upper" cover removed.

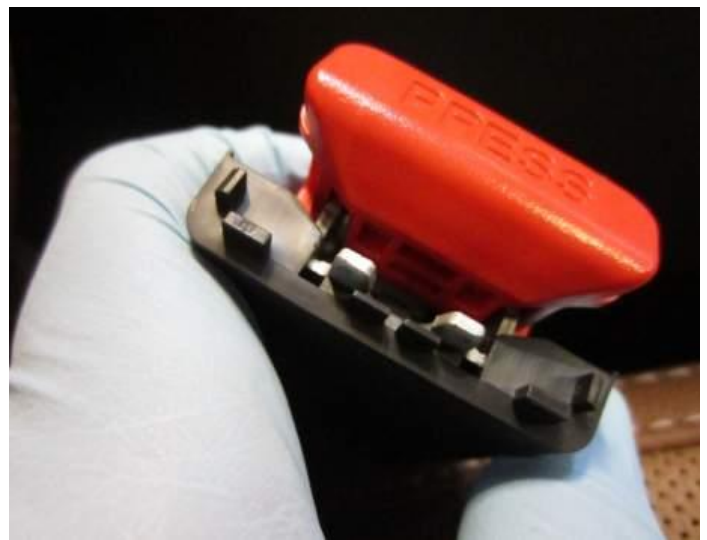
6. Remove the "lower" cover and discard.

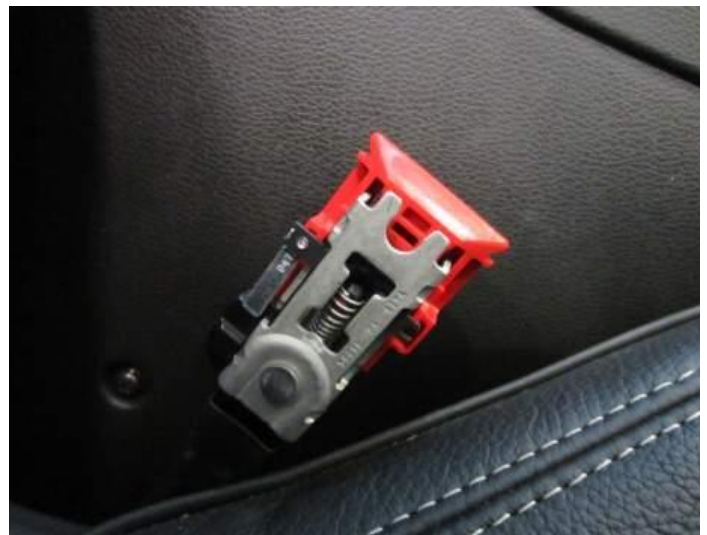
7. Install the new “lower” cover (with metal shield) by fitting the cover into the buckle mechanism. The cover should fit tight against the buckle.

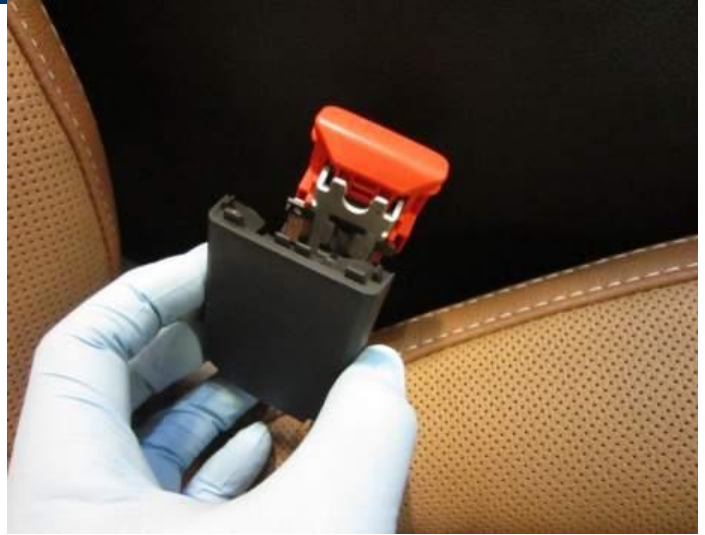
The picture to the right of this text shows the new “lower” cover.

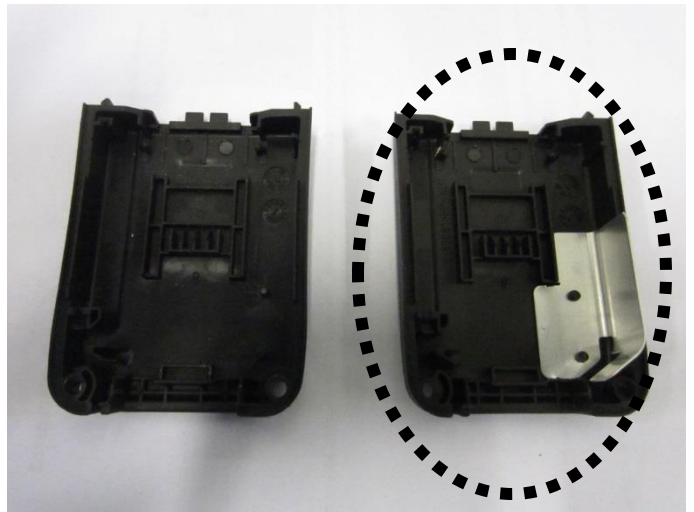
8. Re-install the original “upper” cover onto the new “Lower” cover and snap back into position.

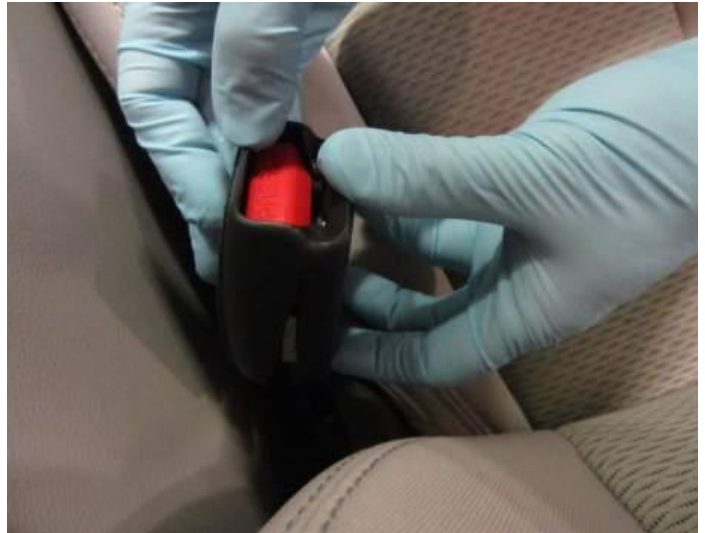
9. Re-install the T10H screws. Fully seat the first screw before installing the second screw. Ensure that the screws are tight and that the screws are fully seated with no gaps between the covers.

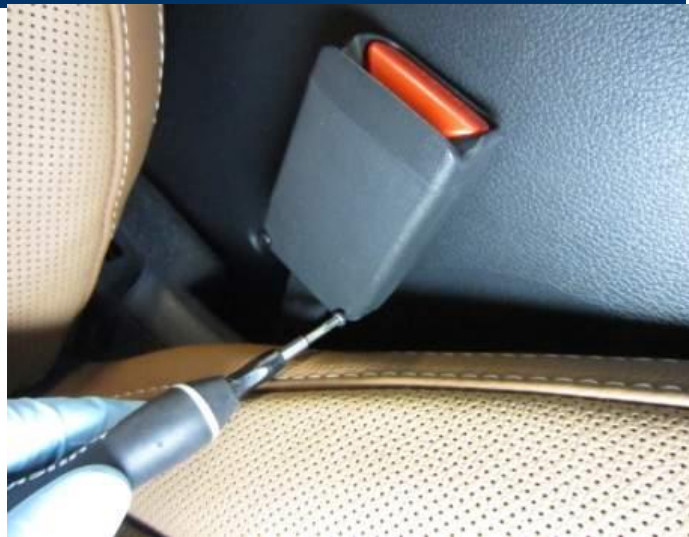
The picture to the right of this text shows the screw fully seated with no gap between the covers.

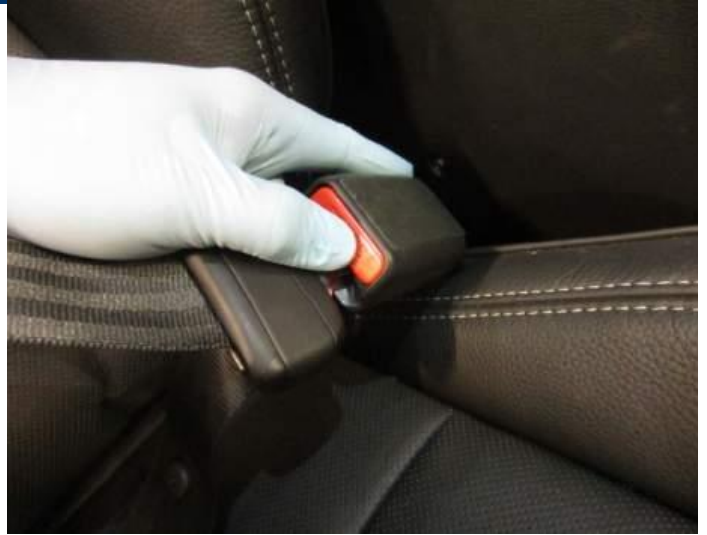
11. Check and erase any related DTC.

Clear Blue Link DTC per TSB  
12-BE-005-02.
