September 17, 2015

02111 Version 3

Safety Recall: A/C Compressor Clutch (Center) Bolt

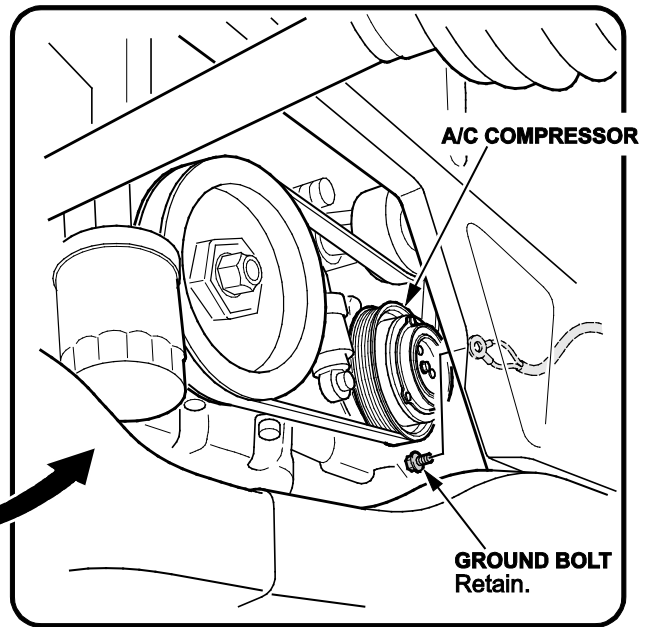
6. Remove the G202 ground bolt.

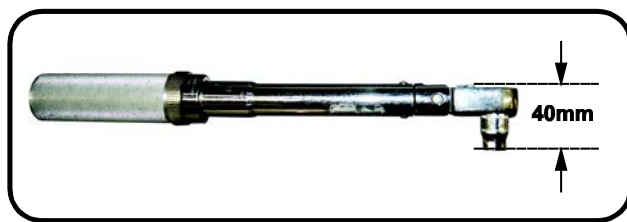
4. Install the new A/C compressor clutch bolt using T/N OTCJ33027A and torque the bolt to **12 N·m (9 lb-ft)**.

- Make sure you torque the bolt to 12 N·m (9 lb-ft); do not use a higher value or you may break the bolt.
- **The A/C compressor clutch bolt is a one time use bolt.** If after installing the bolt, you need to remove it for any reason, including setting the compressor clutch clearance, you need to replace it with a new one.

For clearance, the distance from the tip of the socket to the back of the torque wrench should not exceed 40mm.

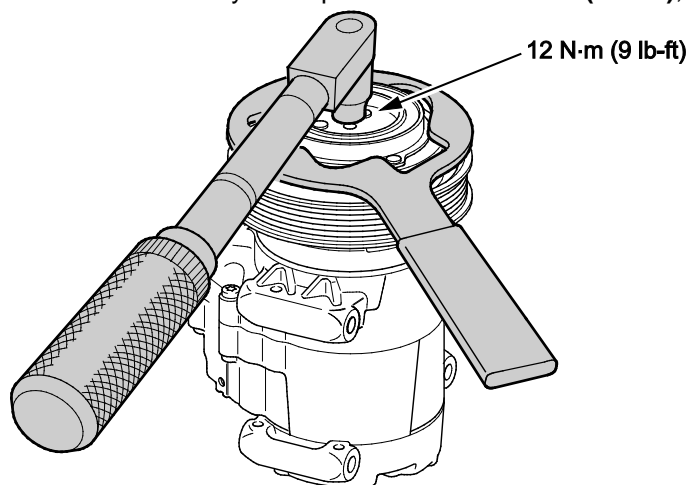
- Transfer the A/C compressor clutch and coil even if the broken bolt cannot be removed. In rare cases, the A/C compressor clutch and coil cannot be transferred to the new unit. In these cases, replace the A/C compressor clutch and coil.
 - **The A/C compressor clutch bolt is a one time use bolt.** If after installing the bolt, you need to remove it for any reason, including setting the compressor clutch clearance, you need to replace it with a new one.
3. Install the new A/C compressor clutch bolt, then torque the bolt to **12 N·m (9 lb-ft)** using T/N OTCJ33027A.

NOTE: Make sure you torque the bolt to **12 N·m (9 lb-ft)**; **do not use a higher value or you may break the bolt.**

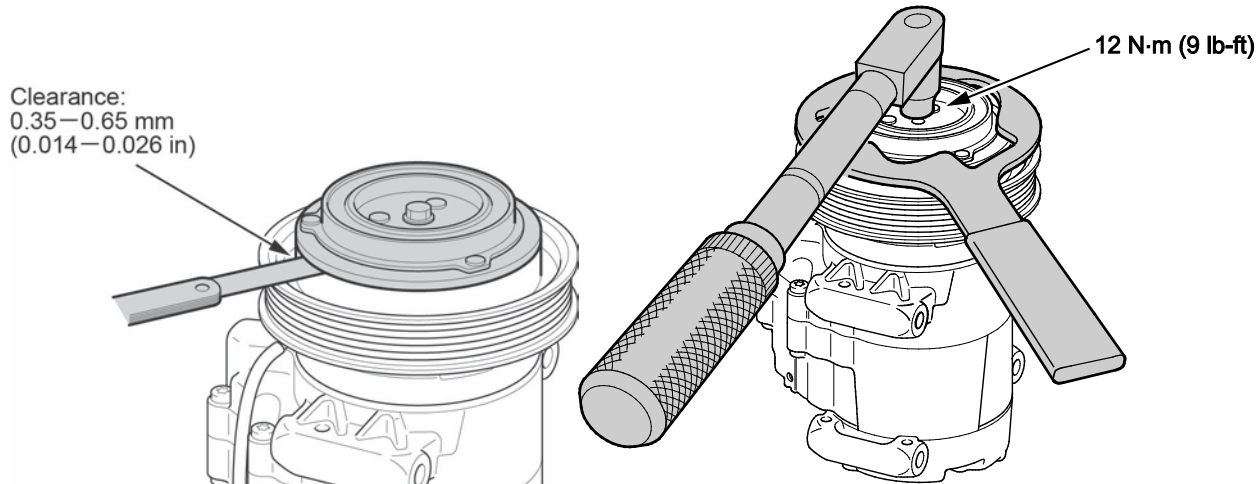
- Transfer the A/C compressor coil even if the broken bolt cannot be removed. In rare cases, you may not be able to transfer the coil. In these cases, replace it with a new one.
 - **The A/C compressor clutch bolt is a one time use bolt.** If after installing the bolt, you need to remove it for any reason, including setting the compressor clutch clearance, you need to replace it with a new one.
4. Use compressed air to blow any debris out of the shaft threads.
 5. Replace the clutch set.
 6. Adjust the A/C compressor clutch clearance to 0.35–0.65 mm (0.014–0.026 in.) using the shims supplied with the clutch set, then torque the A/C compressor clutch bolt to **12 N·m (9 lb-ft)** using T/N OTCJ33027A.

NOTE: Make sure you torque the bolt to **12 N·m (9 lb-ft)**; do not use a higher value or you may break the bolt.
