## Safety Recall: 2016 Pilot Third Row Seat Belt Inspection

### BACKGROUND

The third row seat belts are trapped under the third row seat trim.

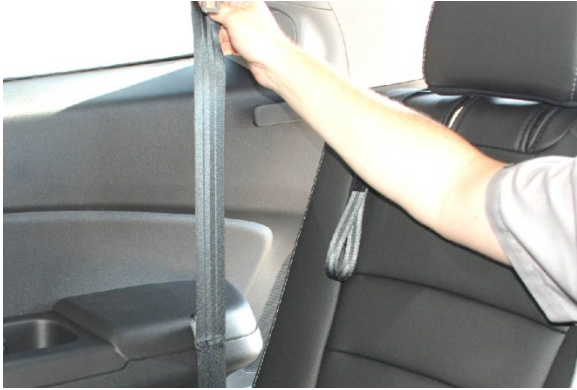
1. Make sure the third row seats are in the upright position. If the third row seat belts are buckled, unbuckle them, and pull them straight up making sure they are fully retracted.

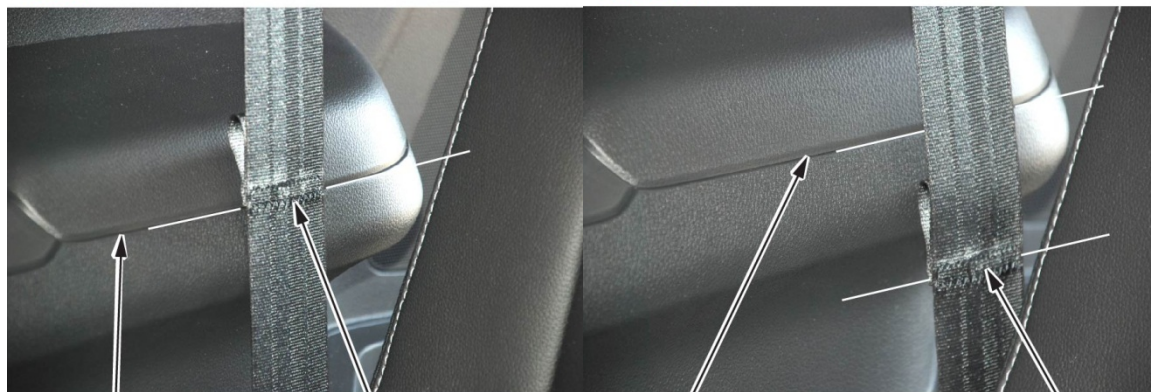
2. Compare the stitching on the seat belt with the edge of the third row side panel arm rest.

- If the seat belt stitching lines up with the edge of the third row arm rest as shown, the seat belt is Good.
- If the seat belt stitching DOES NOT line up with the edge of the third row arm rest, go to step REPAIR PROCEDURE.

GOOD

NO GOOD

SEAM ON  
INTERIOR TRIM

STITCHING ON  
SEAT BELT

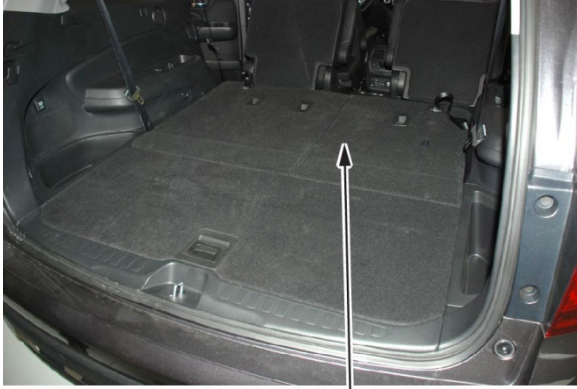
THIRD ROW  
SEATS

1. Fold the third row seat down.

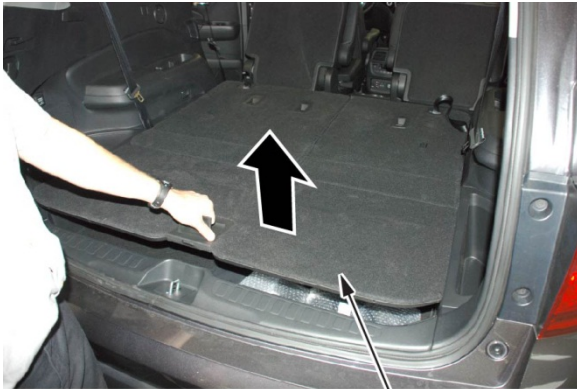
CARGO LID

2. Remove the cargo lid.

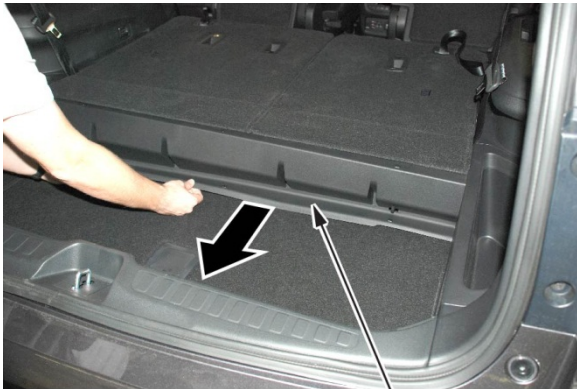
CARGO AREA TRIM

3. Remove the cargo area trim.

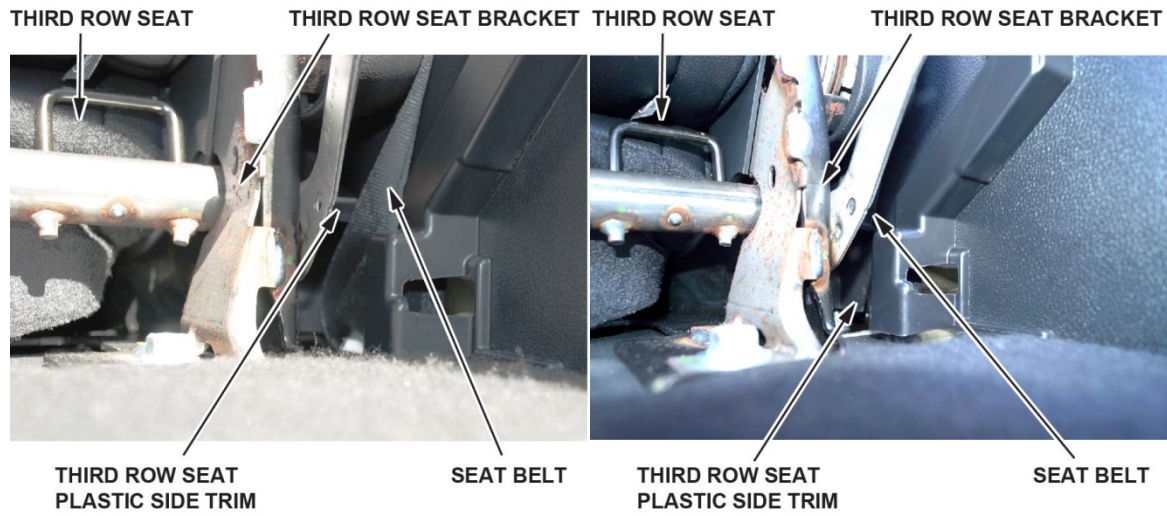
4. While pulling up on the seat belt, maneuver the seat belt from beneath the third row seat side trim to release the belt.

**NO GOOD**

**GOOD**

5. Reinstall the parts in the reverse order of removal.
