Safety Recall R36 / NHTSA 15V-459

Steering Wheel Wiring

2012 – 2014	(DS) RAM 1500 Pickup
2012 – 2014	(DJ) RAM 2500 Pickup
2012 – 2014	(D2) RAM 3500 Pickup
2012 – 2014	(DD) RAM 3500 Cab Chassis
2012 – 2014	(DP) RAM 4500/5500 Cab Chassis

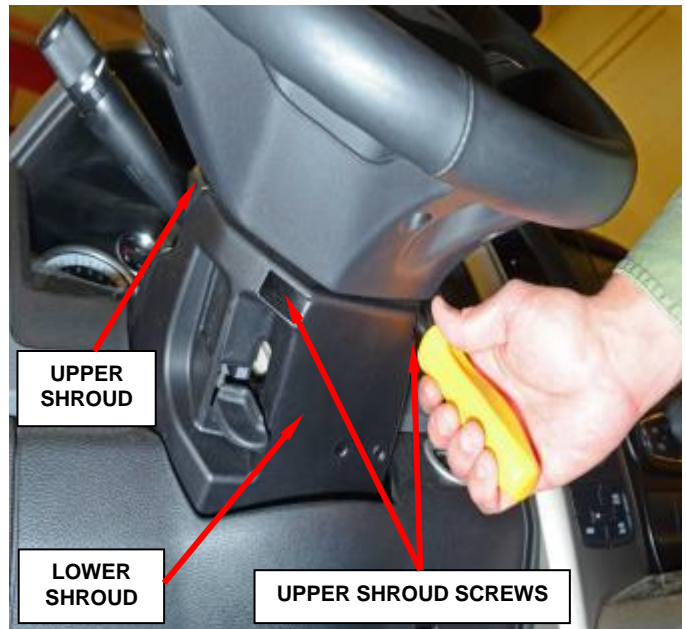
Figure 1 – Upper Shroud Screw Locations

1. Disconnect and isolate the negative battery cable. Wait two minutes for the system capacitor to discharge before further service.
2. Remove the two upper shroud screws from the steering column and remove the upper shroud (Figure 1).
3. Release the steering column tilt lever and lower the column to its most downward position for easiest driver airbag removal access.
4. There are three driver airbag (DAB) retainer access holes on the instrument panel side of the hub of the steering wheel, located at the two o'clock, six o'clock and ten o'clock positions. The steering wheel must be rotated to bring each of these access holes up to the twelve o'clock position of the steering column one at a time for removal access.

24. Reinstall the upper shroud onto the steering column (Figure 1).

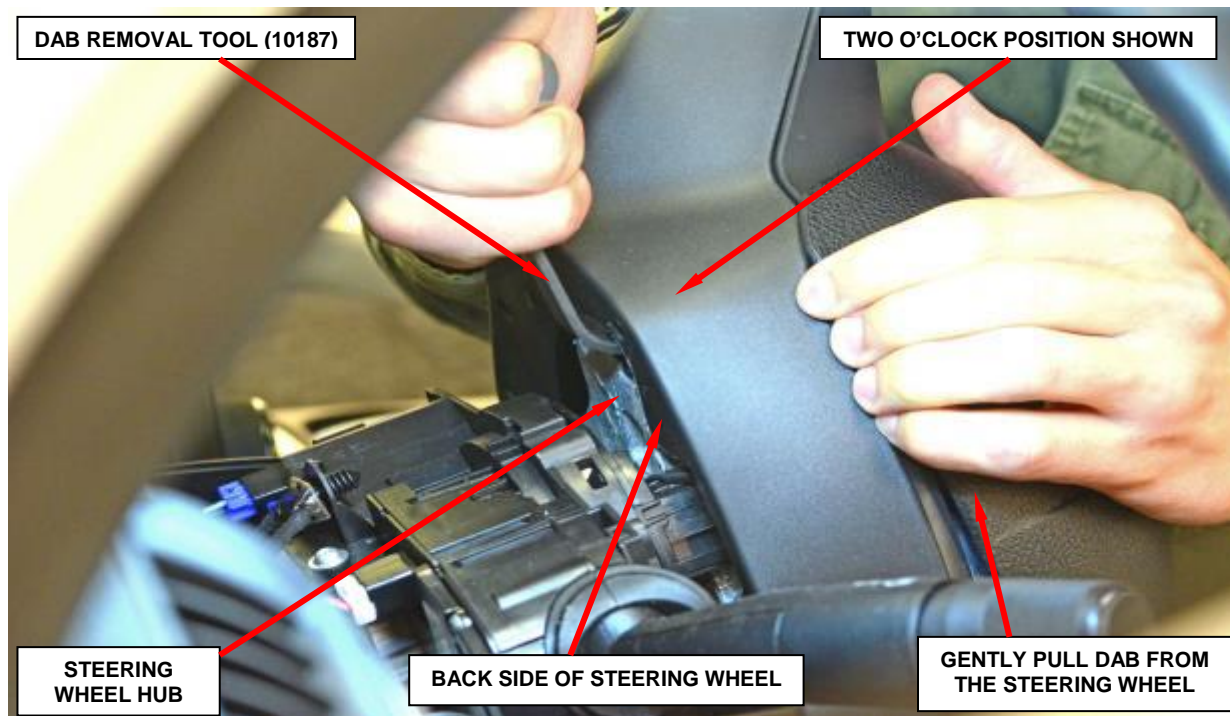
**Figure 2 – DAB Removal Tool (10187)**

5. Insert the short blade (Tip A) of the DAB Removal Tool (Special Tool Number 10187) or the blade of an equivalent prying tool into either of the upper (two o'clock or ten o'clock) access holes of the steering wheel hub rear trim cover, being certain to place the blade of the tool on the inboard (steering wheel hub) side of the airbag snap retainer wire loop (Figure 2).

6. Push the handle of the tool downward for the blade to pry the snap retainer wire loop upward far enough to disengage the loop from the hook of the steering wheel armature. At the same time, gently pull the DAB away from the steering wheel to prevent the retainer from snapping back into place over the hook once it is disengaged (Figure 2).

7. Repeat Steps 5 and 6 at the other upper (two o'clock or ten o'clock) access hole to disengage the other upper snap retainer wire loop.
8. Repeat Steps 5 and 6 at the lower (six o'clock) access hole to disengage the lower snap retainer wire loop. The lower snap retainer wire loop has a distinctive V-shape and must always be installed onto the six o'clock hook of the steering wheel armature.

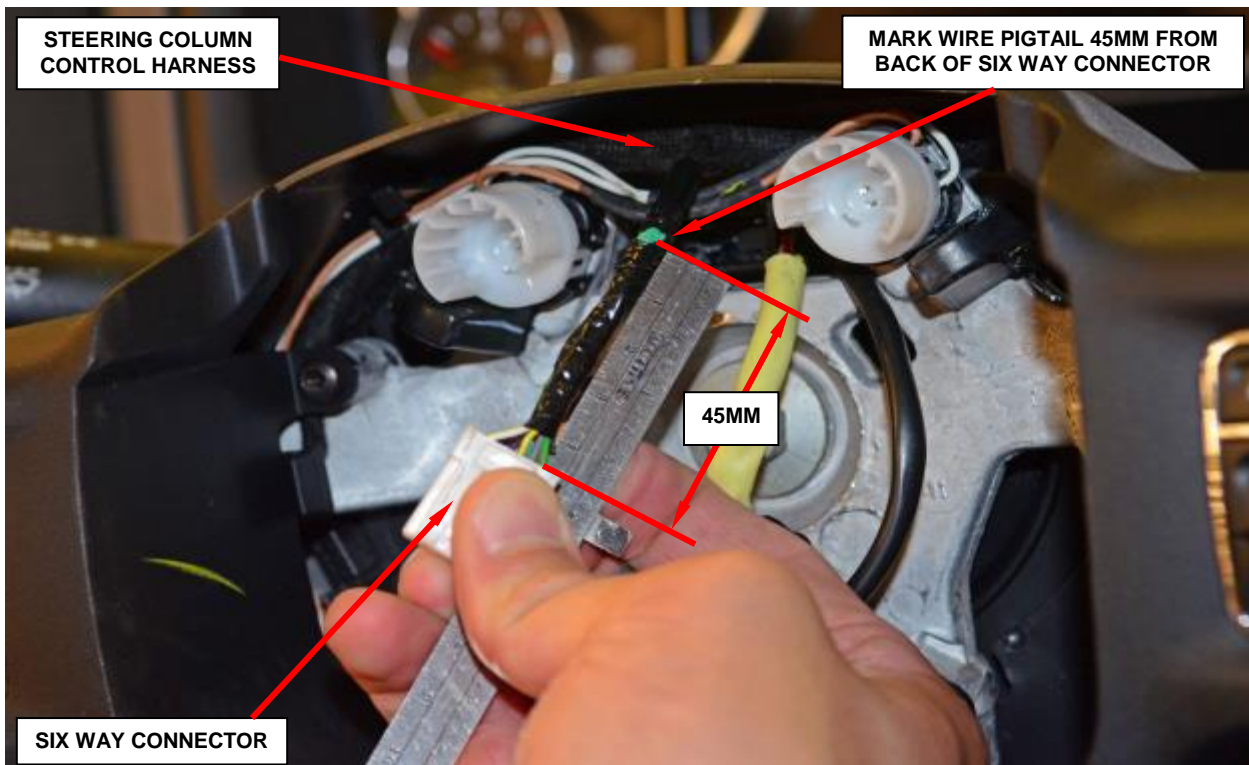
Figure 6 – Mark Wire Harness for Reference

14. Measure 45mm from the back of the six way connector and mark the wire pigtail for reference in step 15 (Figure 6).

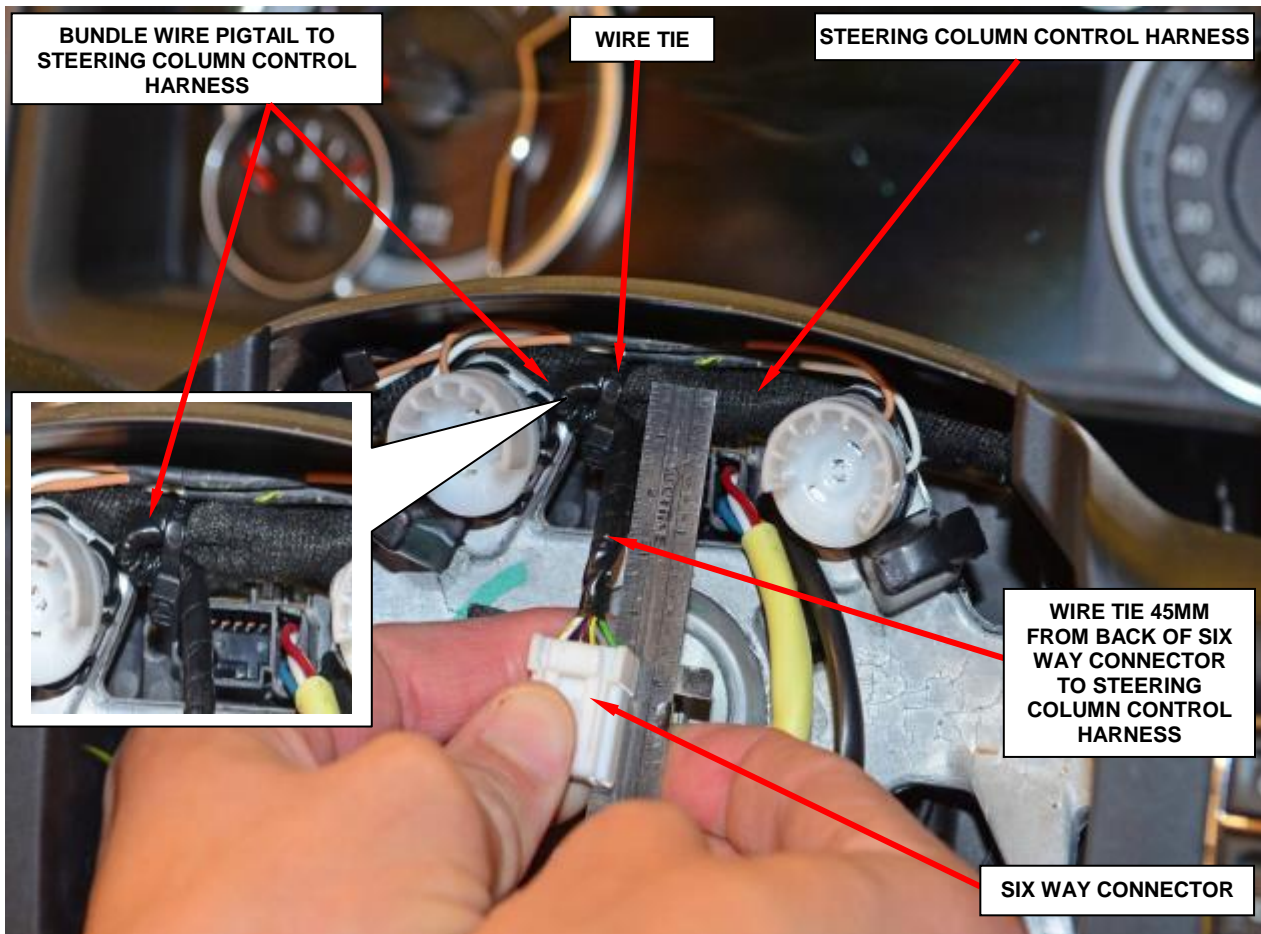
Figure 7 – Wire Tie Installation

15. Bundle the wire pigtail together to the steering column control harness with the supplied wire tie. Use the mark on the wire harness from step 14 as a reference to assure the final length of the wire harness is 45 mm from the steering column control harness. (Figure 7).

16. Cut off the excess wire tie tail.

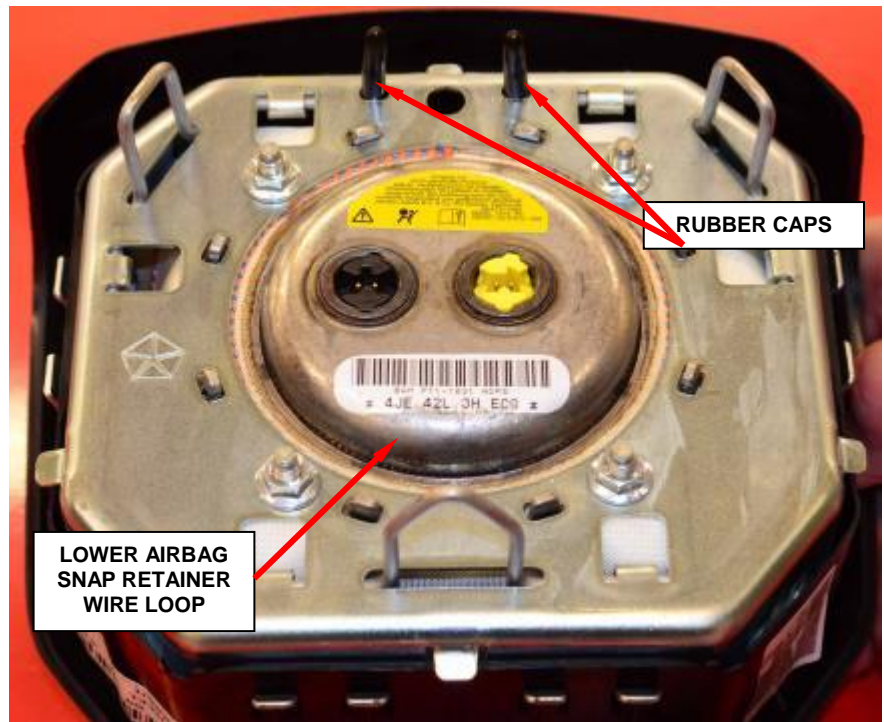
**Figure 8 – Rubber Caps**

17. Position the horn wiring back into the clip (Figure 5).
18. Connect the steering wheel wire harness six way connector (Figure 4).
19. Install the two rubber caps to the two posts on the back side of the driver airbag module (Figure 8).

NOTE: Fully seat the rubber caps onto the posts. The rubber caps are designed to be slightly longer than the posts.

22. Engage the lower airbag snap retainer wire loop onto the lower hook of the steering wheel armature. The lower snap retainer wire loop has a distinctive V-shape and must always be installed onto the six o'clock hook of the steering wheel armature (Figure 8).
