Dealer Service Instructions for:

Safety Recall R24 / NHTSA 15V-470

Power Distribution Center Electrical Connector

2015 (UF) Chrysler 200

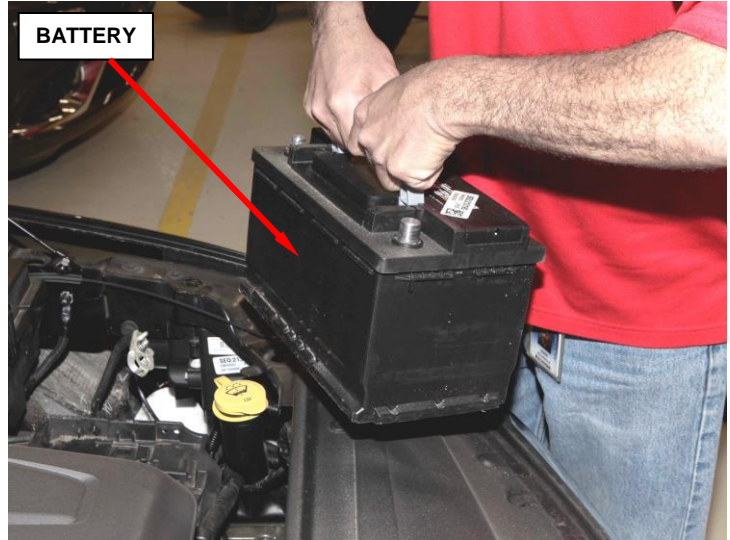
Figure 1 - Battery

1. Open the hood.
2. Remove and save the battery (Figure 1).
3. Remove and save the Power Distribution Center (PDC) cover.
4. Remove and save the Z-case fuse array retaining nut (Figure 2).

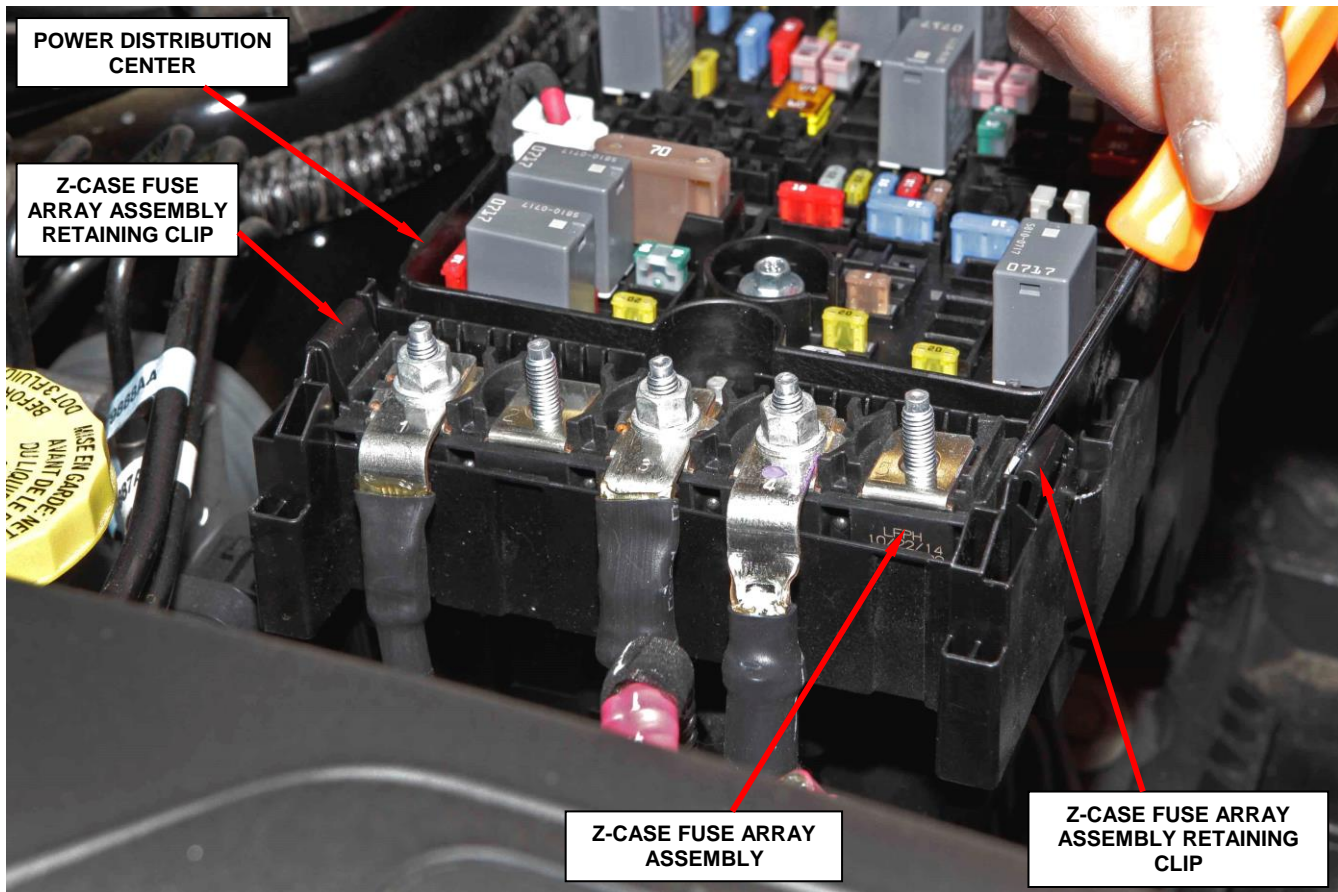
Figure 3 – Z-Case Fuse Array Assembly

5. Disengage the Z-case fuse array retaining clips and separate the Z-case fuse array assembly from the PDC (Figure 3).

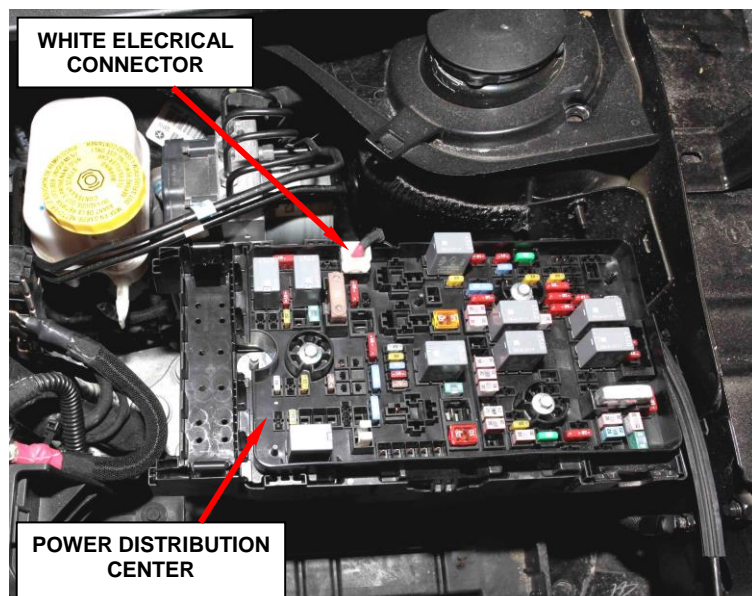
Figure 4 – White Electrical Connector

6. Disconnect the white electrical connector from the PDC (Figure 4).

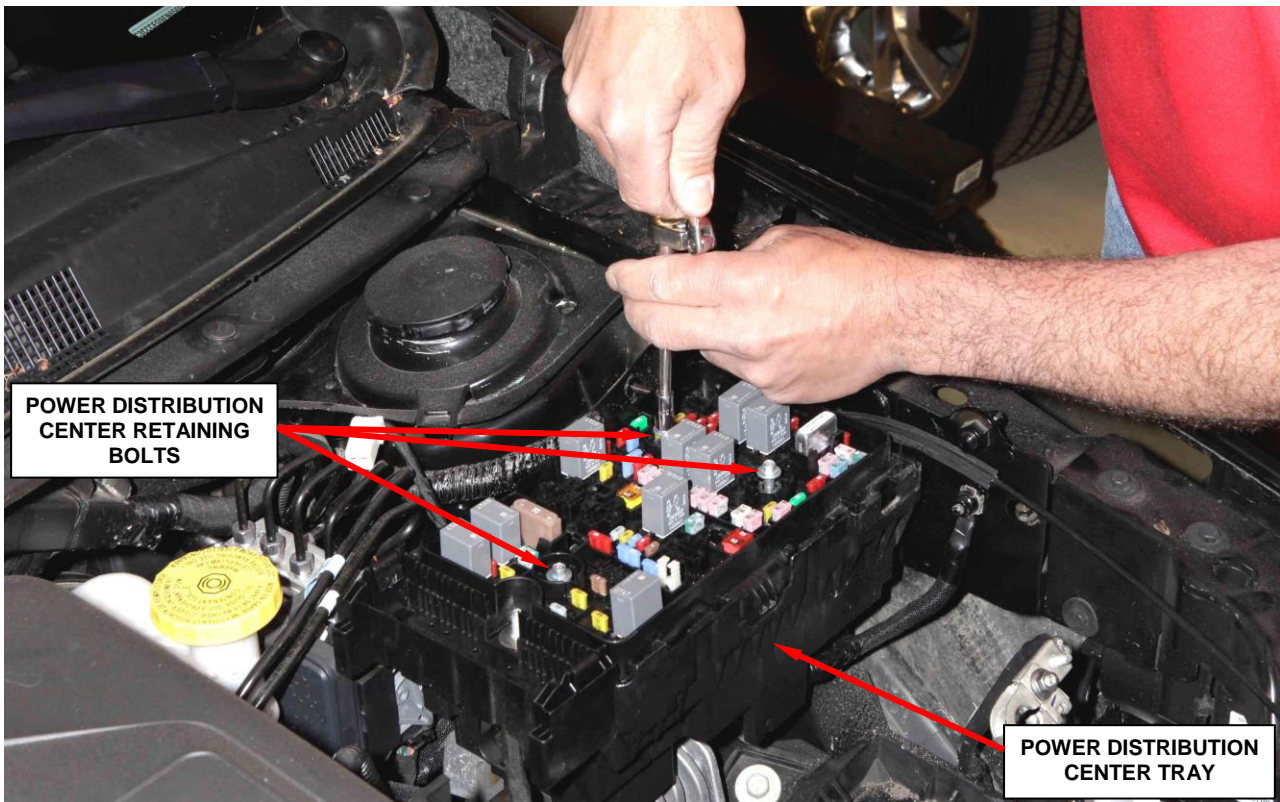
Figure 5 – PDC Retaining Bolts

7. Loosen the three PDC retaining bolts (Figure 5).

CAUTION: The three PDC retaining bolts in the PDC are captured bolts that cannot be removed from the PDC. They can only be loosened. Do not attempt to remove the three PDC retaining bolts.

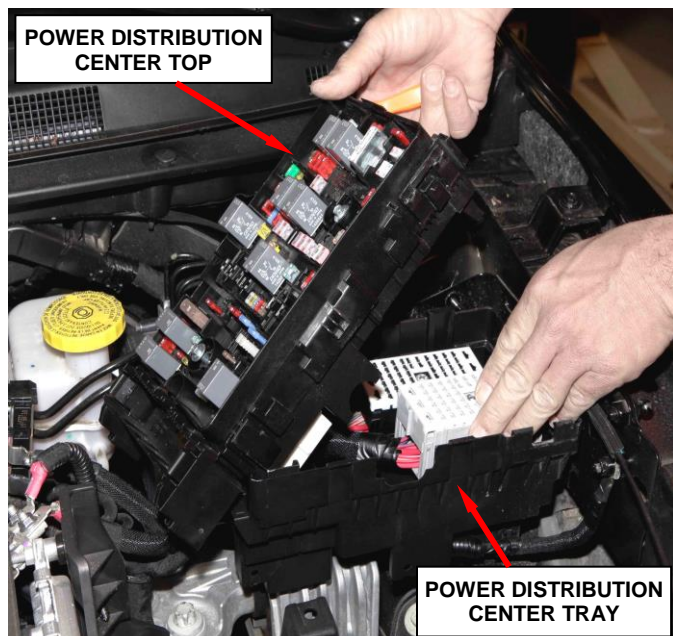
Figure 6 – PDC Top Cover

8. Release the plastic PDC retaining clips and lift the PDC top from the PDC tray (Figure 6).

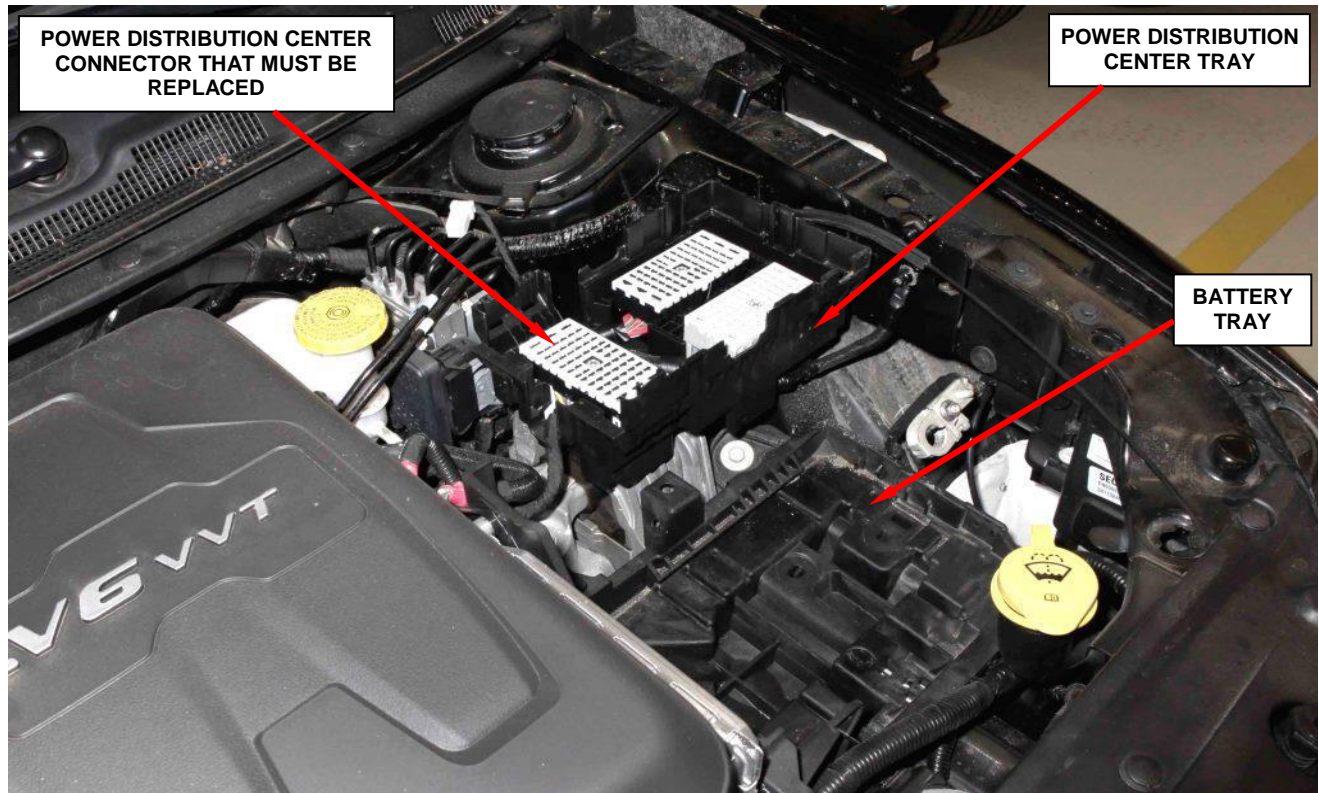
Figure 7 – Locate the Correct Electrical Connector

9. Carefully disconnect the three PDC electrical connectors from the bottoms side of the PDC top cover.
10. Locate the correct PDC electrical connector that is being replaced (Figure 7).
11. Remove and discard the PDC electrical connector white plastic back cover (Figure 8).

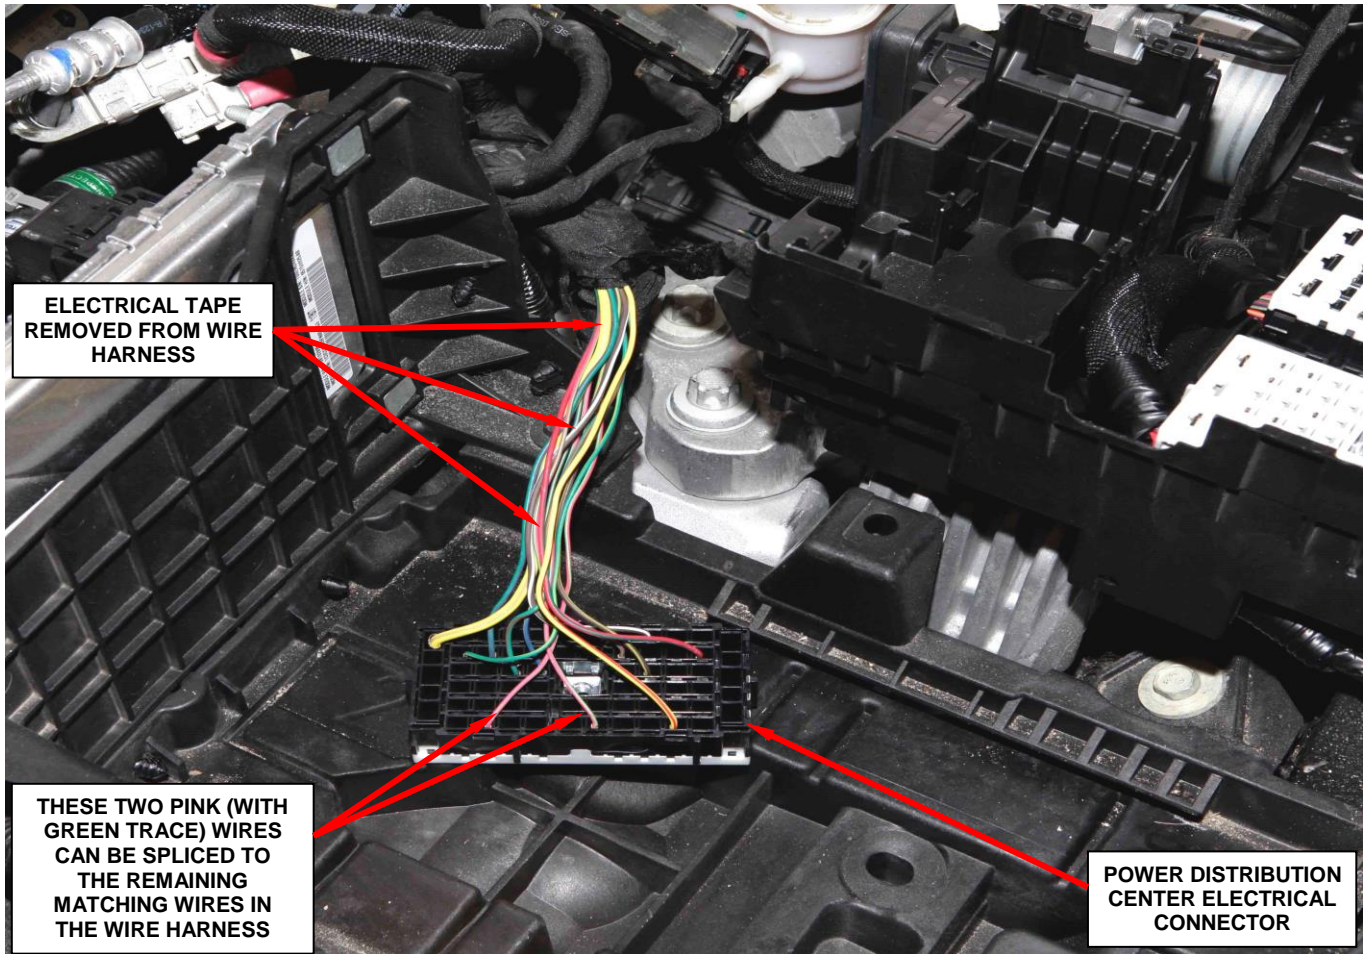
Figure 9 – Wire Harness Tape

12. Remove the wire harness tape all the way back to the main wire harness (Figure 9).

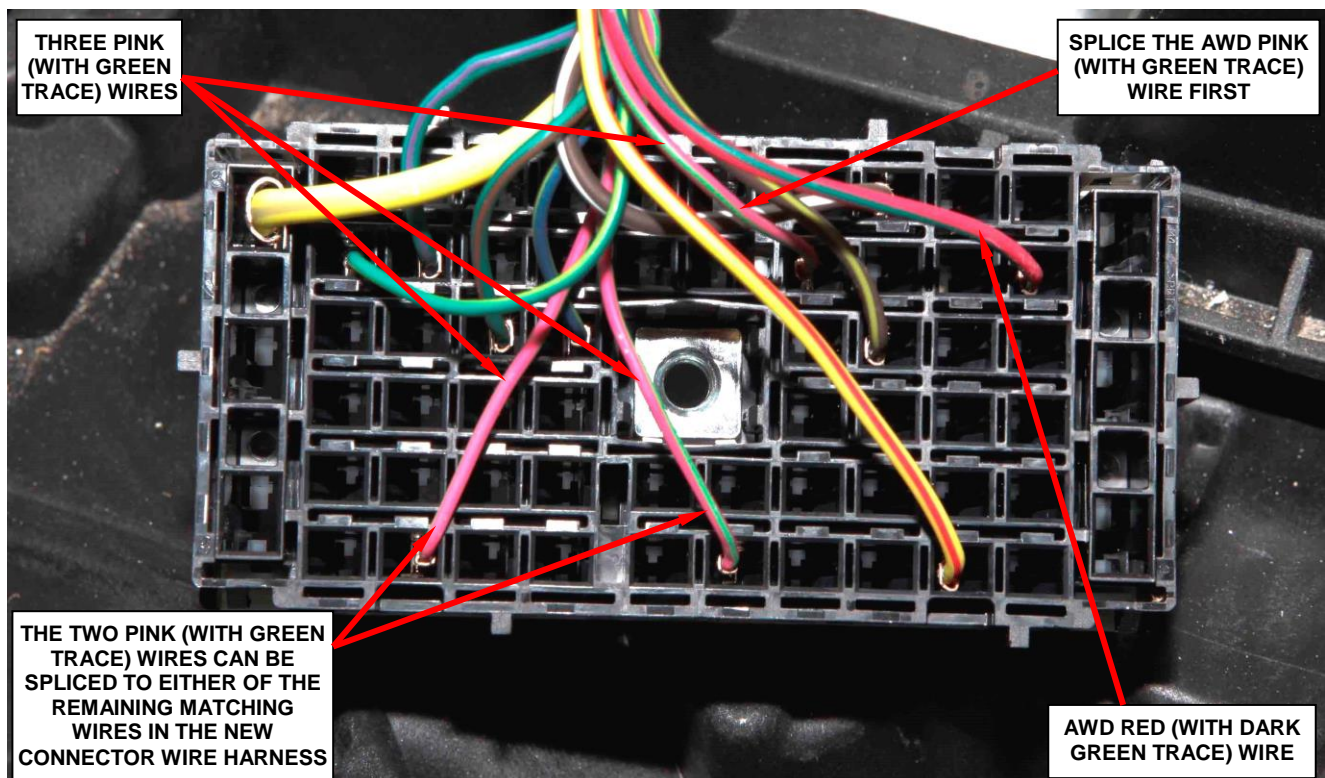
Figure 10 – Wire Color Identification

13. **For All Wheel Drive vehicles**, there are two additional wires for the All Wheel Drive (AWD) system (red wire with a dark green trace and pink wire with a light green trace).

One of the additional wires for AWD is the same color and has the same trace strip (pink with green trace) as two other wires in the PDC electrical connector (Figure 10). **Cut and splice the AWD pink with green trace wire first to prevent splicing the wrong wires together** (Figure 10).

NOTE: The other two wires that have same color and have the same tracer strip (pink with green trace) are interchangeable with each other (Figure 10). Only the AWD pink with green trace wire has a dedicated cavity in the PDC electrical connector.

SPECIAL NOTE: All repair kits will identify the pink with green trace AWD wire with a paper tag (“AWD ONLY”) and some of the repair kits will identify both of the AWD wires with a paper tags (depending on repair kit build date).

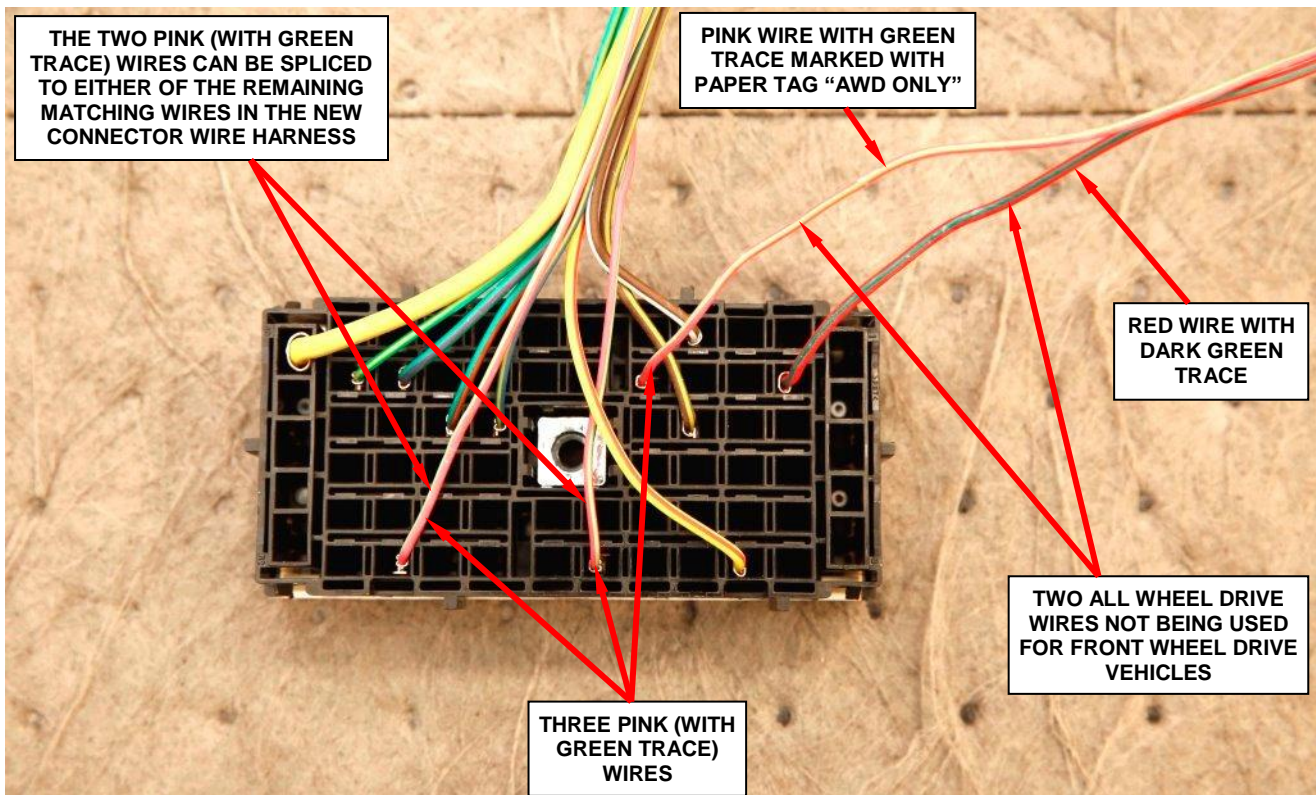
Figure 11 – AWD Wires Not Being Used and Must Be Taped Back to the Wire Harness

14. **For Vehicles not equipped with AWD**, there are two additional wires for the All Wheel Drive (AWD) system (red with a dark green trace wire and pink with a light green trace wire) that will not be used (Figure 11).

The two wires used on AWD vehicles on the new electrical connector will not be connected and must be taped back to the wire harness after all other wire splices are complete.

NOTE: There are two wires that have same color and have the same tracer strip (pink with green trace) (Figure 11). They are interchangeable when being spliced to the original wire harness. As long as the wire colors on the new connector match the wire colors on the original wire harness, orientation of these two wires to the original wire harness is not connector cavity specific.

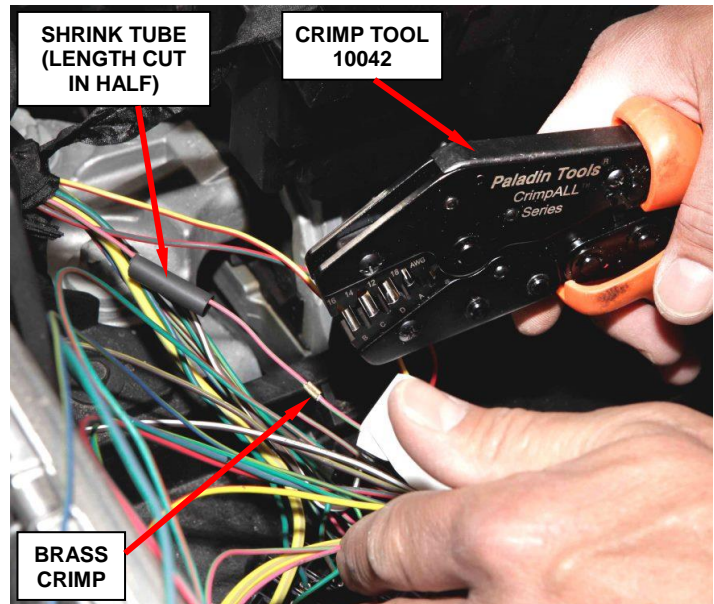
Figure 12 – Splice Wires and Band Clamp

- b. Place the black shrink tube provided in the repair kit over the cut wires (Figure 12).

NOTE: The shrink tube for this application is too long. Cut the shrink tube length in half before installing it onto the wire.

- c. Using the supplied splice band clamps and crimp tool 10042, crimp the wires that had the insulation stripped on the wire harness side to the matching color wire (Figure 12).

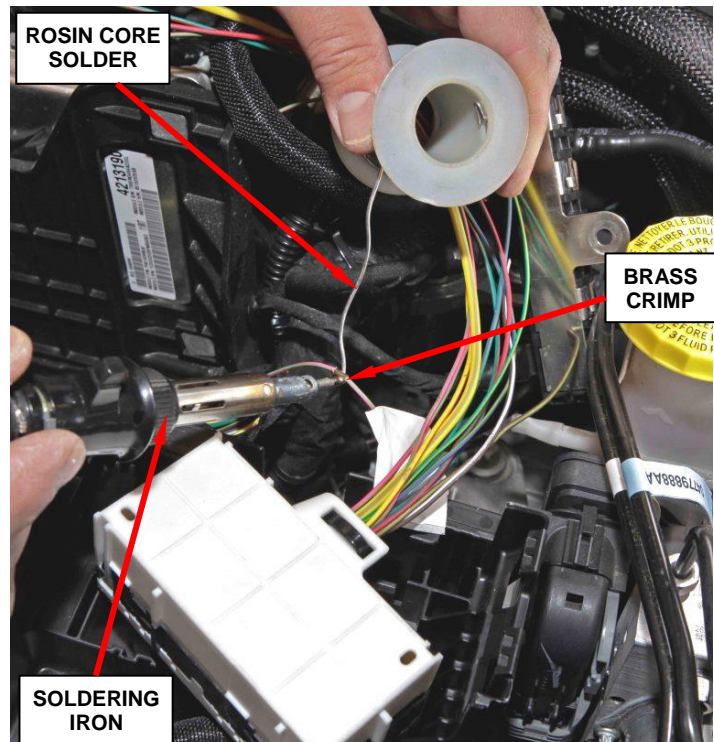
Figure 13 – Solder Crimp

- d. Solder the crimps with rosin core solder (Figure 13).

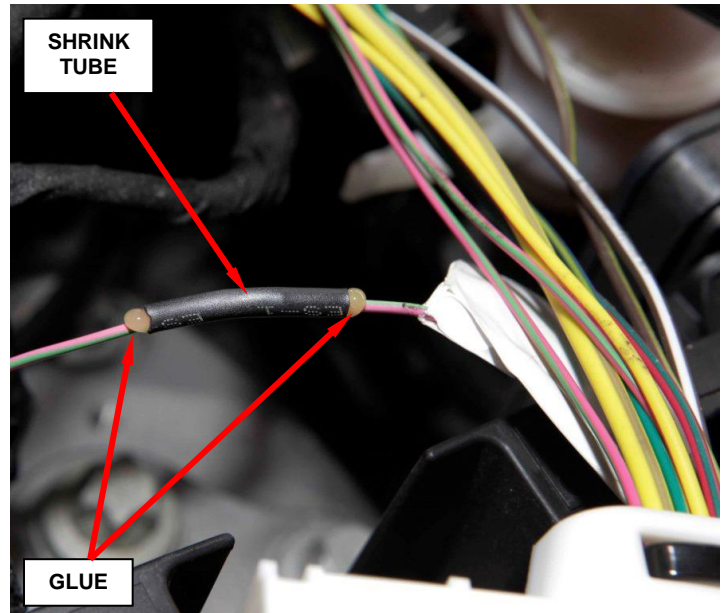
Figure 14 - Shrink Tube

- e. Slide the shrink tube evenly over the splice and apply heat to the shrink tube until glue comes out of both ends of the shrink tube (Figure 14).
- f. Repeat Step 6a through 6e on each wire that requires splicing (Figure 15).

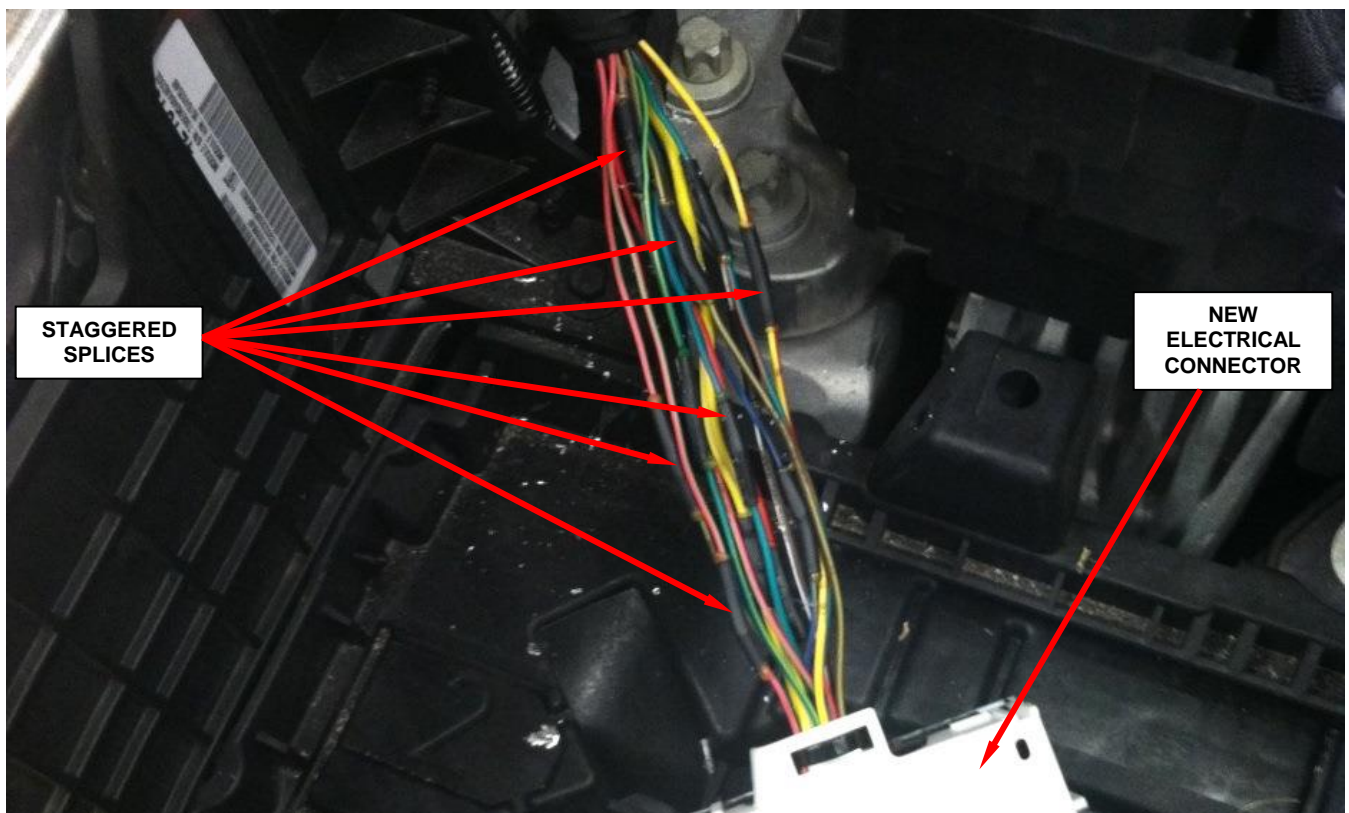
Figure 15 - Stagger the Splices

CAUTION: Be sure to stagger the splice joints to prevent a large “ball” of wire splices in one location on the wire harness.

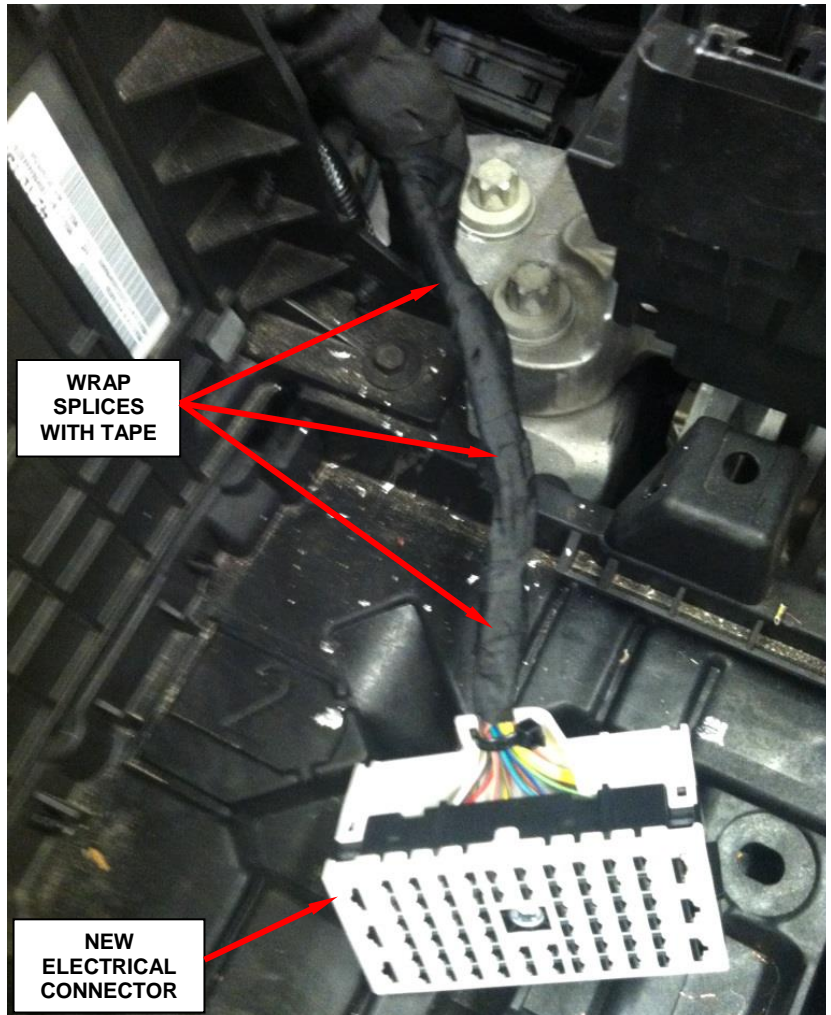
Figure 16 - Wrap Wire Harness Splices with Tape

16. Using the tape specified in this recall, wrap exposed wires with tape (Figure 16).
17. Place the new connector into position in the PDC tray.
18. Snap the PDC top cover into position.
19. Hand start the three PDC cover retaining bolts and tighten securely.
20. Connect the white electrical connector to the PDC.
21. Snap the Z-case fuse array assembly into position on the PDC.
22. Install the Z-case fuse array retaining nut. Tighten the nut securely.

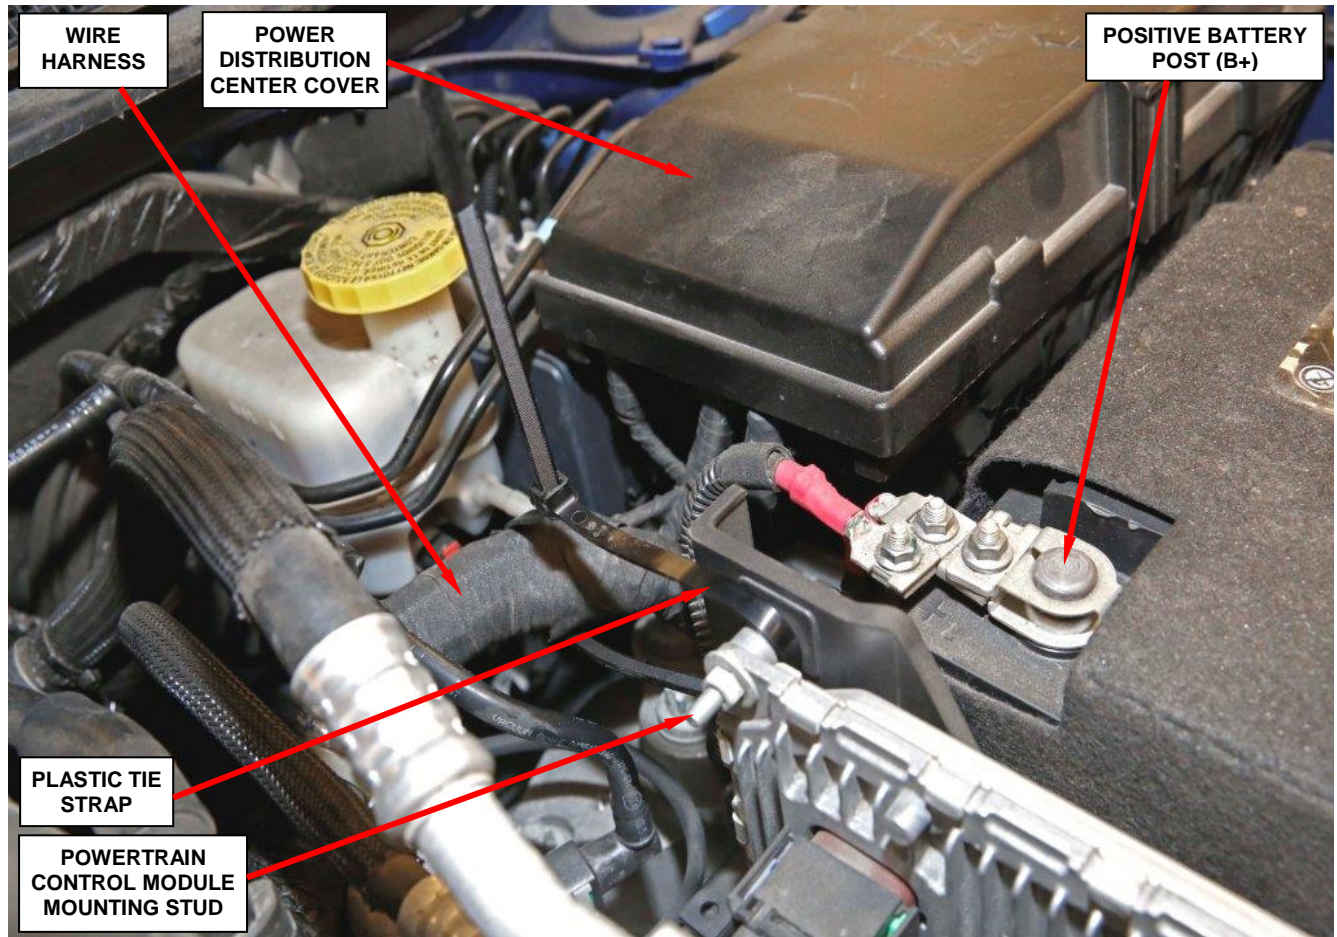
Figure 17 – Install a Plastic Tie Strap to Prevent Wire Harness from Sagging onto the Transaxle

28. Install the negative battery cable clamp to the negative battery post. Tighten the negative battery cable clamp to 80 in. lbs. (9 N·m).
29. Install a plastic tie strap as shown in Figure 17 to prevent the wire harness from sagging onto the transaxle.
30. Cut off plastic tie strap tail (Figure 18)
31. Continue with **Section C. Electronic Power Steering Verification Test.**

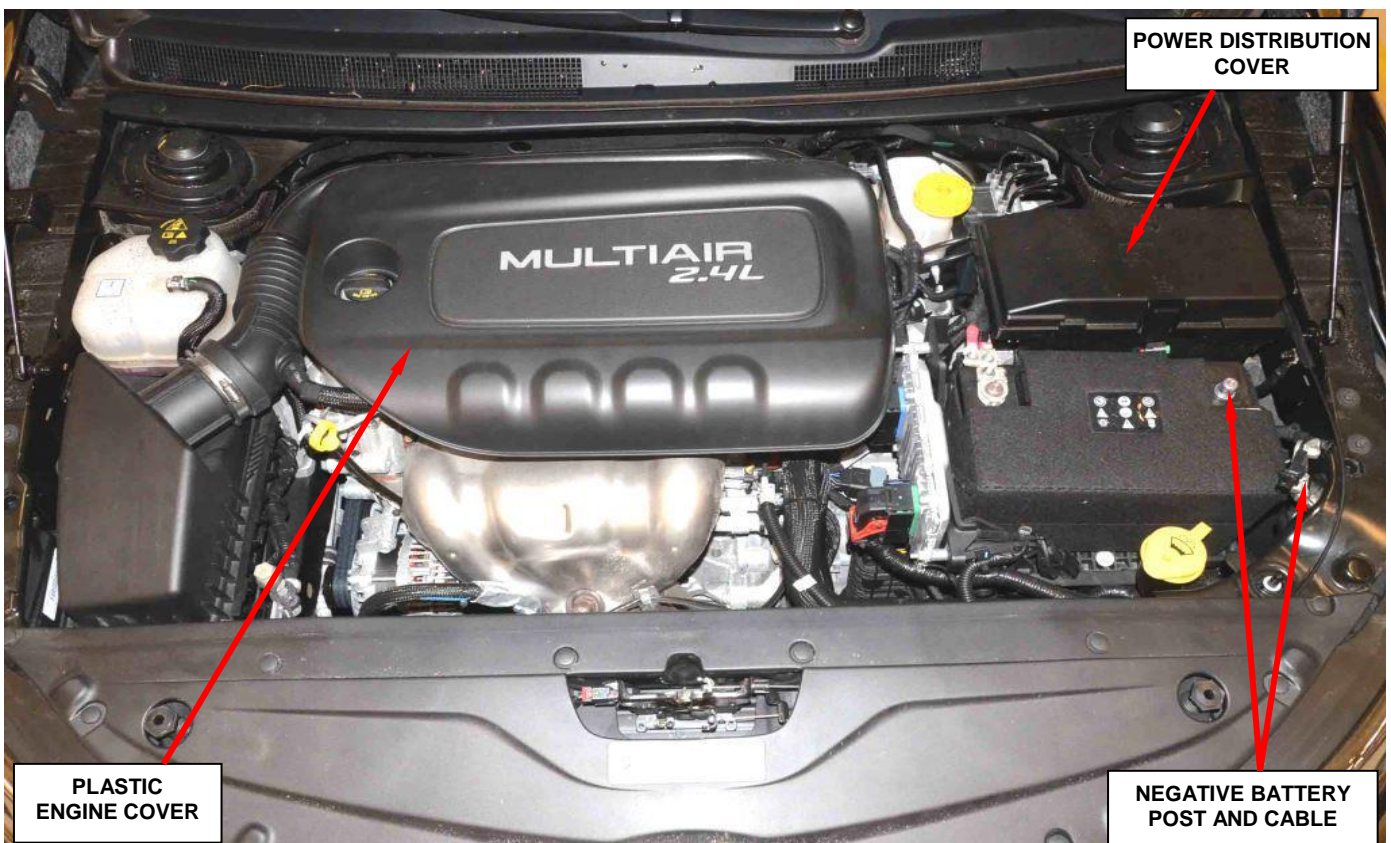
Figure 19 – Plastic Engine Cover / PDC Cover / Battery Cable

1. Place the vehicle in position to be lifted by an appropriate hoist.
2. Disconnect and isolate the negative battery cable (Figure 19).
3. Remove and save the Power Distribution Cover (PDC) (Figure 19).
4. Remove and save the plastic engine cover (Figure 19).

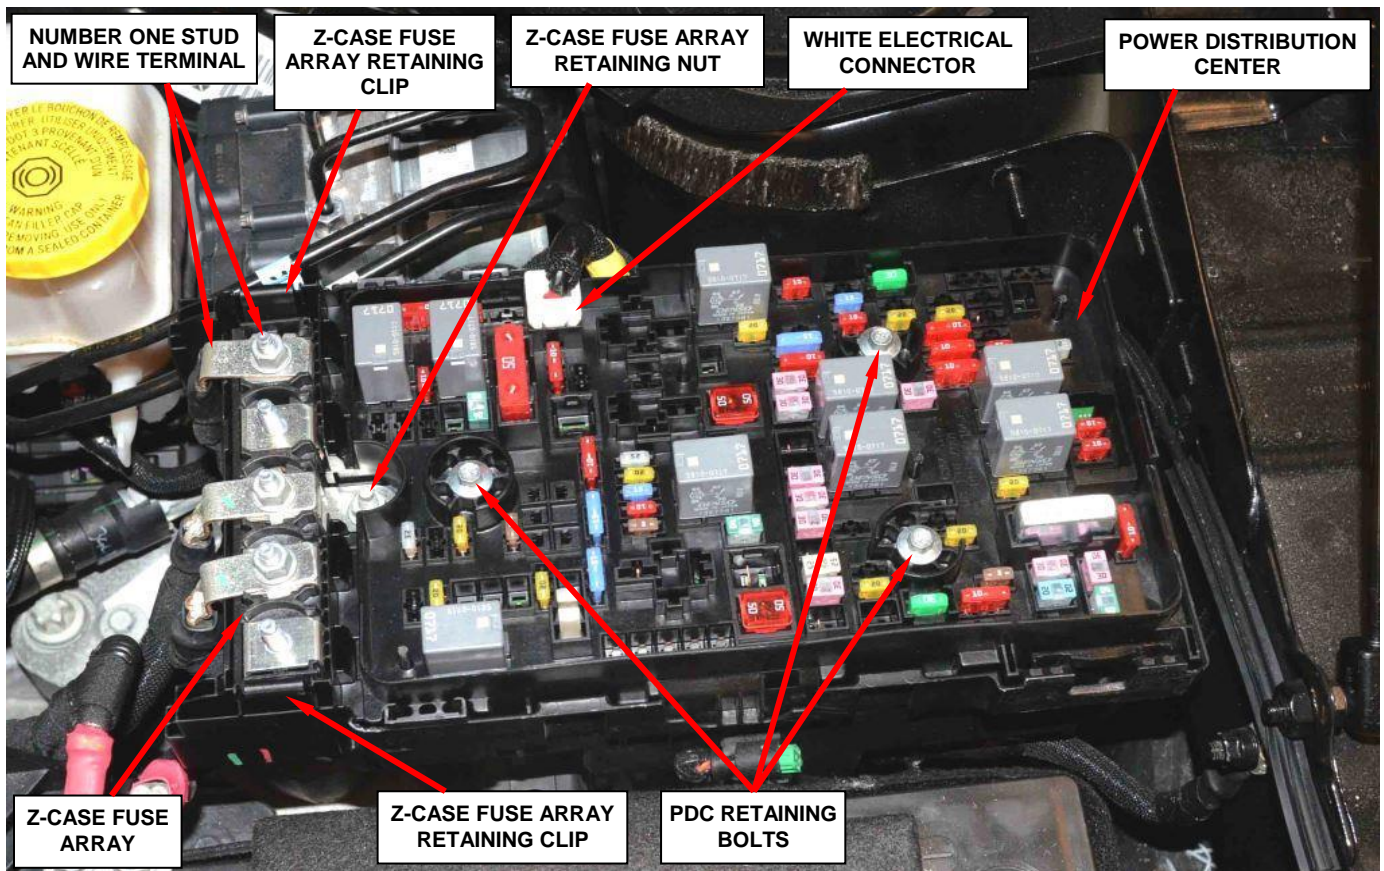
Figure 20 – PDC and Z-Case Fuse Array

5. Remove and save the number one stud wire terminal retaining nut on the Z-case fuse array (Figure 20).
6. Remove and save the Z-case fuse array retaining nut (Figure 20).
7. Disengage the Z-case fuse array retaining clips and separate the Z-case fuse array assembly from the PDC (Figure 20).
8. Disconnect the white electrical connector from the PDC (Figure 20).
9. Loosen the three PDC retaining bolts (Figure 20).

CAUTION: The three PDC retaining bolts in the PDC are captured bolts that cannot be removed from the PDC. They can only be loosened. Do not attempt to remove the three PDC retaining bolts

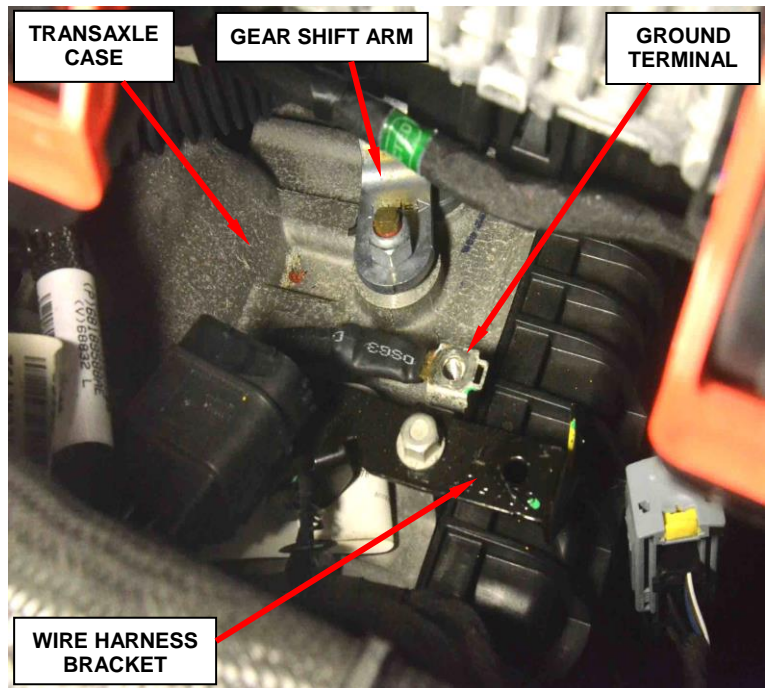
Figure 21 – Ground Terminal

11. Detach the wire harness push pins from the retaining bracket.
12. Disconnect the wire harness ground terminal from the transaxle case (Figure 21).
13. Disconnect the round transaxle valve body connector.
14. Remove and save the wiring harness bracket (Figure 21).
15. Disconnect the wiring harness push pins at the transaxle bellhousing.
16. Disconnect the coolant tube bracket.
17. Disconnect the transaxle control module connector.
18. Lift the vehicle on the hoist.
19. Remove and save the underbody splash shield (Figure 22).
20. Disconnect the power steering electrical connectors at the steering gear.
21. Disconnect the starter motor electrical connectors.
22. Lower the vehicle from the hoist.
23. Disconnect the transaxle gear shift cable at the cable anchor point and the gear shift arm.

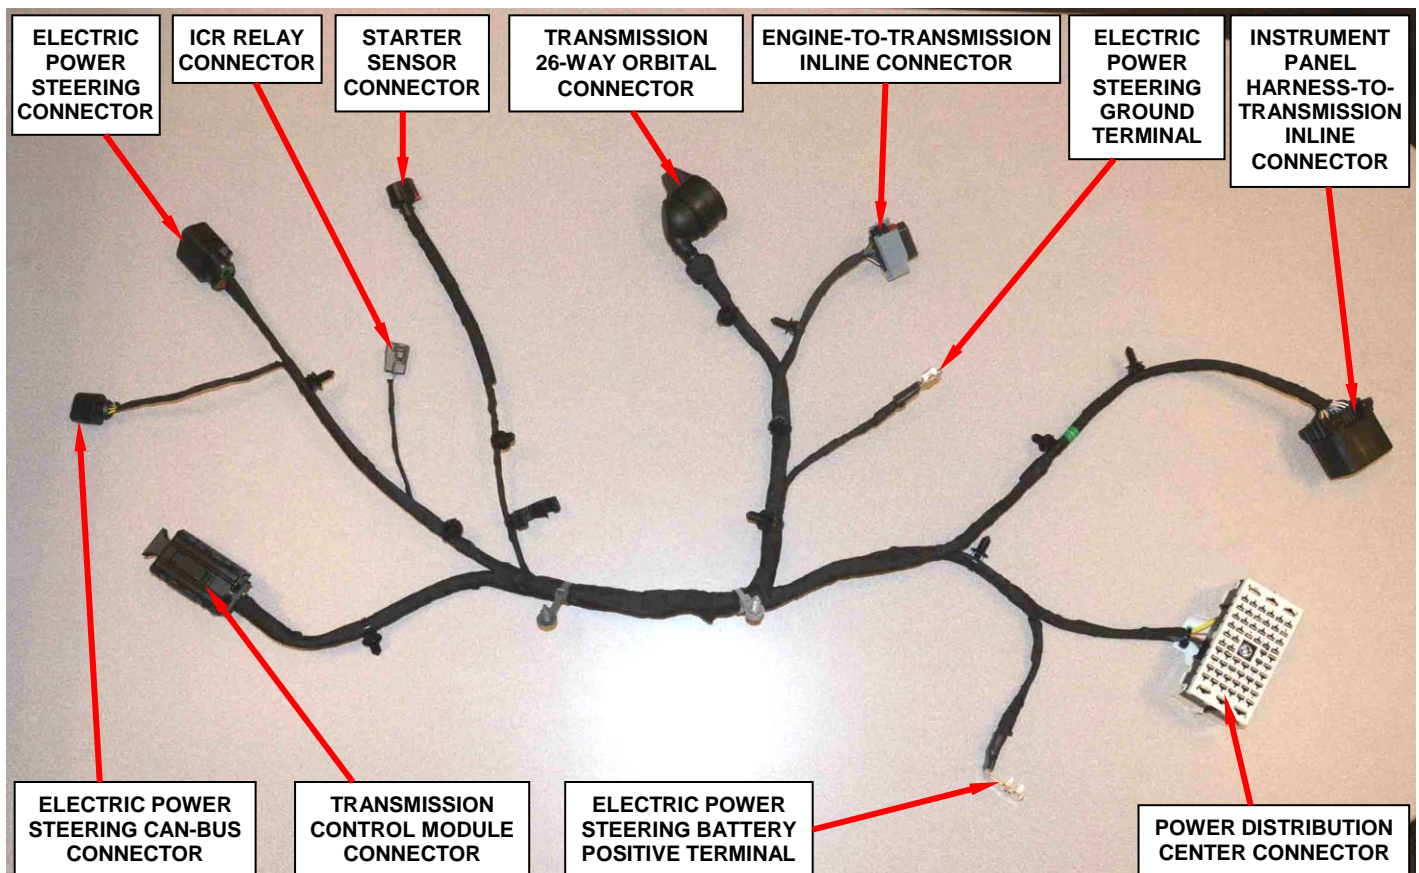
Figure 23 – Wire Harness and Electrical Connectors

24. Carefully remove and discard the original wire harness assembly from the vehicle.
25. Place the original wire harness next to the new wire harness and verify that all the electrical connectors are the same (Figure 23).
26. Place the new wire harness into position.
27. Connect the transaxle gear shift cable at the cable anchor point and the gear shift arm.
28. Raise the vehicle on the hoist.
29. Connect the starter motor electrical connectors.
30. Connect the power steering electrical connectors at the steering gear.
31. Install the underbody splash shield.
