Recall Information Bulletin

No: C1008010 **Issued:** 10/5/2015

Re: Brake Shim Rust

Safety Recall C1008010 – Brake Shim Rust

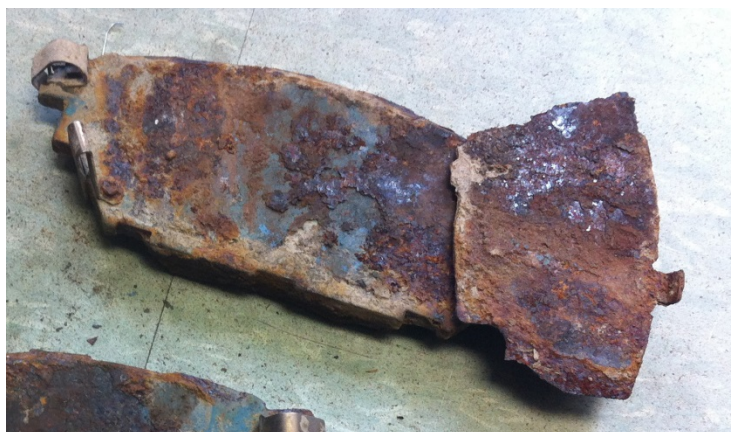
If the brake pads are severely rusted (see image below) and require scraping and repainting prior to stainless steel brake shim installation, use the following for reimbursement of an additional 0.3 hr of labor on a Warranty Service Claim:

IMPORTANT! A photo of the rusted brake pads must be emailed to warranty@mitfuso.com to ensure claim payment. Be sure to include your Dealer Code and Claim # or R/O # in the email.

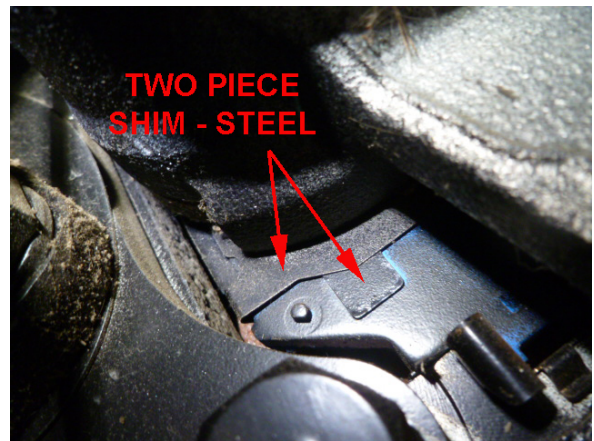
STEEL

2. Inspect the brake shims on the front axle. If two-piece steel shims are installed, replace the shims on that axle with a stainless steel shim kit, using Group 35 of the appropriate Canter Service Manual. If one-piece stainless steel shims are installed, no repair is required.
3. Repeat the above inspection and/or replacement on the rear axle.

Use the illustrations and photos below to identify which shims are currently installed on the vehicle:

The brake pad shims will be inspected on both axles. If the brakes are already equipped with stainless steel brake pad shims, no modification is necessary. If the vehicle is equipped with steel shims, they will be replaced with stainless steel shims on both sides of each affected axle.
