Safety Recall R47 / NHTSA 15V-534 Side Airbag Inflatable Curtain

2014-2015 (DS) RAM 1500 Quad Cab Pickup

The right and left Side Airbag Inflatable Curtains (SABIC) on about 188,000 of the above vehicles may not deploy as intended. An improperly deployed SABIC, during certain crash events, could allow additional injuries to rear seat occupants.

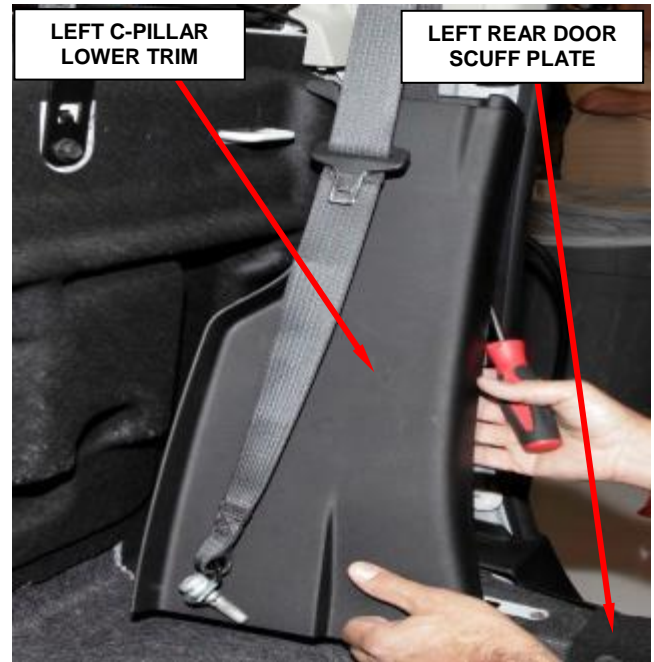
Figure 8 – Left Lower C-Pillar Trim

9. Separate the left lower C-pillar trim retaining clips from the left lower C-pillar and the left rear door scuff plate (Figure 8).

26. Install the left rear turning loop bolt and tighten to 30 ft. lbs. (40 N·m) (Figure 9).
27. Install the left turning loop cover.
28. Install the left seat belt through the hole in the lower C-pillar and install the left lower C-pillar trim (Figure 8).

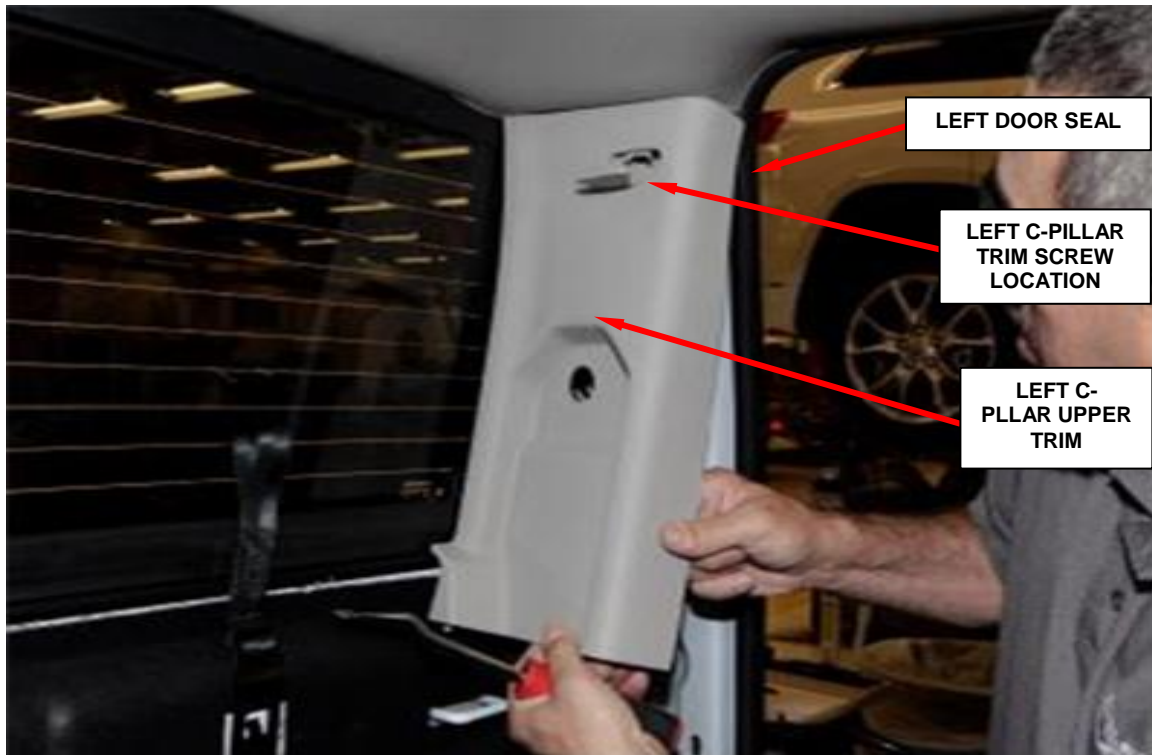
Figure 10 – Left Upper C-Pillar

12. Partially remove the left door seal (Figure 10).

13. Remove the left C-pillar upper trim screw and remove the left C-pillar upper trim (Figure 10).

23. Install the left front door cowl trim panel (Figure 11).
24. Install the left C-pillar upper trim (Figure 10).
25. Install the left C-pillar upper trim screw and tighten (Figure 10).

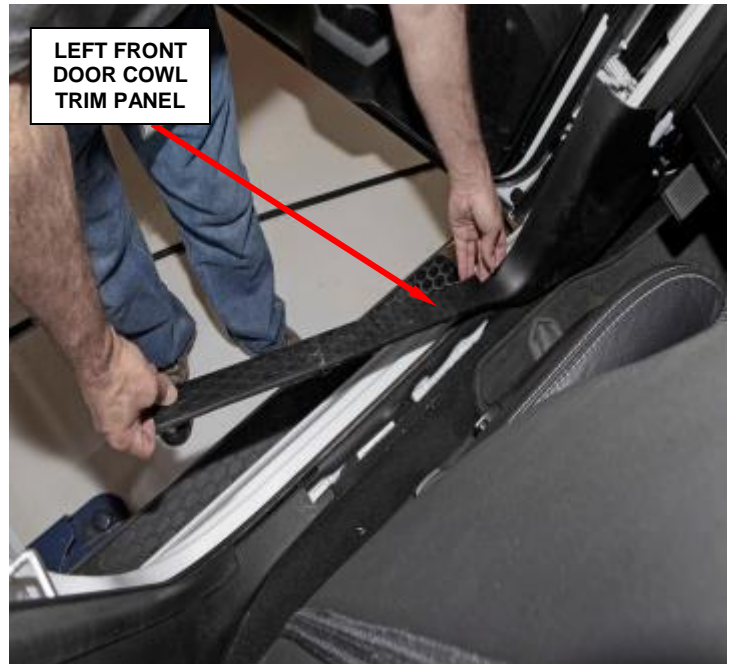
Figure 11 - Left Front Door Cowl Trim

14. Remove the left front door cowl trim panel (Figure 11).

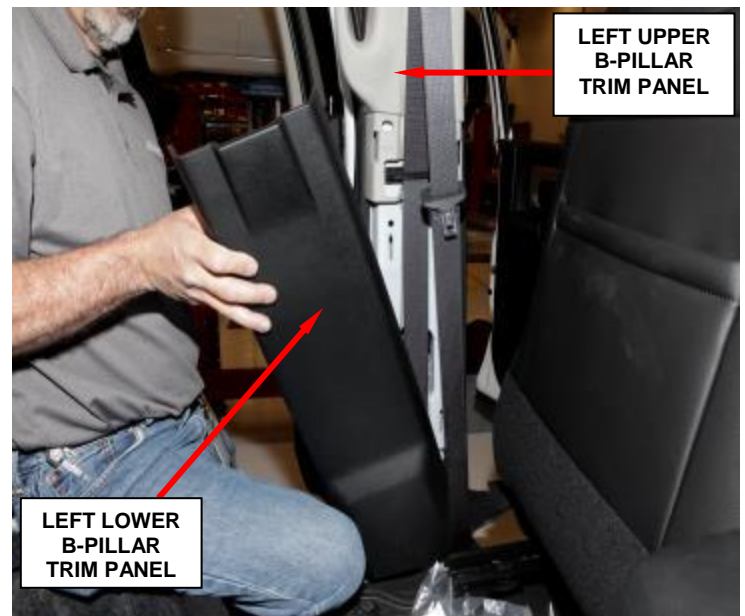
Figure 12 – Left Lower B-Pillar Trim

15. Release the retaining clips and remove the left lower B-pillar trim panel (Figure 12).

22. Install the left lower B-pillar trim panel (Figure 12).

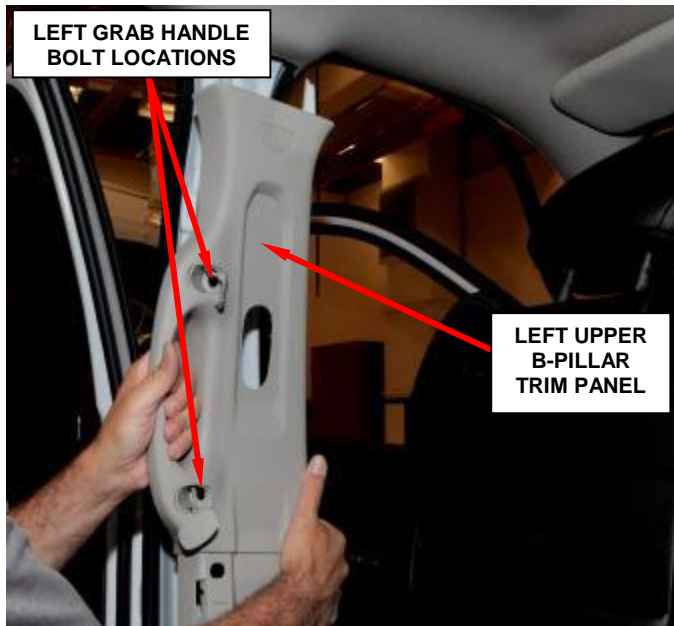
Figure 14 – Grab Handle

18. Remove and save the two fasteners that secure the left grab handle to the B-pillar (Figure 14).
19. Using a trim stick C-4755 or equivalent, disengage the retaining clips that secure the left upper B-pillar trim to the pillar and remove the trim panel (Figure 14).
20. Repeat steps 8 through 19 for the right side of the vehicle.

16. Disconnect the battery negative cable.
 17. Install the left upper B-pillar trim panel to the B-pillar (Figure 14).
 18. Install the B-pillar turning loop and bolt. Tighten to 30 ft. lbs. (40 N·m) (Figure 14).

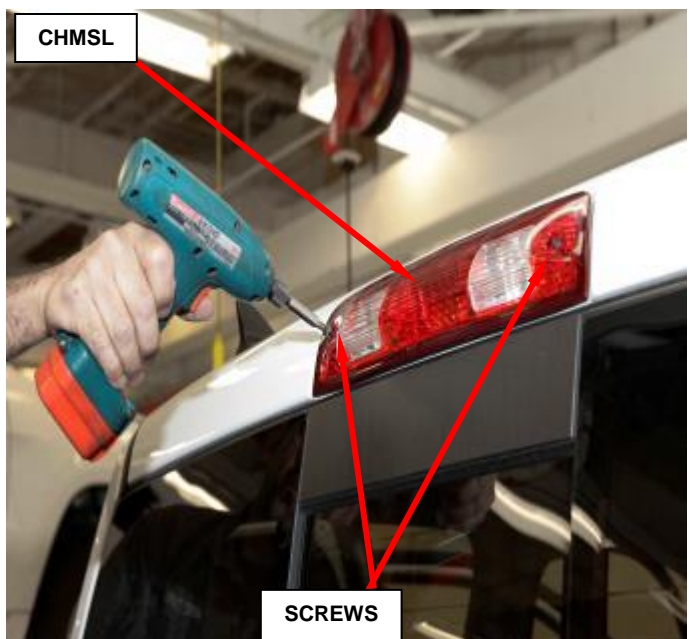
Figure 15 – CHMSL

21. Remove and save the two CHMSL attaching screws and pull the CHMSL from the cab (Figure 15).
22. Disconnect the CHMSL electrical connector.
23. Connect the battery negative cable.
24. Position the front seats to the full rearward position with the seat backs fully reclined.
25. Disconnect the battery negative cable.

13. Install the CHMSL and secure the two screws (Figure 15).
 14. Connect the battery negative cable.
 15. Position the front seats to the full forward position with the seat backs fully forward.

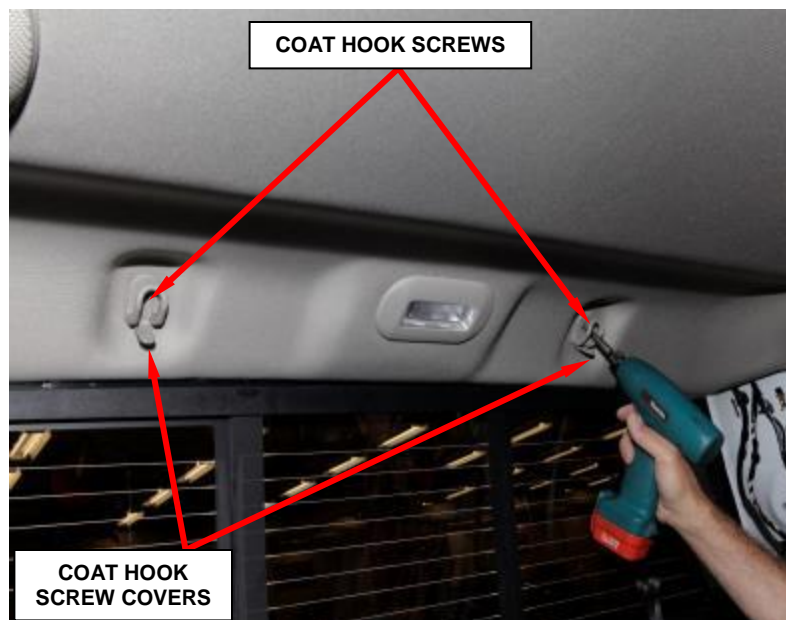
Figure 17 – Coat Hooks

28. Using a small flat bladed tool, open the coat hook screw cover and remove the screws and coat hooks (Figure 17).

10. Install the two coat hooks and covers (Figure 17).
11. Install the right and left sun visors (Figure 16).

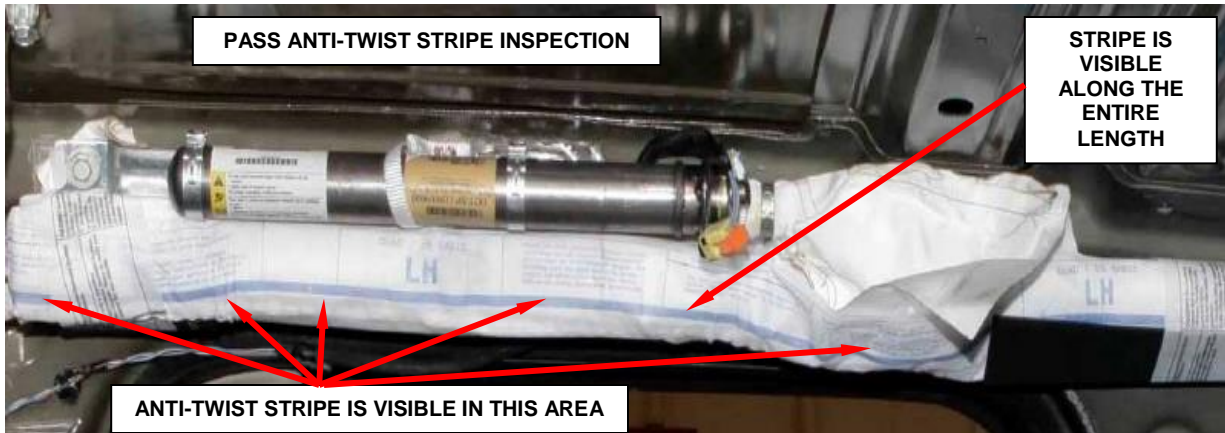
Figure 20 – Passed Inspection: Anti-Twist Stripe Position

1. As viewed through the opposite side door opening, inspect the anti-twist stripe on the inboard side of the right side (red stripe) SABIC and left side (blue stripe) SABIC for twisted cushions.
 - Vehicles that **have** the anti-twist stripe visible on one or both SABICs, continue with **Step 2 of this procedure** (Figure 20).
 - Vehicles that **do not have** the anti-twist stripe visible on one or both SABICs, continue with **Section C. Replace Side Airbag Inflatable Curtain (SABIC)** (Figure 21).

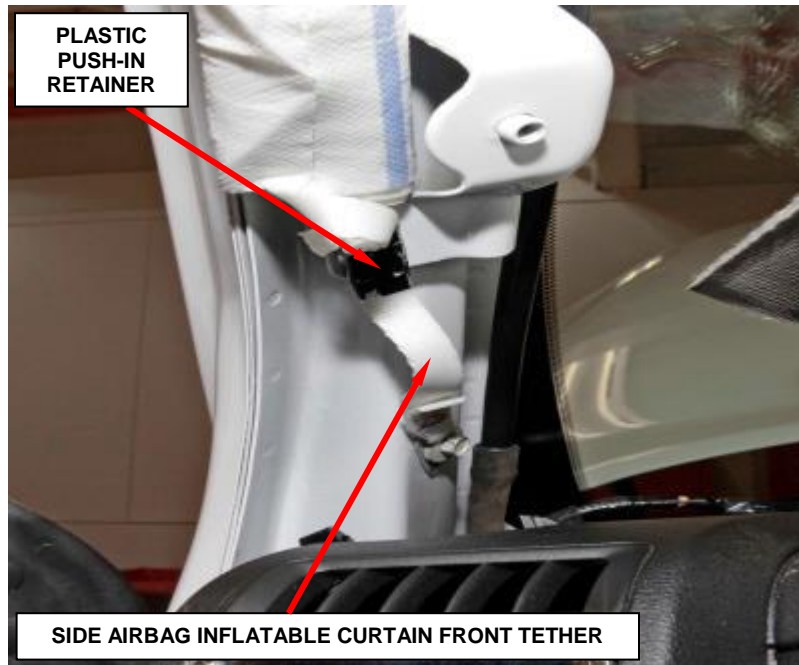
Figure 26 – Plastic Push-in Retainers

2. Disengage the plastic push-in retainer that secures the side airbag inflatable curtain front tether to the assist handle bracket on the inner A-pillar (Figure 26).

14. Engage the plastic push-in retainer that secures the side airbag inflatable curtain front tether to the assist handle bracket on the inner A-pillar (Figure 26).

15. Install the front tether retaining bolt. Tighten to 70 in. lbs. (8 N·m) (Figure 26).
16. Repeat steps 1 through 15 if both side airbag inflatable curtains fail the inspection procedure outlined in **Section B. Inspect Side Airbag Inflatable Curtain (SABIC)**.

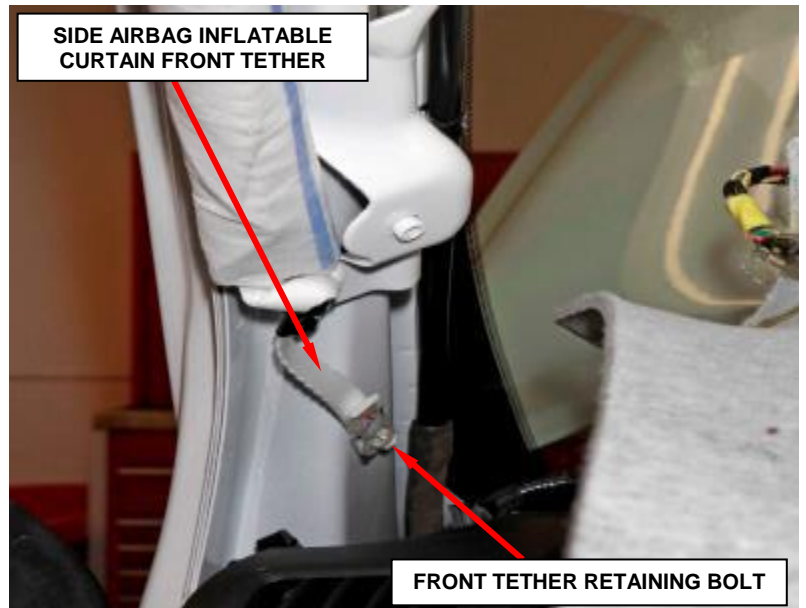
Figure 28 – Tether Retaining Bolt

5. Remove the side airbag inflatable curtain front tether retaining bolt (Figure 28).
