Safety Recall R47 / NHTSA 15V-534

Side Airbag Inflatable Curtain

2014-2015 (DS) RAM 1500 Quad Cab Pickup

The right and left Side Airbag Inflatable Curtains (SABIC) on about 188,000 of the above vehicles may not deploy as intended. An improperly deployed SABIC, during certain crash events, could allow additional injuries to rear seat occupants.

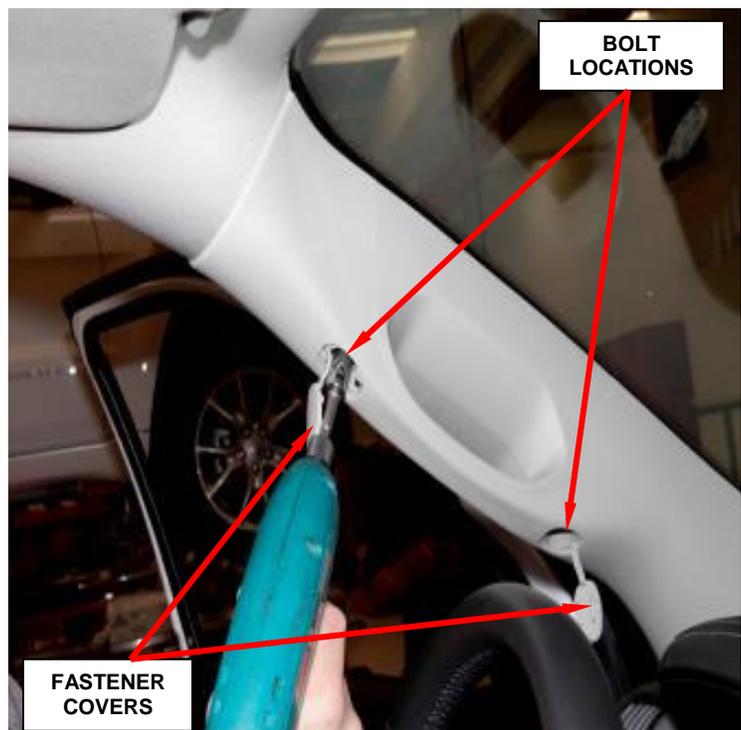
Figure 1 – A-Pillar Trim

1. Using a small flat-bladed tool, carefully open the two fastener covers located in the left A-pillar trim panel (Figure 1).
2. Partially remove the left door seal.
3. Remove and save the two bolts that secure the left A-pillar trim panel to the left A-pillar and remove the trim panel (Figure 1).
4. Repeat steps 1 through 3 for the right A-Pillar.

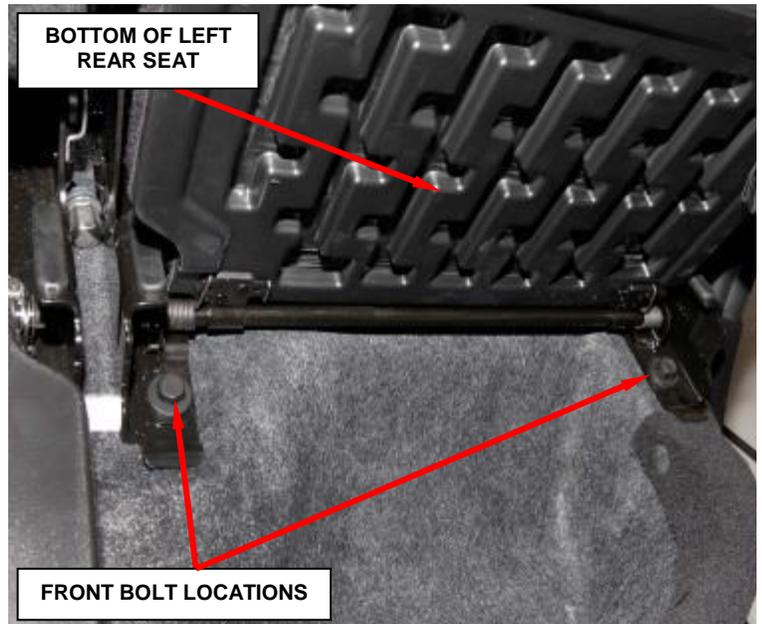
Figure 2 – Left Rear Seat Bolt Locations

- b. Remove the four bolts attaching the left rear seat and remove the left rear seat from the vehicle (Figure 2 and 3).

39. Install the four bolts to the left rear seat and tighten to 35 ft. lbs. (47 N·m) (Figure 2 and 3).
40. Connect the electrical connector to the left rear seat, if equipped.
41. Install the right and left side A-pillar trim panels and close the two fastener covers (Figure 1).
42. Install all four door seals.
43. Do not connect the negative battery cable at this time. Continue with **Section F. Supplemental Restraint System (SRS) Verification Test.**

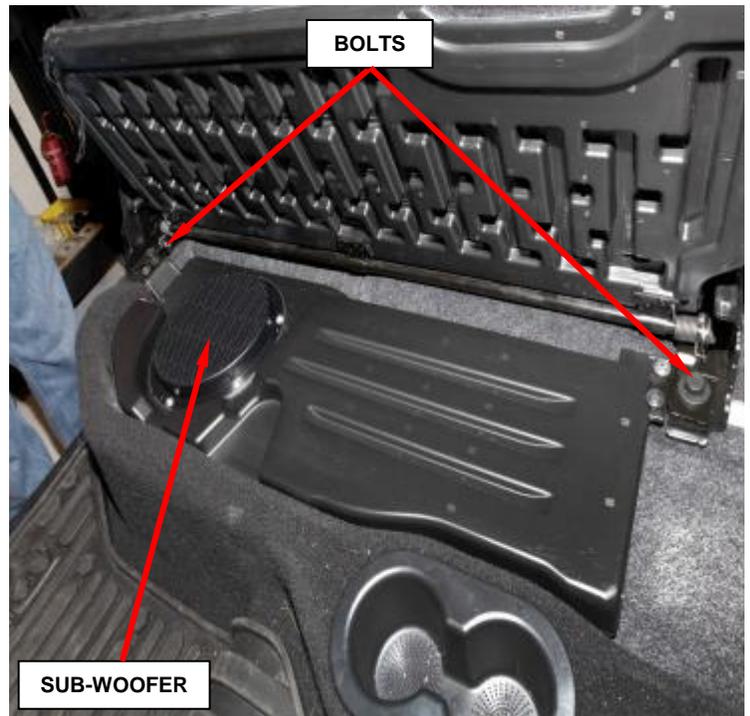
Figure 4 – Sub-Woofer

c. Remove the two rear seat front bolts that attach the sub-woofer and remove the sub-woofer, if equipped (Figure 4).

35. Connect the electrical connector to the right rear seat, if equipped.
36. Connect the electrical connector to the sub-woofer and place the sub-woofer in position, if equipped (Figure 4).

37. Install the two front seat bolts and tighten to 35 ft. lbs. (47 N·m) (Figure 4).
38. Position the left rear seat in the vehicle.

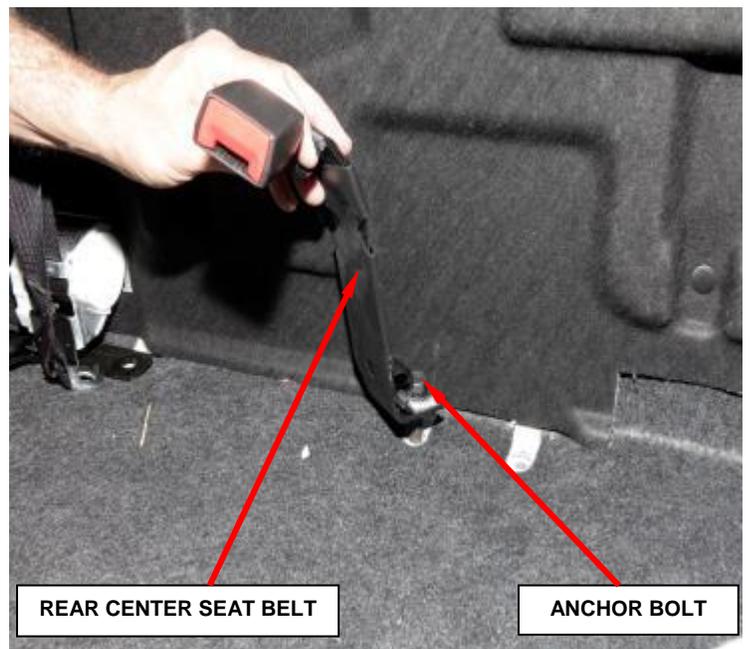
Figure 5 – Seat Belt Anchor

f. Remove the rear center seat belt anchor bolt (Figure 5).

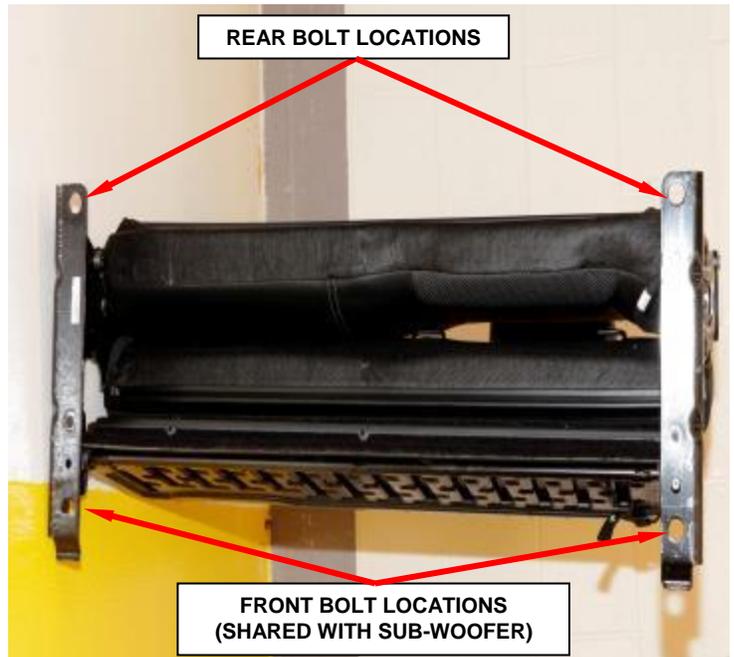
**Figure 6 – Right Seat Bolt Locations
(Shown out of Vehicle for Photographic Purposes)**

- g. Remove the two remaining rear bolts attaching the right rear seat and remove the right rear seat from the vehicle (Figure 6).

32. Position the right rear seat in the vehicle.
33. Install the two rear bolts to the right rear seat and tighten to 35 ft. lbs. (47 N·m) (Figure 6).
34. Position the shoulder belt back into place and install the rear center seat belt anchor bolt. Tighten to 35 ft. lbs. (47 N·m).

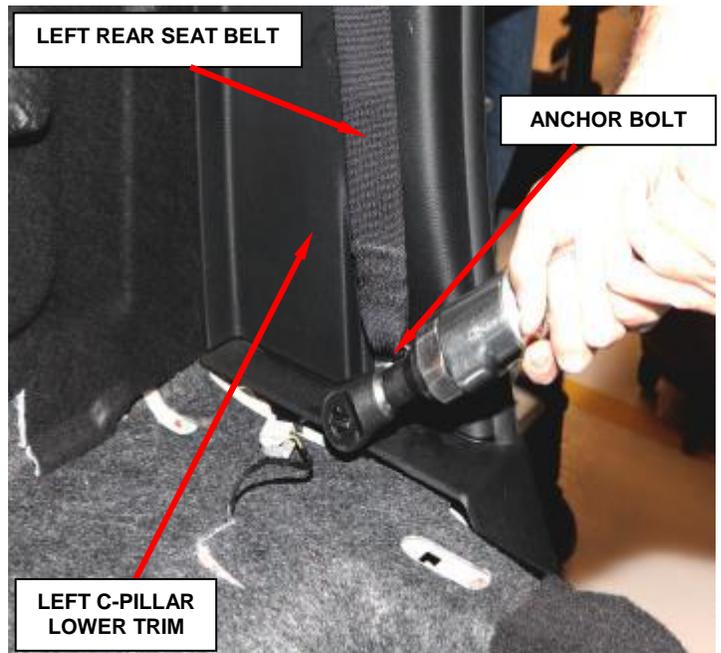
Figure 7 – Left Rear Seat Belt Anchor

- 8. Remove the left rear seat belt anchor bolt (Figure 7).

29. Install the left rear door scuff plate.
30. Install the left rear seat belt anchor and tighten to 30 ft. lbs. (40 N·m) (Figure 7).
31. Repeat steps 16 through 29 on the **right** side of the vehicle.

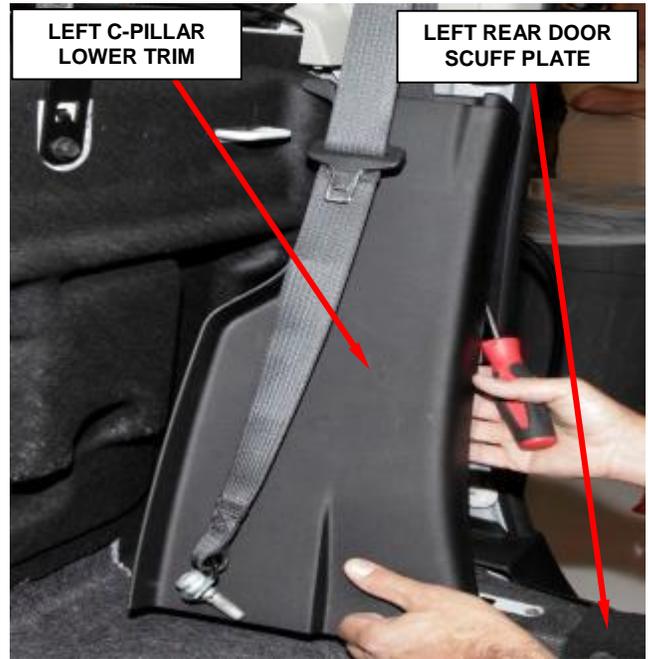
Figure 8 – Left Lower C-Pillar Trim

9. Separate the left lower C-pillar trim retaining clips from the left lower C-pillar and the left rear door scuff plate (Figure 8).

10. Remove the left seat belt from the hole in the lower C-pillar and remove the left lower C-pillar trim.

26. Install the left rear turning loop bolt and tighten to 30 ft. lbs. (40 N·m) (Figure 9).
27. Install the left turning loop cover.
28. Install the left seat belt through the hole in the lower C-pillar and install the left lower C-pillar trim (Figure 8).

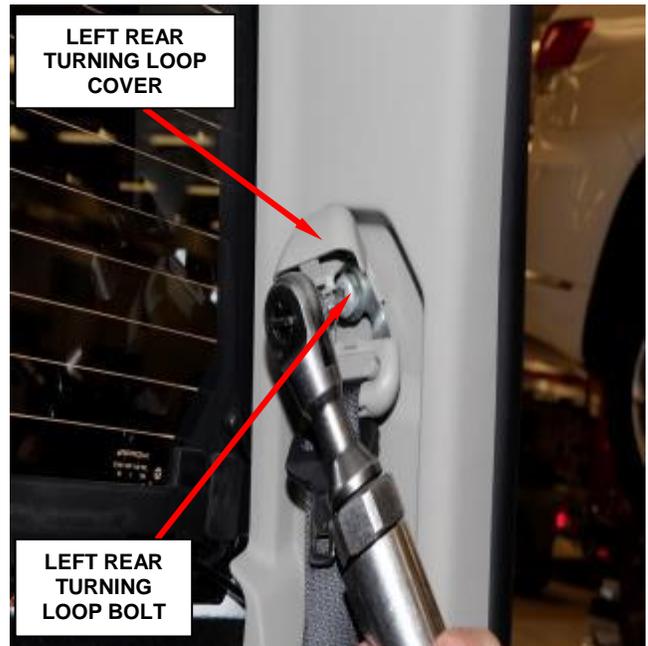
Figure 9 – Left Rear Turning Loop

11. Separate the left rear turning loop cover and remove the left rear turning loop bolt (Figure 9).

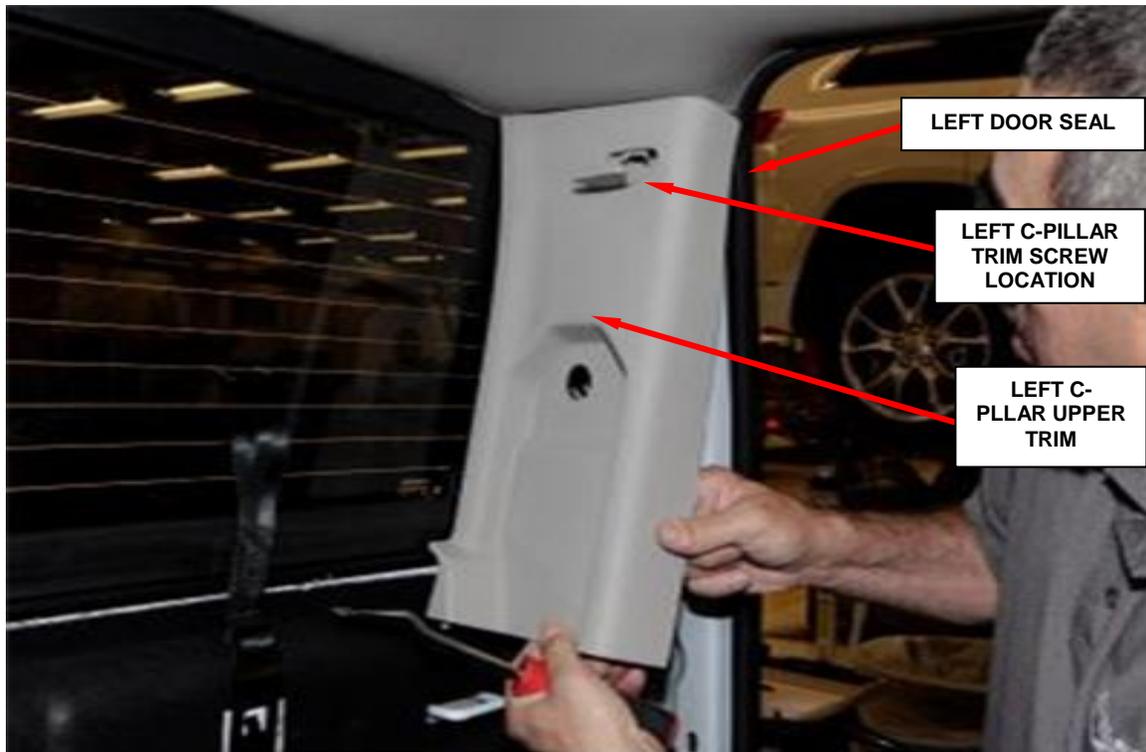
Figure 10 – Left Upper C-Pillar

12. Partially remove the left door seal (Figure 10).

13. Remove the left C-pillar upper trim screw and remove the left C-pillar upper trim (Figure 10).

23. Install the left front door cowl trim panel (Figure 11).
24. Install the left C-pillar upper trim (Figure 10).
25. Install the left C-pillar upper trim screw and tighten (Figure 10).

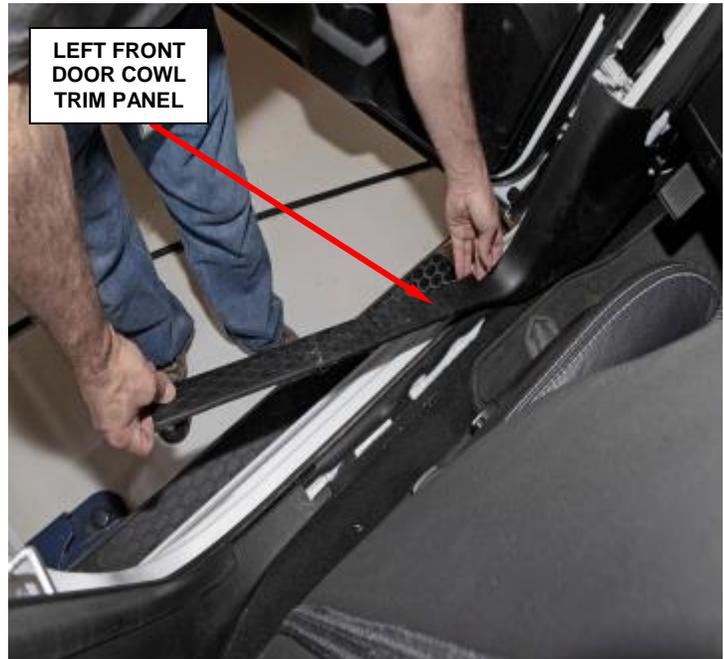
Figure 11 - Left Front Door Cowl Trim

14. Remove the left front door cowl trim panel (Figure 11).

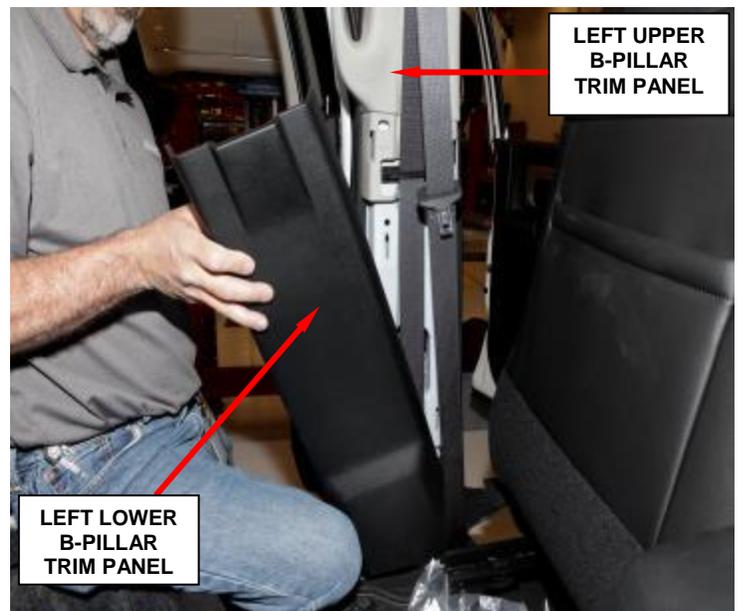
Figure 12 – Left Lower B-Pillar Trim

15. Release the retaining clips and remove the left lower B-pillar trim panel (Figure 12).

22. Install the left lower B-pillar trim panel (Figure 12).

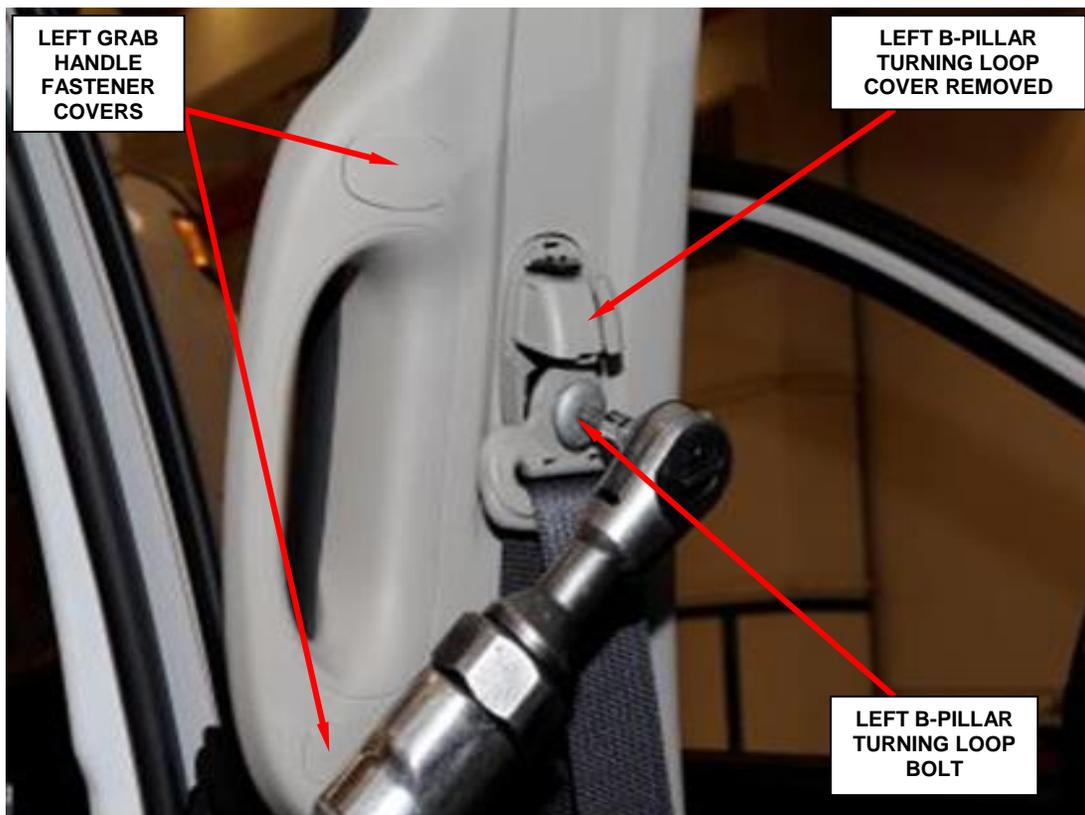
Figure 13 – B-Pillar Turning Loop

16. Separate the left B-pillar turning loop cover and remove the turning loop bolt (Figure 13).

17. Using a small flat-bladed tool, carefully open the two fastener covers located on the left grab handle (Figure 13).

19. Install the B-pillar turning loop cover.
 20. Install the grab handle fasteners and tighten to 44 in. lbs. (5 N·m).
 21. Seat the grab handle fastener caps (Figure 13).

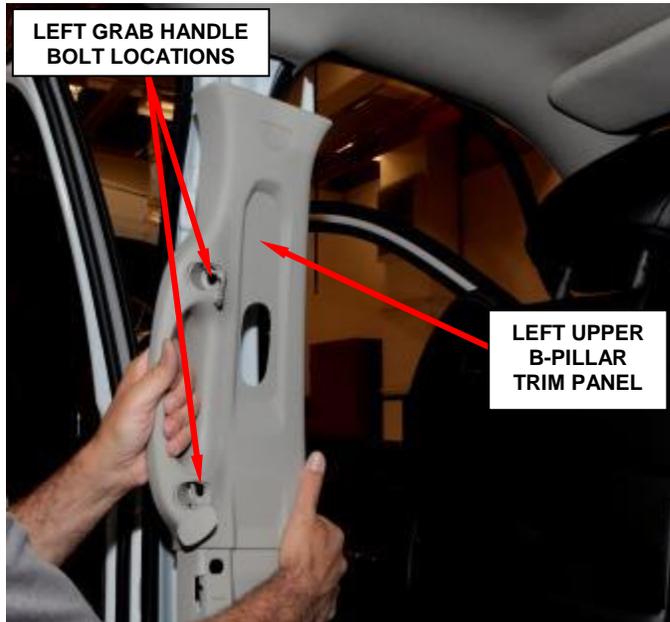
Figure 14 – Grab Handle

18. Remove and save the two fasteners that secure the left grab handle to the B-pillar (Figure 14).
19. Using a trim stick C-4755 or equivalent, disengage the retaining clips that secure the left upper B-pillar trim to the pillar and remove the trim panel (Figure 14).
20. Repeat steps 8 through 19 for the right side of the vehicle.

16. Disconnect the battery negative cable.
 17. Install the left upper B-pillar trim panel to the B-pillar (Figure 14).
 18. Install the B-pillar turning loop and bolt. Tighten to 30 ft. lbs. (40 N·m) (Figure 14).

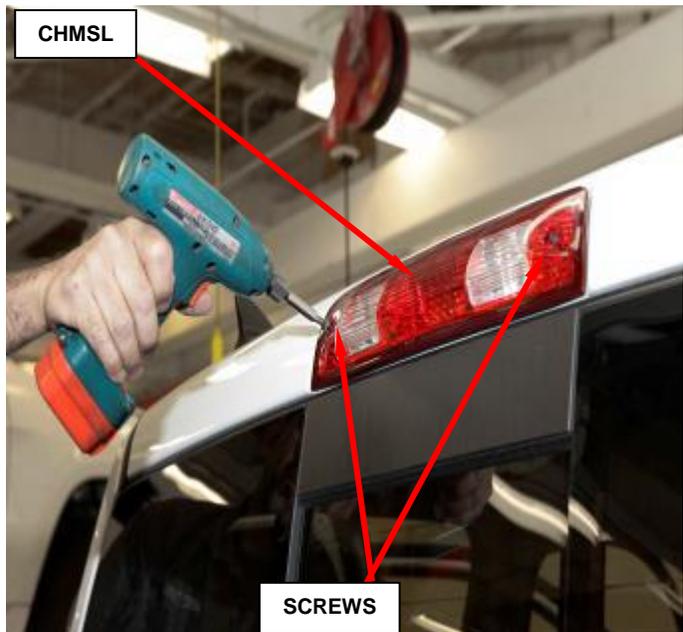
Figure 15 – CHMSL

21. Remove and save the two CHMSL attaching screws and pull the CHMSL from the cab (Figure 15).
22. Disconnect the CHMSL electrical connector.
23. Connect the battery negative cable.
24. Position the front seats to the full rearward position with the seat backs fully reclined.
25. Disconnect the battery negative cable.

13. Install the CHMSL and secure the two screws (Figure 15).
 14. Connect the battery negative cable.
 15. Position the front seats to the full forward position with the seat backs fully forward.

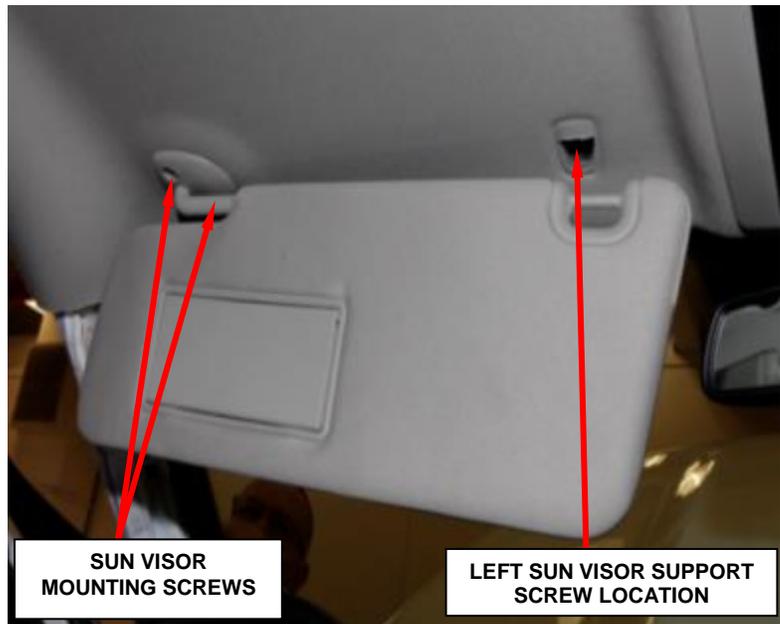
Figure 16 – Sun Visor

26. Remove and save the left and right side sun visor support screws and remove the sun visor supports (Figure 16).

27. Remove and save the left and right side sun visor mounting screws and remove the sun visors (Figure 16).

10. Install the two coat hooks and covers (Figure 17).
11. Install the right and left sun visors (Figure 16).

- a. Position the sun visor support through the headliner and fully seat the base of the support to the roof panel.
 - b. Position the sun visor onto the headliner.

- c. Install the two screws that secure each sun visor to the roof panel. Tighten the screws to 6 N·m (53 in. lbs.).
12. Connect the CHMSL electrical connector.

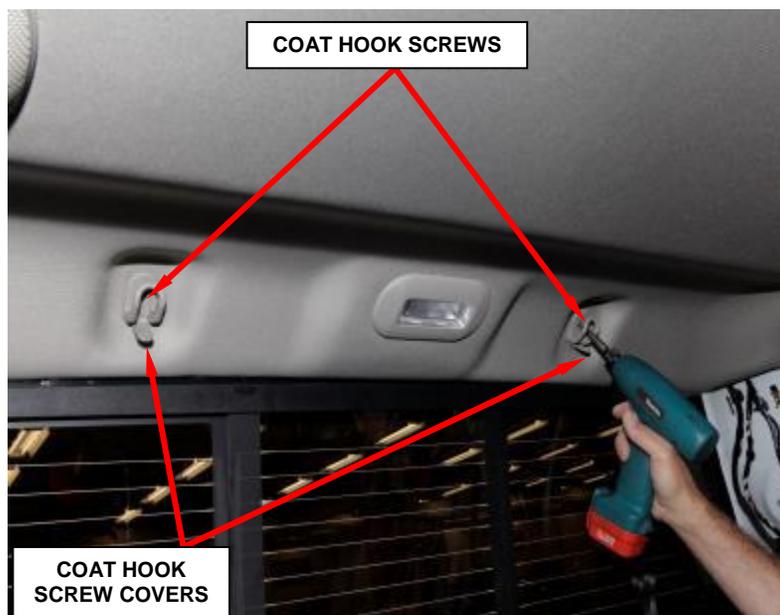
Figure 17 – Coat Hooks

28. Using a small flat bladed tool, open the coat hook screw cover and remove the screws and coat hooks (Figure 17).

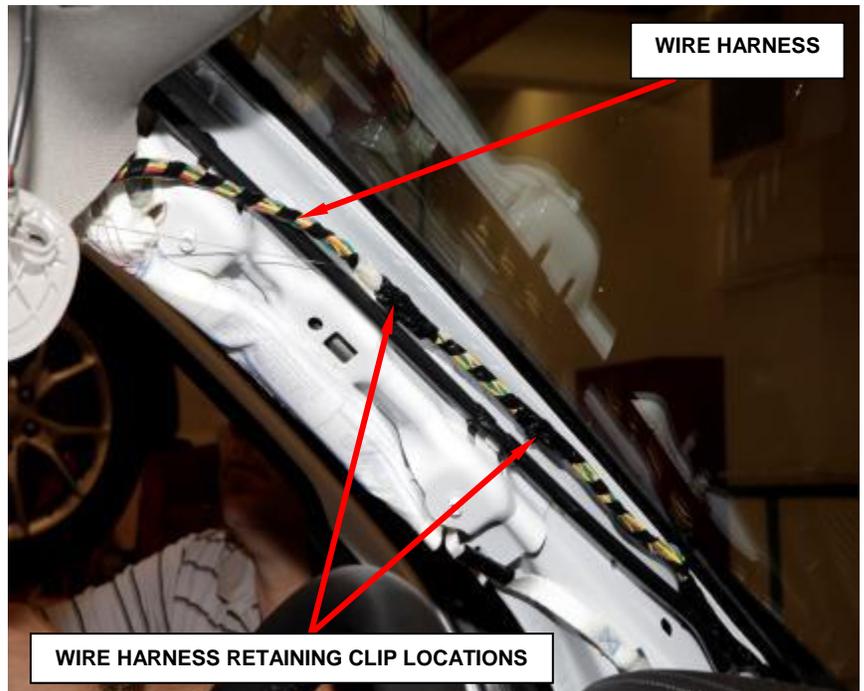
Figure 18 – A-Pillar Wire Harness

- 29. Release the wire harness retaining clips from the right and left A-pillars (Figure 18).

8. Install the wire harness retaining clips on the right and left C-pillars (Figure 19).
9. Install the wire harness retaining clips on the right and left A-pillars (Figure 18).

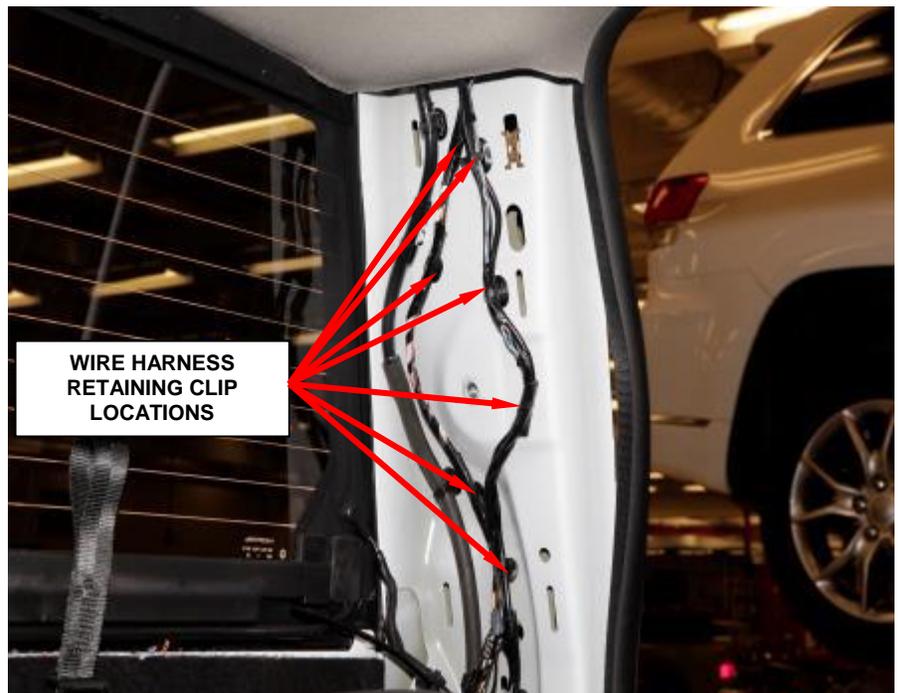
Figure 19 – C-Pillar Wire Harness

- 30. Release the wire harness retaining clips from the right and left C-pillars (Figure 19).

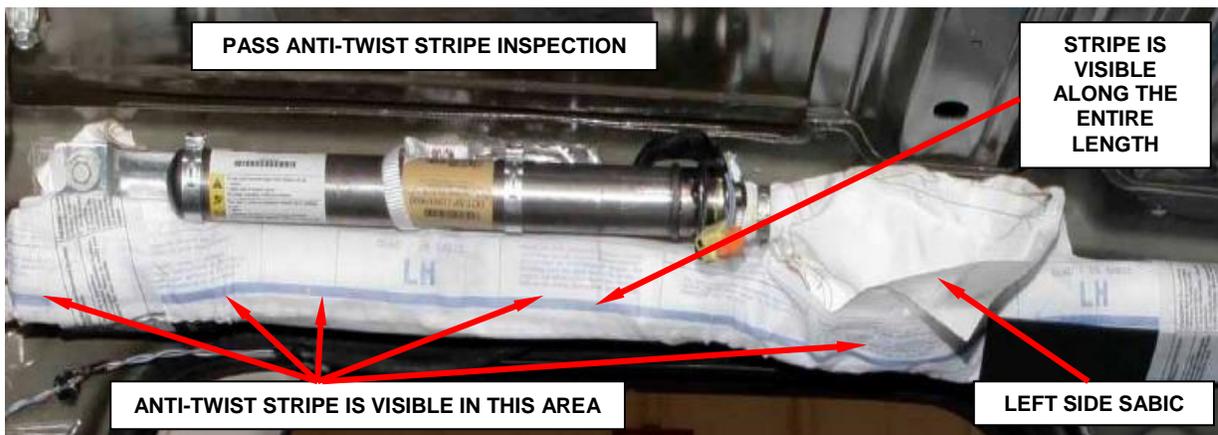
1. As viewed through the opposite side door opening, inspect the anti-twist stripe on the inboard side for twisted cushions.

NOTE: Early builds have a black anti-twist stripe on both SABICs. Late builds have a red anti-twist stripe on the right side SABIC and a blue anti-twist stripe on the left side SABIC.

- Vehicles that **have** the anti-twist stripe visible on one or both SABICs continue with **Step 2 of this procedure** (Figure 20 and 21).

**Figure 20 - Passed Inspection: Anti-Twist Stripe Position
(Red or Blue Stripe for Late Builds)**

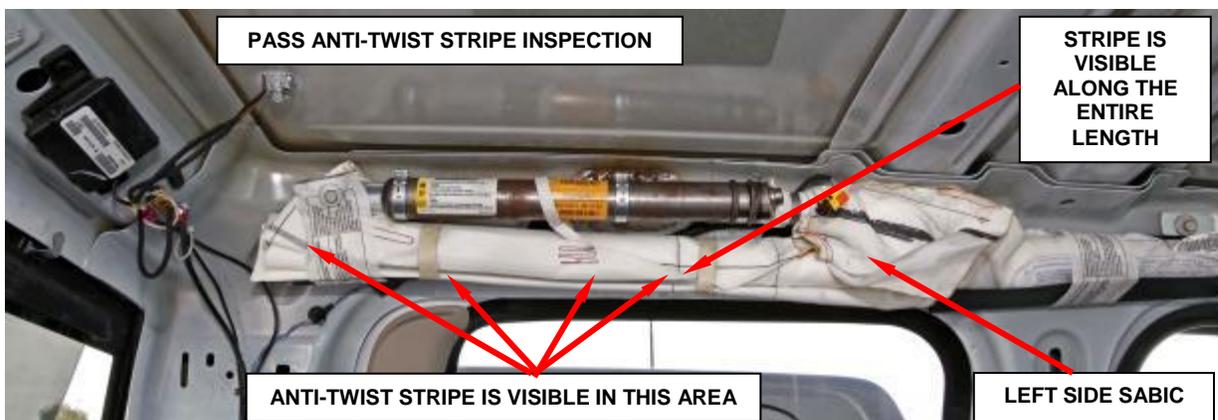
**Figure 21 - Passed Inspection: Anti-Twist Stripe Position
(Black Stripe for Early Builds)**

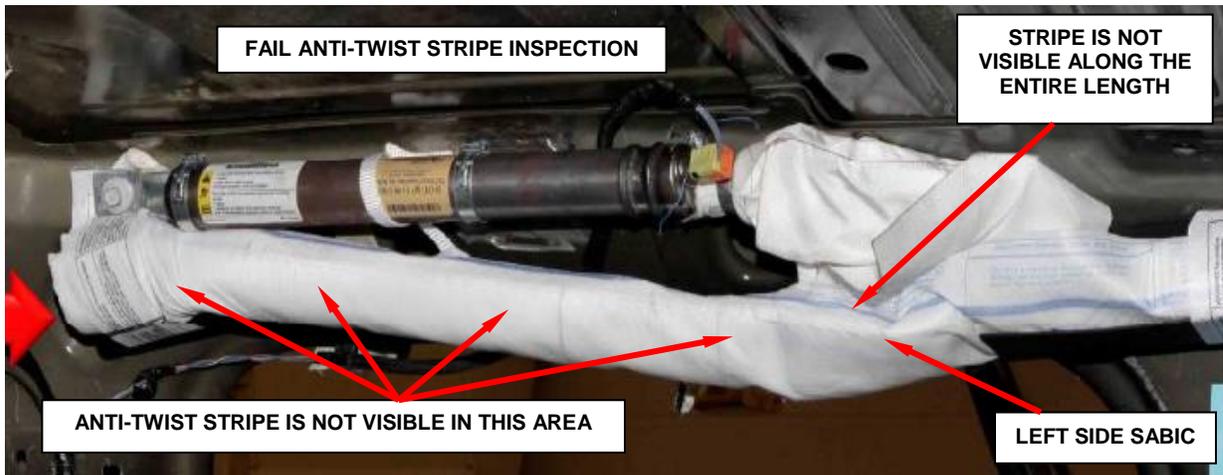
- Vehicles that **do not have** the anti-twist stripe visible on one or both SABICs, continue with **Section C. Replace Side Airbag Inflatable Curtain (SABIC)** (Figure 22 and 23).

**Figure 22 - Failed Inspection: Anti-Twist Stripe Position
(Red or Blue Stripe for Late Builds)**

Service Procedure Continued**C. Replace Side Airbag Inflatable Curtain (SABIC)**

NOTE: Replace the specific SABIC that fails the inspections outlined in Section B. SABIC part numbers: 68161580AJ (right side SABIC) and 68161581AJ (left side SABIC).

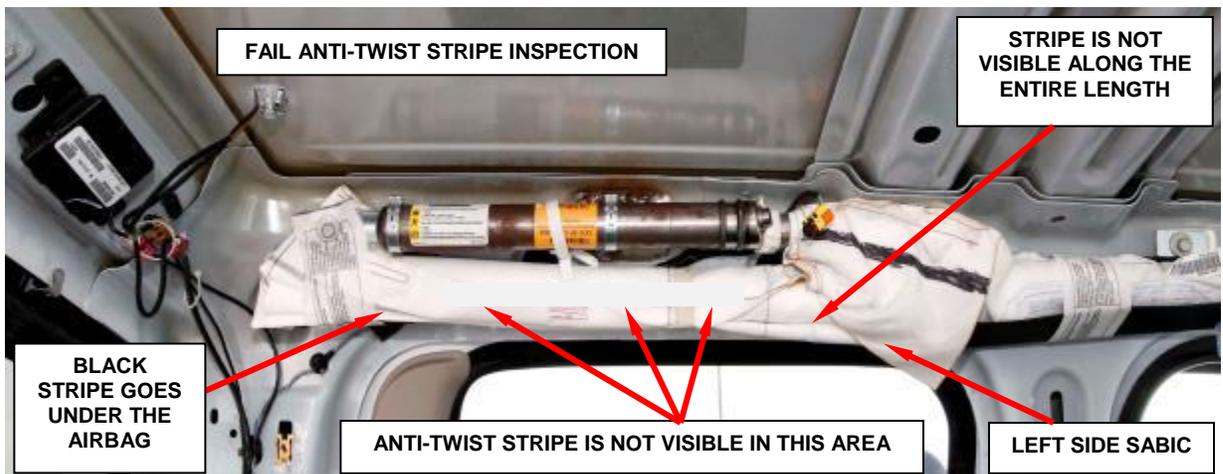
**Figure 23 - Failed Inspection: Anti-Twist Stripe Position
(Black Stripe for Early Builds)**

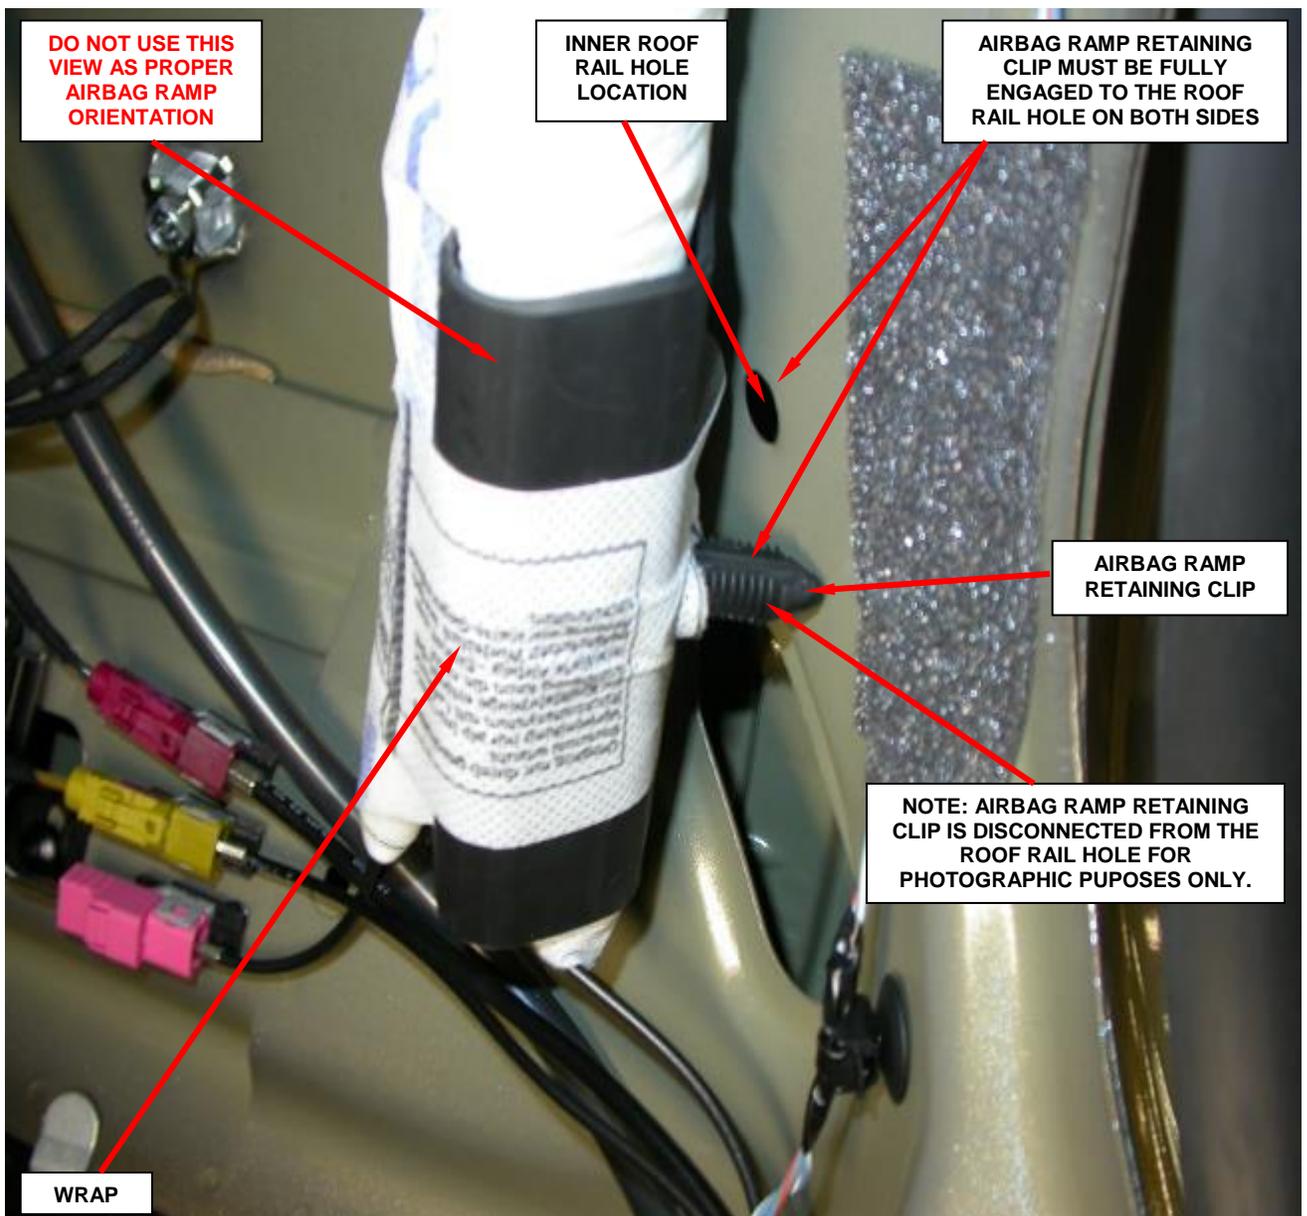
Figure 24 – Airbag Ramp Position (Left Side Shown)

2. Inspect the airbag ramp retaining clip on the right and left side SABIC modules. Ensure the airbag ramp retaining clip is fully engaged to the inner roof rail hole (Figure 24).

CAUTION: The airbag ramp retaining clip must be fully engaged to the roof rail hole on both sides.

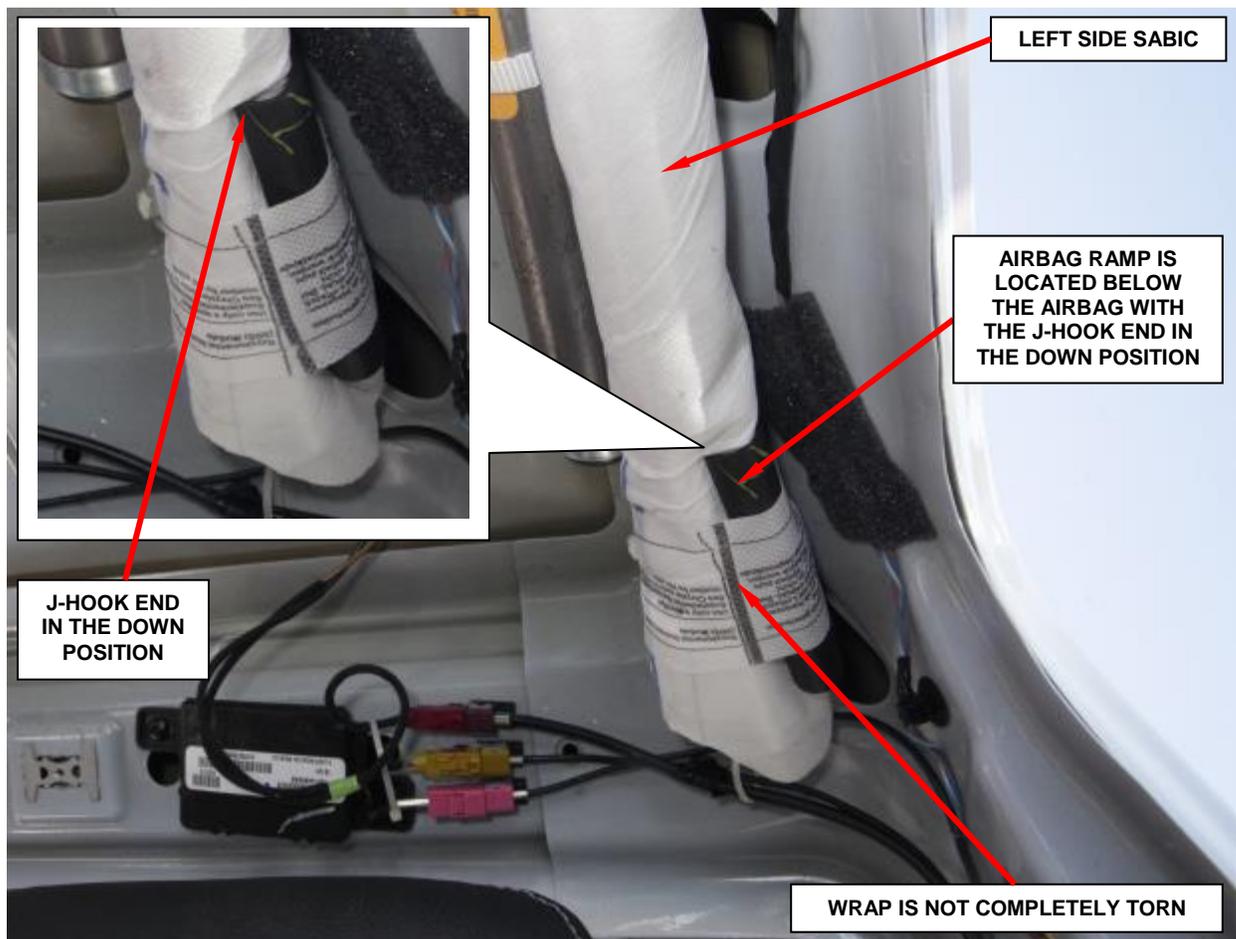
Figure 25 – Passed Inspection: Airbag Ramp and Wrap

3. Inspect the airbag ramp position on the right and left side SABIC modules. The airbag ramp should be located below the airbag with the J-hook end in the down position and the wrap must not be torn.
 - Vehicles that **do not have either airbag ramp out of position or the wrap is not completely torn on either side**, continue with **Section D. Install Foil Patches** (Figure 25).

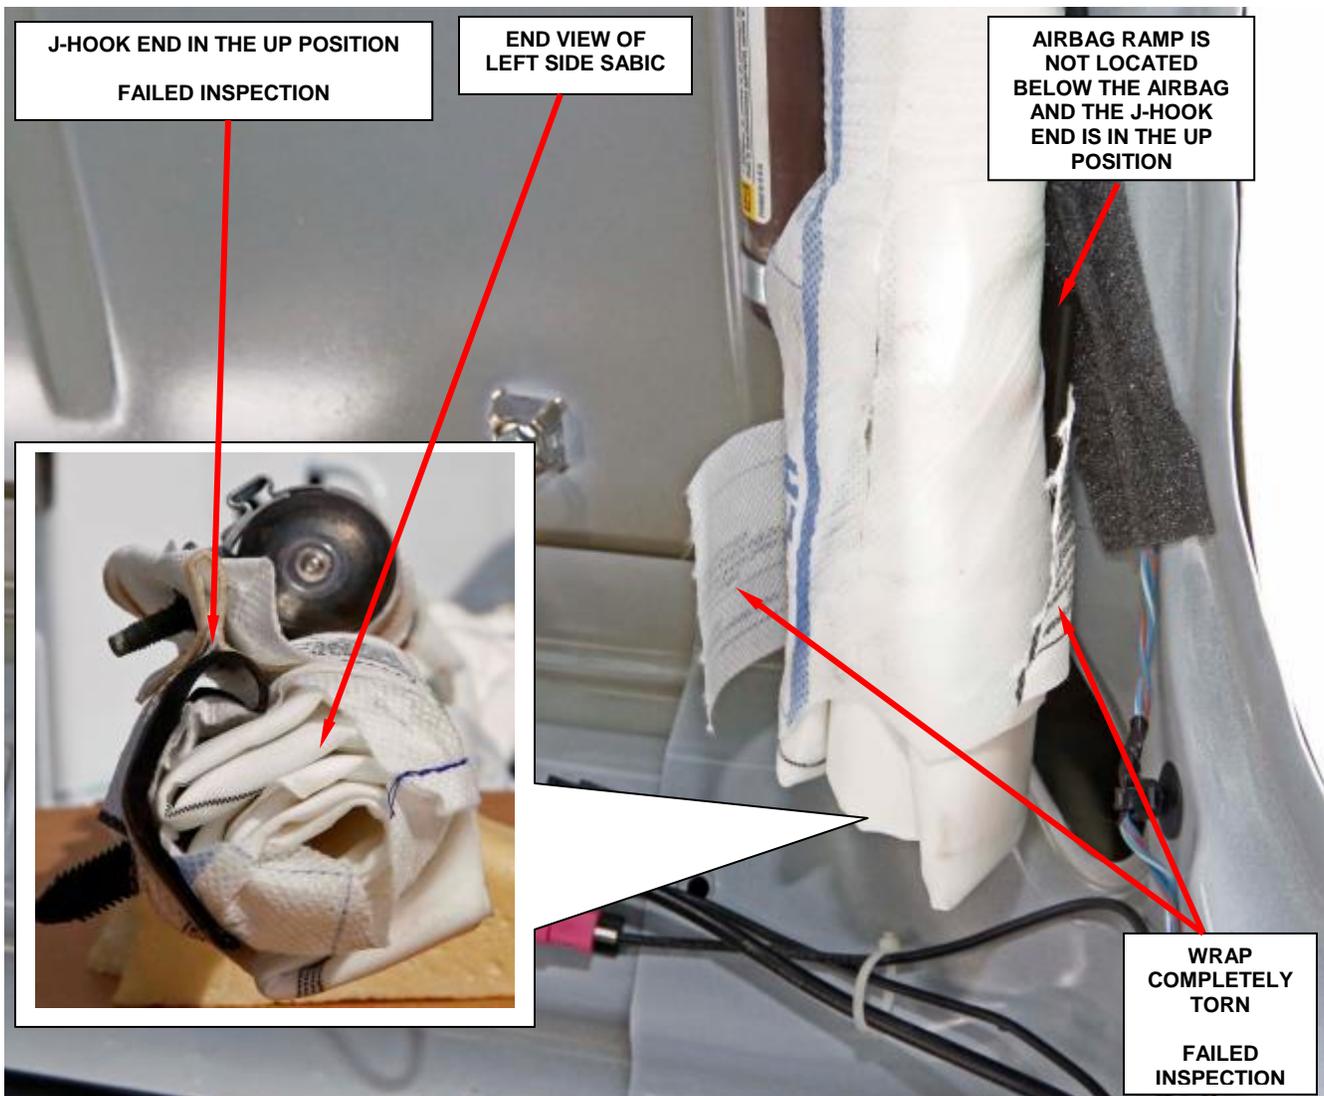
Figure 26 – Failed Inspection: Airbag Ramp and Wrap (Left Side SABIC Shown)

- Vehicles that have either airbag ramp out of position or the wrap is completely torn on either side, continue with Section C. Replace Side Airbag Inflatable Curtain's (SABIC's) (Figure 26).

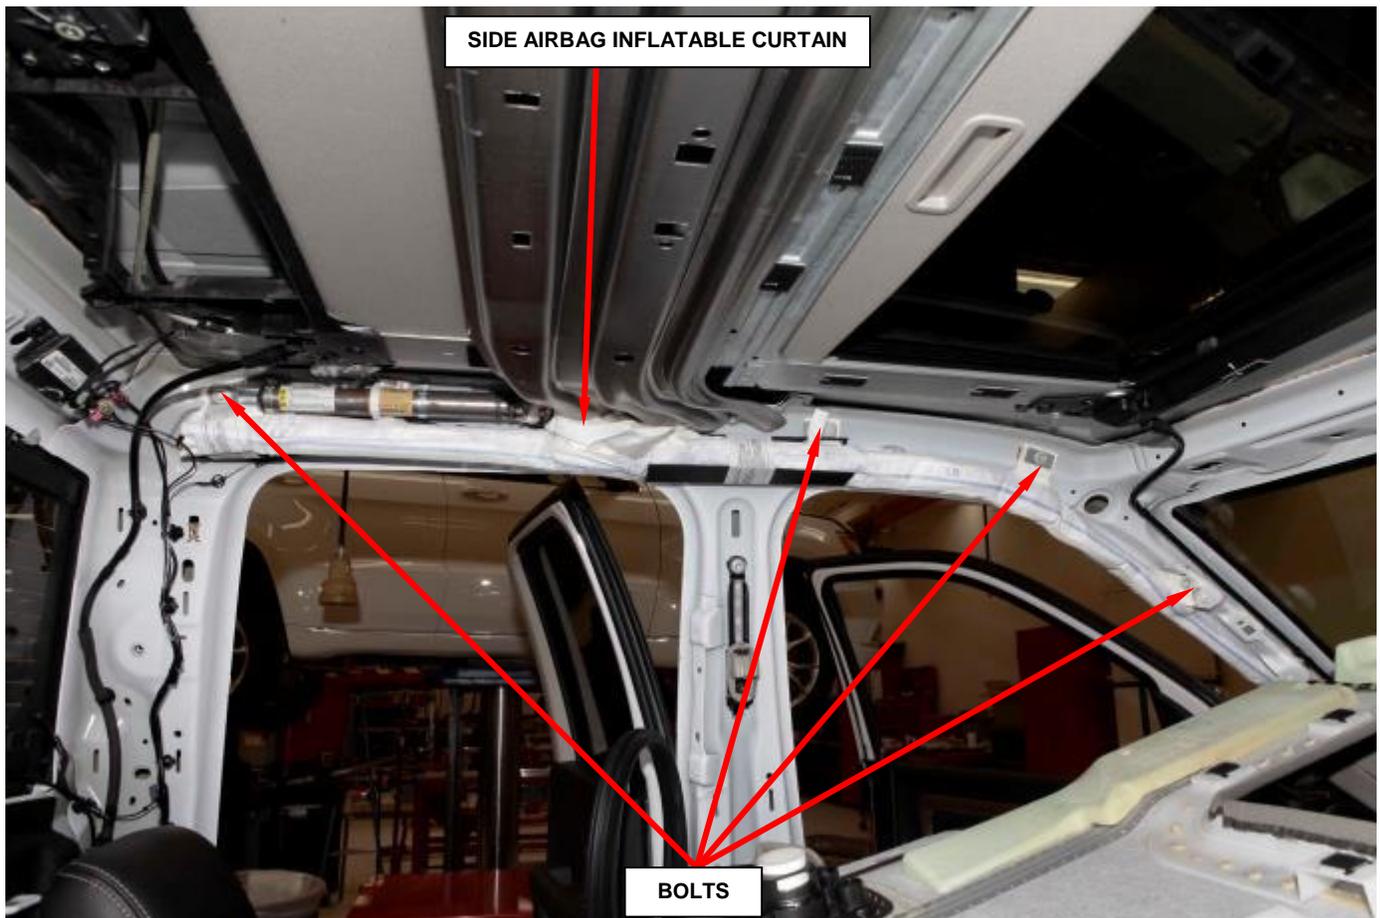
Figure 27 – Side Airbag Inflatable Curtain Bolt Locations

1. Remove the four bolts that secure the side airbag inflatable curtain to the inner roof rail (Figure 27).

13. Working from rear to front, install and tighten the four bolts that secure the side airbag inflatable curtain to the spring nuts in the inner roof rail. Tighten to 70 in. lbs. (8 N·m) (Figure 27).

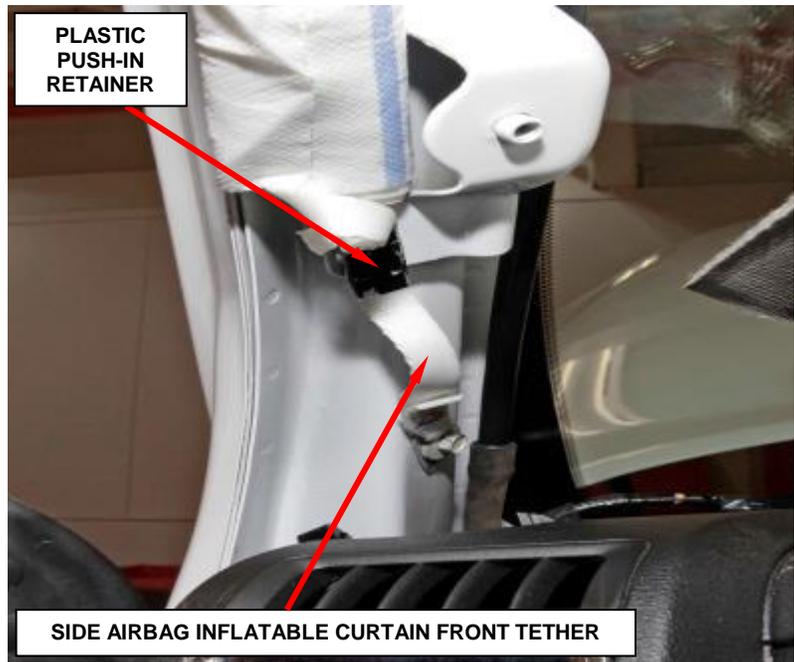
Figure 28 – Plastic Push-in Retainers

2. Disengage the plastic push-in retainer that secures the side airbag inflatable curtain front tether to the assist handle bracket on the inner A-pillar (Figure 28).

14. Engage the plastic push-in retainer that secures the side airbag inflatable curtain front tether to the assist handle bracket on the inner A-pillar (Figure 28).

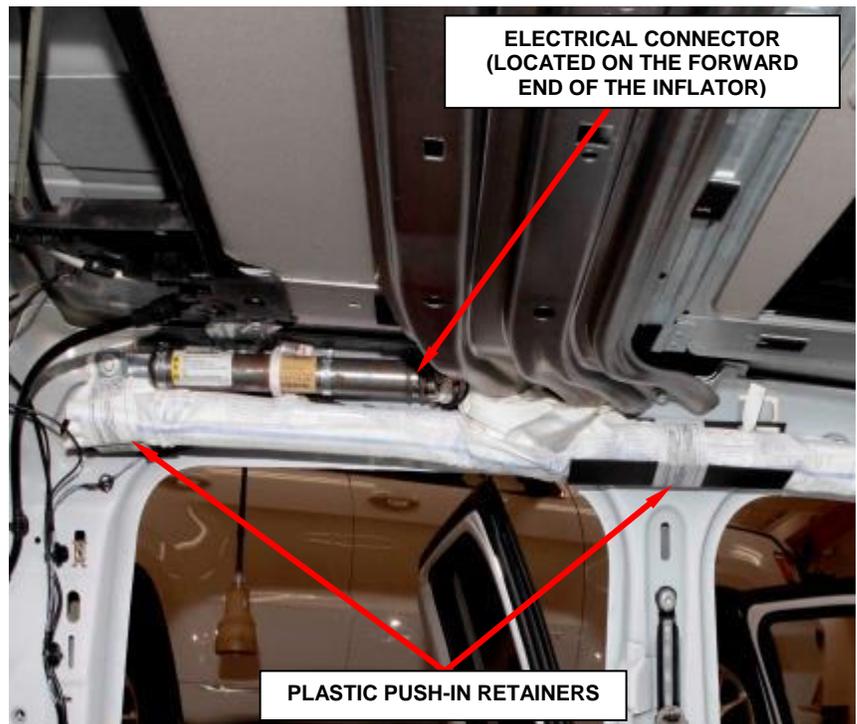
Figure 29 - Plastic Push-in Retainers

3. Disengage the two plastic push-in retainers that secure the side airbag inflatable curtain to the inner roof rail (Figure 29).

4. The body wire harness electrical connector is secured by integral latches to the connector receptacle at the rear of the inflator. Pinch both latches firmly, then pull the insulator straight out from the airbag inflator to disconnect it from the connector receptacle (Figure 29).

11. Connect the body wire harness electrical connector for the side airbag inflatable curtain to the connector receptacle at the back of the inflator. Be certain that each connector is fully engaged in its receptacle by listening carefully for a distinct, audible click as each connector latch snaps into place (Figure 29).

12. Align the two plastic push-in retainers that secure the side airbag inflatable curtain with the holes in the inner roof side rail and push it straight in until they are fully seated (Figure 29).

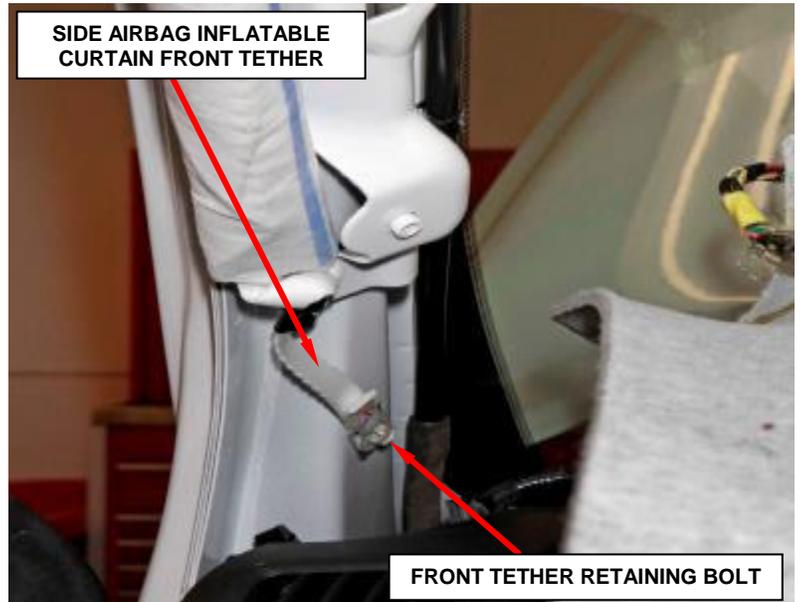
Figure 30 – Tether Retaining Bolt

5. Remove the side airbag inflatable curtain front tether retaining bolt (Figure 30).

15. Install the front tether retaining bolt. Tighten to 70 in. lbs. (8 N·m) (Figure 30).
16. Repeat steps 1 through 15 if both side airbag inflatable curtains fail the inspection procedure outlined in **Section B. Inspect Side Airbag Inflatable Curtain (SABIC)**.

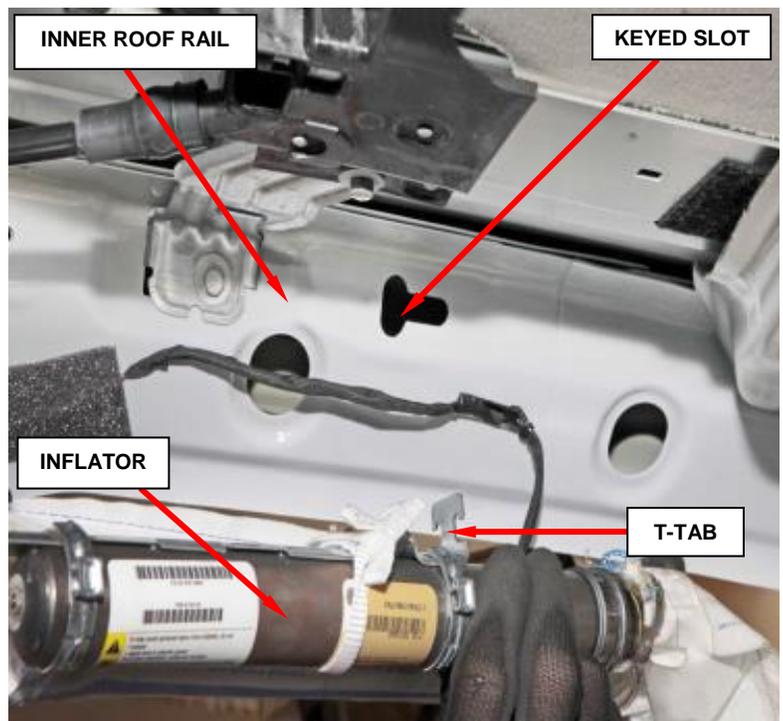
Figure 31 – Inflator T-Tab

6. Slide the inflator rearward far enough to disengage the T-tab at the front of the inflator bracket from the keyed slot in the inner roof rail over the rear door opening (Figure 31).

10. Insert the T-tab at the front of the inflator bracket into the keyed slot in the inner roof rail over the rear door opening and slide the inflator forward to engage it (Figure 31).
