Safety Recall R47 / NHTSA 15V-534

Side Airbag Inflatable Curtain

2014-2015 (DS) RAM 1500 Quad Cab Pickup

The right and left Side Airbag Inflatable Curtains (SABIC) on about 188,000 of the above vehicles may not deploy as intended. An improperly deployed SABIC, during certain crash events, could allow additional injuries to rear seat occupants.

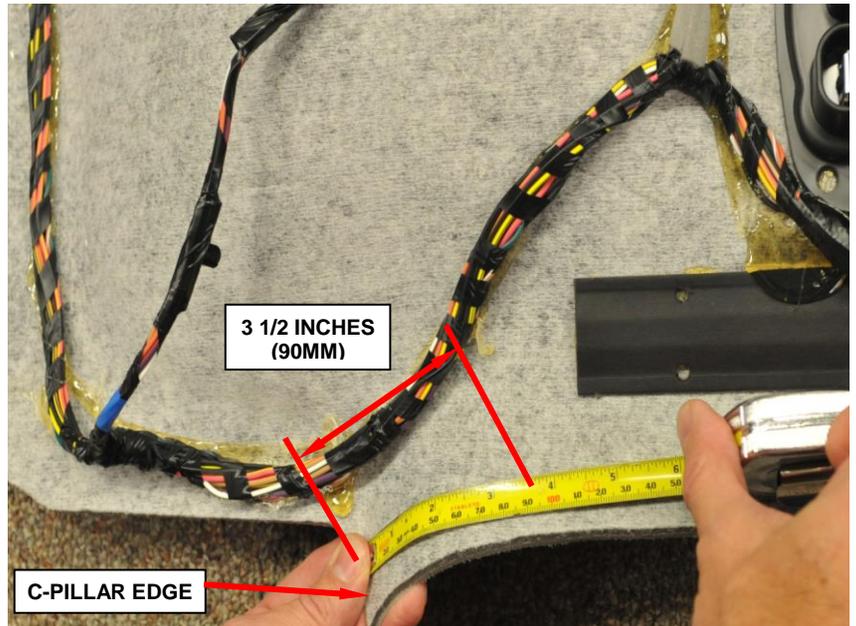
Figure 32 – Mark 3 1/2 inches (90mm) Location on Headliner

1. On the right side of the headliner, measure 3 1/2 inches (90mm) from the C-Pillar edge of the headliner and mark the headliner for the rear edge of the foil patch (Figure 32 and 33).
2. Measure 3/8 inch (10mm) from the outer edge of the headliner and mark the headliner for the outboard edge of the foil patch (Figure 32 and 33).

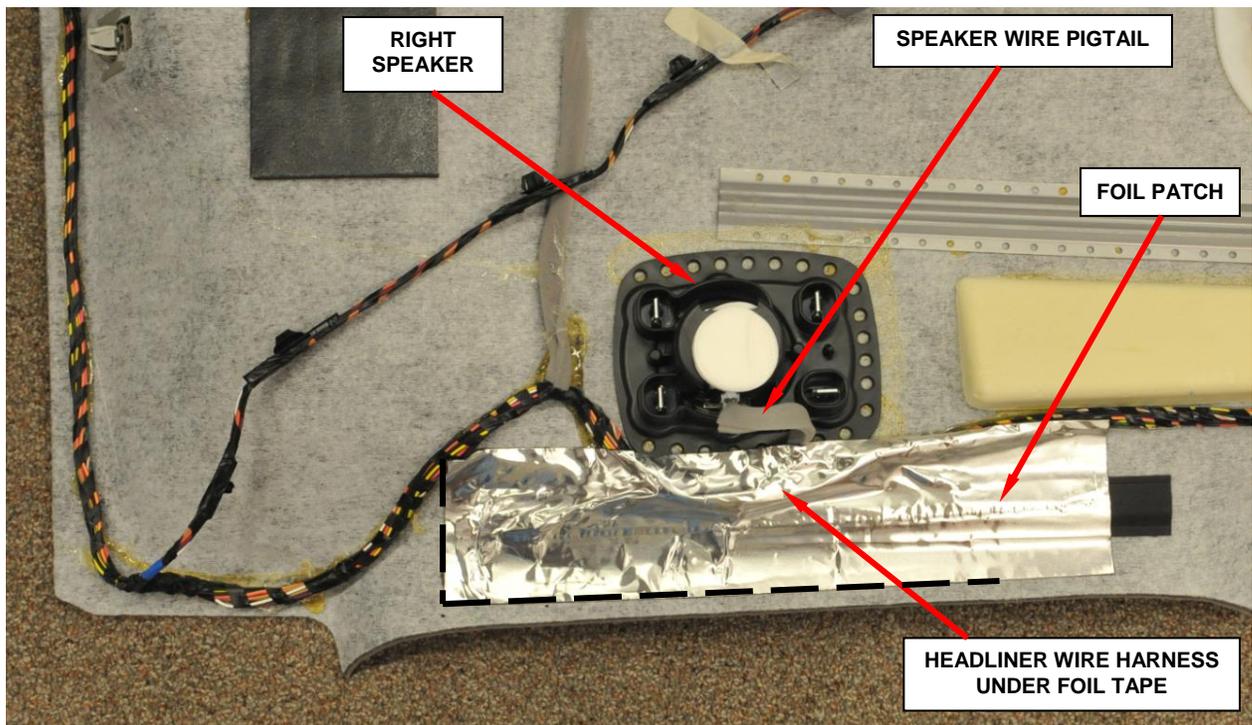
Figure 34 – Foil Patch Installed (Right Side Shown)

4. Install the foil patch to the headliner using the markings as a guideline and smooth the foil patch edges (Figure 34).

NOTE: If the headliner wire harness is positioned under the foil patch, smooth the foil patch around the wire harness.

NOTE: Assure the speaker wire pigtail is not positioned under the foil patch. See Figure 34 for proper speaker wire orientation.
