GROUP	NUMBER
RECALL	17-01-046
DATE	MODEL(S)
<b>JUNE 2017</b>	2011-2012MY
	SONATA (YF)

SONATA GDI ENGINE INSPECTION / REPLACEMENT (RECALL CAMPAIGN 132)

**Description:** Certain 2011-2012 model year Sonata (YF) vehicles equipped with 2.4L and 2.0T GDI engines require an inspection to confirm normal operation. The inspection procedure will help indicate if the engine is operating normally or if an excessive connecting rod bearing wear condition in the engine crankcase may be present. If the vehicle continues to be driven with a worn connecting rod bearing, the bearing can fail and the vehicle could stall.

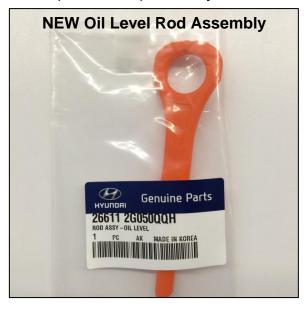
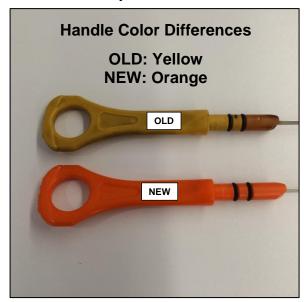
- 2. Replace the engine oil (4.8 quarts) and oil filter.
- 3. Replace the current Oil Level Rod Assembly with the new campaign part.
  - Remove and discard the existing Oil Level Rod Assembly (engine oil dipstick).
  - Install new ORANGE handle Oil Level Rod Assembly (P/N 26611-2G050QQH)

Note: Replace the dipstick only if the current dipstick's handle is yellow.
