TECHNICAL INSTRUCTIONS (REMEDY)
FOR
SAFETY RECALL F0S
FRONT WIPER CRANK ARM
CERTAIN 2009 - 2012 MODEL YEAR RAV4
AND
CERTAIN 2012 - 2014 MODEL YEAR RAV4 EV

IV. BACKGROUND

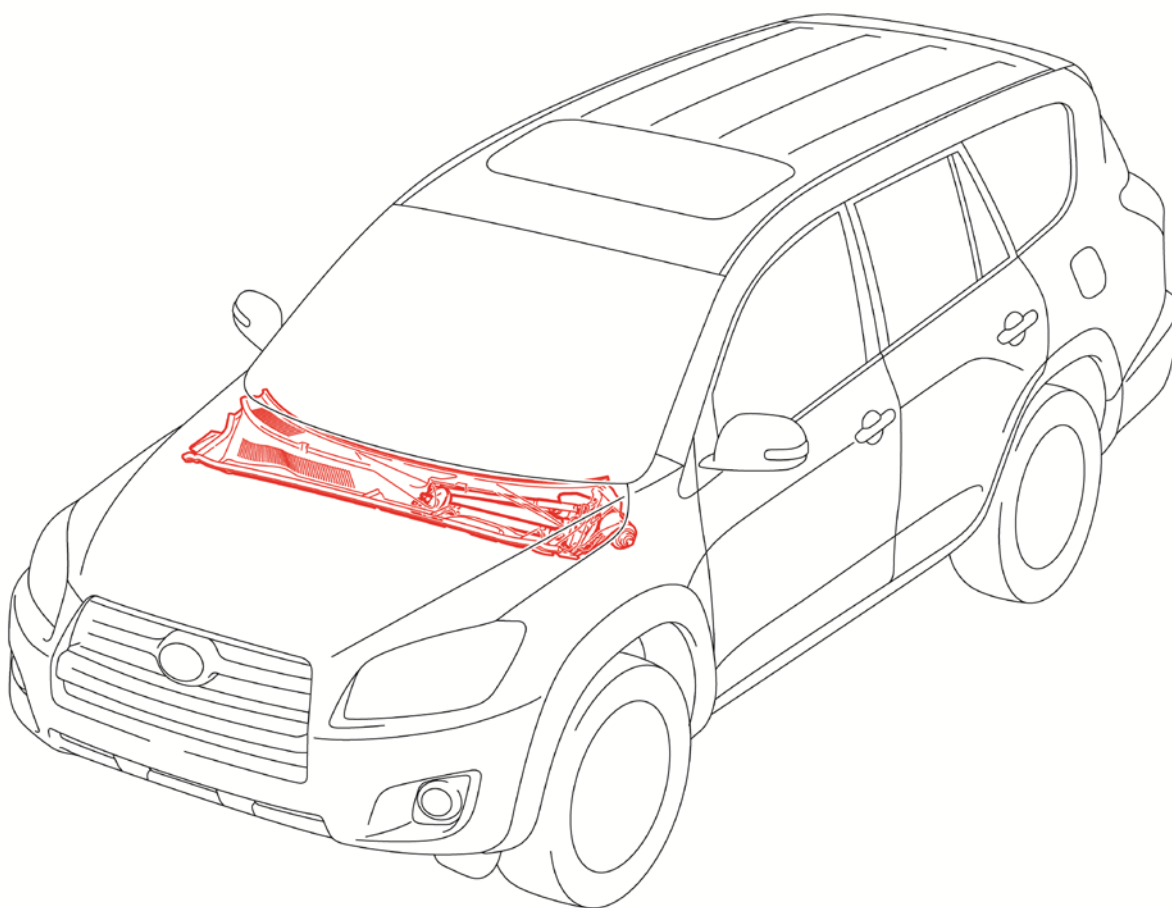
K1500180004

In the involved vehicles, water dripping onto the windshield wiper motor link can, over time, cause corrosion and wear at the wiper motor link joint. In some cases this could result in the separation of the wiper link from the wiper motor crank arm. If separation occurs, the windshield wipers could become inoperative, which could reduce driver visibility and increase the risk of a vehicle crash.

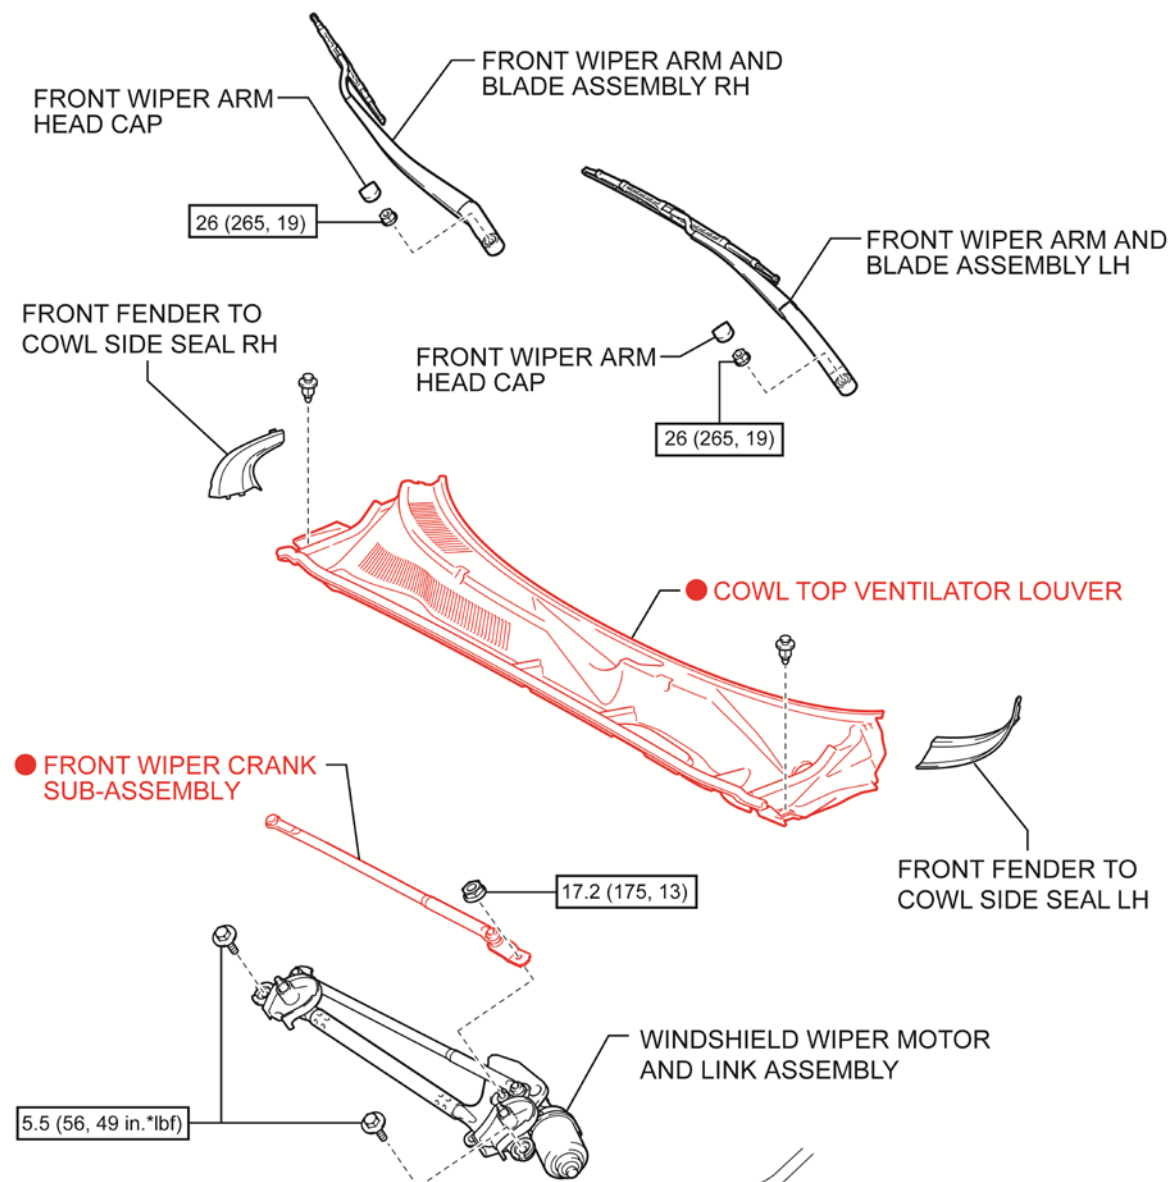
K1500180022b

● : Replacement part

N*m (kgf*cm, ft.*lbf) : Specified torque

- If the interim repair has already been completed replace the cowl top louver only.

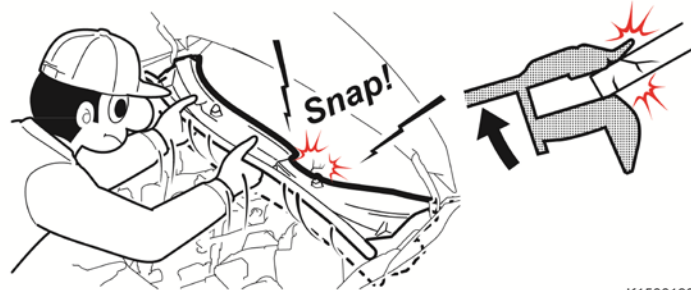
K1500180023a

PRECAUTION WHEN REMOVING THE COWL LOUVER

Always pull the louver down until it disengages from the windshield before removal. If the louver is pulled upward prior disengaging it from the windshield, the windshield could crack.

OK Straight out

NG At an angle

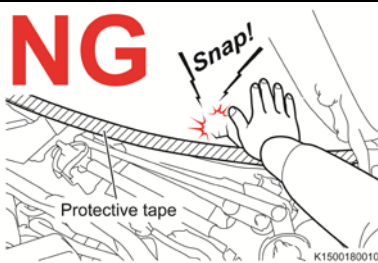
K1500180010

Protective tape

PRECAUTIONS WHEN HANDLING THE GLASS EDGE

To prevent the glass from breaking, clean it and apply protective tape to the bottom edge so that tools and other items **DO NOT** directly contact the glass.

DO NOT put your hand on the bottom edge of the glass to support your weight. The glass could break because there is no support on the rear side of the glass.

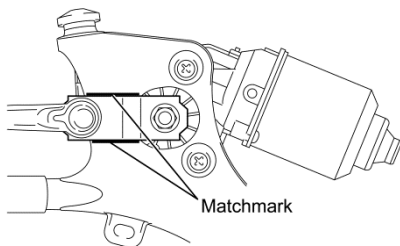
K1500180001

Matchmark

3. REMOVE THE MOTOR FROM THE LINKAGE

- Place matchmarks on the wiper motor on each side of the crank arm as shown.

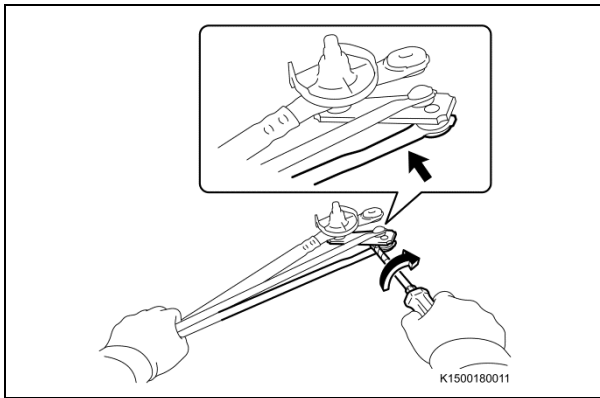
- b) Using a screwdriver wrapped in tape as shown.
- c) Disconnect the wiper link from the crank arm.

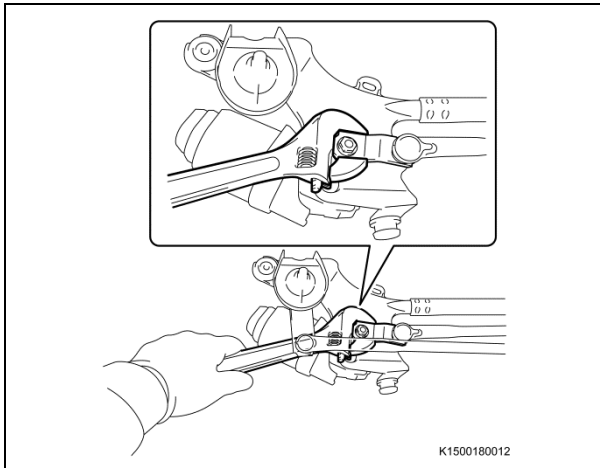
- d) Hold the crank arm with an adjustable wrench as shown.

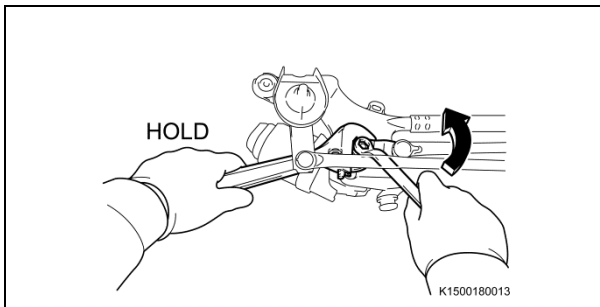
- e) Remove the nut that holds the crank arm to the wiper motor.

NOTE: The nut will be reused.

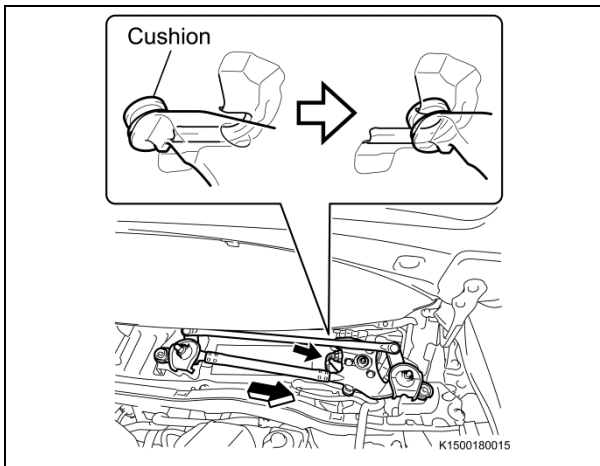
4. INSTALL THE NEW WIPER CRANK

- a) Reconnect the electrical connector for the wiper motor.
- b) Engage the cushion for the linkage into the body as shown.
- c) Temporarily install the 2 bolts.
- d) Turn IG "ON".
- e) Turn the wipers on.
- f) Turn the wipers off.

This step is necessary to ensure that the wiper motor is in the park position. DO NOT turn IG off prior to the wiper motor being in the park position.

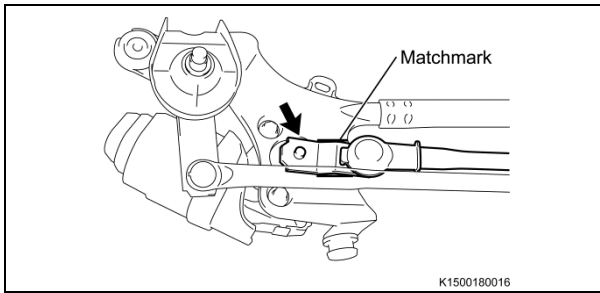
- g) Turn the IG "OFF".
- h) Remove the motor and linkage from the vehicle.
- i) Disconnect the connector for the motor.
- j) Align the NEW crank arm with the matchmarks on the wiper motor and linkage, and insert it onto the motor shaft.

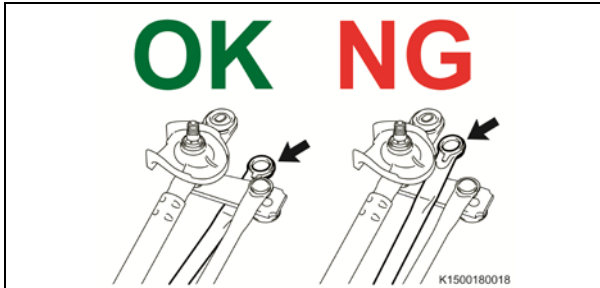
STOP The crank arm and linkage cannot be connected as shown. However, by passing the crank arm under the linkage it will correctly position the arm.

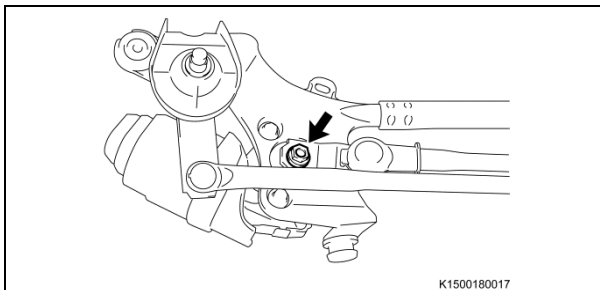
- k) Reinstall the nut and hand tighten.

STOP To ensure that the crank arm is in the correct position hand tighten the nut until the crank arm is seated.

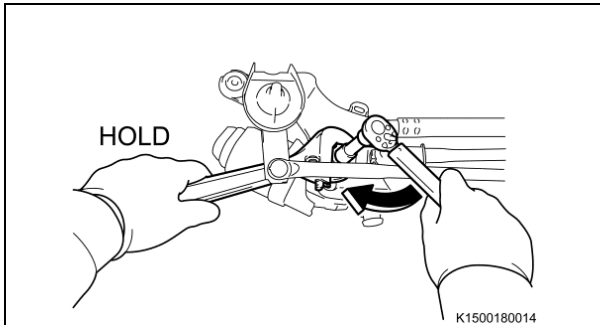
- l) Hold the crank arm with an adjustable wrench and tighten the nut.

Torque: 17.2 N*m (175 kgf*cm, 13 ft*lbf)

STOP Securely hold the crank arm with the adjustable wrench to ensure that the crank arm does not move.

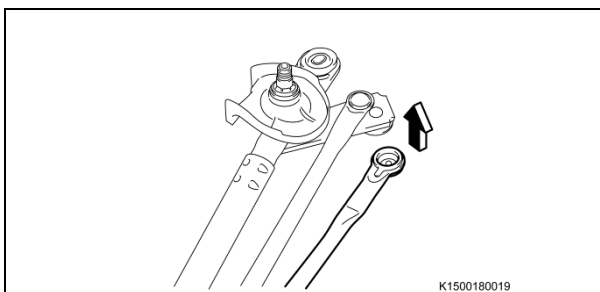
- m) Position and align the crank arm and linkage then connect them.

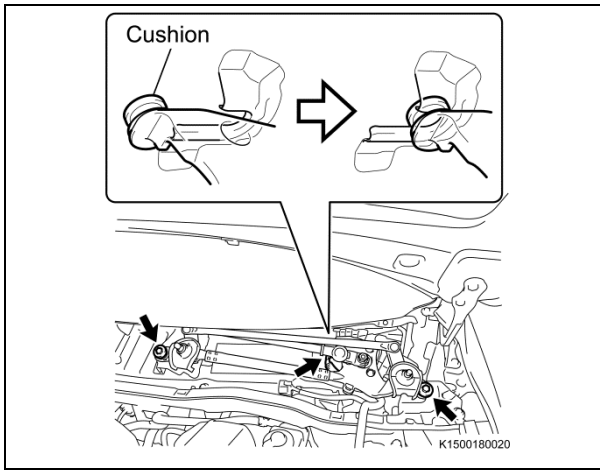
- n) Reconnect the motor connector.
- o) Engage the cushion of the motor and linkage onto the vehicle.
- p) Install the 2 bolts.
Torque: 5.5 N*m (56 kgf*cm, 49 in*lb)
- q) Start engine and cycle the wipers.

This step is necessary to ensure that the wiper motor is in the park position. DO NOT turn the vehicle off prior to the wiper motor being in the park position. Having the engine running ensures correct voltage to the wiper motor.

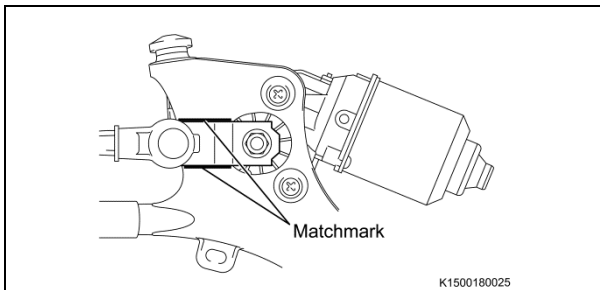
- r) Check that the position of the crank arm and the matchmarks are properly aligned.

If the crank arm and the match marks do not align, cycle the wipers again to double check. If the crank arm is still not aligned return to Section VI Step 1.

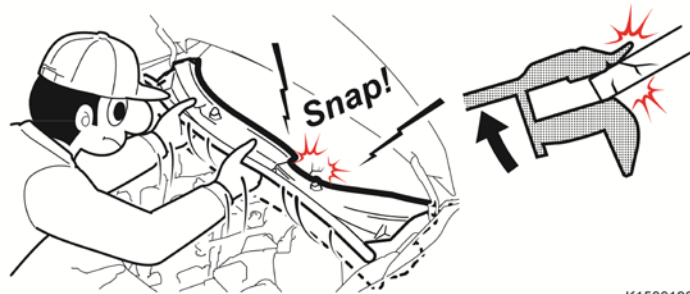
K1500180023a

PRECAUTION WHEN REMOVING THE COWL LOUVER

Always pull the louver down until it disengages from the windshield before removal. If the louver is pulled upward prior to disengaging it from the windshield, the windshield could crack.

OK Straight out

NG At an angle

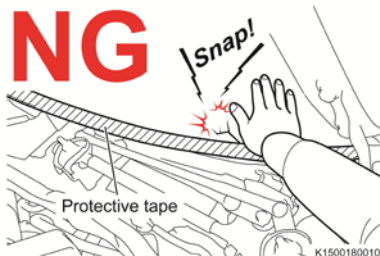
K1500180010

Protective tape

PRECAUTIONS WHEN HANDLING THE GLASS EDGE

To prevent the glass from breaking, clean it and apply protective tape to the bottom edge so that tools and other items **DO NOT** directly contact the glass.

DO NOT put your hand on the bottom edge of the glass to support your weight. The glass could break because there is no support on the rear side of the glass.

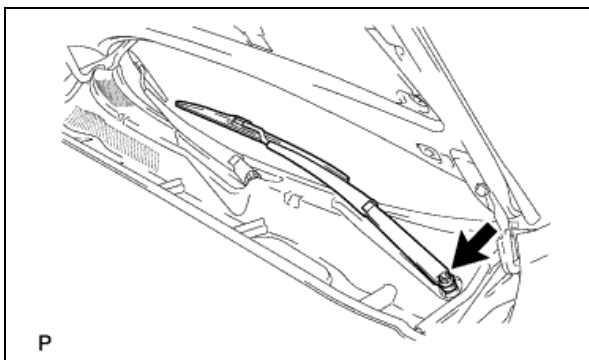
1. REMOVE THE FRONT WIPER ARMS

- Remove the left wiper arm cap
- Remove the nut for the left wiper arm.
- Remove the wiper arm.

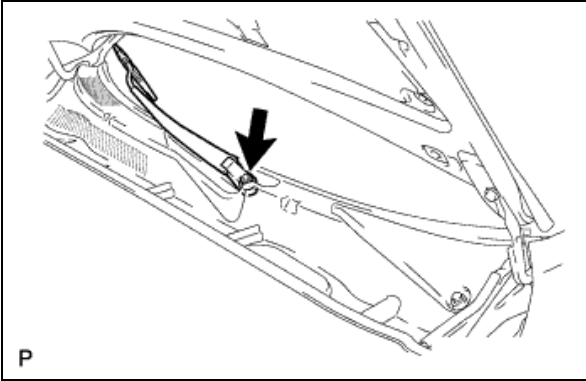
- d) Remove the right wiper arm cap
- e) Remove the nut for the right wiper arm.
- f) Remove the wiper arm.

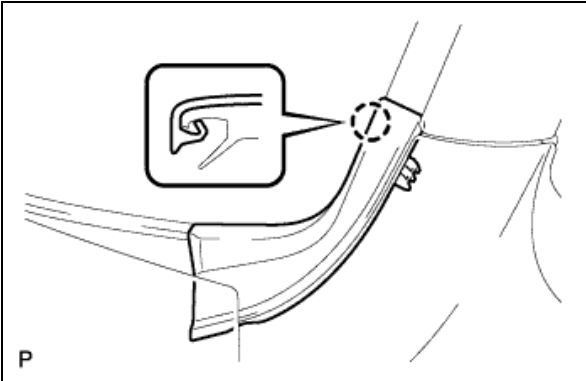
2. REMOVE THE FRONT COWL SEALS

- a) Detach the claw and remove the left front cowl seal.

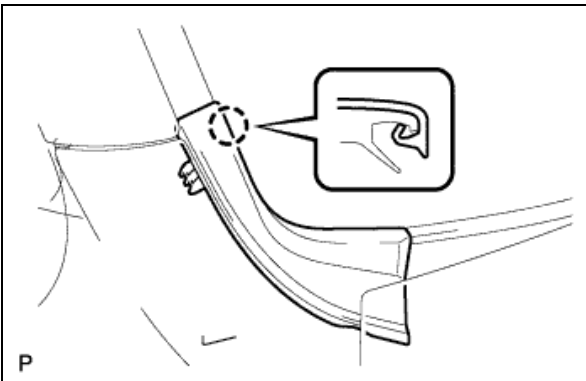
- b) Detach the claw and remove the right front cowl seal.

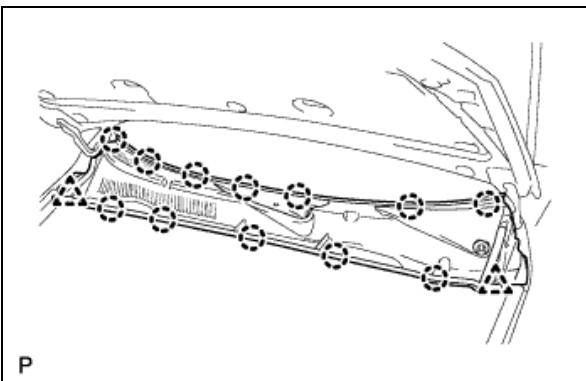
3. REMOVE THE COWL TOP VENT LOUVER

- a) Remove the 2 clips.
- b) Detach the 12 claws and remove the louver.
- c) Mark the old louver so it is not reused.

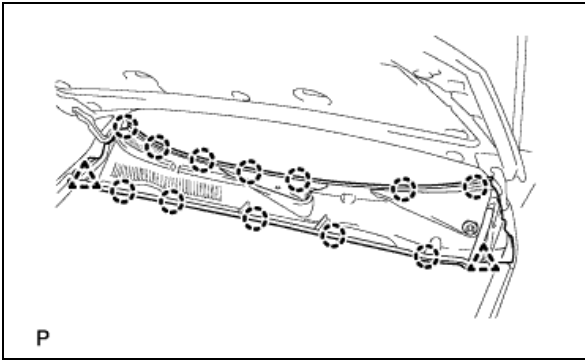
4. INSTALL THE NEW COWL TOP VENT LOUVER

- a) Install the new louver.
- b) Attach the 12 claws.
- c) Reinstall the 2 clips.

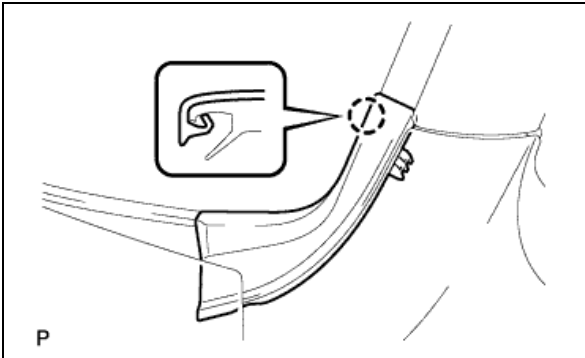
5. REINSTALL THE FRONT COWL SEALS

- a) Reattach the claw to reinstall the left side seal.

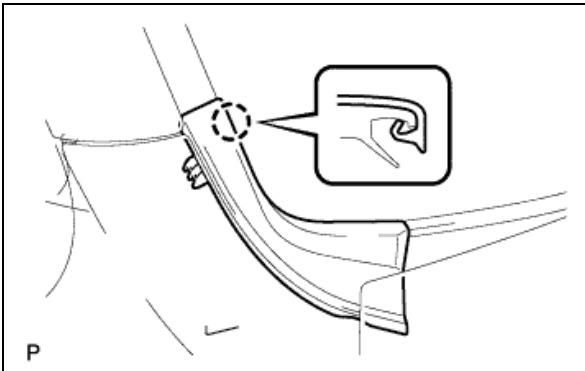
- b) Reattach the claw to reinstall the right side seal.

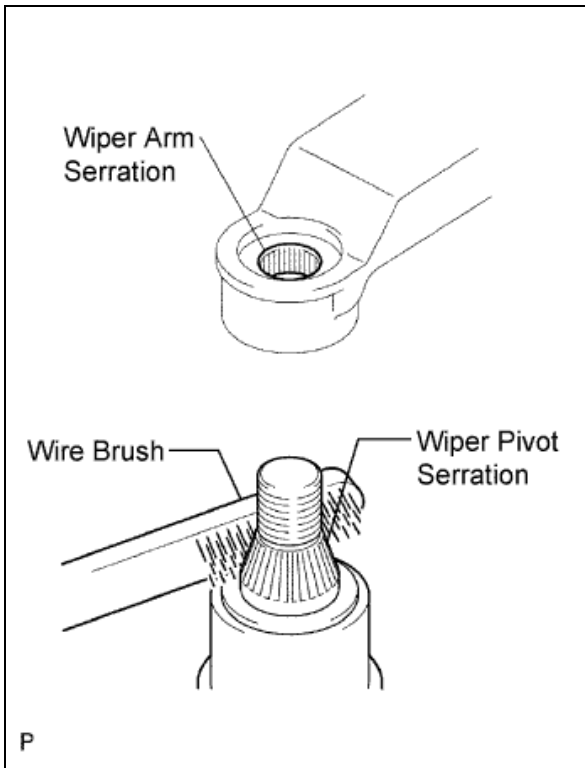
6. REINSTALL THE WIPER ARMS

- Turn IG "ON"
- Turn on the wipers.
- Turn off the wipers.
- Turn IG "OFF".
- NOTE: Allow enough time for the wipers to return to the park position prior to turning IG "OFF".**
- Clean both wiper arm serrations with a round file or equivalent.
- Clean both wiper pivot serrations with a wire brush.

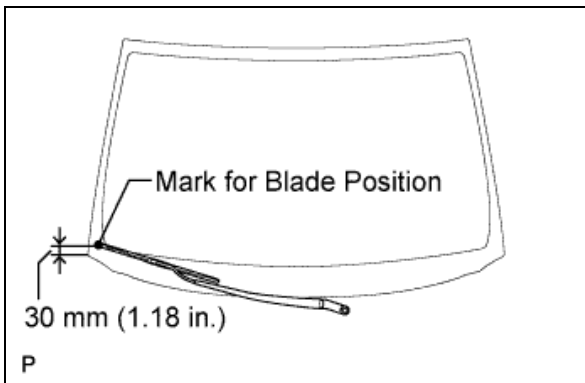
- Reinstall the right wiper arm and nut.
Torque: 26 N·m (265 kgf·cm, 19 ft lbf)
NOTE: Ensure to position the arm and blade as shown.

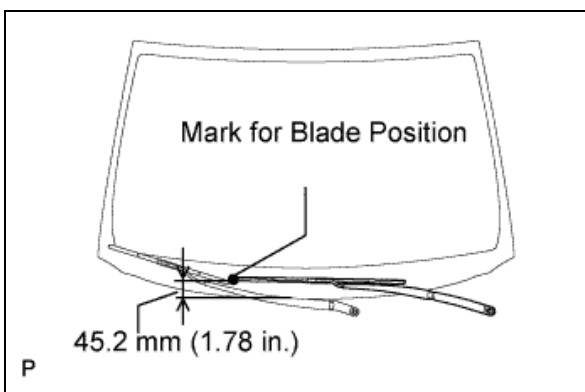
- Reinstall the left wiper arm and nut.
Torque: 26 N·m (265 kgf·cm, 19 ft lbf)
NOTE: Ensure to position the arm and blade as shown.
- Operate the front washers and wipers and check that there is no interference between the blades and the pillar.
- Reinstall the left and right wiper arm caps.
