Safety Recall R54 / NHTSA 15V-590 Passenger Airbag Module

2015 (BF) FIAT 500L

Replace Passenger Airbag Module

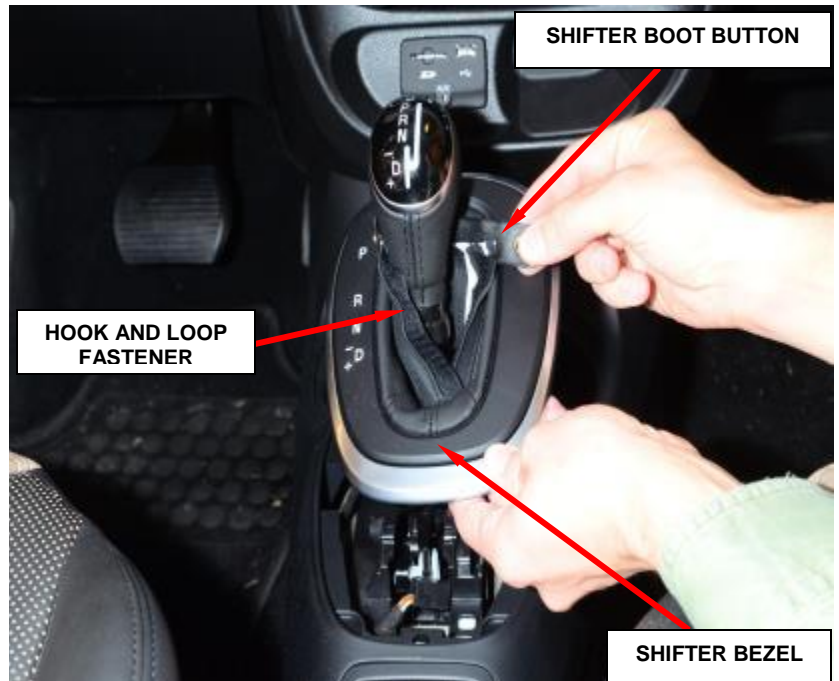
Figure 1 - Shifter Boot

2. Use the following steps to remove the floor console.
 - a. Unfasten the shifter boot button and release the hook and loop fastener (Figure 1).
 - b. Using a trim stick or equivalent, release the retainers securing the shifter bezel to the floor console (Figure 1).
 - c. **If equipped**, disconnect the shifter bezel electrical connector.
 - d. Remove and save the shifter bezel.
 - e. Position the parking brake handle in the full up position.
 - f. Grasp the park brake handle bezel in the center area and pull upward to release the retaining tabs (Figure 2).

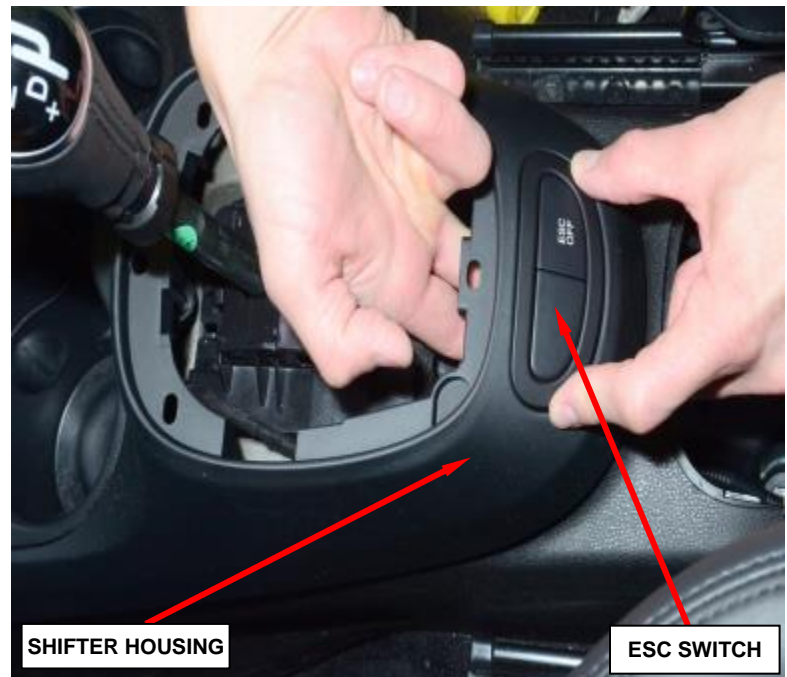
Figure 3 – ESC Switch

- g. Reach into the rear area of the shifter housing and press the retaining tabs on the back of the Electronic Stability Control (ESC) switch. Then push up releasing the switch (Figure 3).
- h. Disconnect the electrical connector from the switch.
- i. Remove and save the screw from the floor console in the ESC switch pocket area.
- j. Using a trim stick or equivalent, release the retainers securing the cup holder bezel to the floor console.
- k. Remove and save the three screws from the cup holder. Then lift up the cup holder and disconnect the electrical connector for the accessory power outlet (Figure 4).

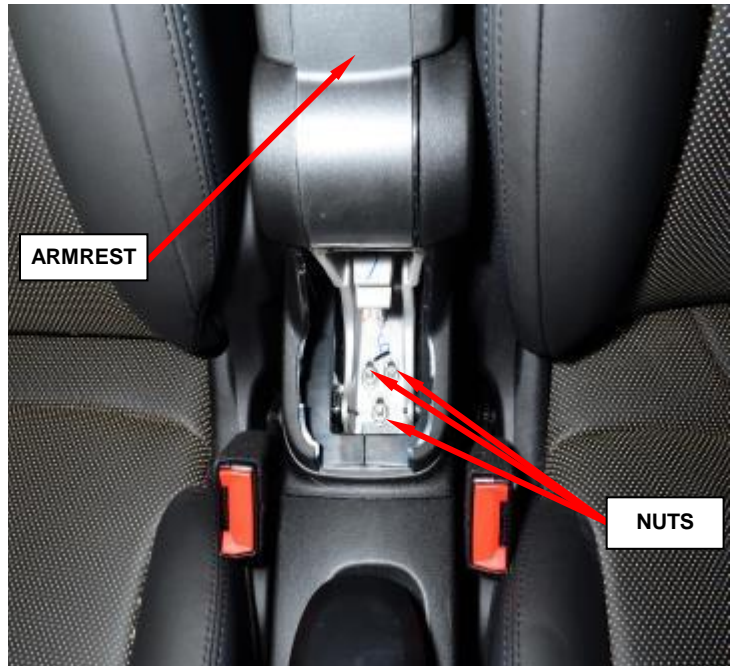
Figure 5 – Arm Rest

- l. Using a trim stick or equivalent, placed between the armrest hinge and arm rest bezel, release the armrest bezel retainers.

- m. Remove and save the three armrest nuts and remove and save the arm rest (Figure 5).

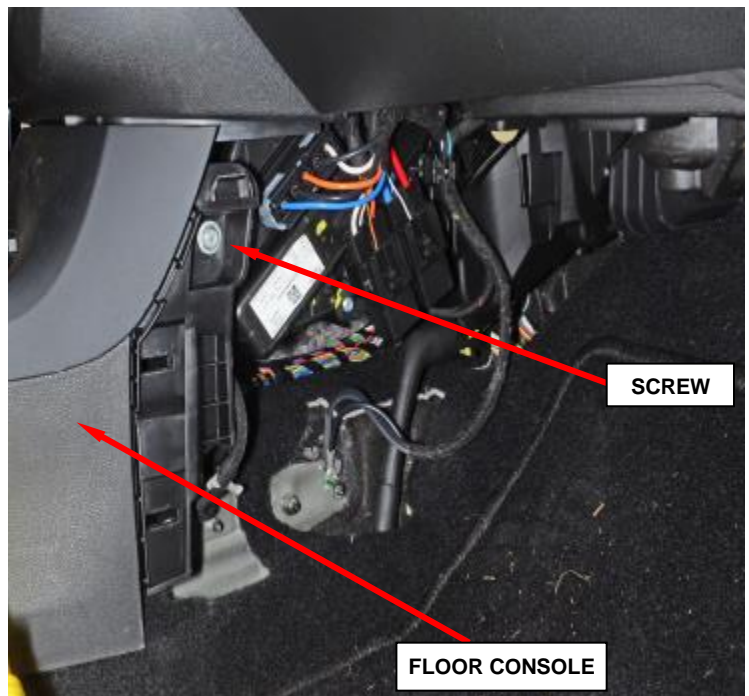
Figure 6 – Right Side Floor Console

- n. Using a trim stick or equivalent, release the retainers along the rear edge of the right side floor console side cover then slide the floor console side cover rearward to release front retainer.

- o. Remove and save the screw from the front of the floor console (Figure 6).

- p. Repeat steps n and o on the left side.

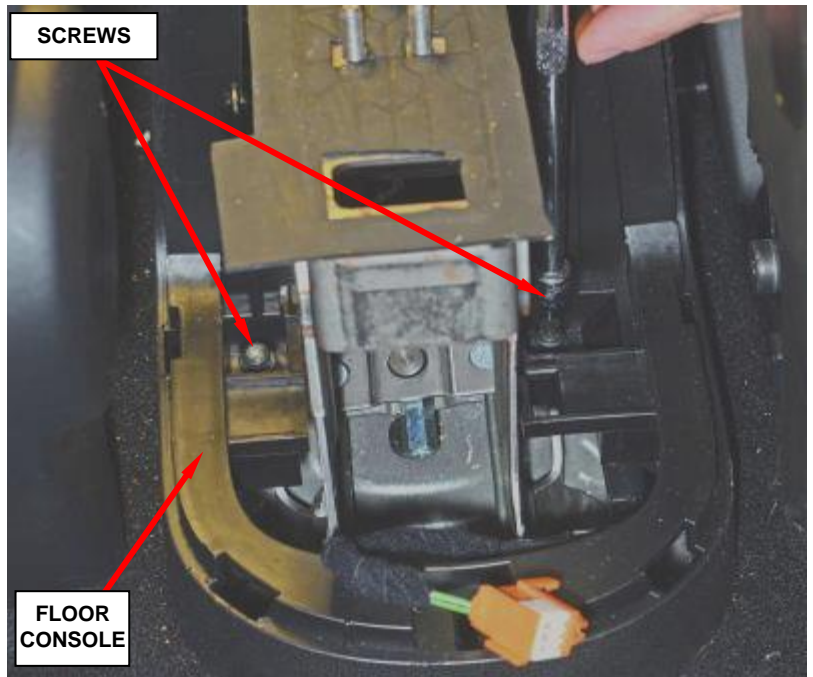
Figure 7 - Floor Console

- q. Using a trim stick or equivalent, release the retainers for the floor console rear cover and disconnect the electrical connector.
- r. Remove and save the two screws securing the rear of the floor console (Figure 7).
- s. Lower the parking brake handle.
- t. Slide the floor console slightly rearward and lift the floor console from the rear and then up, routing it over the shifter and remove the console from the vehicle.

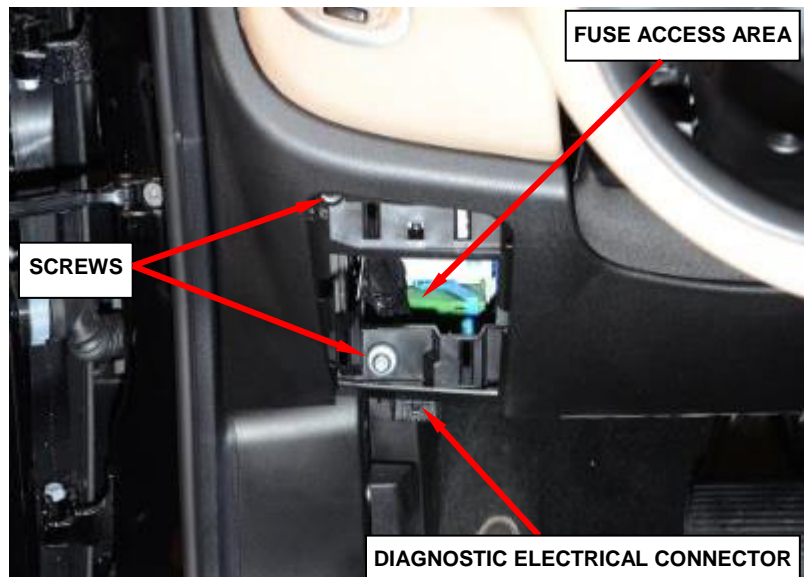
Figure 8 – Fuse Cover

- 3. Grasp the fuse access cover from the bottom and pull outward to remove.
- 4. Remove and save the two screws from the fuse access area (Figure 8).
- 5. Release the diagnostic electrical connector from the steering column closeout panel (Figure 8).

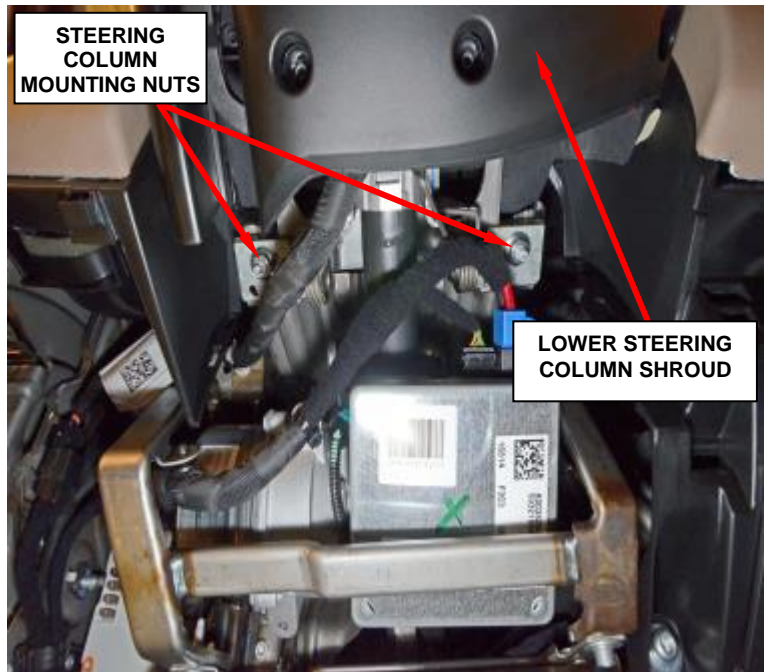
Figure 9 – Steering Column Mounting Nuts

7. Remove and save the two lower steering column mounting nuts (Figure 9).

8. Support the steering column with an appropriate device.

h. Remove and save the two mounting nuts attaching the steering column to the instrument panel (Figure 9).

- c. Loosely install the two column mounting nuts (Figure 9).

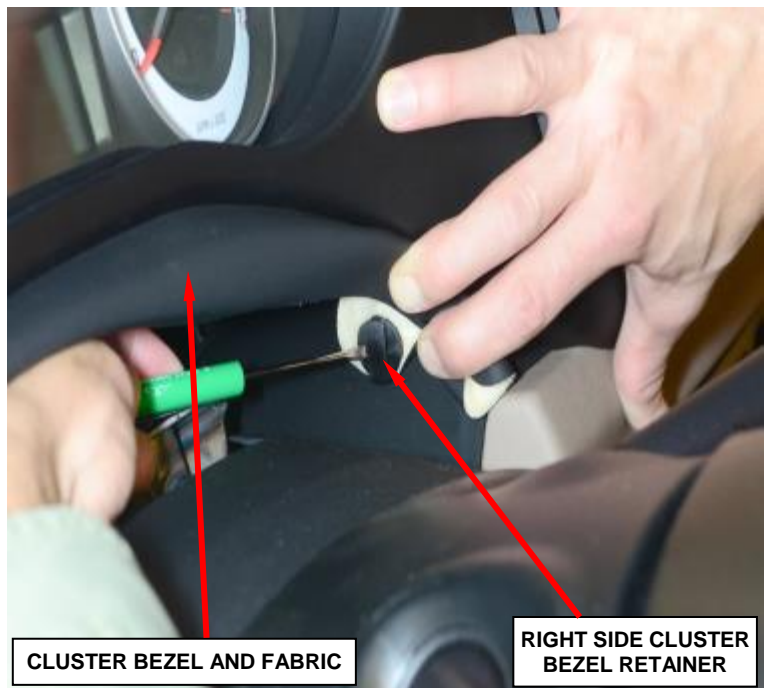
Figure 10 – Cluster Bezel

9. Using a small flat bladed tool or equivalent, remove the center insert from the cluster bezel retainer located above the right side of the steering column (Figure 10).

10. Using a trim stick or equivalent, remove the retainer securing the cluster bezel and fabric to the instrument panel (Figure 10).

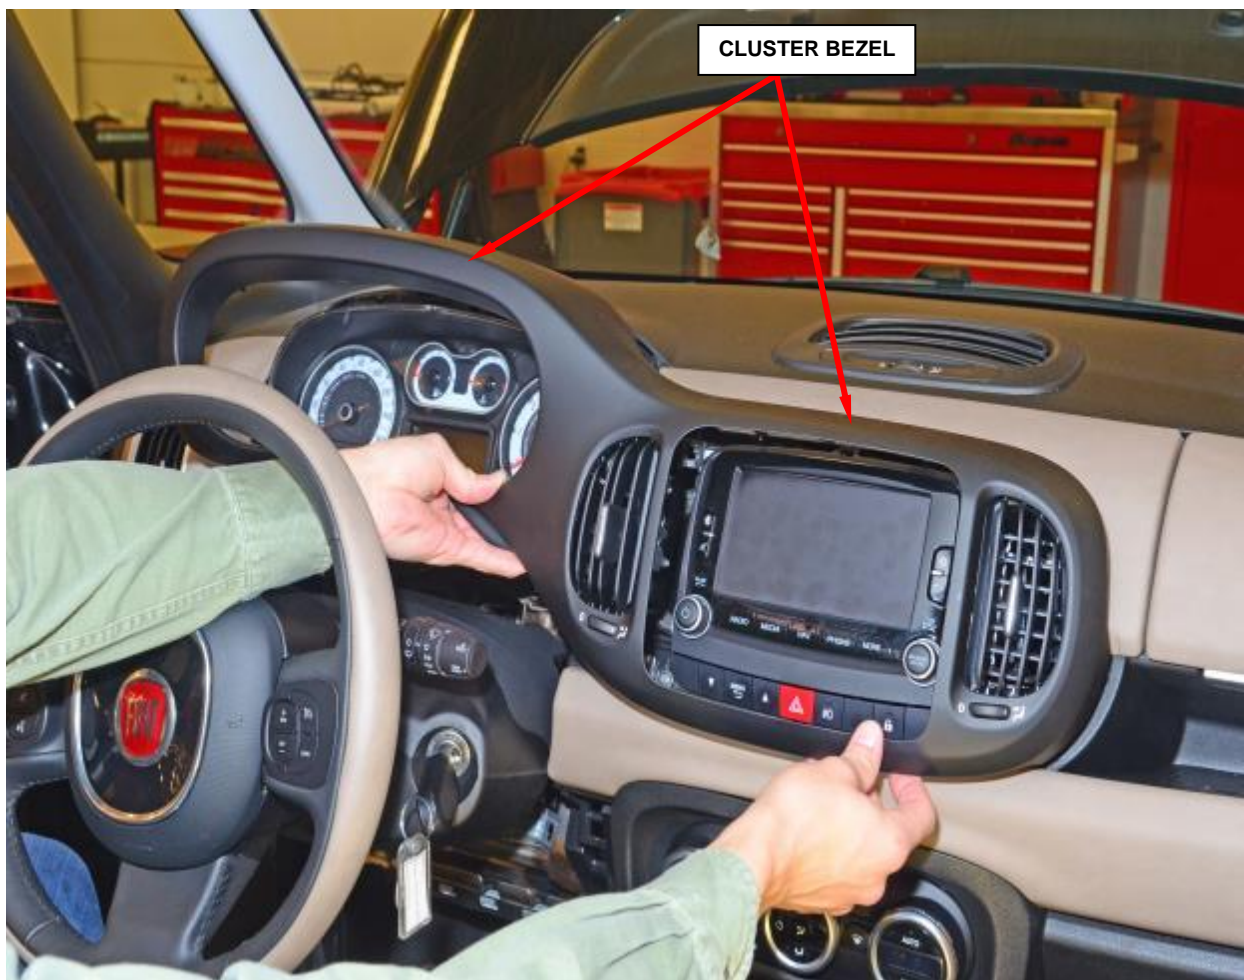
Figure 11 – Cluster Bezel

12. Using trim stick or equivalent, release the cluster bezel retaining clips and remove the cluster bezel (Figure 11).

13. Raise the steering column into place and loosely install the nuts.

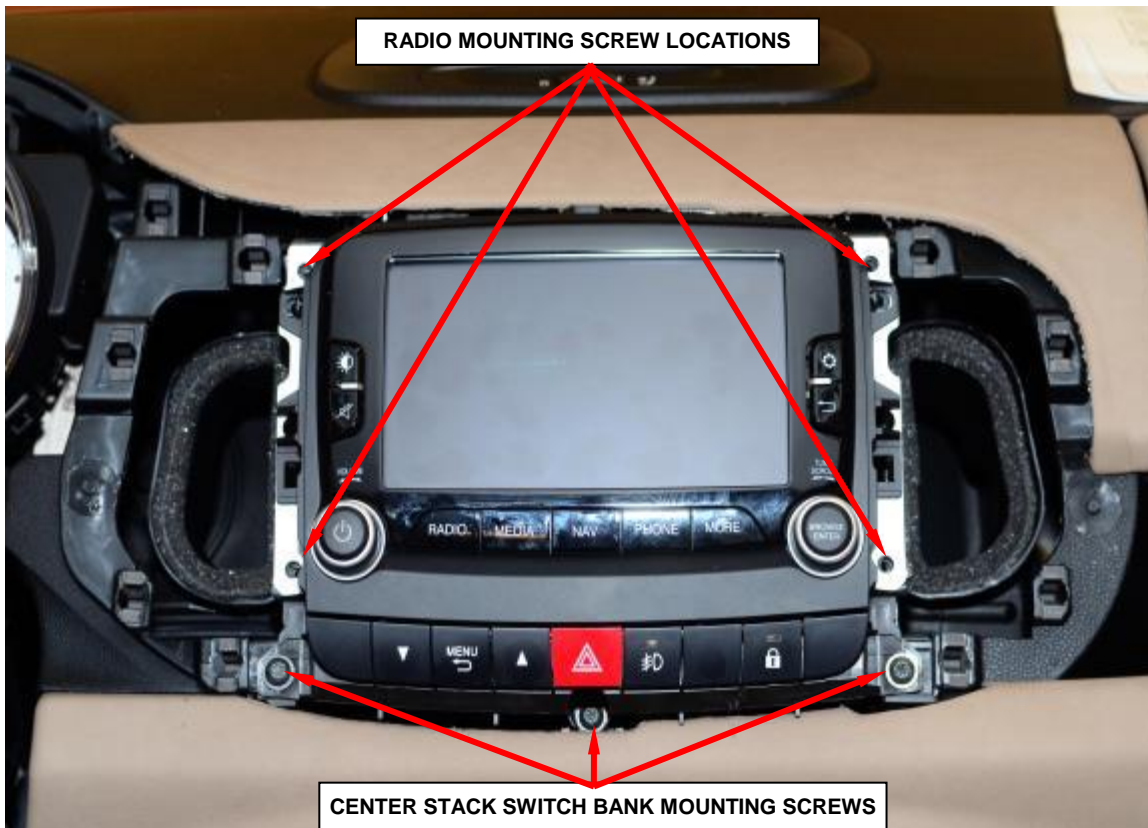
Figure 12 - Radio - Radio

14. Use the following steps to remove the radio and radio controls
 - a. Remove and save the four radio mounting screws and the three center stack switch bank mounting screws (Figure 12).
 - b. Disconnect the center stack switch bank electrical connector and remove and save the center stack switch bank (Figure 12).
 - c. Gently wiggle radio back and forth while pulling out releasing the inner locating pin.
 - d. Disconnect the radio electrical connectors.

CAUTION: Pulling the antenna cable straight out of the radio without pulling on the locking antenna connector could damage the cable or radio.

108. Insert the radio into the instrument panel and engage the inner locating pin.
109. Install the four radio mounting screws and tighten securely (Figure 12).

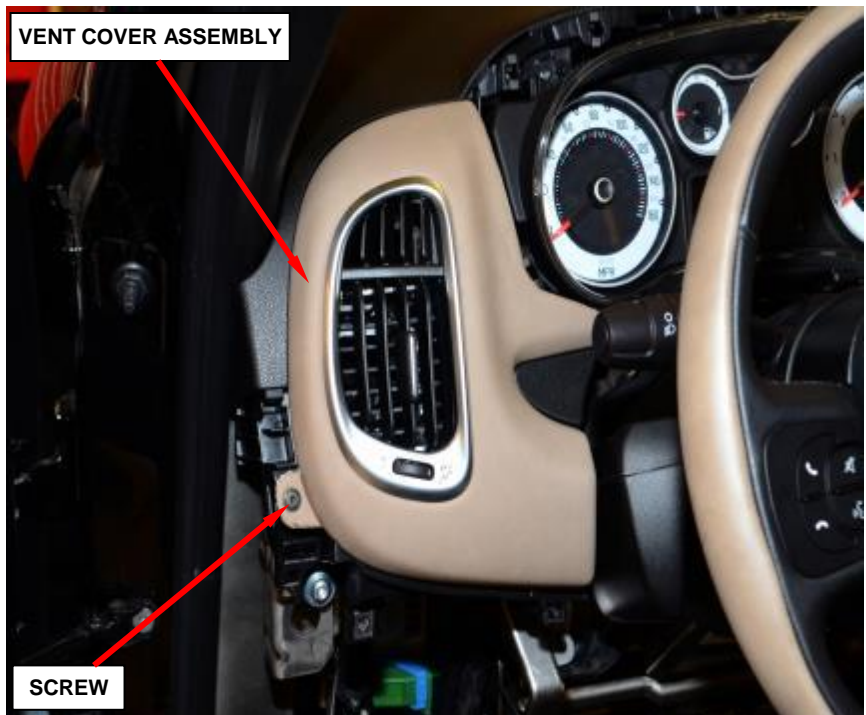
**Figure 13 –Vent Cover Assembly**

- e. Disconnect the antenna connectors and remove the radio from the vehicle.
15. Remove and save the screw from the driver side vent cover assembly (Figure 13).
16. Using a trim stick or equivalent, release the driver side vent cover assembly retaining clips.

103. Position the driver side vent cove assembly to the instrument panel cover (Figure 13).
104. Insert the driver side vent cover assembly retaining clips fully.

105. Install the screw into the driver side vent cover assembly and tighten securely (Figure 13).
106. Connect the antenna connectors to the radio.
107. Connect the radio electrical connectors to the radio.

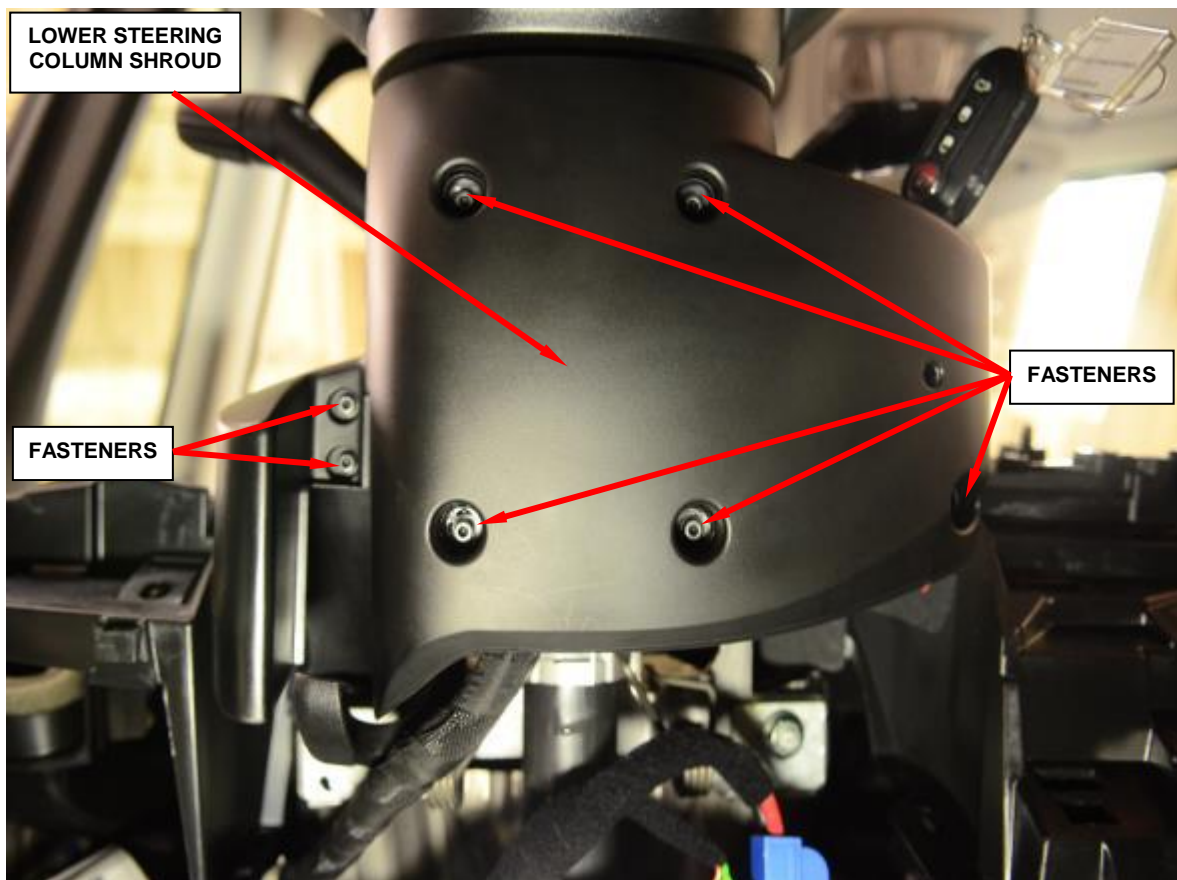
Figure 14 - Lower Steering Column Shroud

19. Lower the steering wheel position lever.
20. Remove and save the seven fasteners from the lower steering column shroud (Figure 14).
21. Unclip the upper steering column and lower steering column shrouds and remove the lower steering column shroud.

102. Install the seven fasteners into the lower steering column shroud and tighten securely (Figure 14).

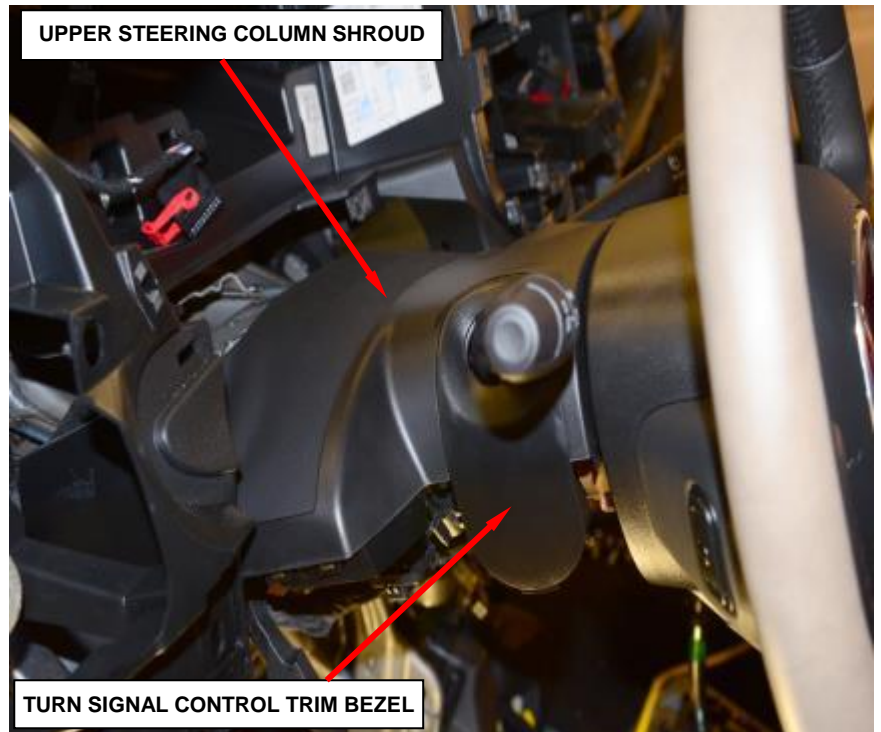
Figure 15 – Turn Signal Control Trim Bezel

22. Using a trim stick or equivalent, remove the turn signal control trim bezel from the upper steering column shroud (Figure 15).

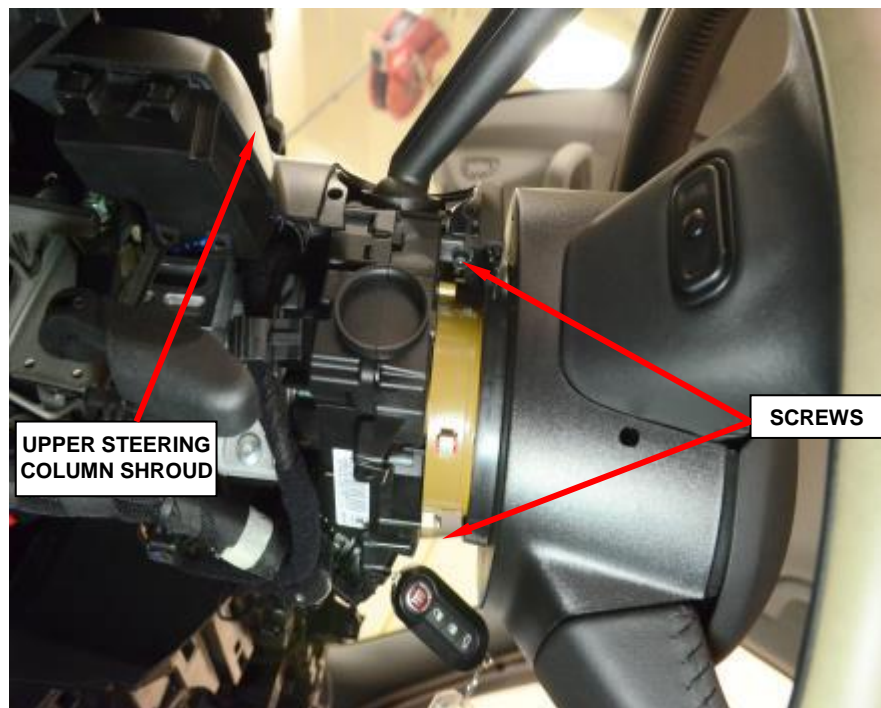
Figure 16 – Upper Steering Column Shroud Screws

23. Remove the two upper steering column shroud screws (Figure 16).

24. Route the upper steering column shroud off of the turn signal control lever.

25. Remove the upper steering column shroud from the vehicle.

- m. Remove the duct tape from the steering wheel.
98. Route the upper shroud over the control lever (Figure 16).
99. Install the two upper steering column shroud screws and tighten securely (Figure 16).

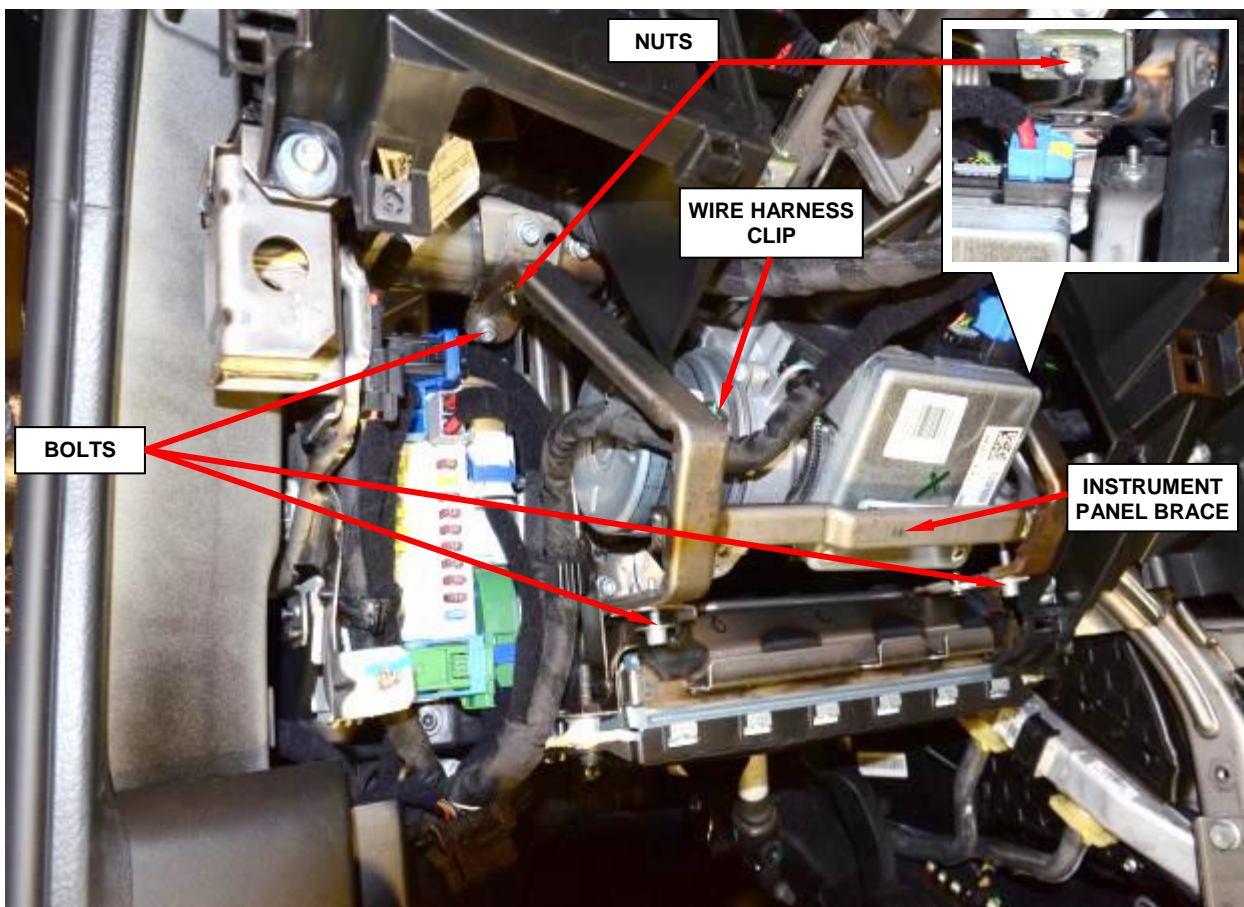
Figure 17 - Instrument Panel Brace

- a. Adjust the steering wheel so that the tires are in the STRAIGHT-AHEAD position.
- b. Release the wire harness clip from the instrument panel brace (Figure 17).
- c. Remove and save the three bolts and two nuts securing the instrument panel brace and remove the brace (Figure 17).

- k. Connect the electrical connectors at the ignition switch (Figure 18).
 - l. Install the instrument panel brace using the three bolts and two nuts and securely tighten (Figure 17).

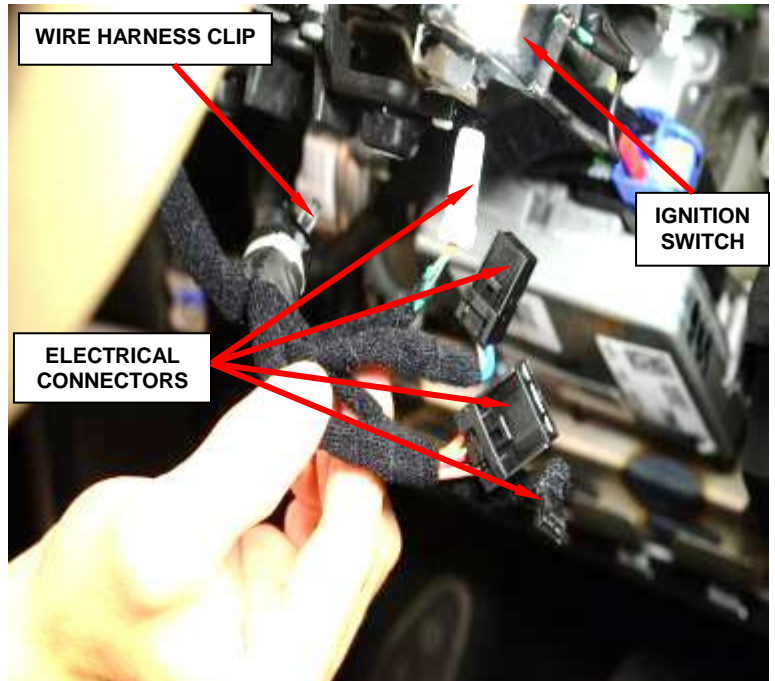
Figure 18 – Wiring Harness Connections

d. Disconnect the electrical harness connectors at the ignition switch (Figure 18).

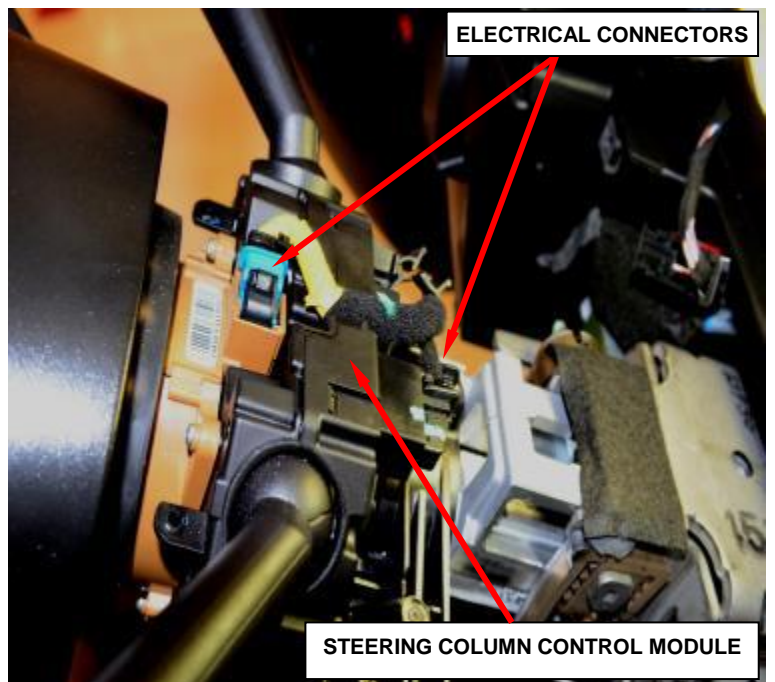
Figure 19 - Steering Column Control Module

f. Disconnect the two electrical connectors at the Steering Column Control Module (SCCM) (Figure 19).

- i. Connect the electrical connectors at the Steering Column Control Module (SCCM) (Figure 19).
 - j. Connect the electrical connectors at the Steering Column Control Module (Figure 19).

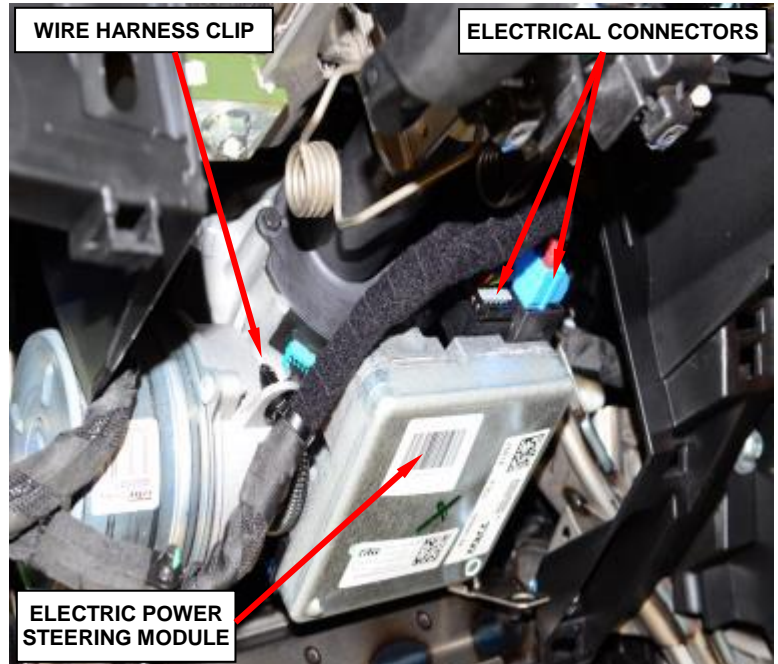
Figure 20 – Electric Power Steering Module

g. Disconnect the two electrical connectors and wire harness clip at the electric power steering module (Figure 20).

- g. Install a **NEW** pinch bolt and tighten to 40 ft. lbs. (55 N·m) (Figure 21).
 - h. Connect the electrical connectors and the wire harness tie to the electric power steering module (Figure 20).

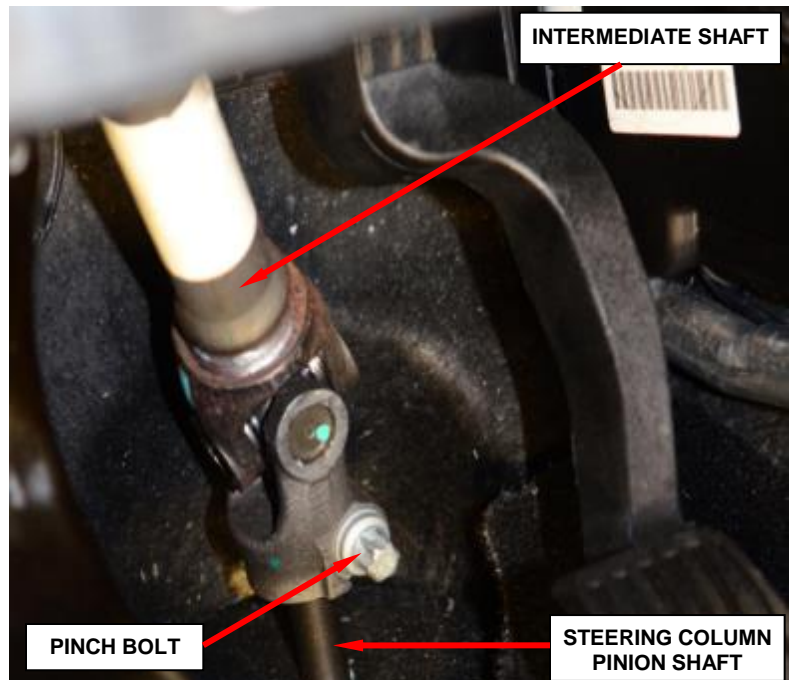
Figure 21 – Intermediate Shaft Pinch Bolt

j. Remove and **discard** the intermediate shaft pinch bolt and separate the intermediate shaft at the base of the column from the steering gear pinion shaft. **Discard the pinch bolt; it is not to be reused** (Figure 21).

- e. Verify the front wheels of vehicle are in the STRAIGHT-AHEAD position.
 - f. Slide the intermediate shaft onto the steering gear pinion shaft (Figure 21).

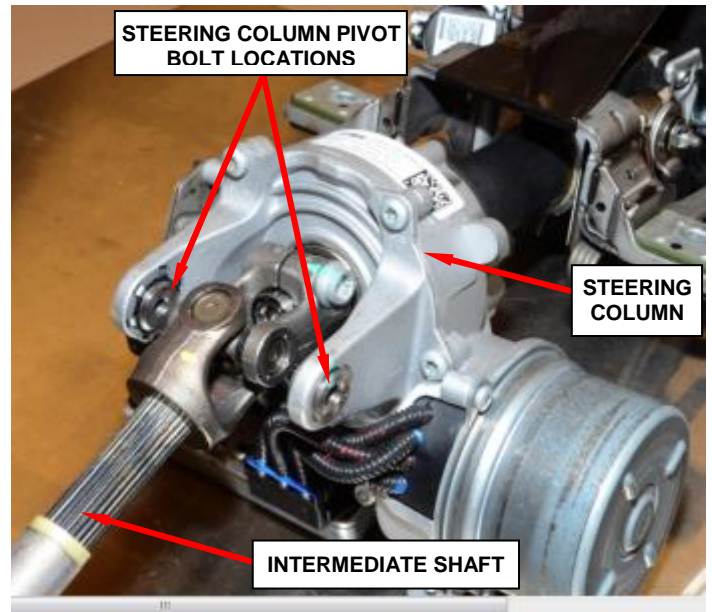
Figure 22 – Steering Column Pivot Bolts (Steering Column Removed for Photographic Purposes)

- k. Remove and save the two rear steering column pivot bolts (Figure 22).
- l. Carefully remove the steering column from the vehicle.

- a. Install the steering column through the steering column opening.
 - b. Raise the column into the mounting location and install the pivot mounting bolts. Do not tighten the nuts at this time (Figure 22).

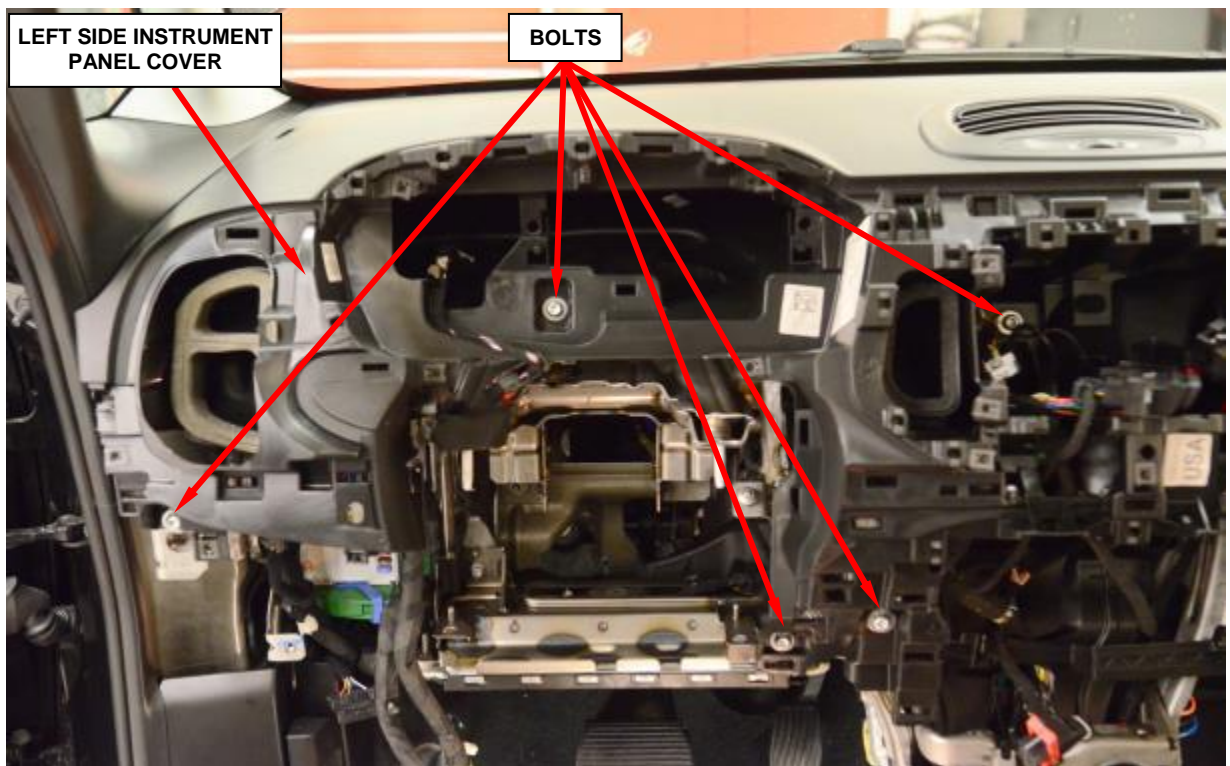
Figure 23 – Left Side Instrument Panel Cover

- 27. Remove and save the five bolts from the left side of the instrument panel cover (Figure 23).
- 28. Release the wiring harness retainers for the radio and antenna connections from the instrument panel cover.

- c. Close the glove box.
96. Install the five bolts into the left side of the instrument panel cover and tighten to 53 in. lbs. (6 N·m) (Figure 23).
97. Use the following steps to install the steering column.

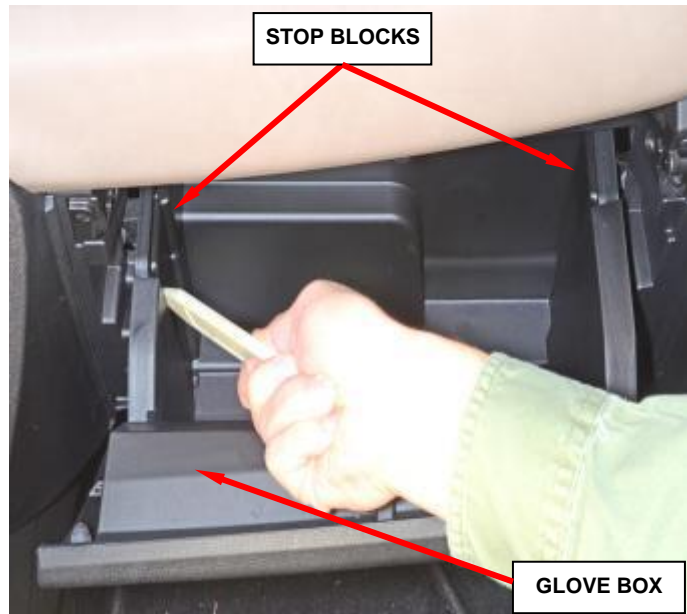
Figure 24 – Glove Box Stop Blocks

- a. Open the glove box, using a trim stick or equivalent, remove and save the two stop blocks from the glove box (Figure 24).

- a. Partially close the glove box and engage the retainer for the travel limiter (Figure 25).
 - b. Close the glove box further (not completely) and engage the two stop blocks (Figure 24).

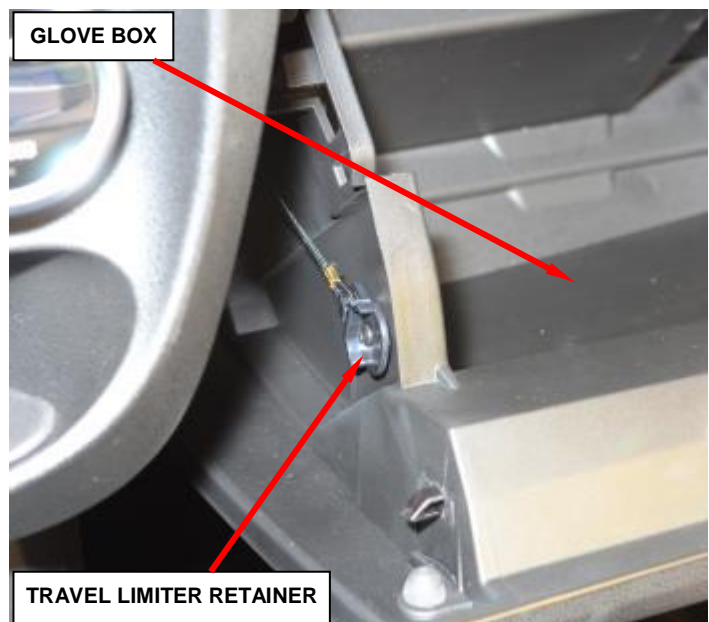
Figure 25 - Travel Limiter Retainer

- b. Slightly lower the glove box and release the retainer for the travel limiter (Figure 25).

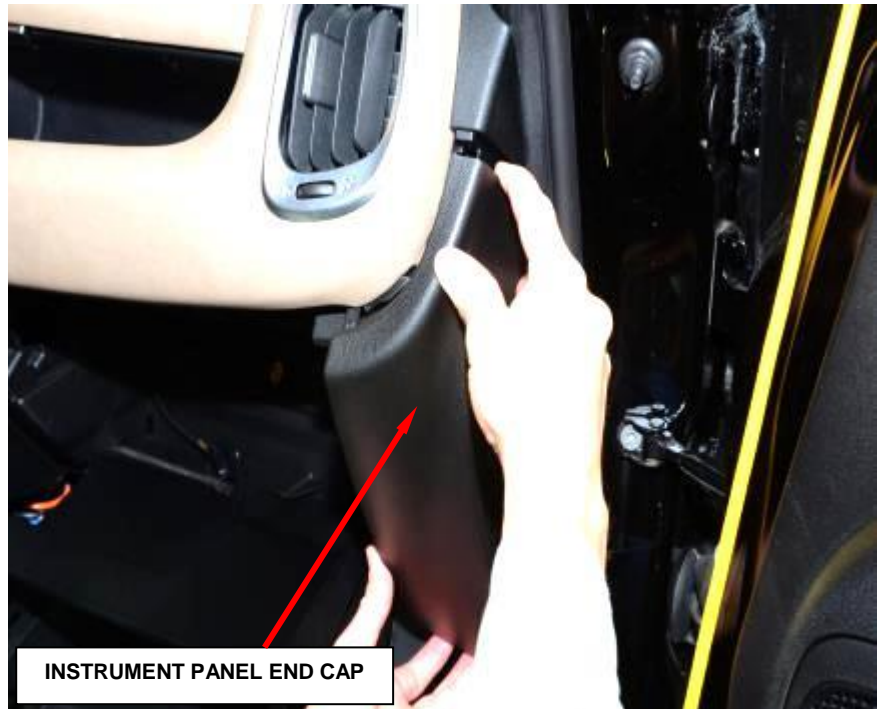
Figure 26 – Instrument Panel End Cap

31. Using a trim stick or equivalent, release right instrument panel end cap retaining clips (Figure 26).

32. Remove the end cap.

91. Position the instrument panel end cap to the instrument panel and engage the instrument panel end cap fully (Figure 26).
92. Position the center instrument panel bezel to the instrument panel cover (Figure 30).

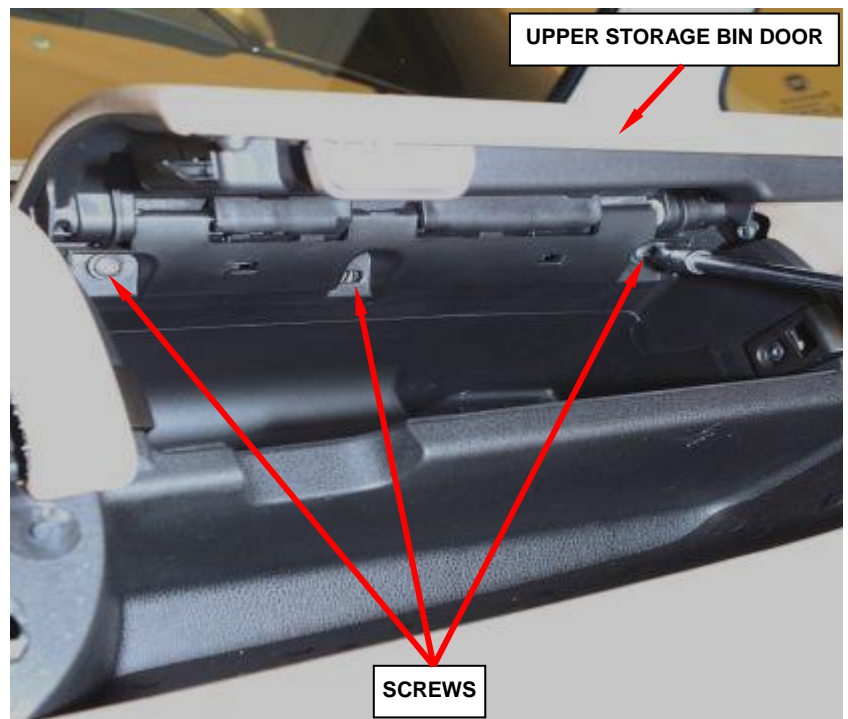
Figure 27 – Upper Storage Bin Door

34. Remove and save the three screws from the upper storage bin door (Figure 27).

35. Remove and save the upper storage bin door from the vehicle.

88. Install the four screws into the lower instrument panel bezel and tighten securely (Figure 28).
89. Position the upper storage bin door to the upper storage bin (Figure 27).

90. Install the three screws into the upper storage bin door and tighten securely (Figure 27).

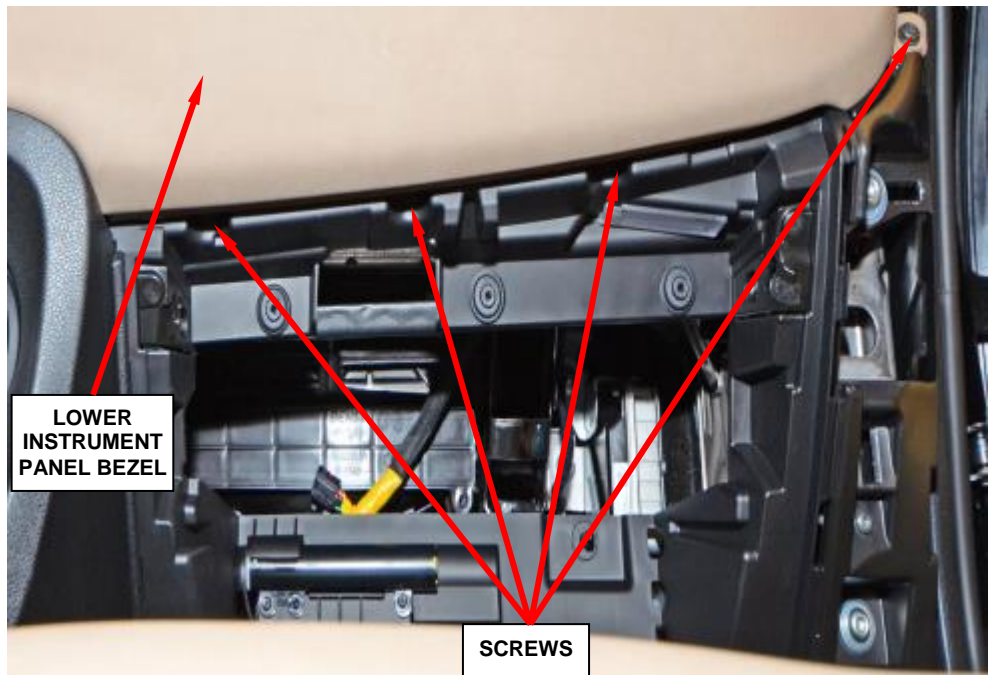
Figure 28 – Lower Instrument Panel Bezel

36. Remove and save the four screws from the lower instrument panel bezel (Figure 28).

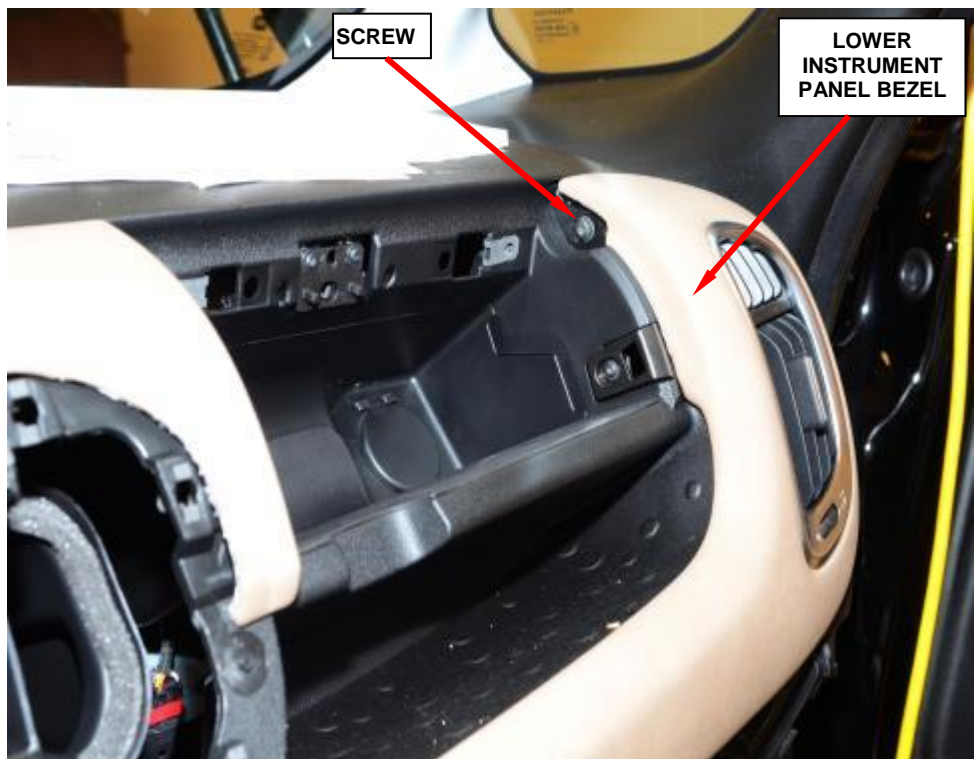
Figure 29 - Instrument Panel Bezel Screw

37. Remove and save the lower instrument panel bezel screw (Figure 29).

38. Using a trim stick or equivalent, release the lower instrument panel bezel retaining clips.

86. Insert the lower instrument panel bezel retaining clips fully (Figure 29).
87. Install the lower instrument panel bezel screw and tighten securely (Figure 29).

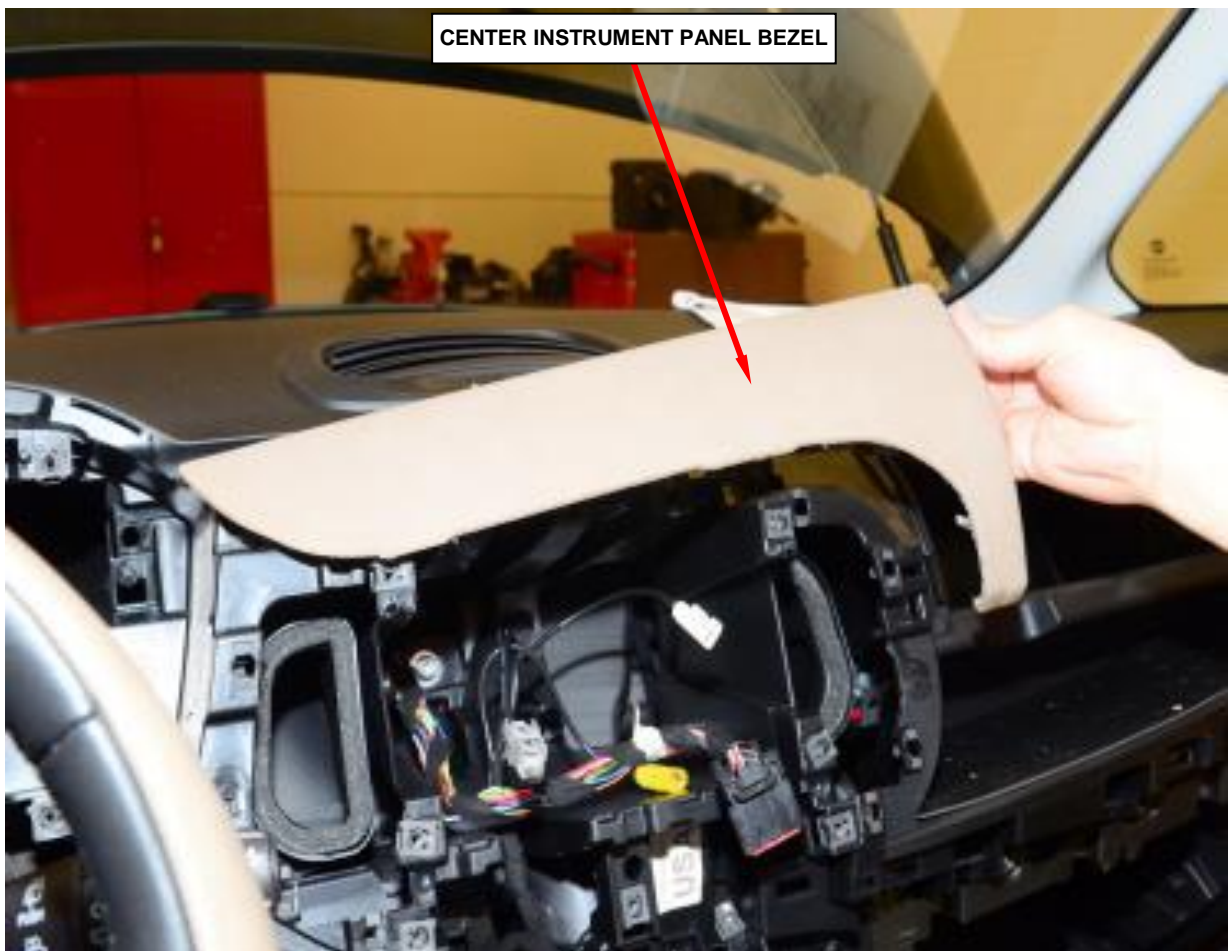
Figure 30 – Center Instrument Panel Bezel

40. Using a trim stick or equivalent, release the center instrument panel bezel retaining clips.

41. Remove the center instrument panel bezel from the vehicle (Figure 30).

93. Engage the center instrument panel bezel retaining clips fully (Figure 30).
94. Open the glove box door.
95. Use the following steps to install the glove box limiter the instrument panel.

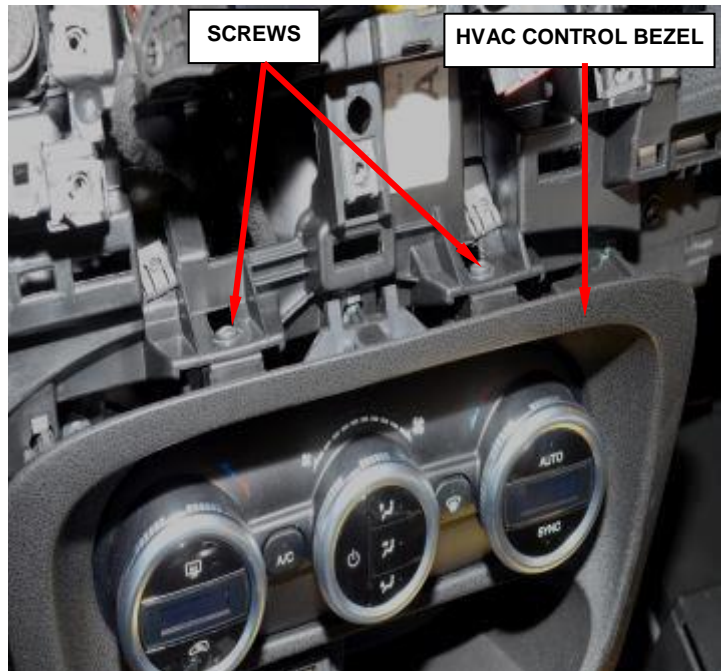
Figure 31 - HVAC Control Bezel

42. Remove and save the two upper screws from the HVAC control bezel (Figure 31).
43. Pull rearward on the bezel to release the inner retainers.
44. Disconnect the electrical connectors from the multi-media port.
45. Remove the HVAC control bezel from the vehicle.

79. Install the four screws that secure the A/C heater control to the instrument panel. Tighten the screws securely (Figure 32).
80. Position the HVAC control bezel into the vehicle (Figure 31).

81. Connect the electrical connectors to the multi-media port.
82. Align the HVAC control bezel to the instrument panel.
83. Push inward on the HVAC control bezel to engage the inner retainers.

84. Install the two upper screws into HVAC bezel and tighten securely (Figure 31).
85. Position the lower instrument panel bezel to the instrument panel.
