Safety Recall R54 / NHTSA 15V-590 Passenger Airbag Module

2015 (BF) FIAT 500L

Replace Passenger Airbag Module

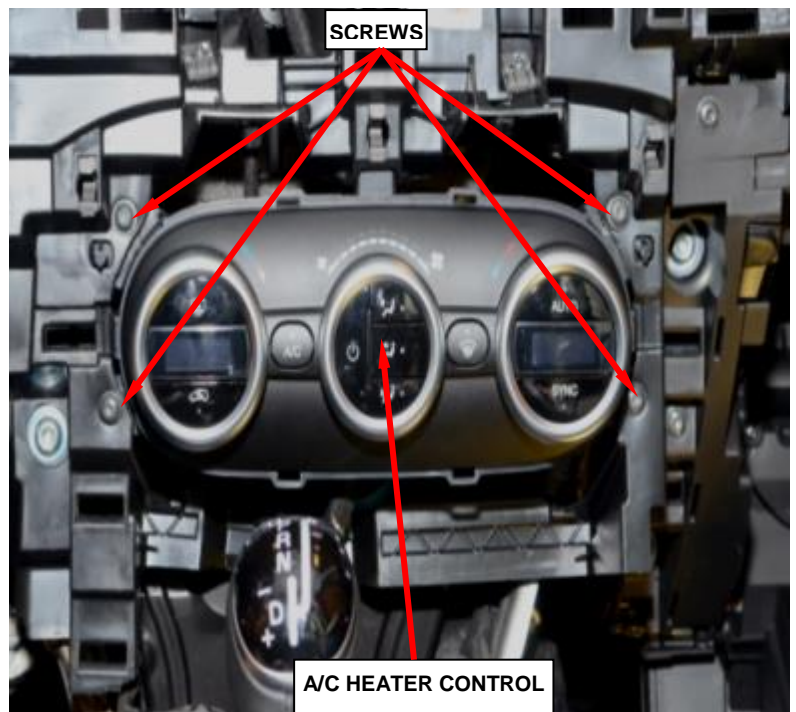
Figure 32 – HVAC Control

46. Use the following steps to remove the heating and air conditioning control.
 - a. Remove and save the four screws that secure the A/C heater control to the instrument panel (Figure 32)
 - b. Disconnect the HVAC electrical harness connector from the A/C heater control and remove the A/C heater control.

77. Insert the wiring harness retainers for the radio and the antenna electrical connections to the instrument panel cover.
78. Position the A/C heater control to the instrument panel and connect the HVAC electrical connector (Figure 32).

79. Install the four screws that secure the A/C heater control to the instrument panel. Tighten the screws securely (Figure 32).
80. Position the HVAC control bezel into the vehicle (Figure 31).

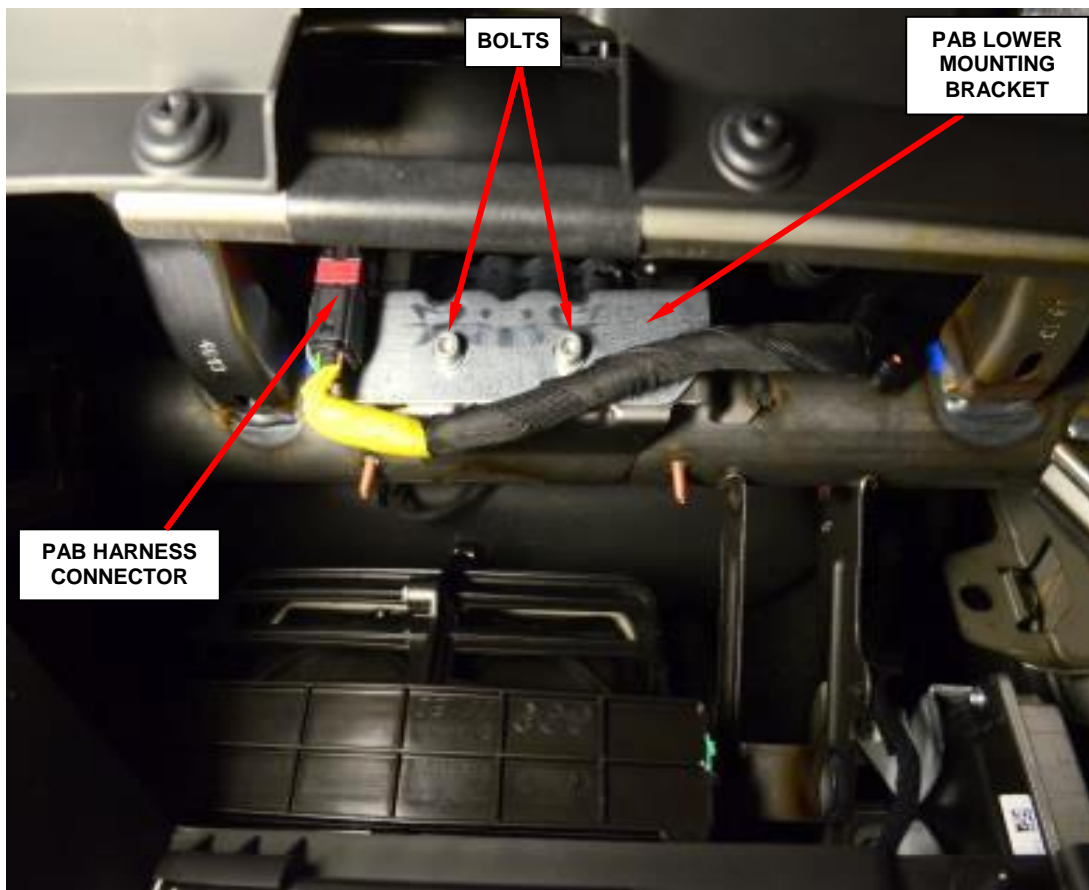
**Figure 33 – PAB Lower Mounting Bracket**

47. Reach through the instrument panel glove box opening to access and disconnect the instrument panel wire harness connection from the Passenger Airbag (PAB) pigtail harness connector on the underside on the instrument panel structural support (Figure 33).

48. Reach through the instrument panel glove box opening to access and remove and save the two bolts that secure the PAB lower bracket to the instrument panel structural support (Figure 33).

68. Within the upper storage bin, engage the retainers for the air flow tube (Figure 35).
69. Install the air flow adjustment knob (Figure 35).
70. Install the passenger side air bag bracket mounting bolts and tighten to 71 in. lbs. (8 N·m) (Figure 33).

71. Connect the passenger side air bag electrical connector (Figure 33).
72. Position the glove box assembly to the vehicle.
73. Rotate the glove box assembly upward and forwards until it is engaged to the crossmember.

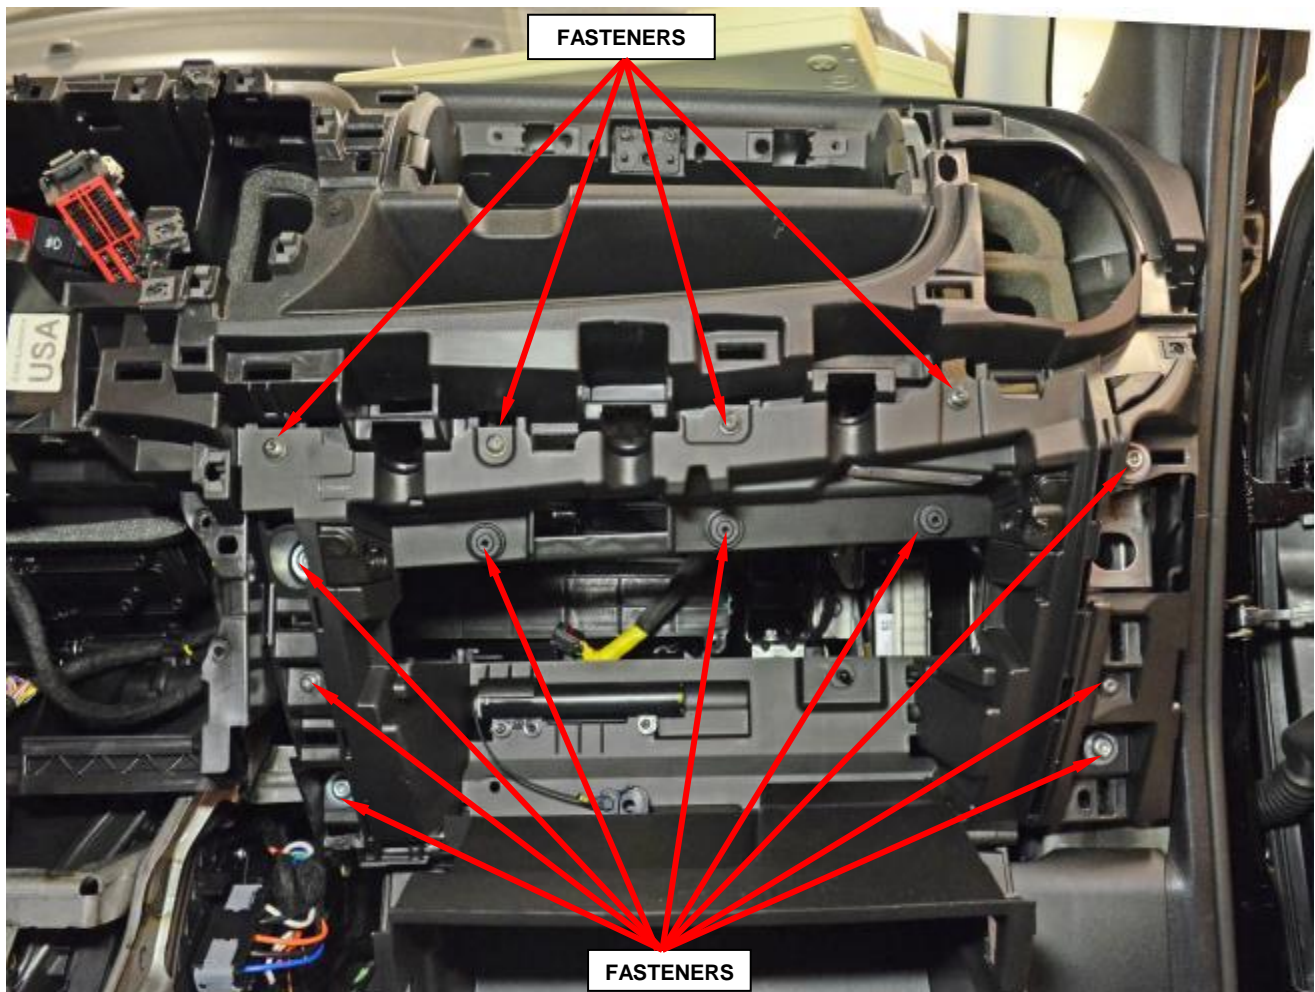
**Figure 34 – Glove Box Assembly Fasteners**

49. Remove and save the thirteen fasteners from the glove box assembly (Figure 34).
50. Disconnect the glove box light switch and light electrical connectors.
51. Rotate the glove box assembly rearward and downwards until it is released from the crossmember.
52. Remove the glove box assembly.

75. Install the bolt into the right side of the instrument panel cover within the upper storage bin and tighten to 53 in. lbs. (6 N·m) (Figure 35).
76. Install the thirteen fasteners into the glove box assembly and tighten the fasteners securely (Figure 34).

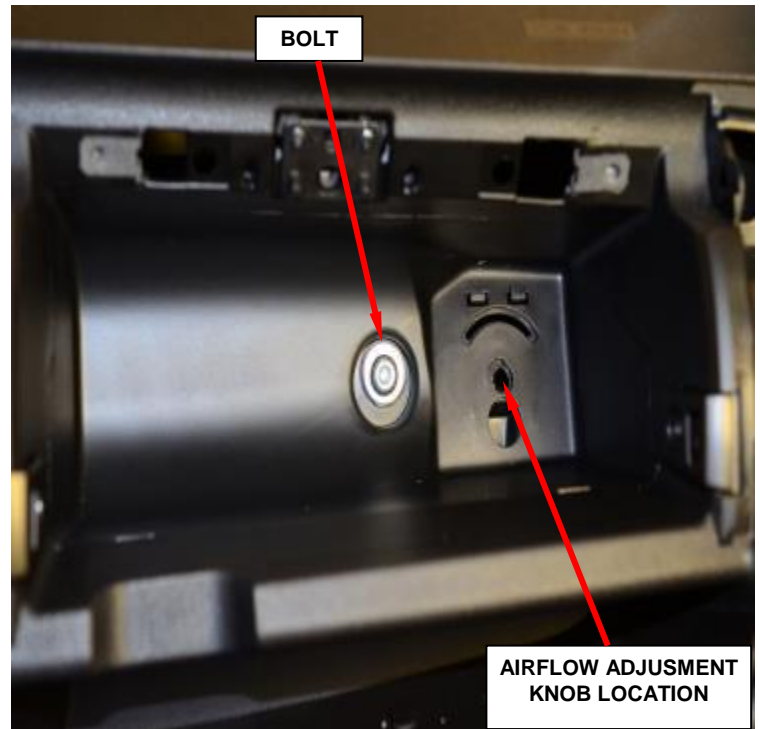
**Figure 35 – Upper Storage Bin**

53. Remove and save the bolt from the right side of the instrument panel cover within the upper storage bin (Figure 35).
54. Within the upper storage bin, remove the air flow adjustment knob with an appropriate tool, if equipped.
55. With the use of a small flat bladed tool, release the retainers for the air flow tube, if equipped.

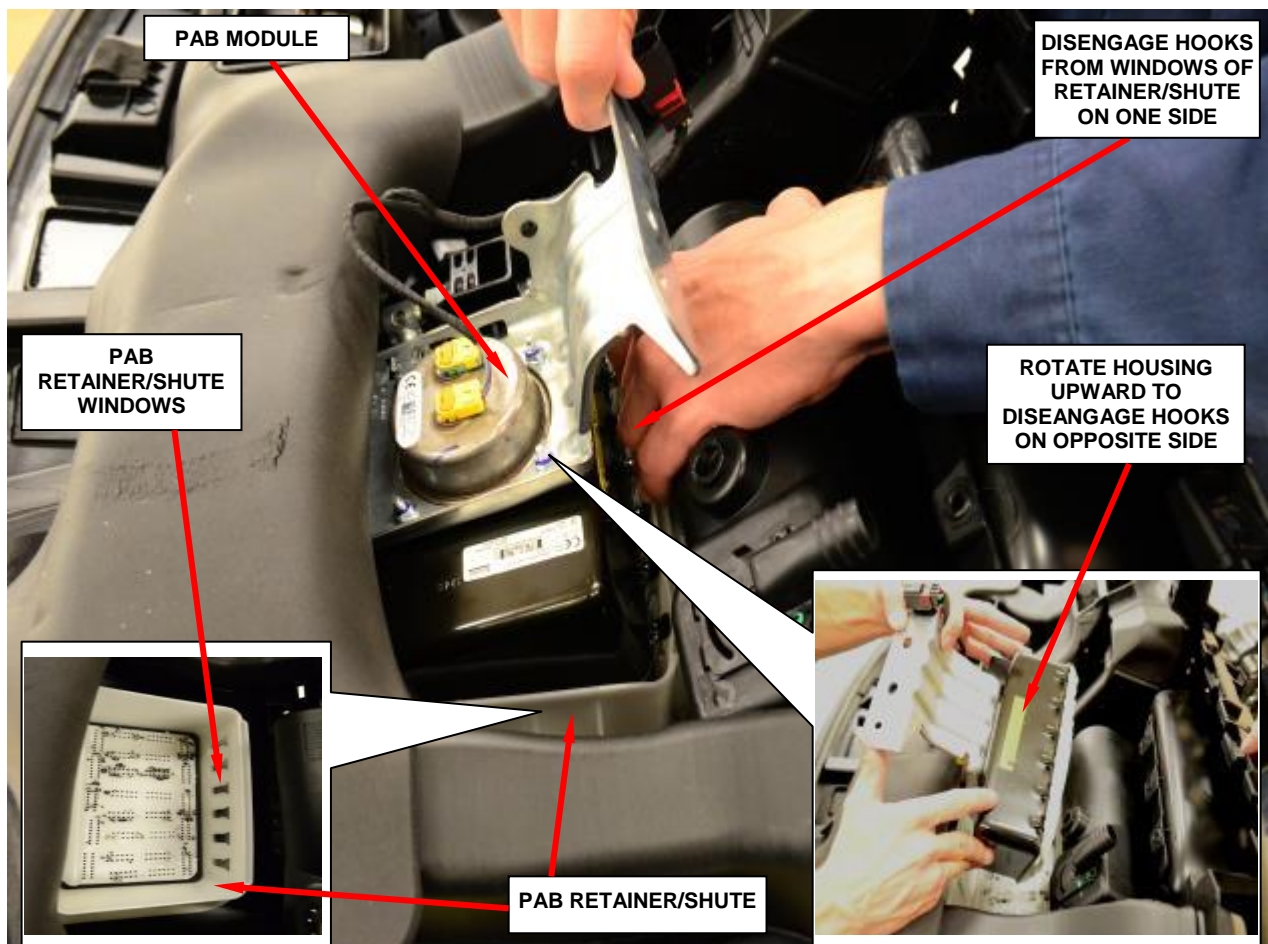
Figure 36 – PAB Module

60. Disengage each of the hooks on one side of the PAB housing from the windows in the forward and rearward vertical walls of the PAB retainer/chute on the underside of the instrument panel cover. To disengage the hooks, use hand pressure to pull the adjacent edge of the PAB housing firmly and evenly upward out of the retainer receptacle, while at the same time pulling the upper edge of the PAB receptacle wall outward far enough to disengage the hooks (Figure 36).
61. With all of the hooks on one side of the PAB housing disengaged from the PAB retainer receptacle, rotate that side of the housing upward far enough to disengage the hooks on the opposite side of the housing from the retainer.

62. With all of the hooks disengaged, lift the housing, inflator, and cushion as a unit from the receptacle of the PAB retainer/chute on the underside of the instrument panel cover.

63. Carefully position the **NEW** PAB housing into the PAB retainer/chute receptacle. The side of the PAB housing with 5 hooks faces forward in the vehicle.

64. Engage all of the hooks on one side of the PAB housing through the windows on the same side of the PAB retainer/chute and then rotate the opposite side of the PAB housing downward into the receptacle.

65. Inspect around the perimeter of the PAB making certain each of the hooks on the PAB housing is fully engaged through the windows in the forward and rearward vertical walls of the PAB retainer or chute receptacle.
