# TECHNICAL BULLETIN

P072NAS1

### Safety Recall: Second Row Seat Backrest Recline Function

**Situation:** An issue has been identified on a limited number of vehicles listed within the Affected Vehicles Range where the backrest recline mechanisms may not latch correctly.

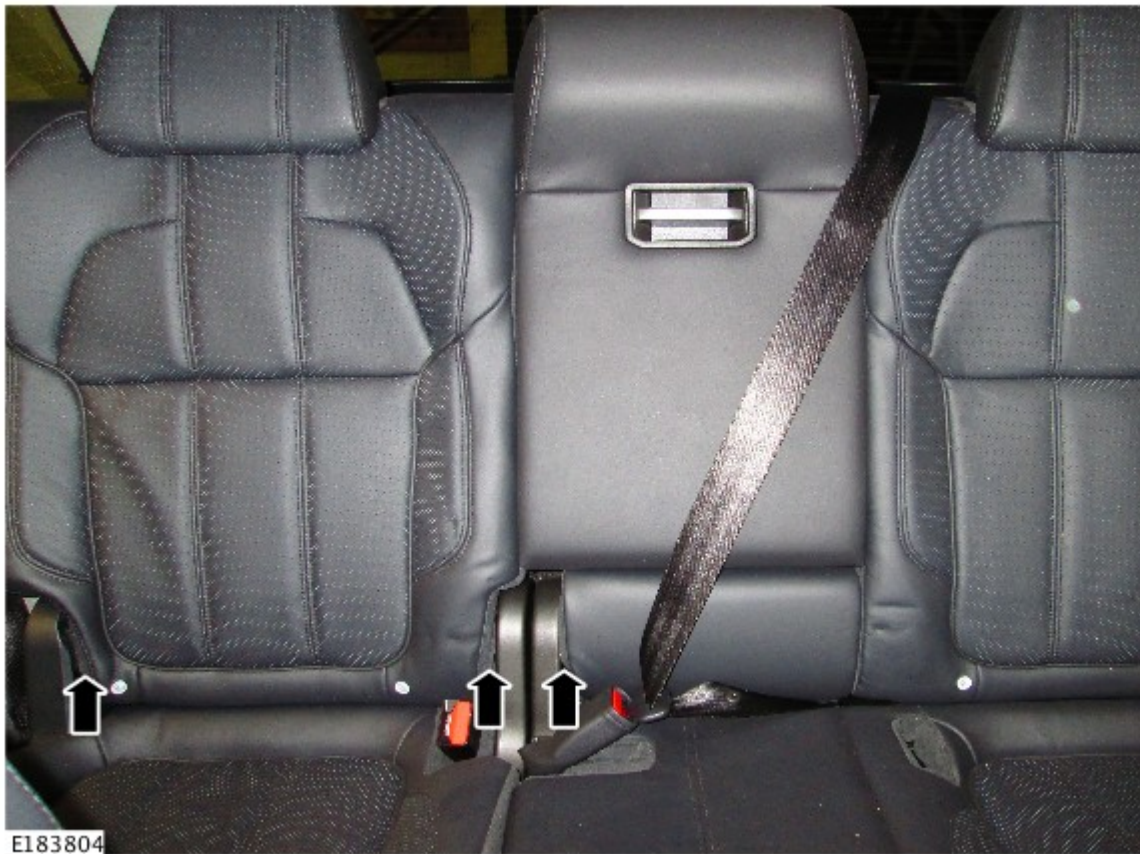
**Range  
Rover  
Sport  
(L494)  
shown;  
Range  
Rover  
(L405)  
similar.**

Location of  
second row  
seat  
backrest  
recliner  
mechanisms  
to be  
inspected.

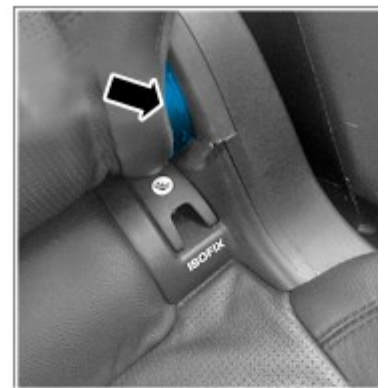
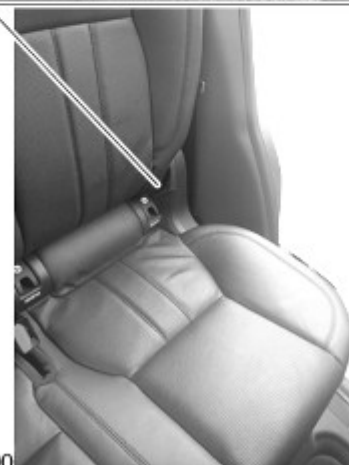
E180900

- 1 Move the second row left-hand seat squab outer trim to one side to reveal the metallic face of the recliner mechanism.

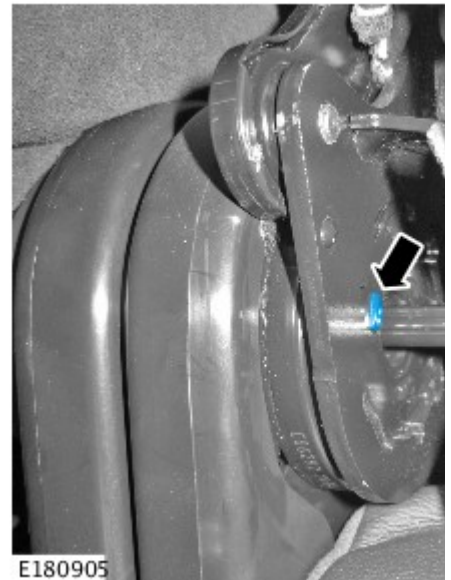
6 Move the second row left-hand seat squab inner trim to one side and inspect for a visible metallic tab on the face of the recliner mechanism.

- Note if a visible metallic tab is present ( " ").
  - If a visible metallic tab is present on the face of **ALL** of the recliner mechanisms ( " " ), the vehicle may be released for sale or onward distribution.
  - If visible metallic tab is **NOT** present on the face a recliner mechanism(s), continue to the Service Instruction to replace the affected seat frame(s).
