SI B65 18 15
Audio, Navigation, Monitors, Alarms, SRS

Recall 15V-628: Passenger's Front Air bag

SI B65 18 15 Recall 15V-628: Passenger-Side Front Airbag

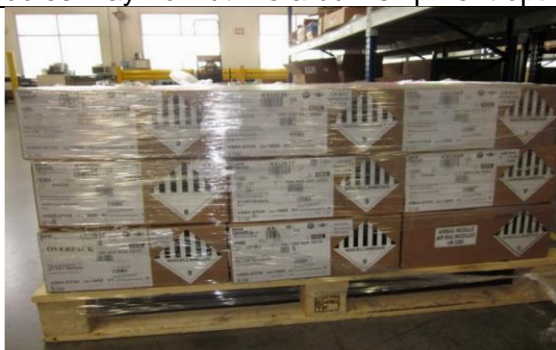
<p>1 Stacking:</p> <p>Place the safety device and shrink-wrap them on the pallet.</p> <p><u>(no more than 60 inches in height).</u></p>

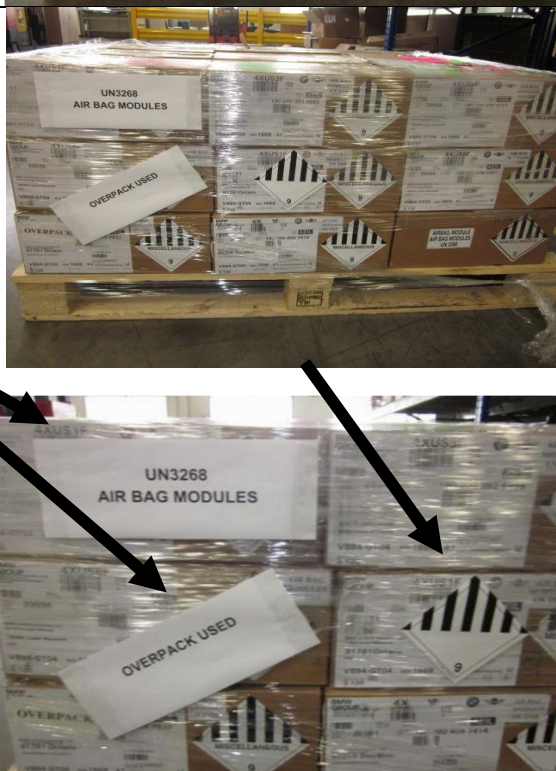
<p>2 Labeling:</p> <p>Put the following labels on both sides of the skid:</p> <ul style="list-style-type: none"> <input type="checkbox"/> Class 9 <input type="checkbox"/> UN3268 (Safety Devices)* <input type="checkbox"/> OVERPACK USED* <p>*Can be printed on Letter Size paper using Microsoft Word</p>

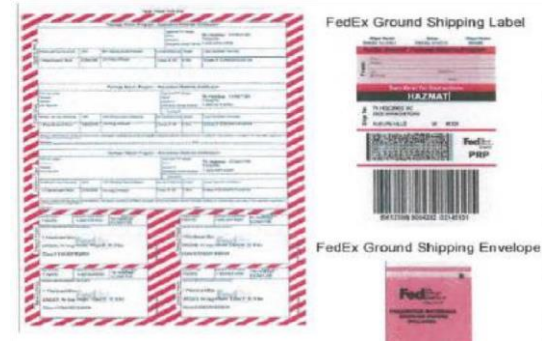
OP 900PRP Hazardous Materials Certification Form

1. Shipping Documents

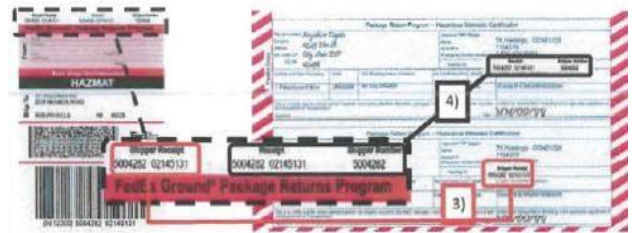
- Peel off the SHIPPER RECEIPT from the top of the FedEx Ground PRP Shipping label, place it in the Tracking ID box on the Customer Copy of the OP 900PRP form.
- Peel off the RECEIPT & SHIPPER NUMBER from the top of the FedEx Ground PRP Shipping label, and place it in the Tracking ID box on the FedEx Copy.

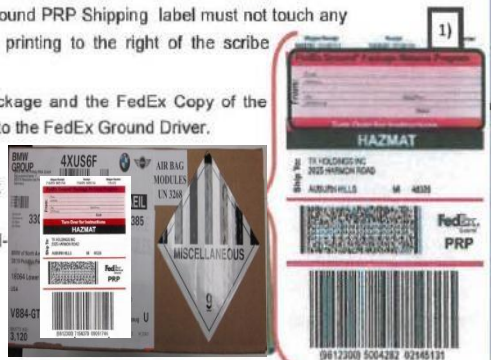
- Fill in Shipper Name & Address in the upper section of the FedEx Ground Shipping label. Note: (RMA# is not required).
- Peel off the backing of the FedEx Ground PRP Shipping label and affix to the box to left of the Class 9 label.
 - Use the scribe line on the box as a guide.
 - The FedEx Ground PRP Shipping label must not touch any portion of the printing to the right of the scribe line.
- Provide the package and the FedEx Copy of the OP 900PRP form to the FedEx Ground Driver.

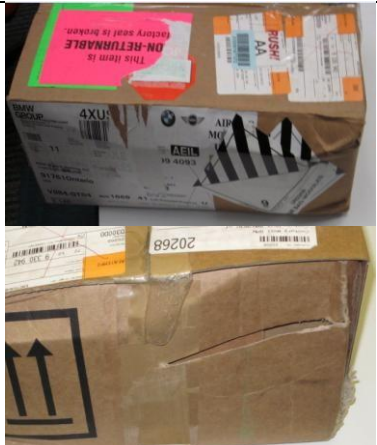
Damage Type	NO
L	Labeling Packages with improper labeling are NOT acceptable, particularly, If the labels obscure other required marks and labels.

I	Improper Packing Improper packing is always unacceptable. The packages must be properly packaged to prevent movement in all directions.

O	Other Damages Multiple damages, such as those may affect the integrity of the package. Others are not as severe and may be acceptable. If questionable, repackage the material.
