Technical Service Bulletin

GROUP CAMPAIGN	NUMBER 17-01-041
DATE MAY 2017	MODEL(S) Sonata (YF) Elantra (MD)

SUBJECT: INSTALLATION OF URETHANE PROTECTOR OVER FRONT COIL SPRINGS
(RECALL CAMPAIGN 133)

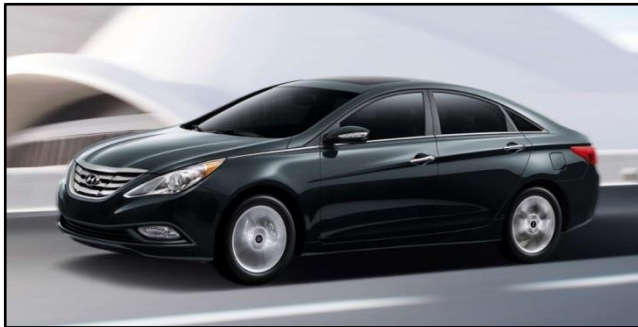
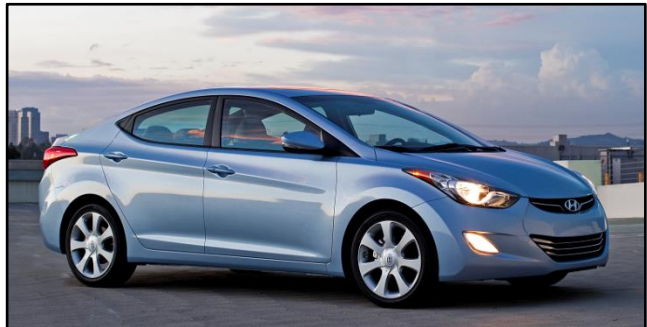
On certain 2011 Sonatas (YF) and Elantras (MD), corrosion can build up at the front coil springs, resulting in possible fracture near the base. A fractured spring can make contact with the tire, potentially resulting in a tire puncture and increasing the risk of a crash. This bulletin describes the procedure to install urethane tubes over the front coil springs to prevent a tire puncture.

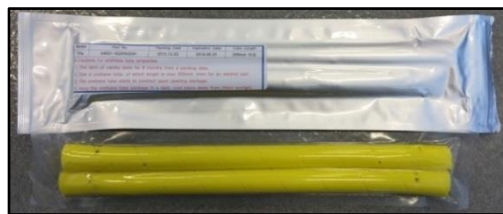
Part Name	Model	Part Number	Remark
URETHANE TUBE	Elantra (MD)	54631-3X000QQH	(2) Blue Tubes
	Sonata (YF)	54631-3Q000QQH	(2) Yellow Tubes

NOTE: Each foil package contains a clear pouch with (2) urethane tubes.

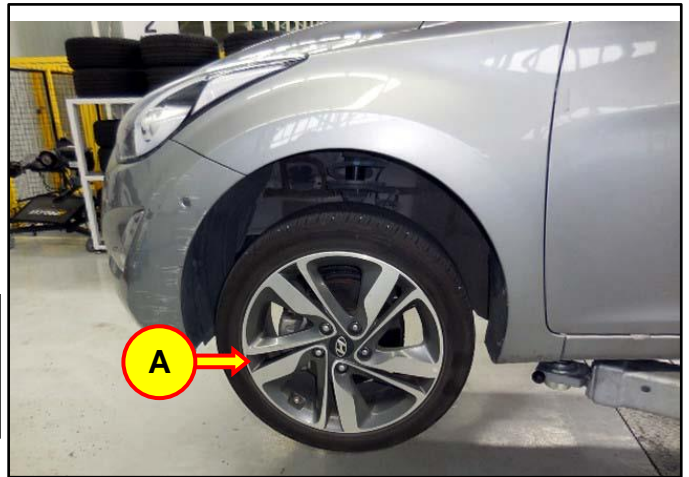
- 1a. Lift up the vehicle and then remove the front wheels & tires (A).

Tightening torque:

88.2 ~ 107.8 Nm (9.0 ~ 11.0 kgf.m, 65.0 ~ 79.5 lb-ft)

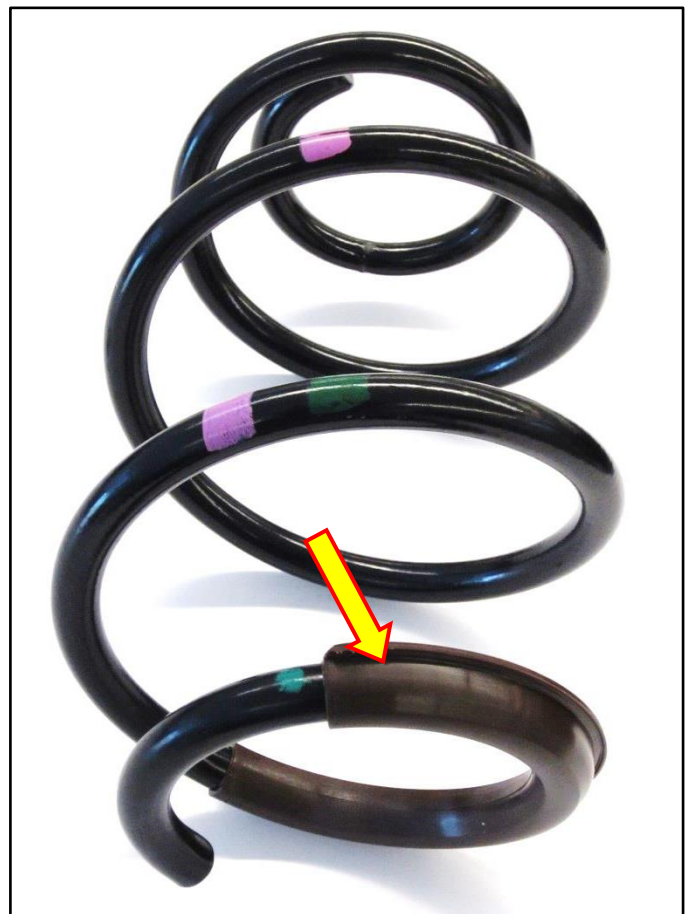
- 1b. Some Sonatas might have a brown urethane tube installed on the spring.
- Carefully remove the tube without damaging the black coating.
 - Then perform the procedures in this TSB.

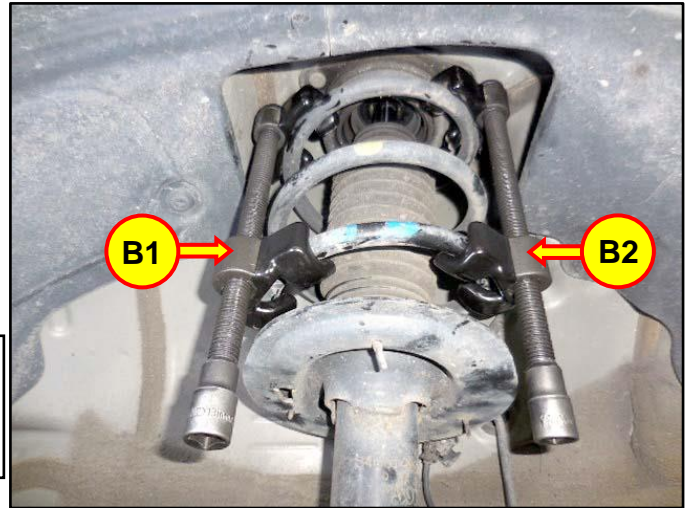
2. On one side of the vehicle, install the coil spring compressor jig (B1, B2) on opposite sides of the spring as shown in the picture.

Compress the coil one side at a time. Do not compress each side more than 25 mm (1.0 in.) at a time.

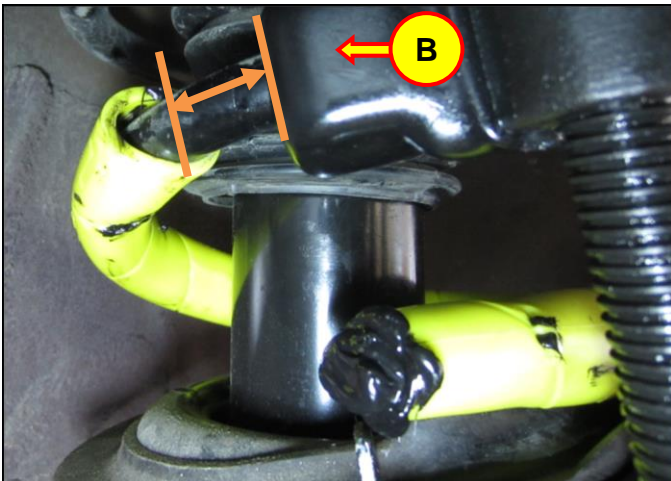
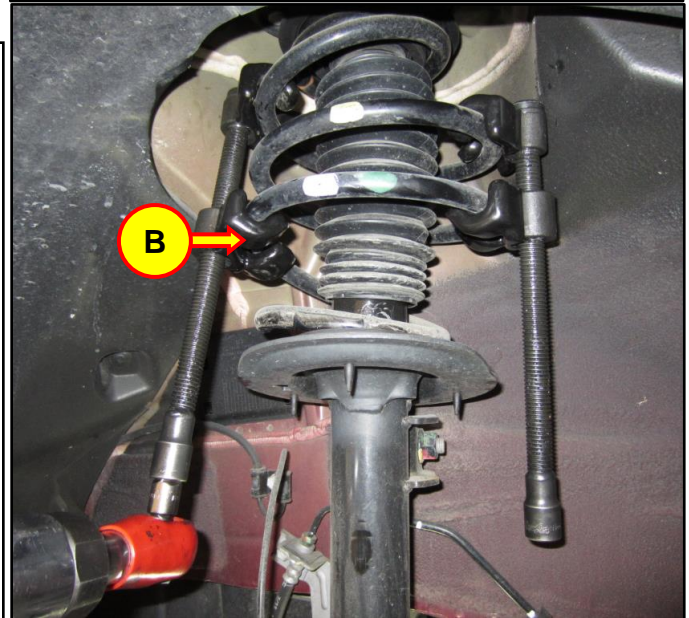
Do not compress the spring more than 50 mm (2.0 in.).

Place the jig (B) on the spring to allow enough clearance to completely slide on the tube.

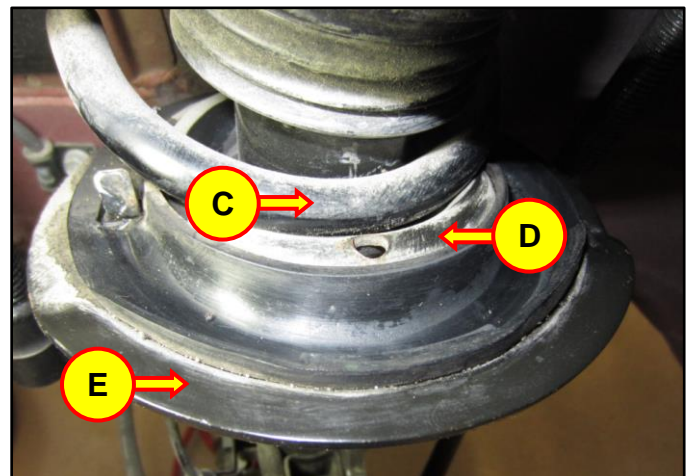
3. Move the bottom of the spring (C) over the inside hump (D) of the lower spring seat (E).

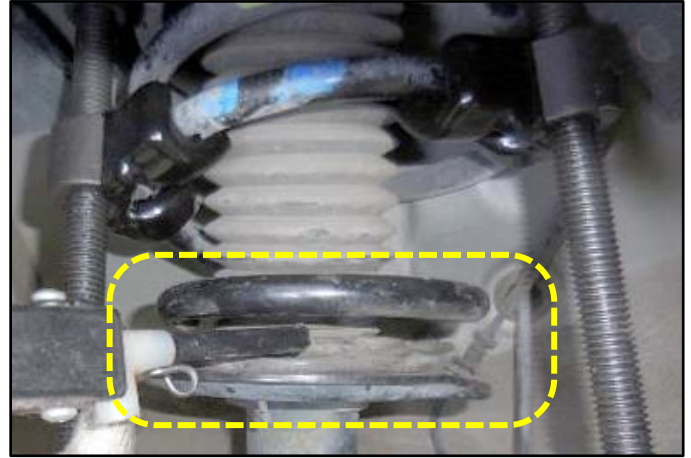
- 4a. Use an air nozzle to remove any debris from around the lower spring seat.

-Clean the lower portion of the spring where the urethane tube will be installed.

-Inspect the lower coils of the spring for damage or corrosion. Replace as necessary. If the spring is still under warranty, submit a separate claim using the same Repair Order. If the spring is out of warranty, submit a Prior Approval Request for goodwill consideration prior to performing the work.

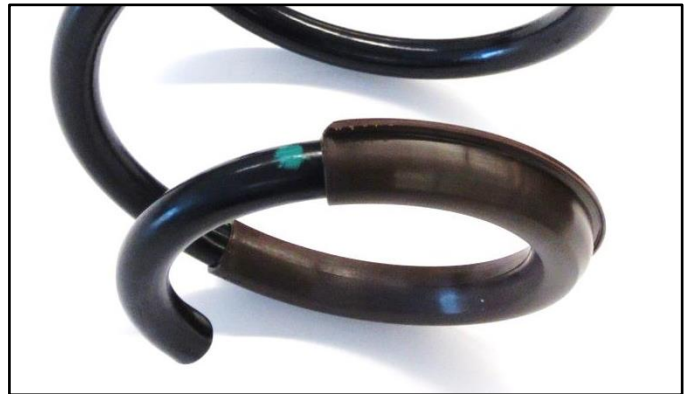
- 4b. If a Sonata is in need of a replacement spring, P/N 54630-3Q010, the spring might have a brown urethane tube installed.

- Carefully remove the brown urethane tube without damaging the black coating.
- Install the yellow urethane tube, P/N 54631-3Q000QQH, onto the replacement spring as described in this TSB.
- Remove the spring from the vehicle according to the applicable workshop manual.
- Install the replacement spring into the vehicle according to the applicable workshop manual.

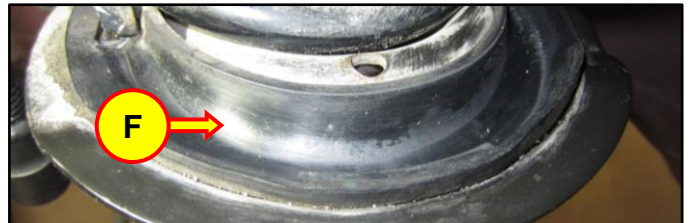
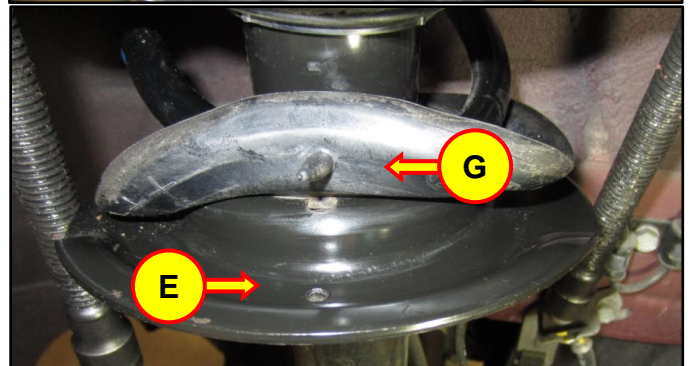
5. Carefully pull the rubber spring pad (F) off the lower spring seat.

-Clean the top (F) and bottom (G) surfaces of the rubber spring pad.

-Clean the lower spring seat (E).

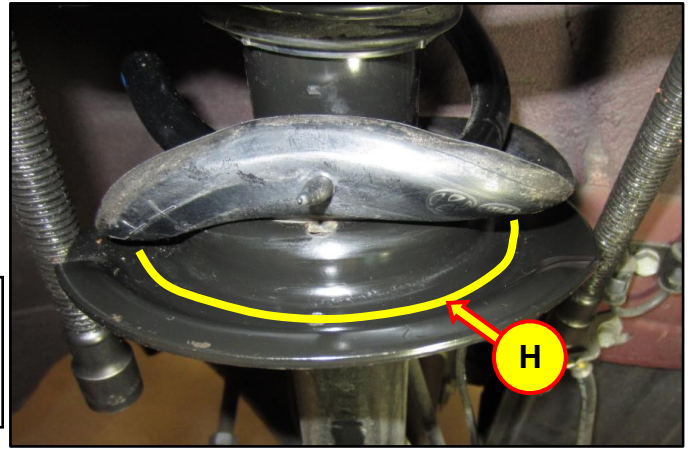
6. Apply a bead of sealant in between the pad and the lower spring seat as shown by line. (H).

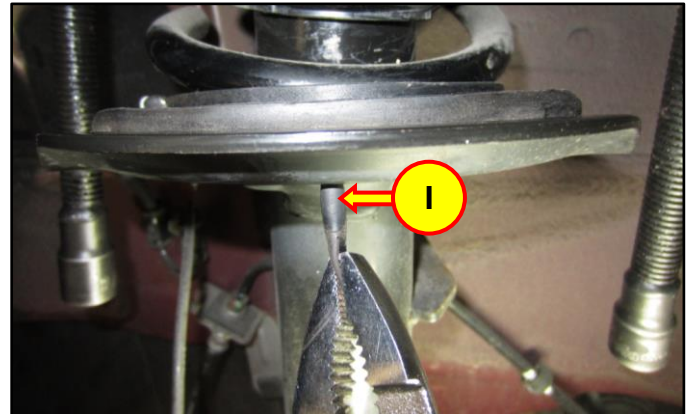
7. Return the rubber spring pad to its original position. Carefully pull rubber pins (I) back through their respective holes in the lower spring seat.

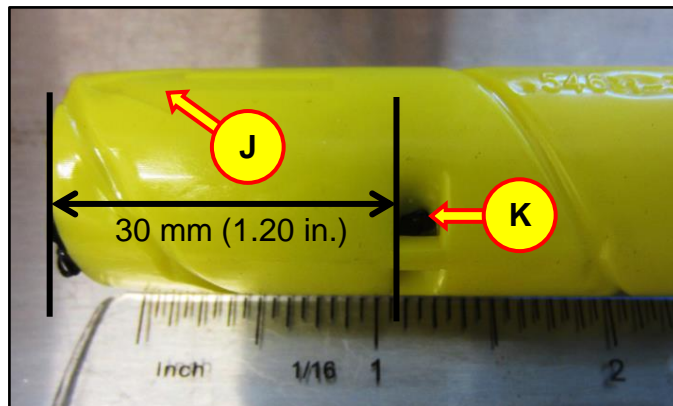
9. Locate arrow at one end of the tube (J).
Fill the tube with sealant from the end with the arrow, until it reaches approximately 30 mm (1.20 in.) or to the square openings (K).

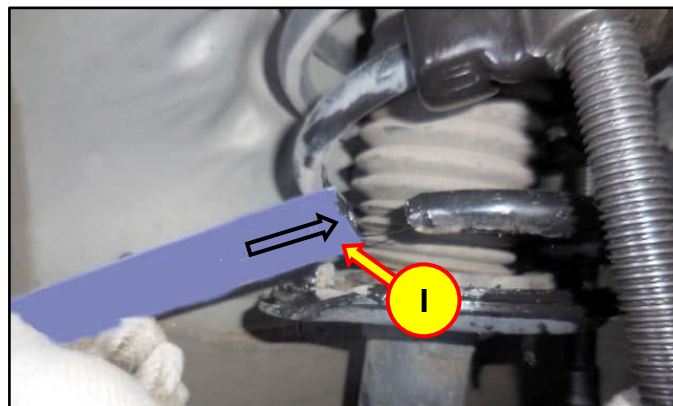
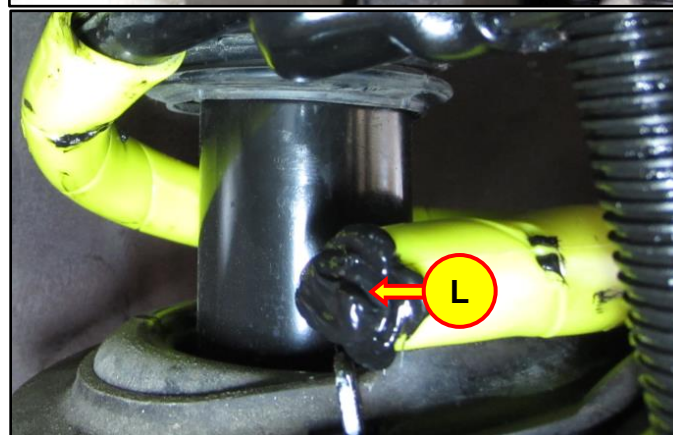
10. Starting from the end with the arrow (I), slide the urethane tube over the end of the coil spring until the end of the tube (L) aligns with the end of the spring.

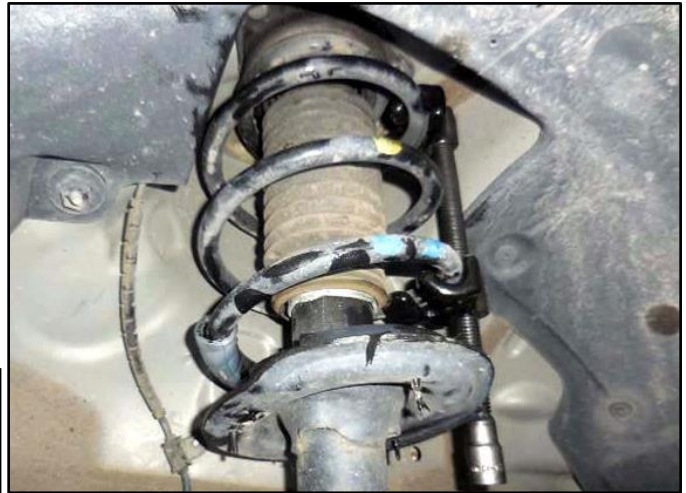
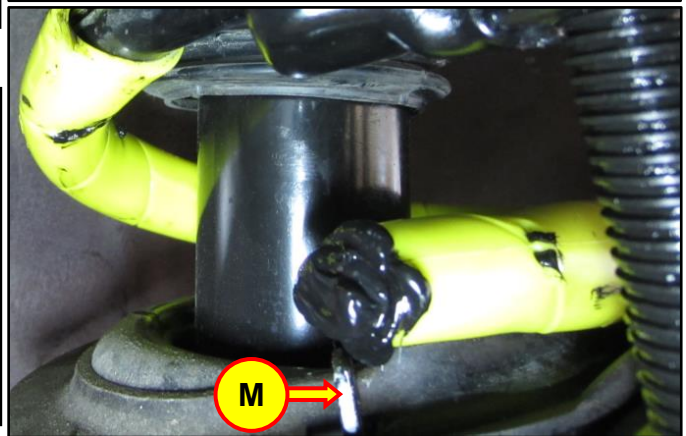
11. Carefully decompress the springs, making sure the spring is properly engaged with upper and lower spring seats on the strut. The end of the spring should line up against the lower spring seat guide (M).

Ensure the tube does not slide out of position while decompressing the springs.

- Confirm the coil spring is properly engaged with the strut at the upper and lower spring seats. If it is out of position, compress the spring again and realign.
- Confirm the tube did not slide out of position. If it is out of position, compress the spring again and realign.
