## Technical Service Bulletin

| GROUP<br><b>RECALL</b> | NUMBER<br><b>26-01-038H</b> |

**SUBJECT:** FRONT COIL SPRING URETHANE TUBE INSTALLATION  
(RECALL 133)

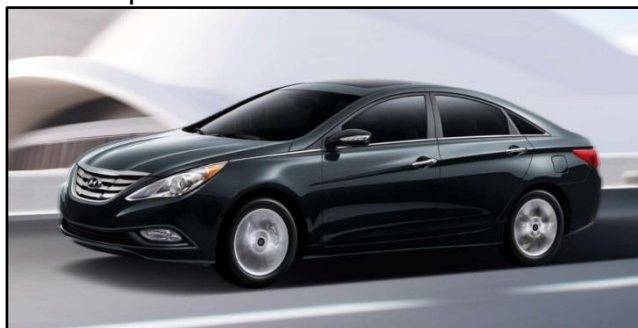
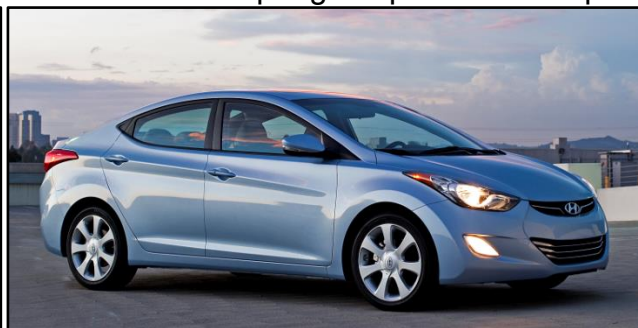
**Description:** On certain 2011 Elantra (MD) and Sonata (YF) vehicles, corrosion can build up at the front coil springs, resulting in a possible fracture near the base. A fractured spring can make contact with the tire, potentially resulting in a tire puncture and increasing the risk of a crash. This bulletin describes the procedure to install urethane tubes over the front coil springs to prevent a tire puncture.

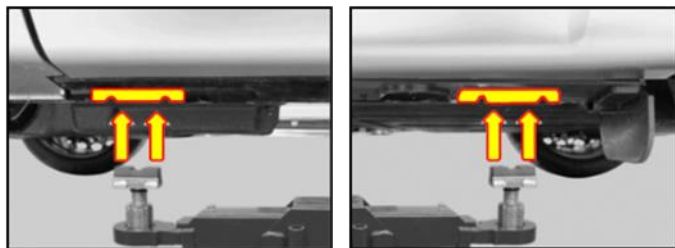
1. Visually check that the lift blocks are properly seated on the vehicle support points and raise the vehicle.

Raising the vehicle from anywhere other than the support points may damage vehicle components.

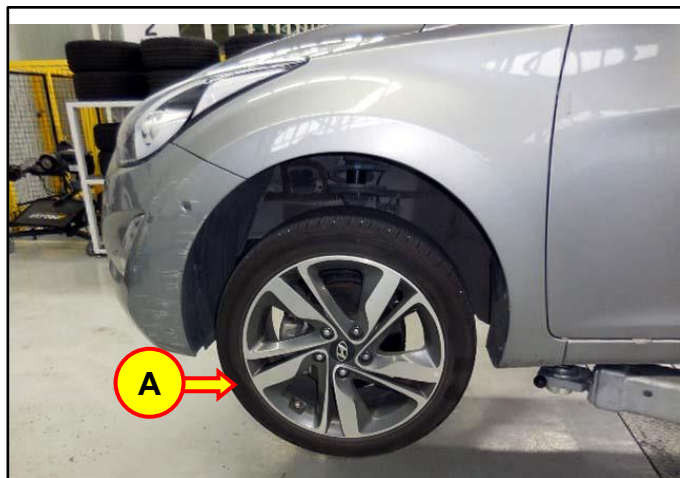
2. Remove the front wheels and tires (A).

Wear eye protection when performing work for spring compression.

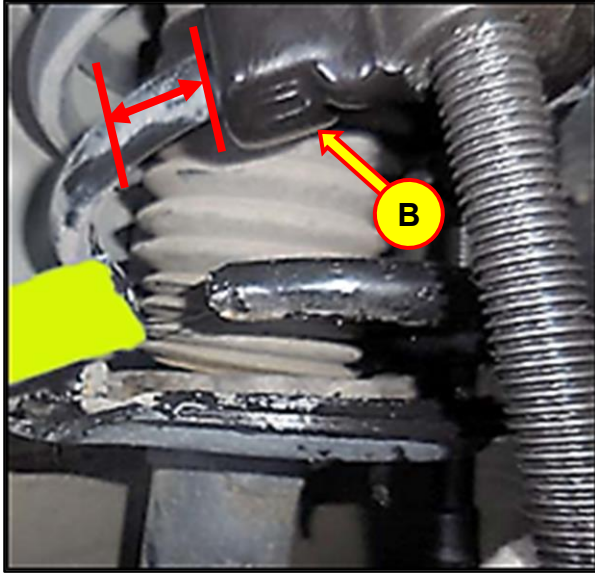
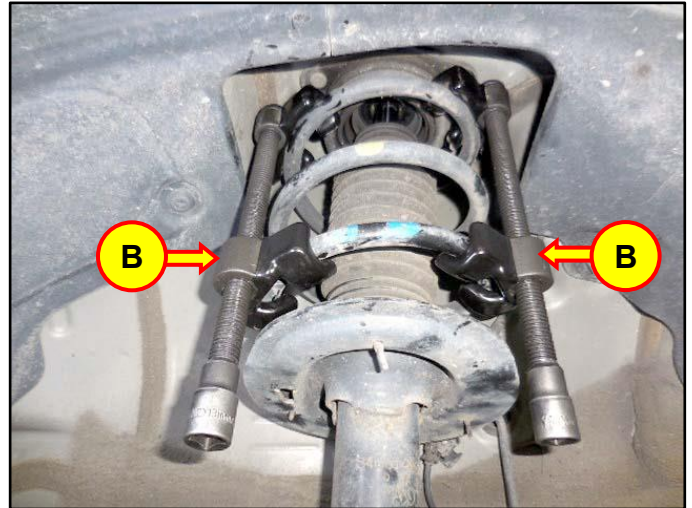
3. On one side of the vehicle, place the spring compression jigs (B) on opposite sides of the spring as shown.

Place the jig (B) on the spring to allow at least **14 inches** of clearance for the tube to fully slide on.

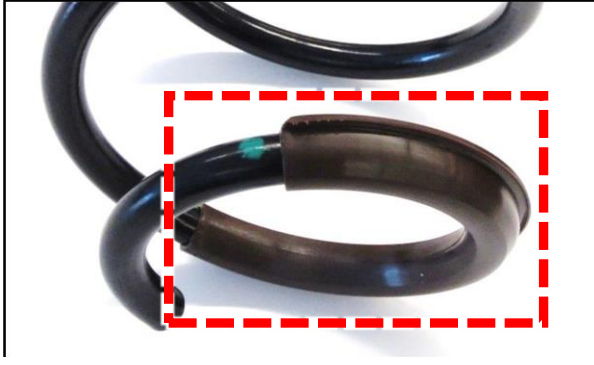
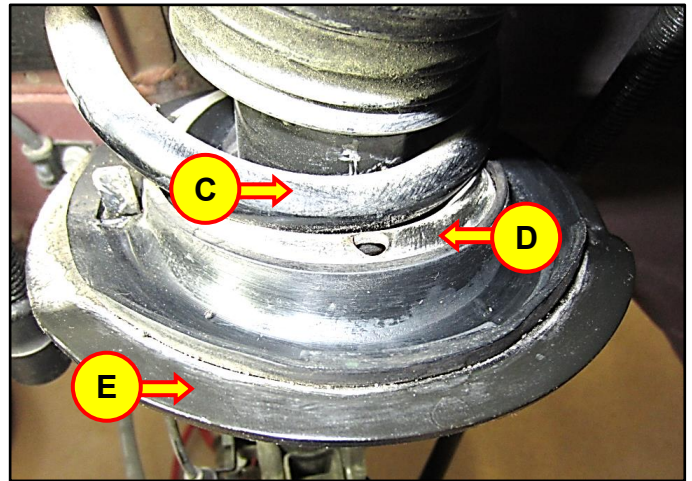
4. Compress the coil evenly.

Ensure **NOT** to compress either side more than **25mm (1 inch)** at a time.

Do **NOT** compress the spring more than **50 mm (2 inches)**.

5. Move the bottom of the spring (C) over the inside hump (D) of the lower spring seat (E).

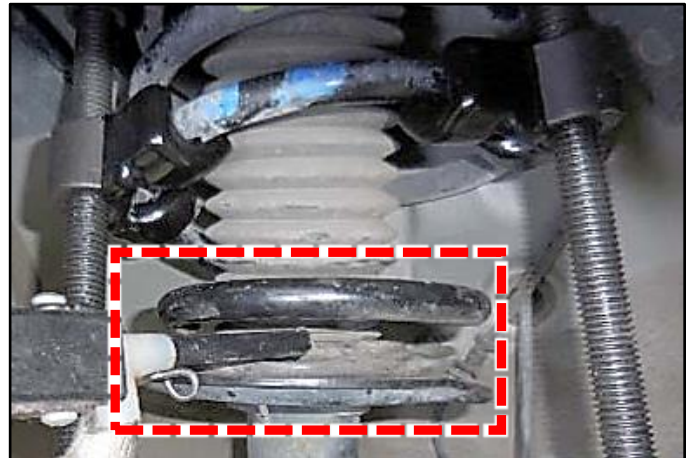
6. Use an air nozzle to remove debris from the lower spring seat, then clean the lower part of the spring where the urethane tube will be installed.
7. Inspect the lower coils for damage or corrosion:
- If the lower coils are damaged or corroded, proceed to the [Spring and Urethane Tube Replacement](#) section of this TSB.
  - If the lower coils are **NOT** damaged or corroded, proceed to **Step 8**.

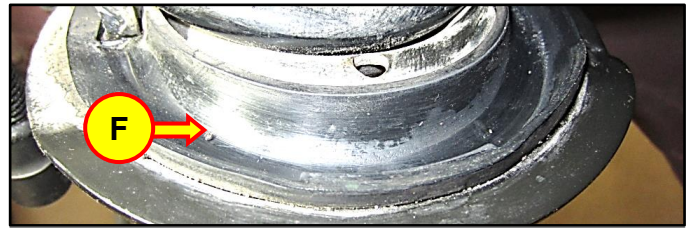
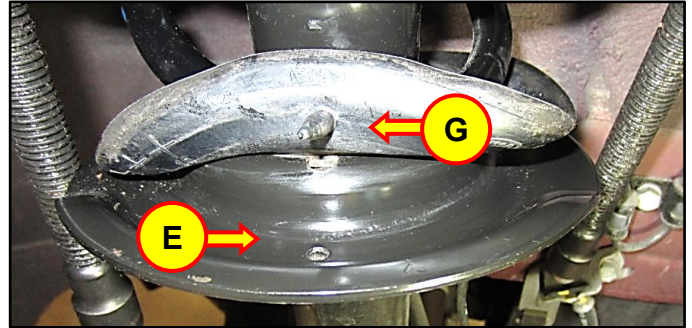
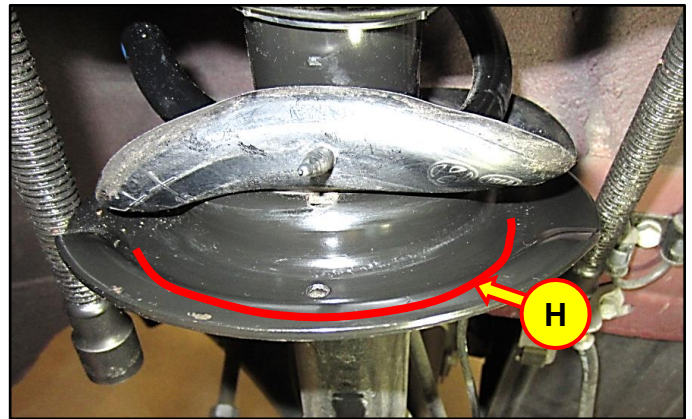
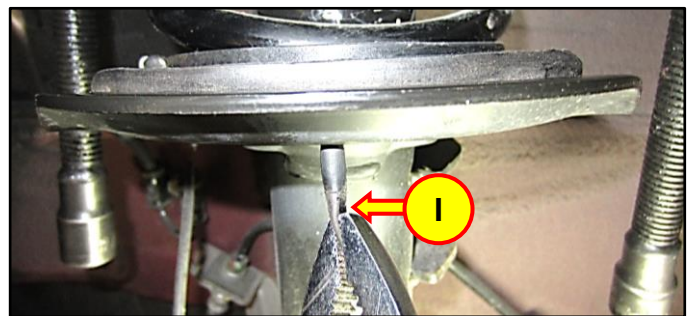
8. Remove the rubber spring pad (F) from the lower spring seat.
9. Clean the top (F) and bottom (G). surfaces of the pad and the lower spring seat (E).
10. Apply a bead of sealant between the rubber pad and lower spring seat (H) as shown.

11. Reinstall the rubber spring pad by pulling the rubber pins (I) back through their respective holes in the lower spring seat.

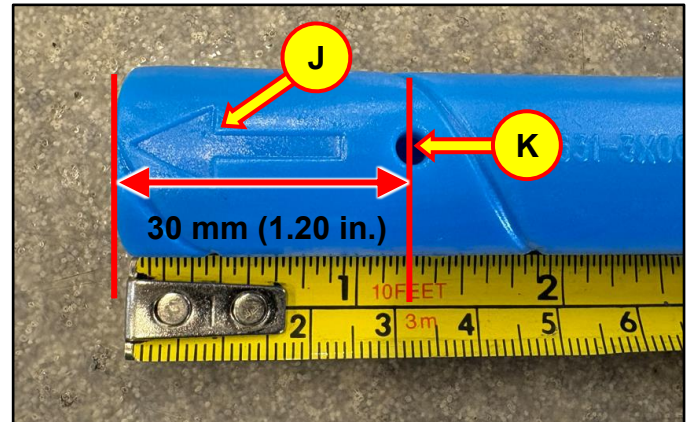
13. Locate the arrow on one end of the tube (J).

Fill the tube with sealant from the end marked with the arrow until the sealant reaches **30 mm (1.2 inches)** or the round openings (K).

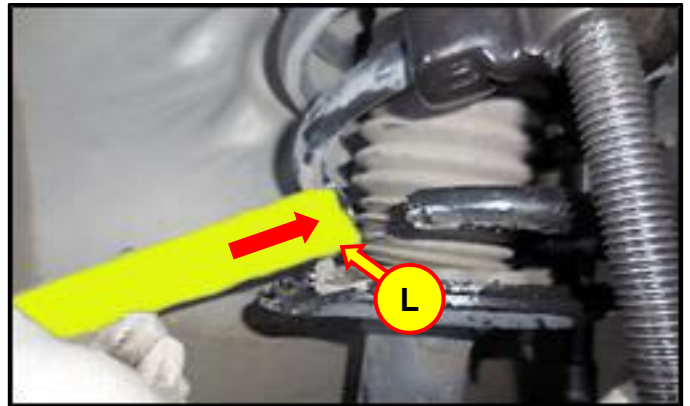
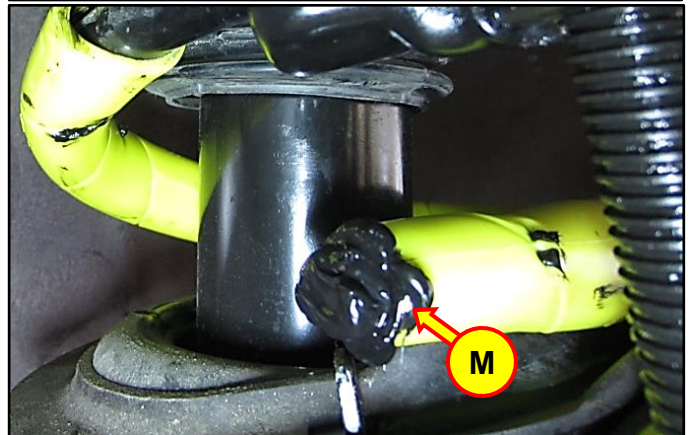
14. Starting from the end marked with the arrow (L), slide the urethane tube over the end of the coil spring until tube (M) end aligns with the spring end.

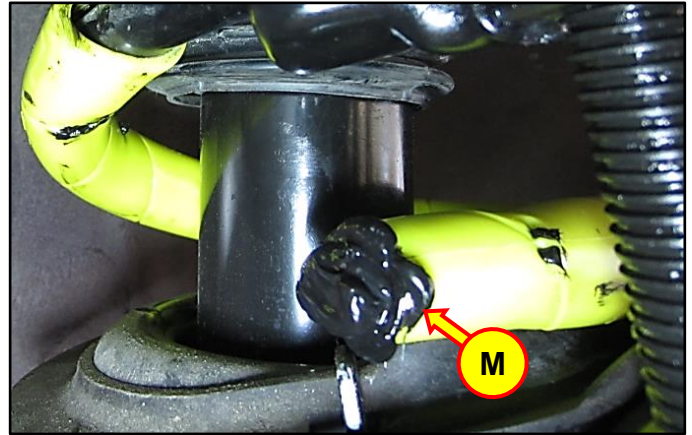
15. Decompress the spring evenly, one side at a time, ensuring the spring is properly engaged with the upper and lower spring seats on the strut.

Decompress each side of the spring by no more than **25 mm (1 inch)** at a time.

The end of the spring should align with the lower spring seat guide (M). If misaligned, then recompress the spring and realign the tube.

Confirm the coil spring is properly engaged with the strut at the upper and lower spring seats. If misaligned, then recompress the spring and realign the tube.

Ensure the urethane tube stays in position during decompression.

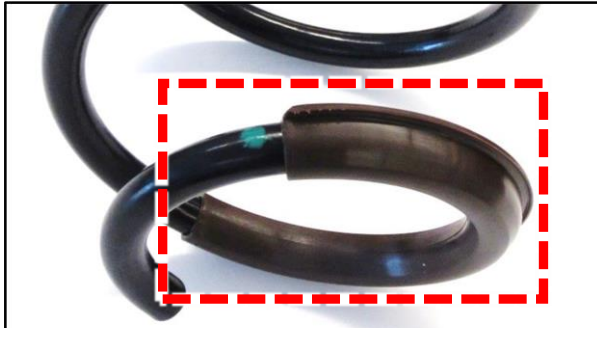
1. Remove the damaged spring by referring to the shop manual:

If the replacement spring is already equipped with a urethane tube, carefully remove it without damaging the black coating.

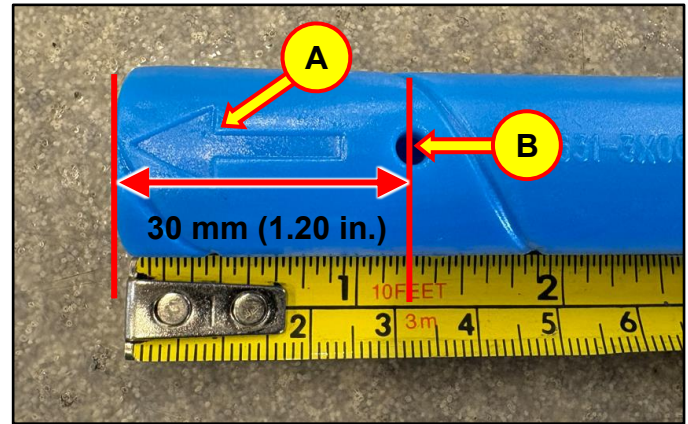
3. Locate the arrow on one end of the tube (A).

Fill the tube with sealant from the end marked with the arrow until the sealant reaches **30 mm (1.2 inches)** or the round openings (B).

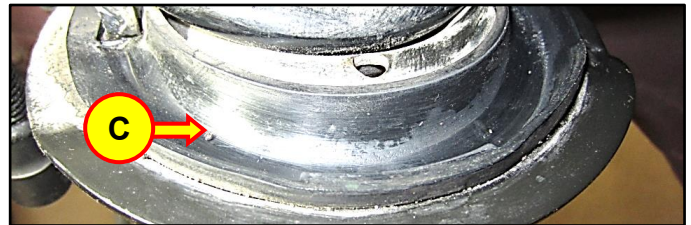
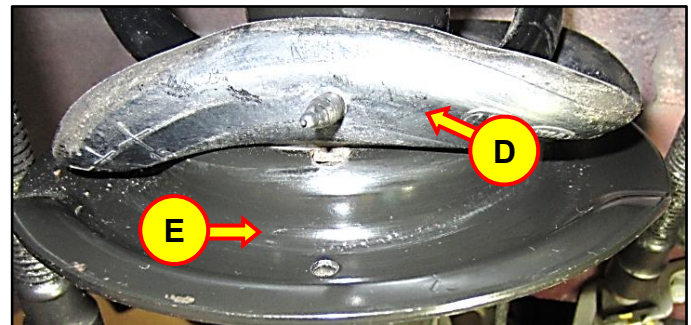
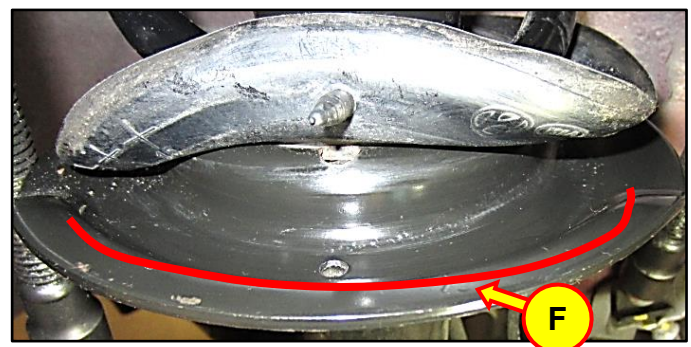
4. Starting from the end marked with the arrow (A), slide the urethane tube over the lower end of the coil spring until tube end aligns with the spring end.
5. Remove the rubber spring pad (C) from the lower spring seat.
6. Clean the top (C) and bottom (D) surfaces of the pad and the lower spring seat (E).
7. Apply a bead of sealant between the rubber pad and lower spring seat (F) as shown in the photo.

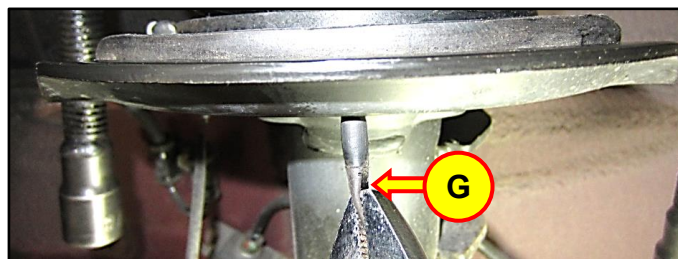
8. Reinstall the rubber spring pad by pulling the rubber pins (G) back through their respective holes in the lower spring seat.
