**SUBJECT:** IFS Ball Joints

**CONDITION:** For a select group of IFS units, it is possible that the central steering system ball joints were not properly torqued or secured into the relay rod

**APPLIES TO:** This bulletin applies to ReycoGranning IFS models IFS20-XXXXX and IFS24-XXXXX used on Fire Apparatus.

**CORRECTION:** Inspect per instruction and tighten if required

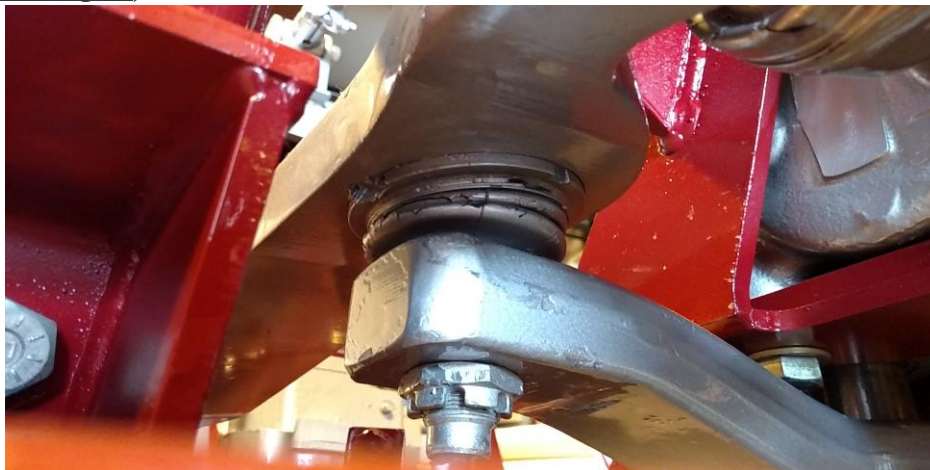
**FIG. 2-2**

2. Visually inspect the ball joints located in pitman arms, the ball joints will be seated in both pitman arms off of the steering gears. The ball joint shall be fully engaged with the notched flange in contact with the spot face surface of the relay rod. If it is not, please proceed to the repair procedure. Refer to FIG. 2-2 and 3-1 (pictures may not represent suspension you are working on).

3. If the ball joint appears to be seated, using a 0.001 inch feeler gauges to check under the notched flange. If the feeler gauge slides under the flange, please proceed to the step by step instructions.
4. With a punch and hammer use moderate force in an effort to tighten the ball joint in place (clockwise). If it moves proceed to the step by step instructions. If it is tight this will finish the inspection and vehicle can be returned to service.
