Revised December 2015

Dealer Service Instructions for:

Safety Recall R59 / NHTSA 15V-661

Left Rear Axle Shaft

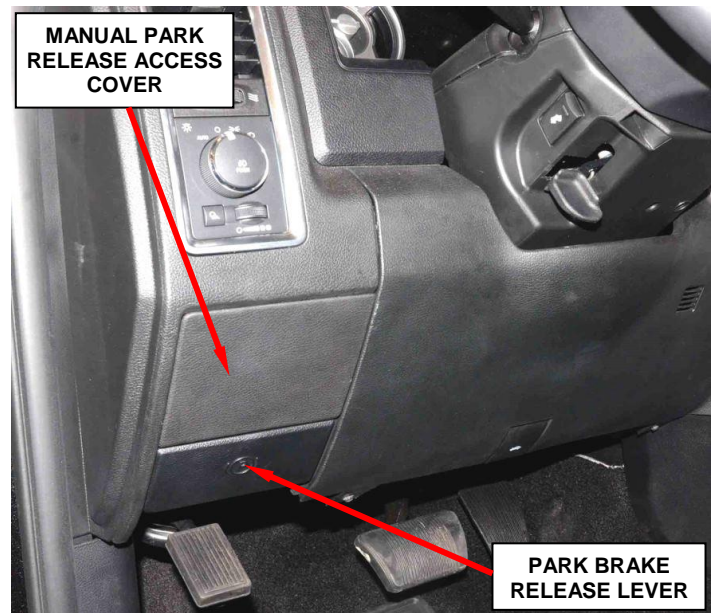
**Figure 1 – Manual Park Release Access Cover**

1. Use the following procedure to release the transmission manual park release lever:
 - a. Remove and save the transmission manual park release access cover (Figure 1).
 - b. Using a small screwdriver, slide the release lever lock to the right and hold in that position (Figure 2).
 - c. Pull the orange release lever tether until it locks in place (Figure 2).

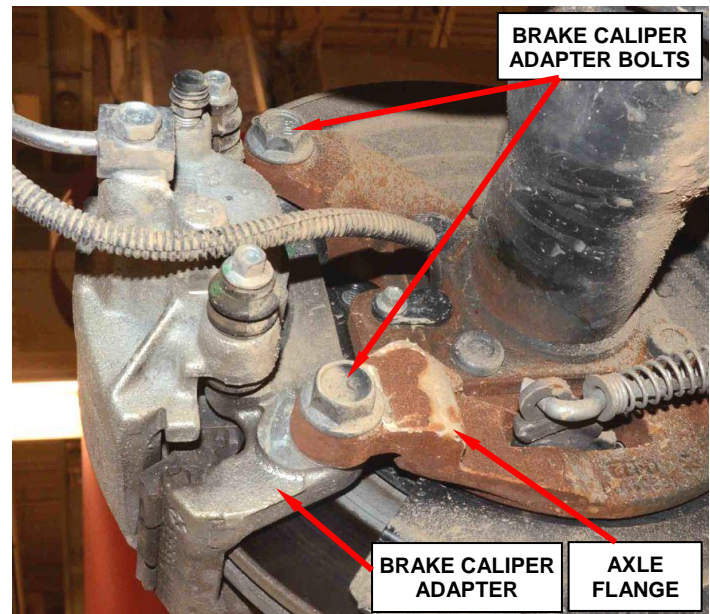
Figure 3 – Brake Caliper and Adapter

2. Raise the vehicle on an appropriate hoist.
3. Remove and save the left rear wheel/tire assembly.
4. Remove and discard the left side rear caliper adapter bolts and position the left side brake caliper and adapter assembly aside (Figure 3).

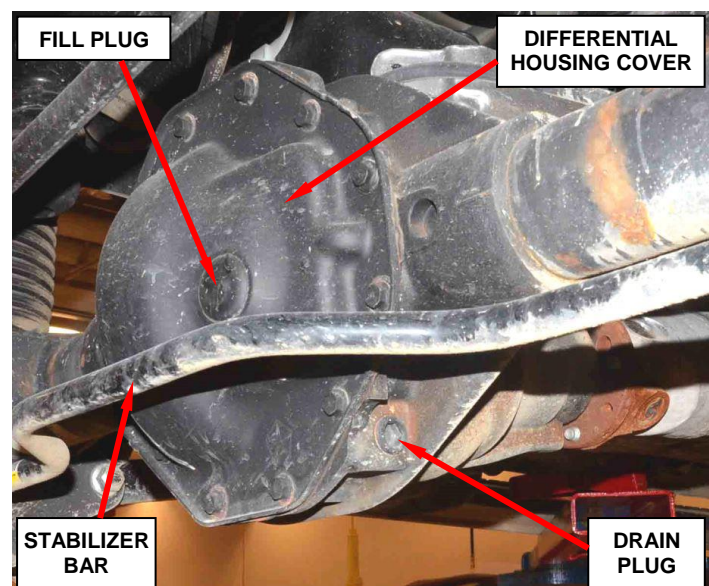
Figure 4 – Drain Rear Axle Fluid

5. Remove and save the left brake rotor.
6. Clean the differential and drain plug area to prevent debris from entering the rear axle during differential cover removal.
7. Remove and save the rear axle oil drain plug to drain the rear axle fluid (Figure 4).

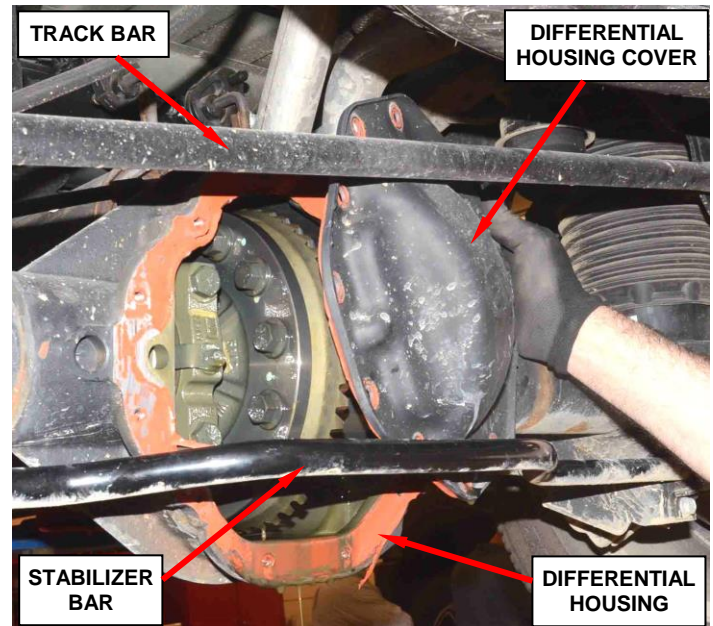
Figure 5 – Differential Case Cover

8. Remove and save the rear axle differential housing cover (Figure 5).

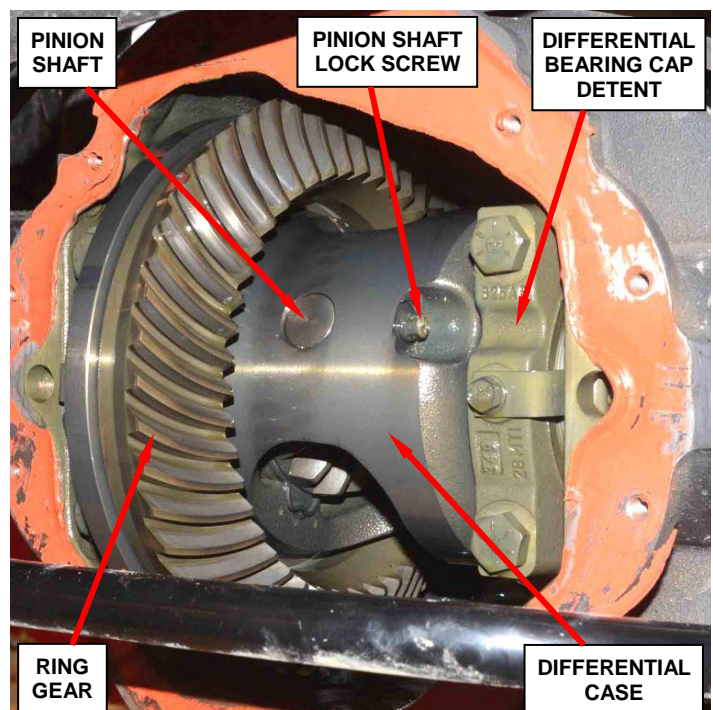
Figure 6 – Pinion Shaft

9. Rotate the differential case so pinion shaft lock screw is aligned with the differential bearing cap detent (Figure 6).

10. Remove and discard the original pinion shaft lock screw (Figure 6).

11. Remove and save the pinion shaft from the differential case (Figure 6).

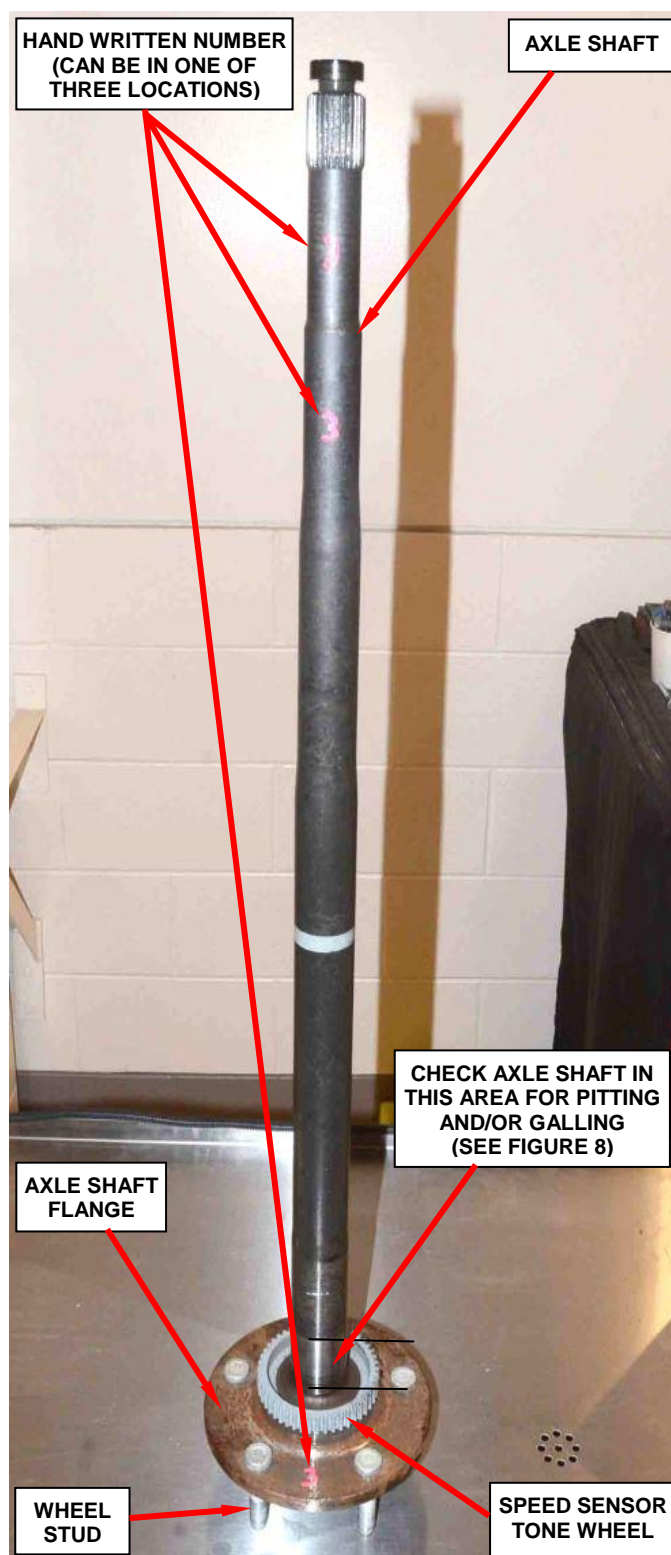
Figure 7 – Inspect Hand Written Number on Axle Shaft

14. Inspect the left axle shaft (Figure 7):

NOTE: The hand written number can be in three different locations on the axle shaft (Figure 7).

- If the left axle shaft has a hand written number “1” - “2” - “5” - “6” - “7” - “8” - “9” or “10” on the axle shaft, continue with Step 15 of this procedure.
- If the left axle shaft has a hand written number “3” or “4” on the axle shaft and has not failed, continue with Step 16 of this procedure.
- If the left axle shaft has no hand written number (or the number is not legible) and the axle shaft has not failed, continue with Step 16 of this procedure.
- If the left axle shaft failed, for trucks with air suspension, continue with **Section B. Depressurize Air Suspension** and for trucks without air suspension, continue with **Section C. Replace Rear Axle**.

NOTE: A failed axle shaft will have metal pitting and/or galling on the axle shaft where the axle shaft bearing rides (Figure 7 and 8).

15. **For vehicles with a hand written number “1” - “2” - “5” - “6” - “7” - “8” - “9” or a “10” on the axle shaft**, install the original left axle shaft and engage into side gear splines.

16. **For vehicles with a hand written number “3” or “4” on the axle shaft or the hand written number is missing or illegible**, install a new left axle shaft and engage into side gear splines.

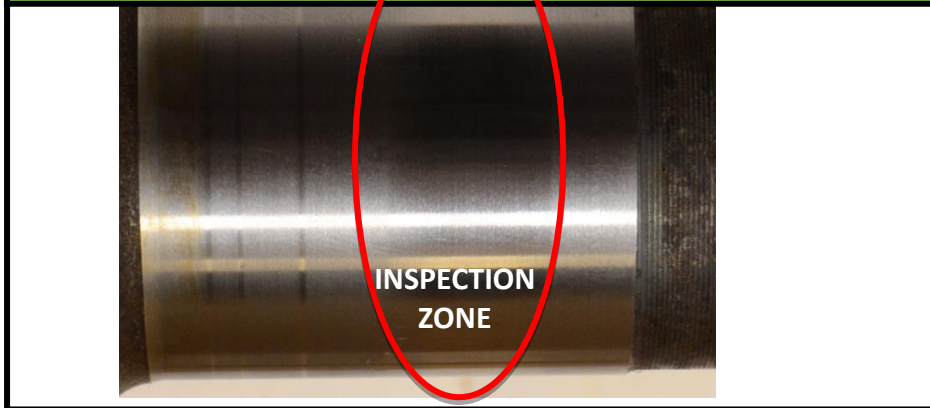
Inspection Zone: Left Hand Axle Shaft Bearing Journal

Shaft Replacement Only:

- Marked with a “3” or “4”
- Polished and smooth
- No pitting present

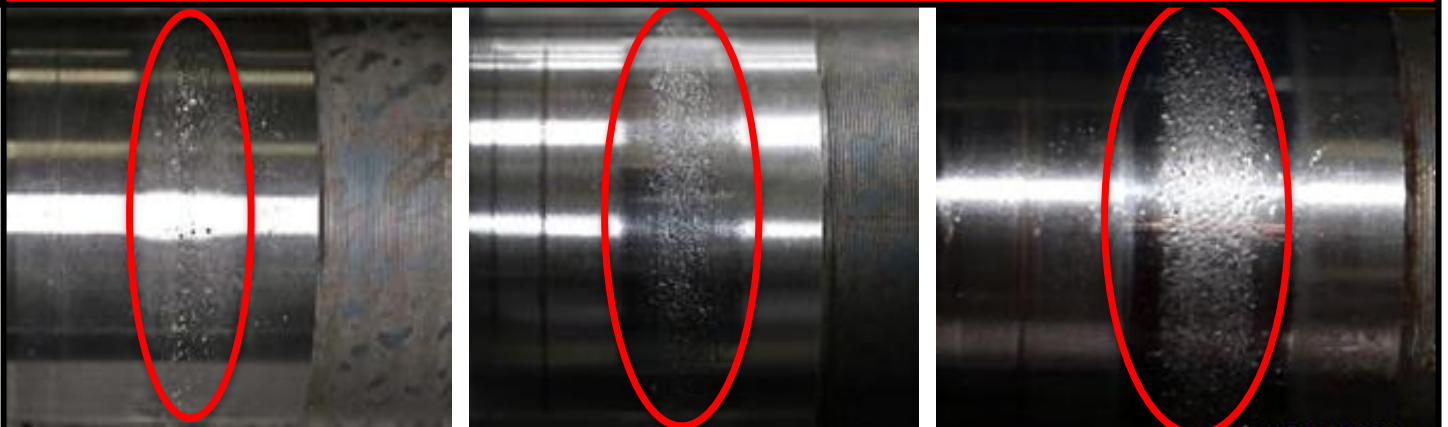
Figure 8 – Examples of Axle Shaft Conditions that Require Axle Assembly Replacement

Inspection Zone: Conditions Shown Below Require Full Axle Assembly Replacement

- Any pitting & wear marks or worse on shaft in the inspection zone.
- Possible groove beginning to form in the inspection zone.

Note: Debris remaining in the axle assembly may lead to long term durability risk to seals, bearings, and gears.

If the rear axle inspection determines that the axle shaft has failed, the rear axle assembly must be replaced.

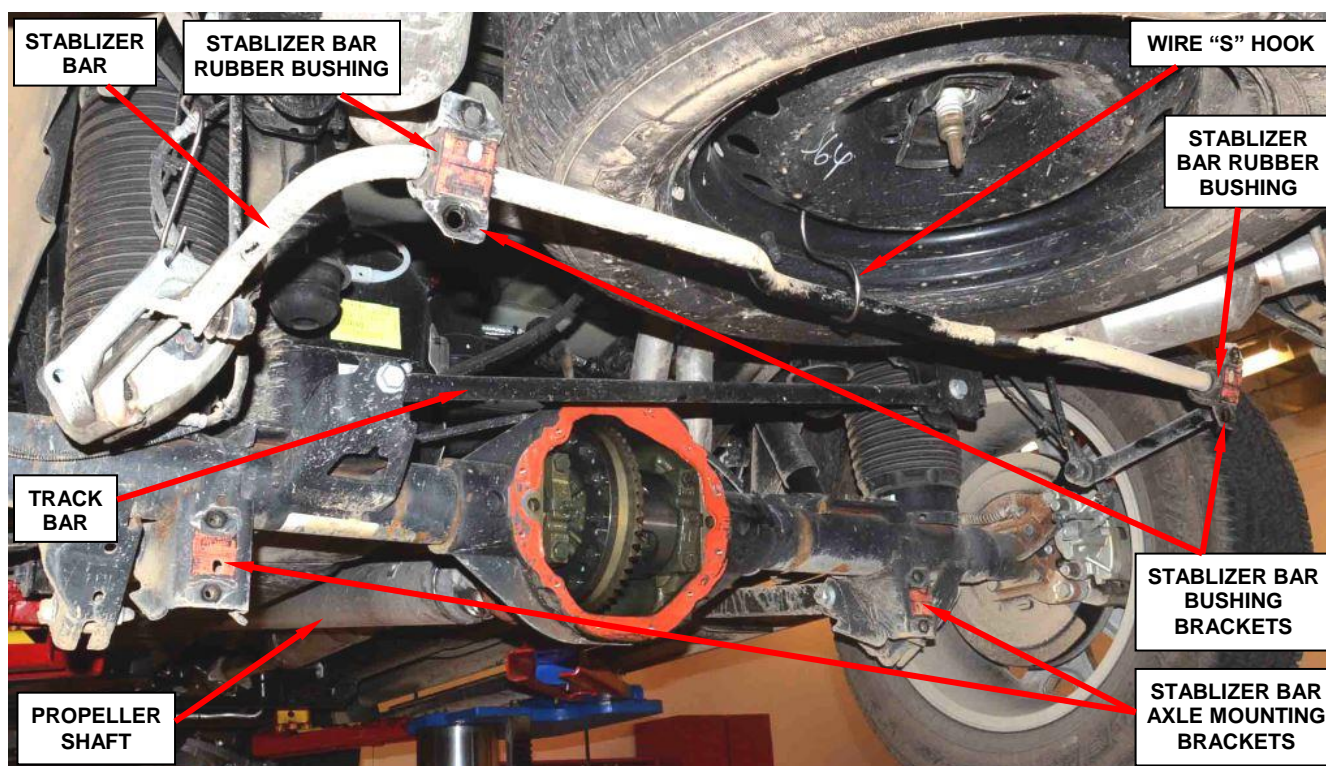
Figure 9 – Relocate Stabilizer Bar to Gain Clearance to Install Rear Axle Cover

20. Remove and save the four stabilizer bar mounting bolts at the axle mounting brackets (Figure 9).
21. Swing the stabilizer bar back towards the spare tire and secure the stabilizer bar with a hook (Figure 9).

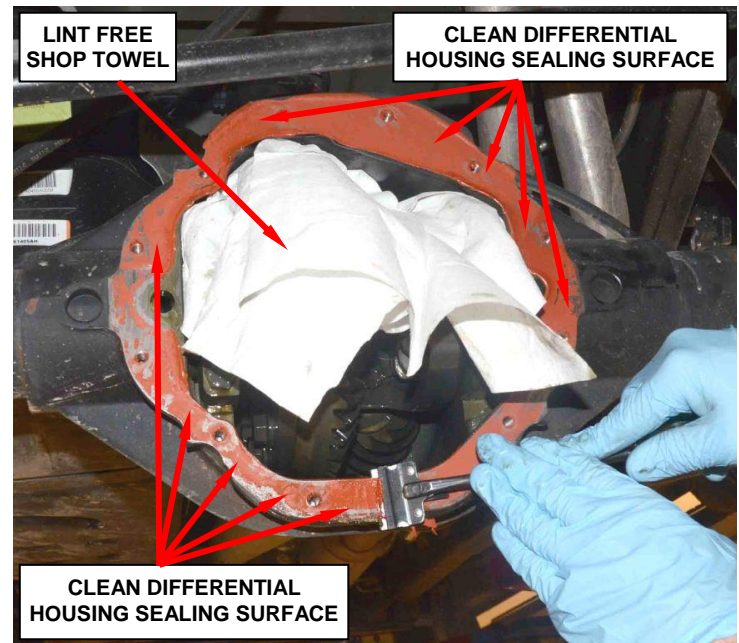
Figure 10 – Clean Differential Housing Sealing Surface

22. Using a lint free shop towel, cover the ring gear to protect the internal axle components from debris (Figure 10).
23. Clean the differential housing sealing surface (Figure 10).
24. Clean the differential cover sealing surface.

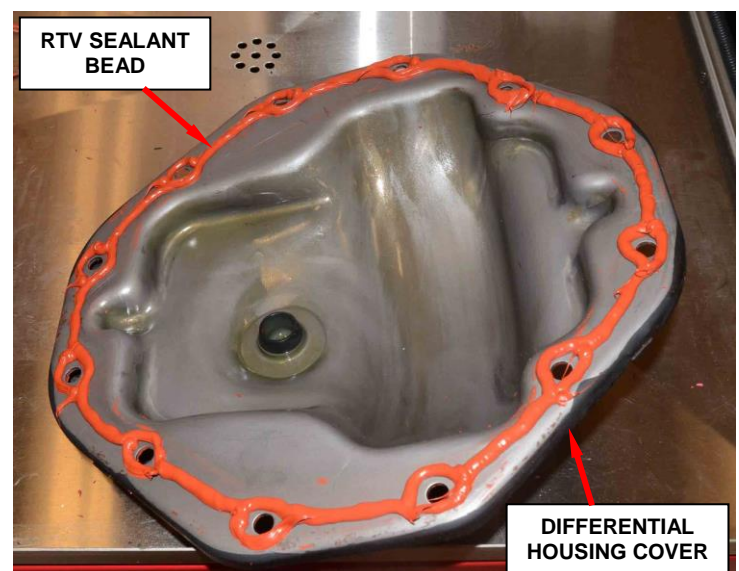
Figure 11 – Apply Mopar Axle RTV Sealant

25. Apply a ¼ inch (6.35mm) bead of Mopar Axle RTV Sealant to the cover with the RTV sealant bead to the inner side of the bolt holes (Figure 11).

CAUTION: Do not use any other type of RTV silicone sealant to seal the rear differential housing cover.

CAUTION: The differential housing cover must be installed within five minutes of applying RTV sealant.

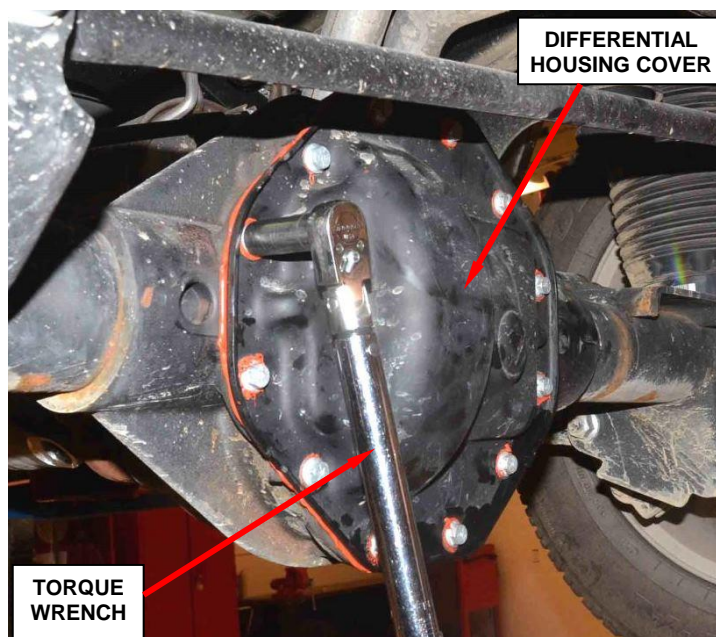
Figure 12 – Install Differential Cover

26. Using new differential cover bolts, install the differential cover and the differential cover bolts. Tighten the differential cover bolts in a crisscross pattern to 32 ft. lbs. (44 N·m) (Figure 12).
27. Apply sealant to the drain plug threads and install the rear axle drain plug. Tighten the rear axle drain plug to 52 ft. lbs. (70 N·m).
28. For vehicles equipped with a limited slip differential, install five ounces of Mopar Limited Slip Additive (friction modifier).
29. Fill the rear axle with Mopar gear lubricant.

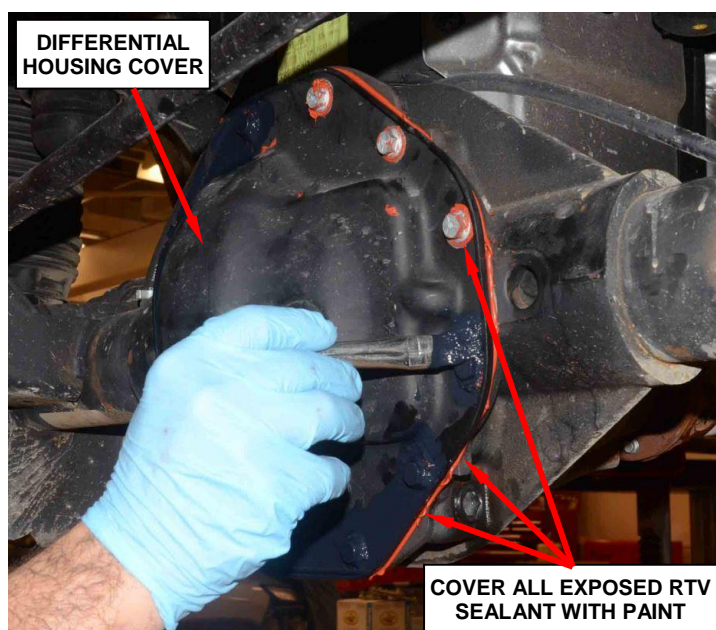
Figure 13 – Apply Black Paint to Exposed RTV Sealant

30. Using the supplied paint, paint all areas of the rear axle where orange silicone sealant can be seen (Figure 13).
31. Place the stabilizer bar into position and install the four retaining bolts. Tighten the bolts to 37 ft. lbs. (50 N·m) (Figure 9).
32. Install brake rotor onto the axle shaft hub.
33. Install the brake caliper adapter and brake caliper as an assembly. Tighten the **NEW** brake caliper adapter bolts to 132 ft. lbs. (179 N·m).

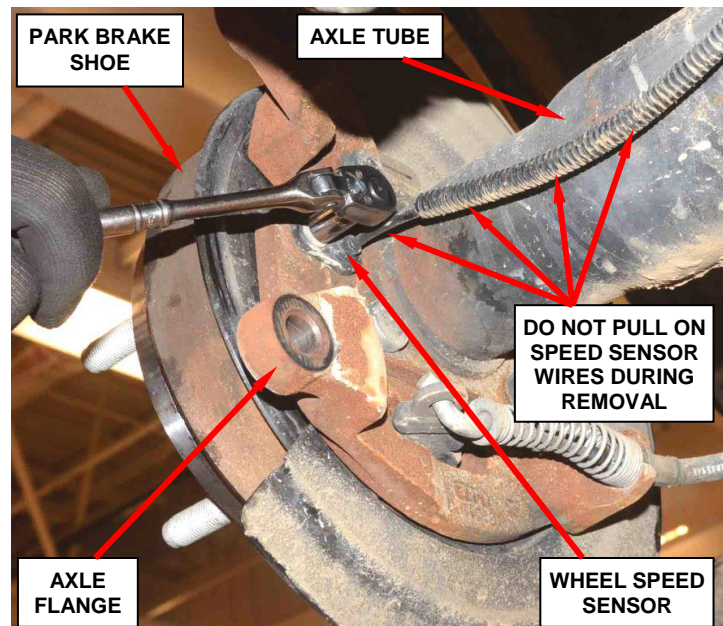
Figure 14 – Speed Sensor

3. Remove the right side rear brake rotor.
4. Remove and save the mounting bolt from the rear wheel speed sensors (Figure 14).
5. Remove the right and left side wheel speed sensors from the axle flanges (Figure 14).

CAUTION: When removing the speed sensor from the axle flange, do not pull on the speed sensor wires. Speed sensor damage may occur.

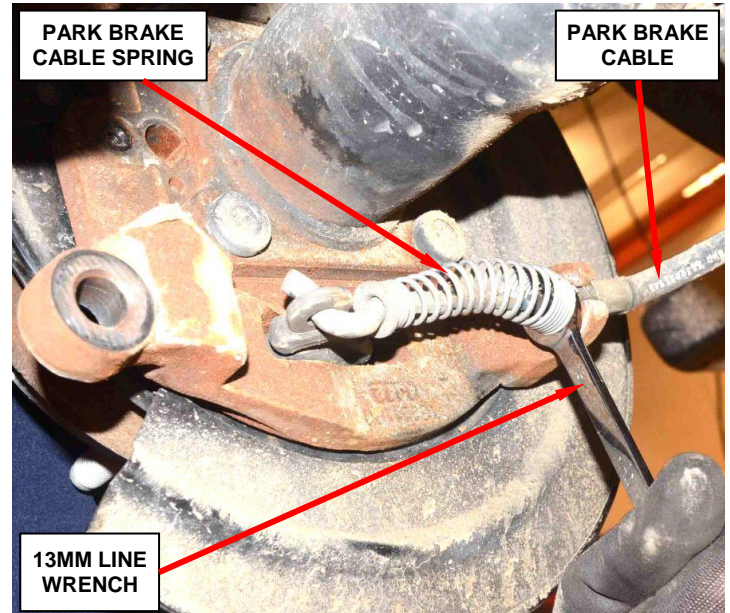
Figure 15 – Park Brake Cable

- a. Pull the park brake cable spring back.
- b. Compress the cable tabs on each cable end fitting at the brake cable support plate using a 13 mm line wrench (Figure 15).

NOTE: A 13mm line wrench can be used to compress the cable tabs. Insert while spring is pulled back and rotate the wrench to compress the cable tabs.

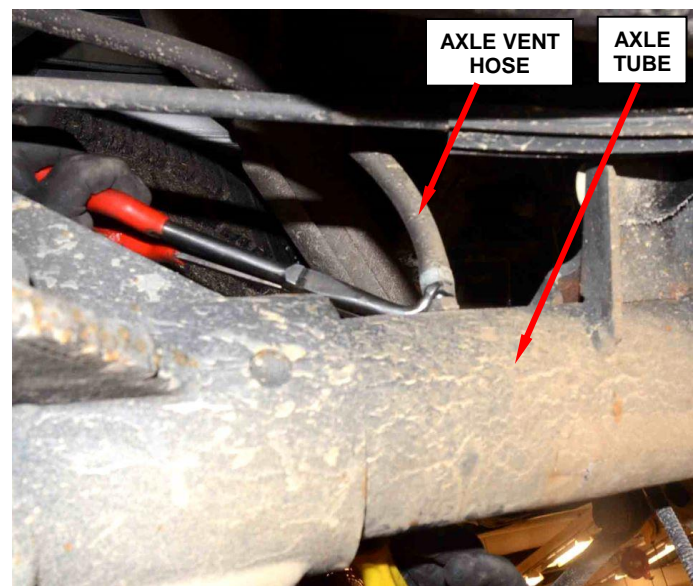
Figure 16 – Axle Vent Hose

- c. Remove the park brake cable from the brake cable support plate.
 - d. Remove the upper park brake cable bolt from the rear axle.
 - e. Remove the park brake bolt on the upper control arm bracket.
 - f. Position the park brake cable away from the rear axle.
7. Loosen the clamp and disconnect the axle vent hose from the rear axle (Figure 16).

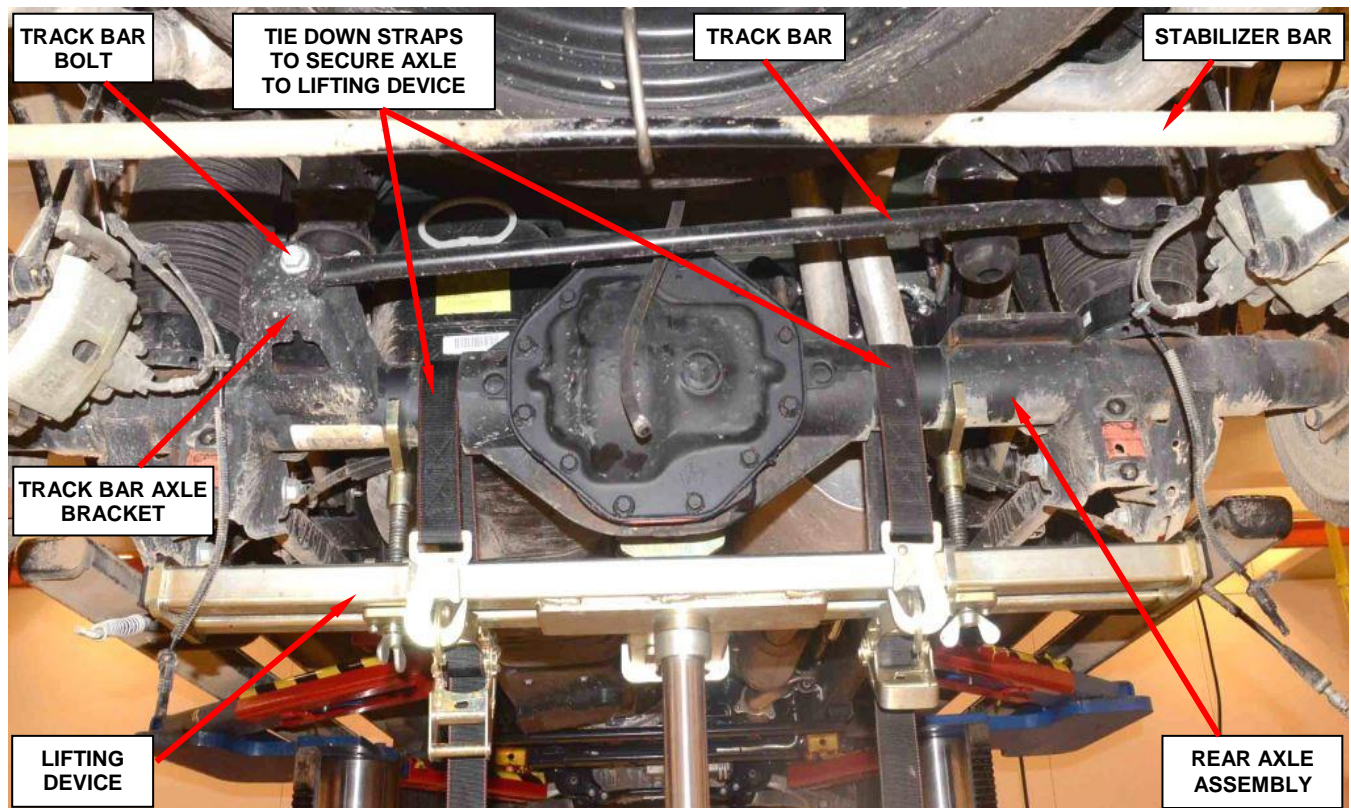
**Figure 17 – Secure Axle Assembly to a Lifting Device**

8. Remove and discard the rear propeller shaft companion flange bolts.
9. Suspend the rear propeller shaft using a bungee cord or equivalent.
10. Position a lifting device under the rear axle and secure the rear axle to the lifting device (Figure 17).
11. Remove and discard the track bar bolt and position the track bar away from the rear axle (Figure 17 and 18).

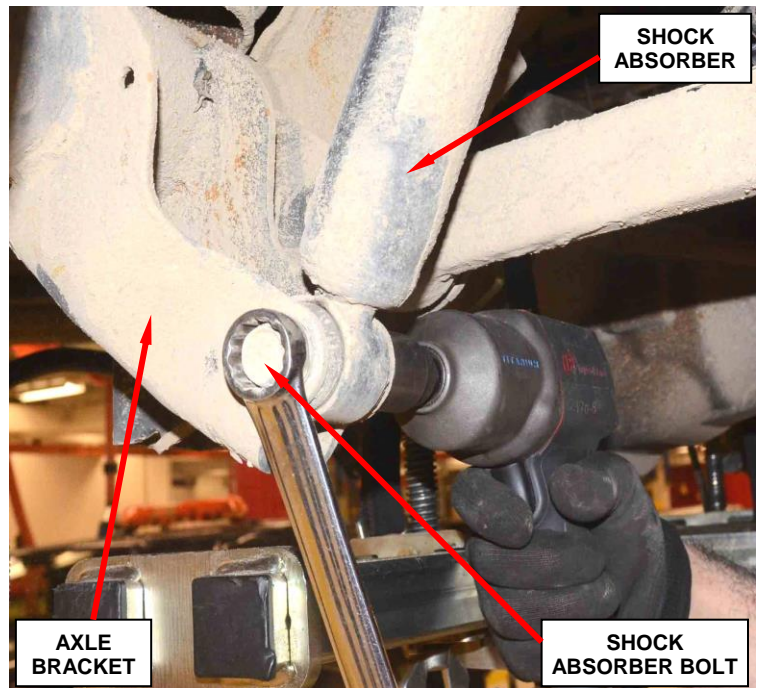
**Figure 19 – Shock Absorber Lower Bolt**

12. Remove and save both lower shock absorber bolts and position the shock absorbers away from the rear axle (Figure 19).
13. Remove and discard both the upper control arm-to-rear axle bolts and position the upper control arms away from the rear axle (Figure 20).
14. Remove and discard both the lower control arm-to-rear axle bolts and position the lower control arms away from the rear axle (Figure 20).

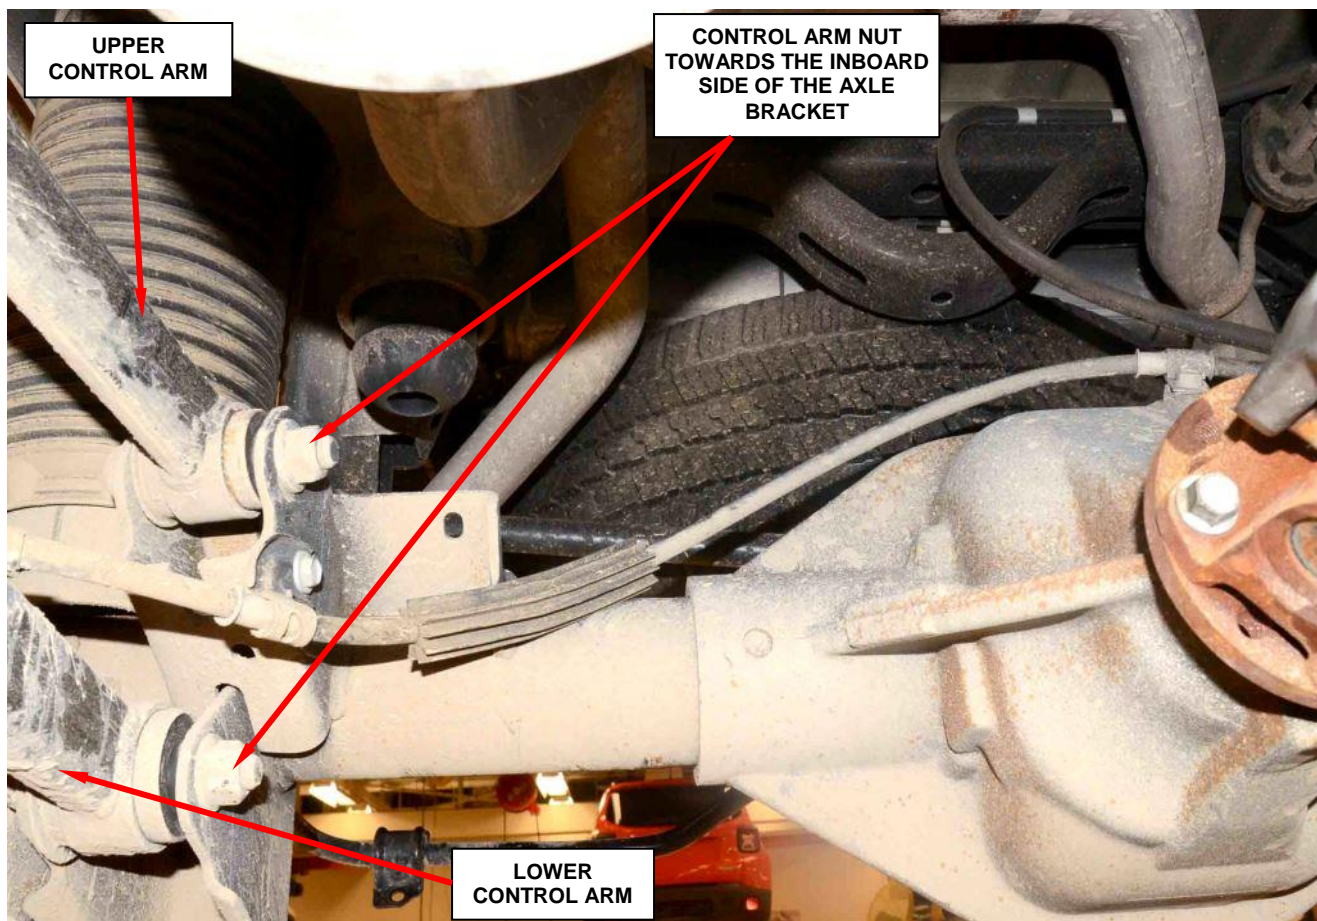
Figure 21 – Upper and Lower Control Arm Bolt Orientation
(right side shown)

CAUTION: The lower control arm bolt must be installed pointing inward (nut on the inside of the mounting bracket) (Figure 21).

CAUTION: The upper control arm bolt must be installed pointing inward (nut on the inside of the mounting bracket) (Figure 21).

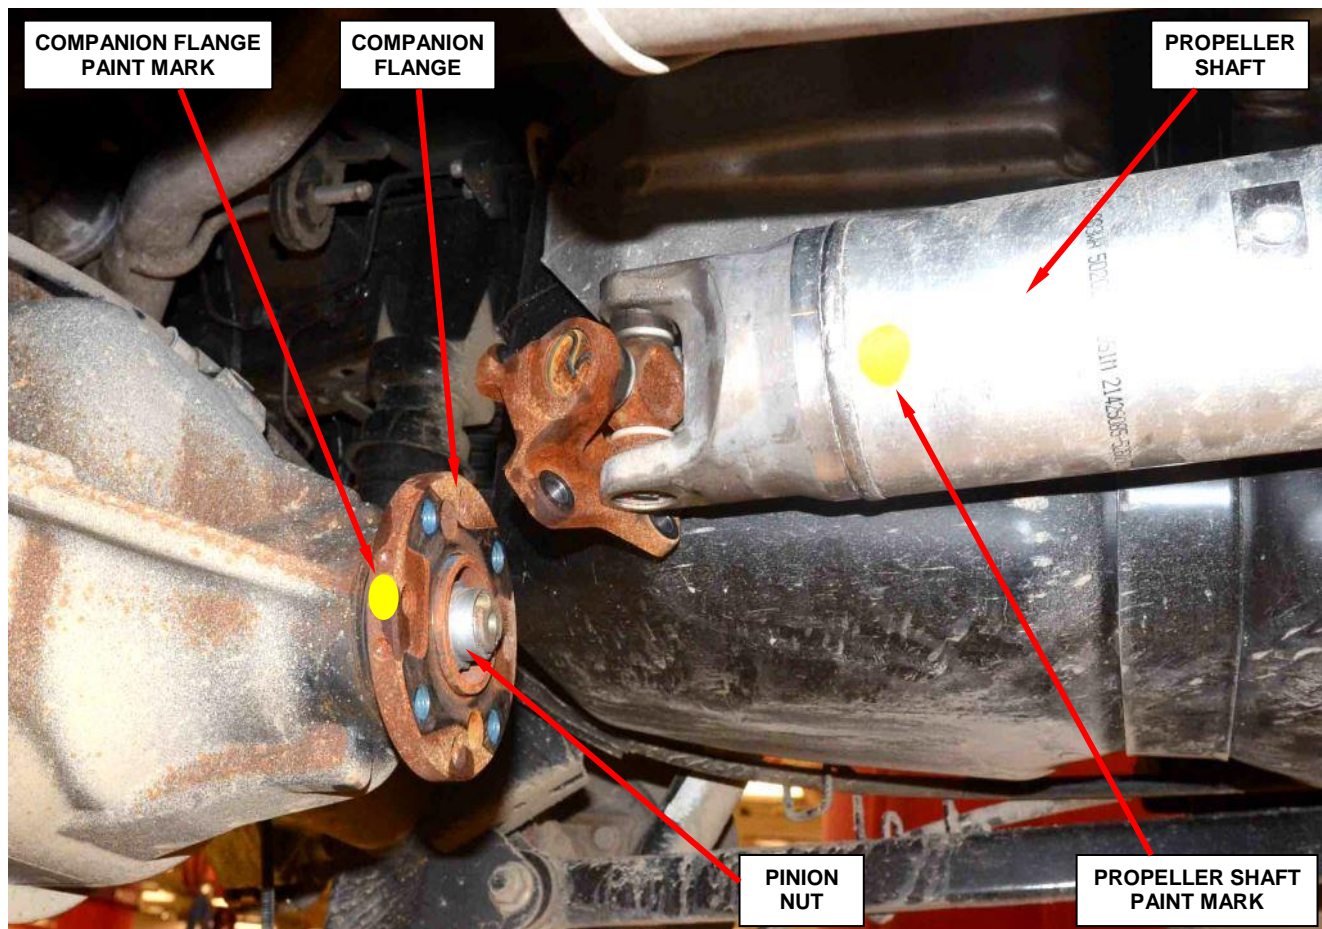
Figure 22 – Align Marks on Propeller Shaft and Companion Flange

32. Place the rear propeller shaft into position. Install new rear propeller shaft companion flange bolts and tighten to 85 ft. lbs. (115 N·m).

CAUTION: Be sure to align the factory alignment paint mark on the propeller shaft as closely to the factory alignment paint mark on the new axle companion flange (Figure 22).
