Recall Bulletin

PRODUCT SAFETY RECALL

SUBJECT: Front Seat Side Impact Airbag Module

MODELS: 2015 Buick LaCrosse
2015 Cadillac XTS, XTS Professional
2015 Chevrolet Camaro, Equinox, Malibu
2015 GMC Terrain

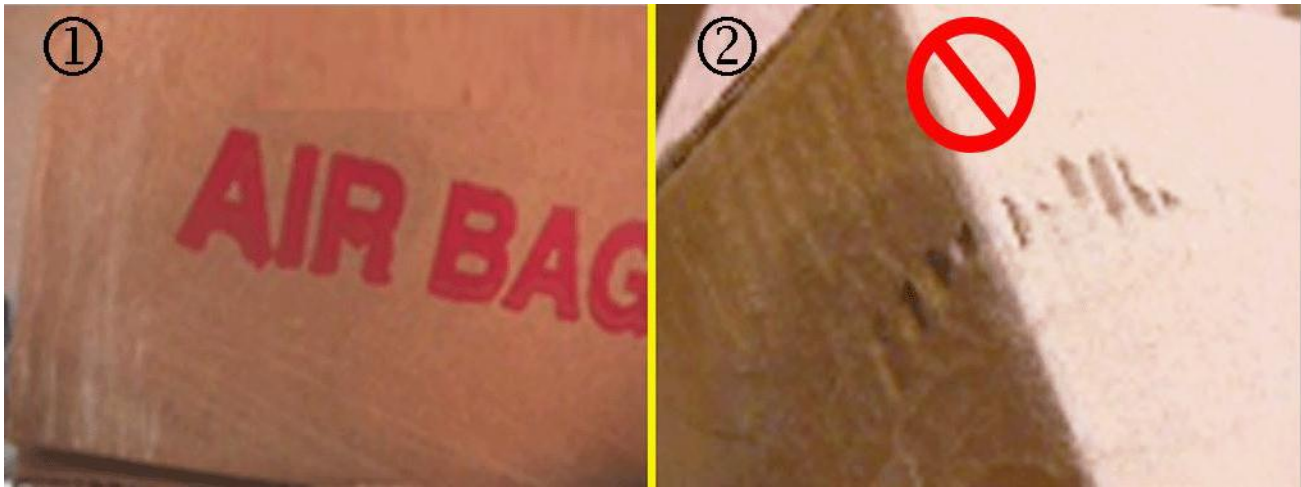
3961561

- **Abrasions:** Abrasions result from sliding the package against a rough surface (e.g. concrete floors). Major abrasions (2) are NOT acceptable. Note the flutes are visible.

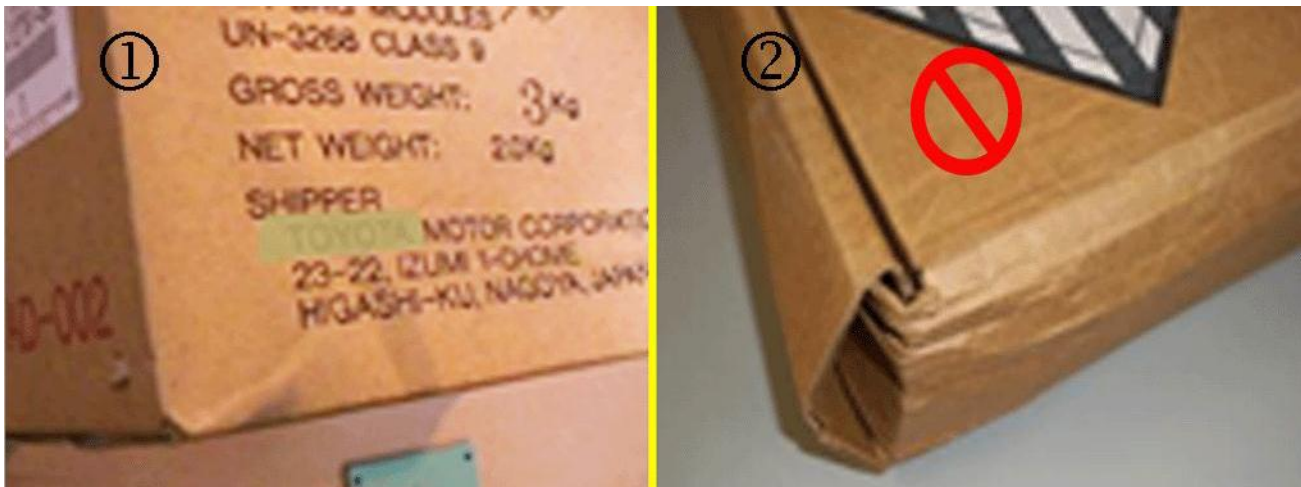
3961563

- **Compressions:** Compressions result from superimposed weights (e.g. stacked too high) or from dropping the packages. Small dimples (1) are acceptable.

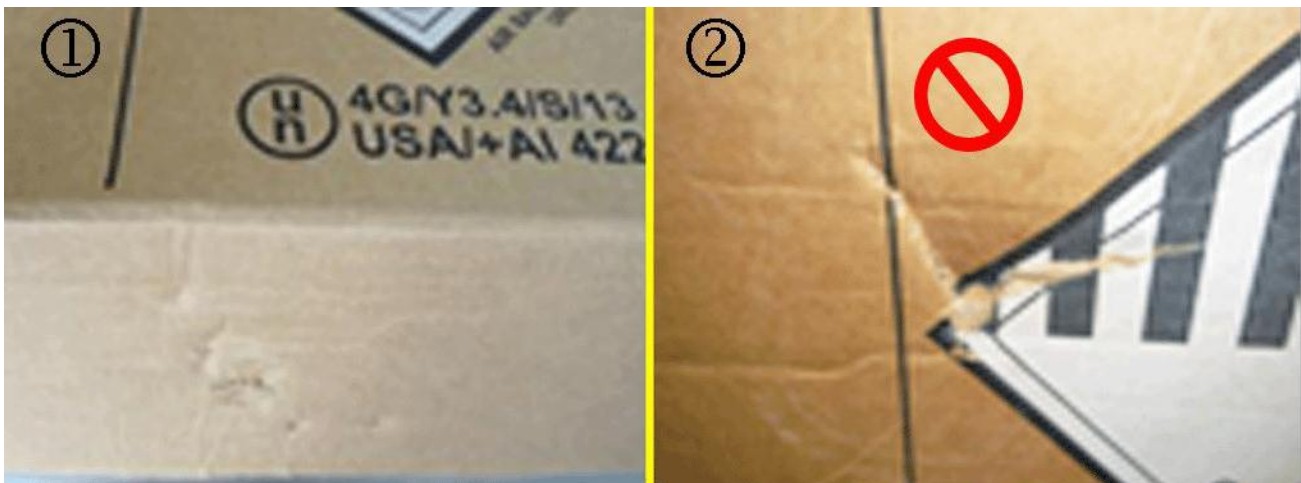
3961564

- **Dents:** Minor dents (1) occur through normal handling and picking (e.g. pulling from bin locations) and are acceptable. Major dents (2) result from impacts with others objects (e.g. pallet impacts).

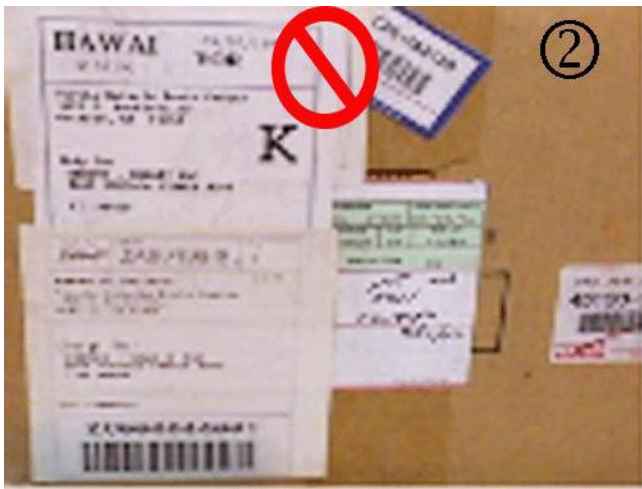
3961566

- **Labeling:** Packages with excessive labeling are NOT acceptable, particularly if the labels obscure other required marks and labels.

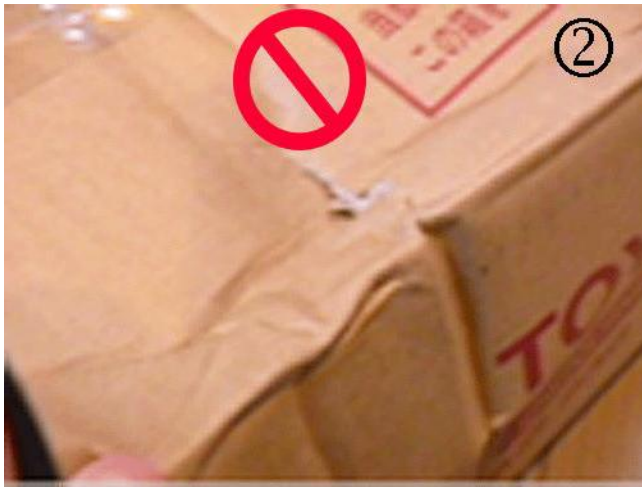
3961567

- **Other Damages:** Multiple damages, such as those shown above, may affect the integrity of the packages, and are NOT acceptable. Others that are not as severe may be acceptable. If questionable, repackage the material.

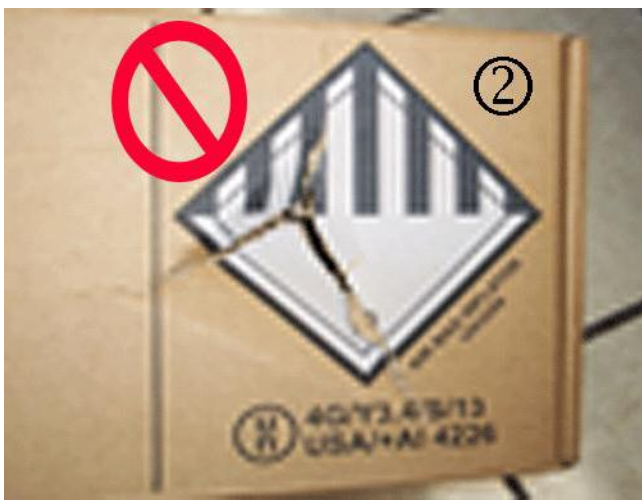
3961568

- **Punctures:** Any punctures, even minor ones, are NOT acceptable.

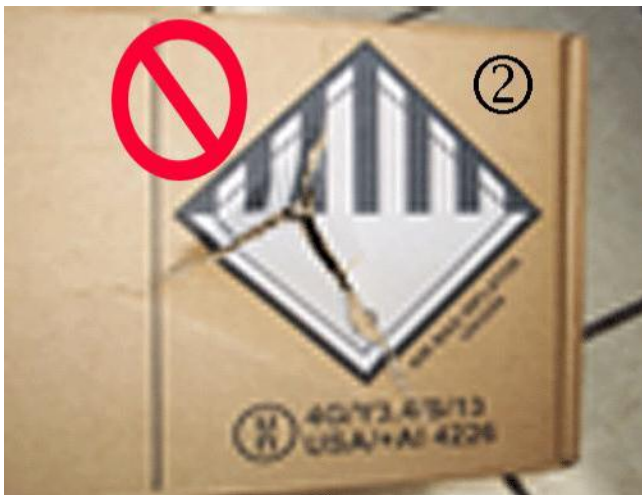
3961568

- **Tears:** Minor tears will not generally affect the structural integrity of the packaging and are considered to be normal "wear and tear", however, large tears or rips are NOT acceptable.

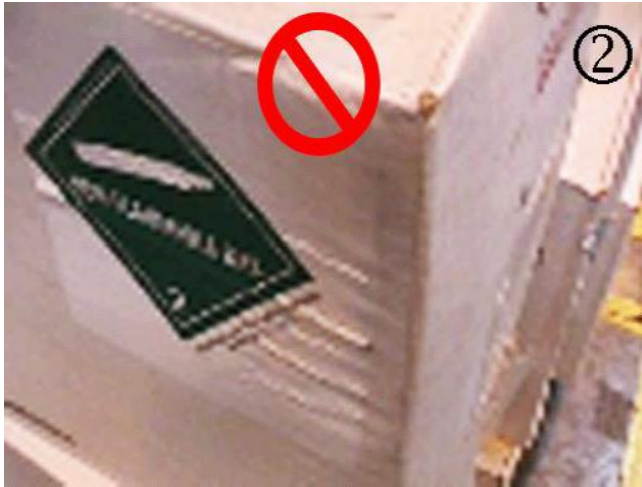
3961569

- **Water Damages:** Water Damages, such as the example shown above, are NOT acceptable. Water damages will affect the structural integrity of the packaging. These packages should be repacked in appropriate specification packages.
1. **DO NOT DEPLOY THE AIRBAG.** Ensure that the box the replacement airbag arrived in is not damaged and place the Front Seat Side Impact Airbag Module in the box. Also, make sure to include a copy of the repair order in the box. (Generic packaging shown)

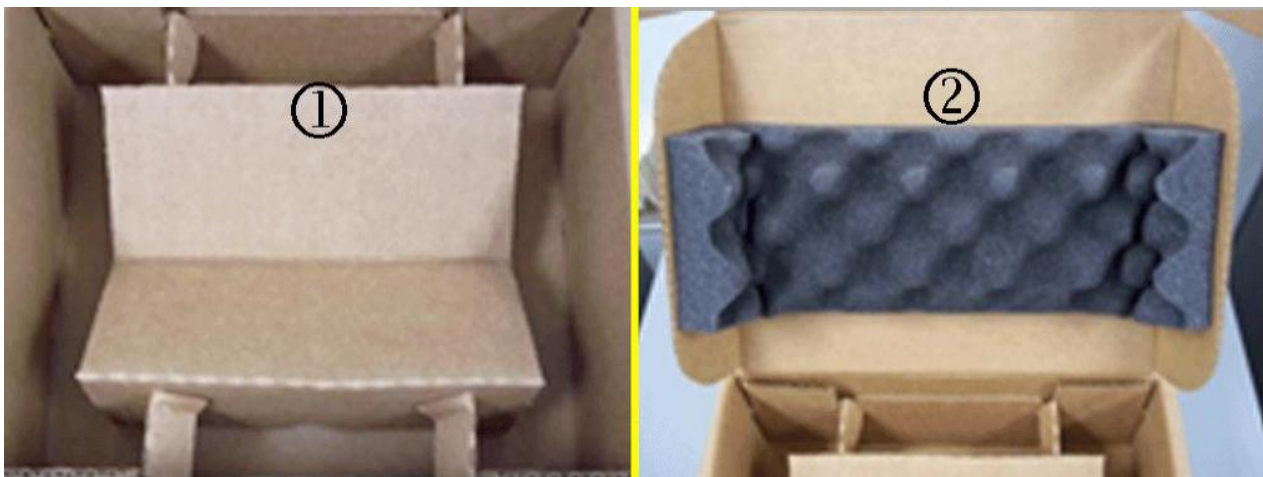
3961570

Important: The components required for the completed return package are dunnage (1) and foam (2), as shown in the graphic above.

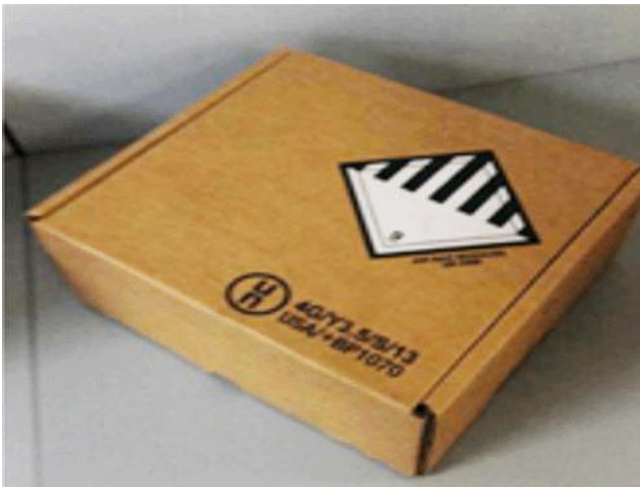
3955264

2. Close and secure any rollover tucks / flaps following the closing instructions below:

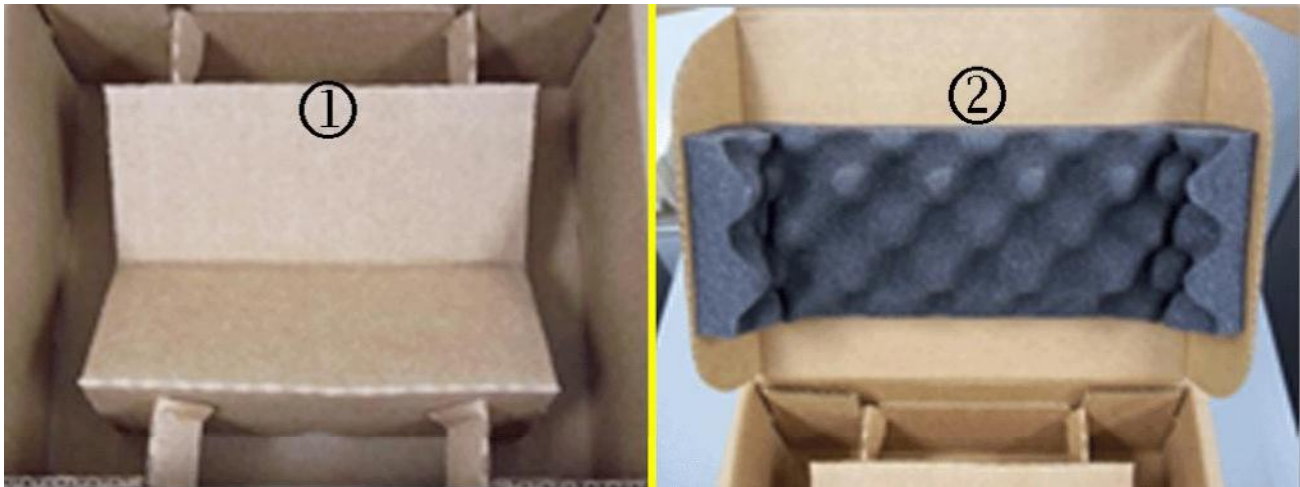
3961570

Important: The components required for the completed return package are dunnage (1) and foam (2), as shown in the graphic above.

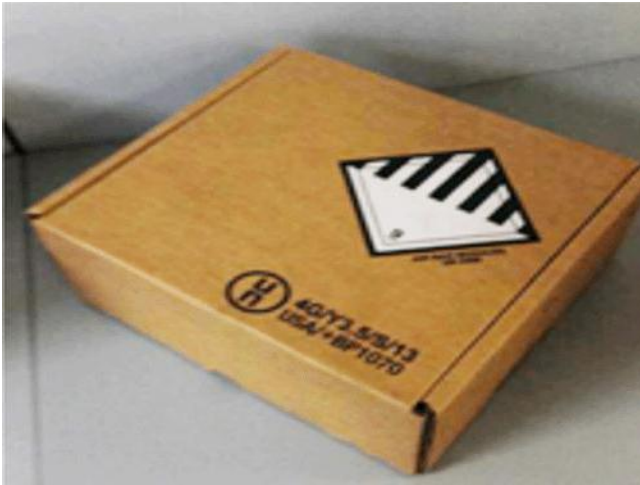
3955264

2. Close and secure any rollover tucks or flaps on the box following the closing instructions below:
