Dealer Service Instructions for:

## **Safety Recall R57 / NHTSA 15V-676**

### **Air Conditioning Hose**

**2015 (KL) Jeep® Cherokee**

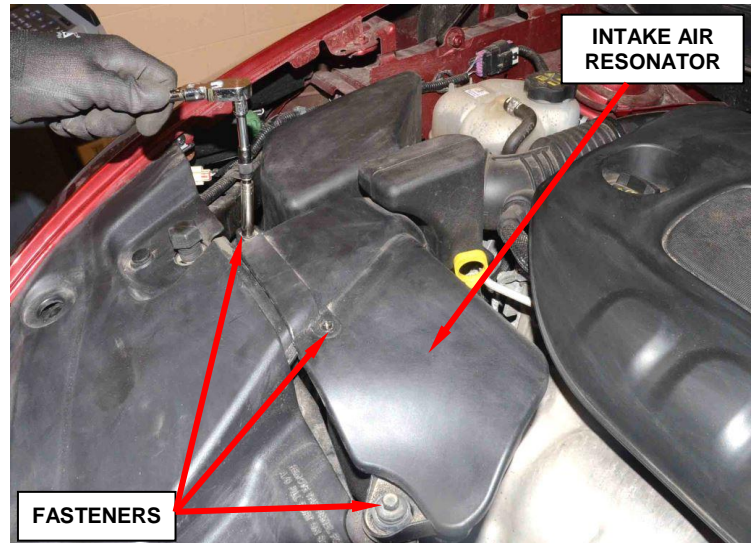
**Figure 1 – Intake Air Resonator**

1. Open the hood.
2. Remove and save the intake air resonator (Figure 1).

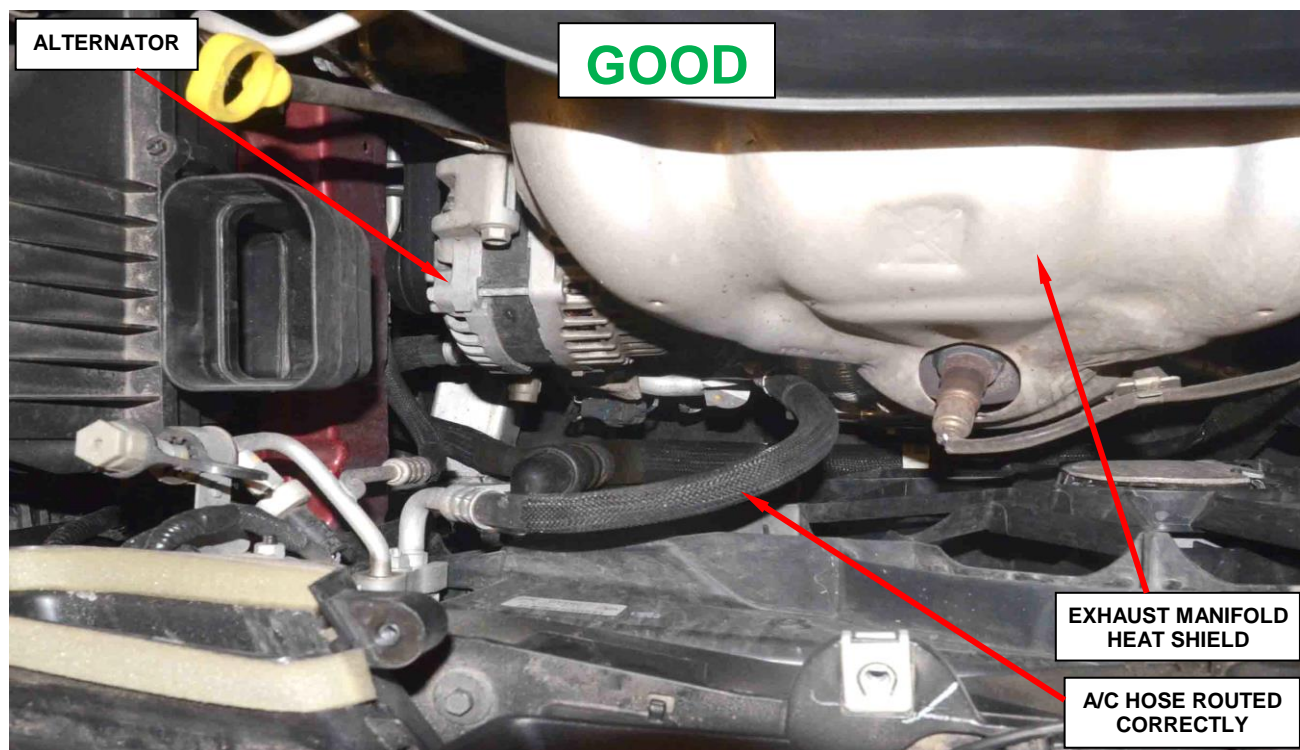
**Figure 2 - Correctly Routed A/C Hose**

3. Inspect the air conditioning hose routing:
  - If the A/C hose is routed correctly, continue with Step 4 of this procedure (Figure 2).
  - If the A/C hose is misrouted, and the refrigerant has been lost due to hose failure at the exhaust manifold, continue with **Section B: Replace Air Conditioning Condenser** (Figure 3).
  - If the A/C hose is misrouted, but there is no loss of refrigerant, continue with **Section C: Replace Air Conditioning Hose** (Figure 3).
4. Install the intake air resonator.
5. Close the hood.
6. Return the vehicle to the customer.

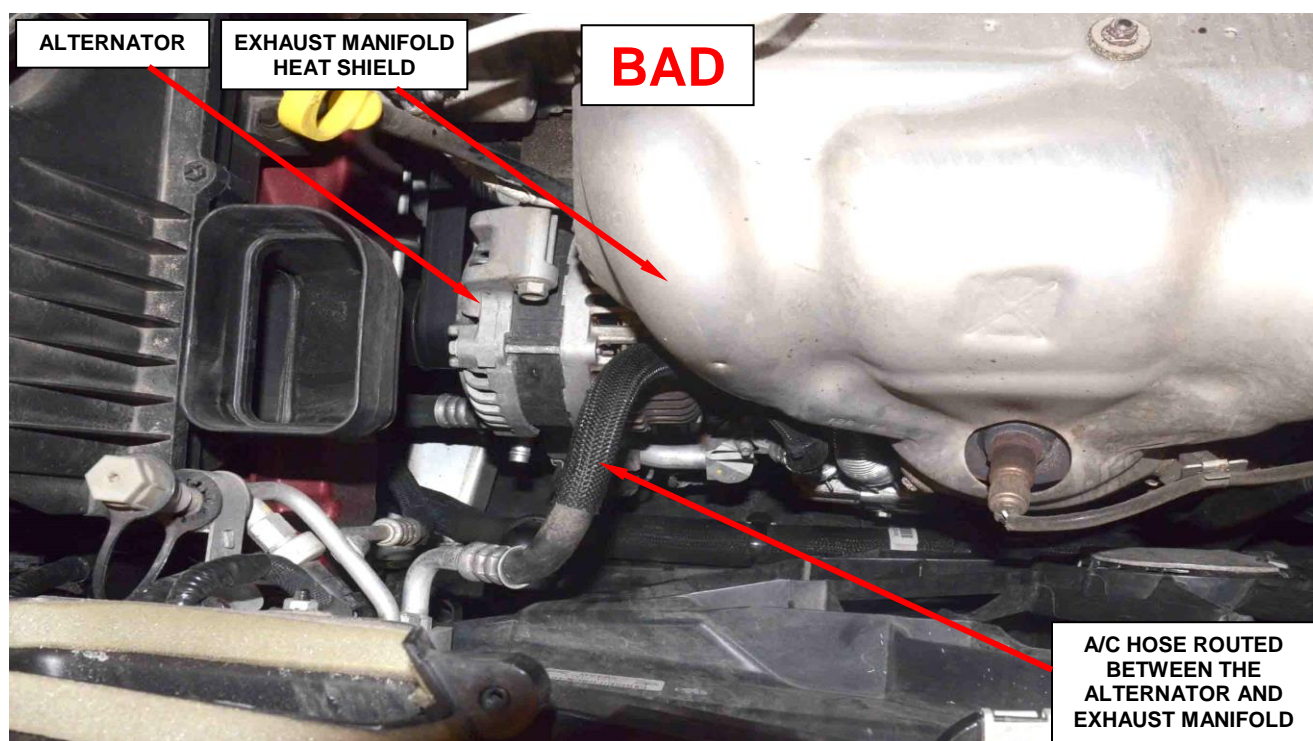
**Figure 3 – Incorrectly Routed A/C Hose**

The Air Conditioning (A/C) hose on about 75,500 of the above vehicles may have been misrouted during the manufacturing process. The A/C hose may come in contact with the engine exhaust manifold. Prolonged A/C hose contact with the engine exhaust manifold may result in a leak of the A/C refrigerant and/or A/C refrigerant oil. A/C refrigerant oil on a hot exhaust manifold could result in underhood smoke and/or an engine compartment fire.

The A/C hose routing must be inspected. Vehicles found with a misrouted A/C hose will have the hose replaced.

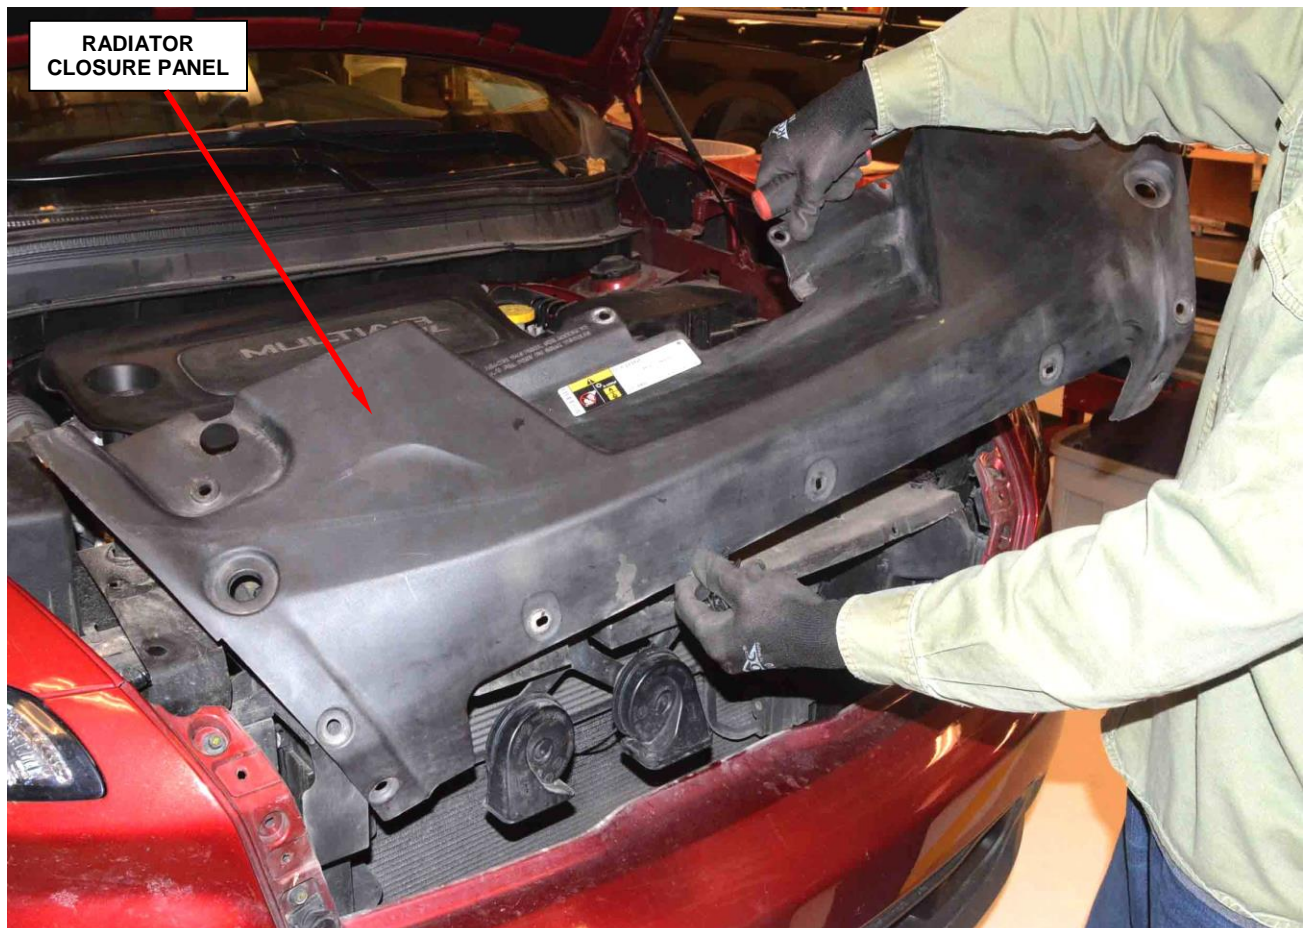
**Figure 4 – Radiator Closure Panel**

2. Remove and save the radiator closure plastic panel (Figure 4).

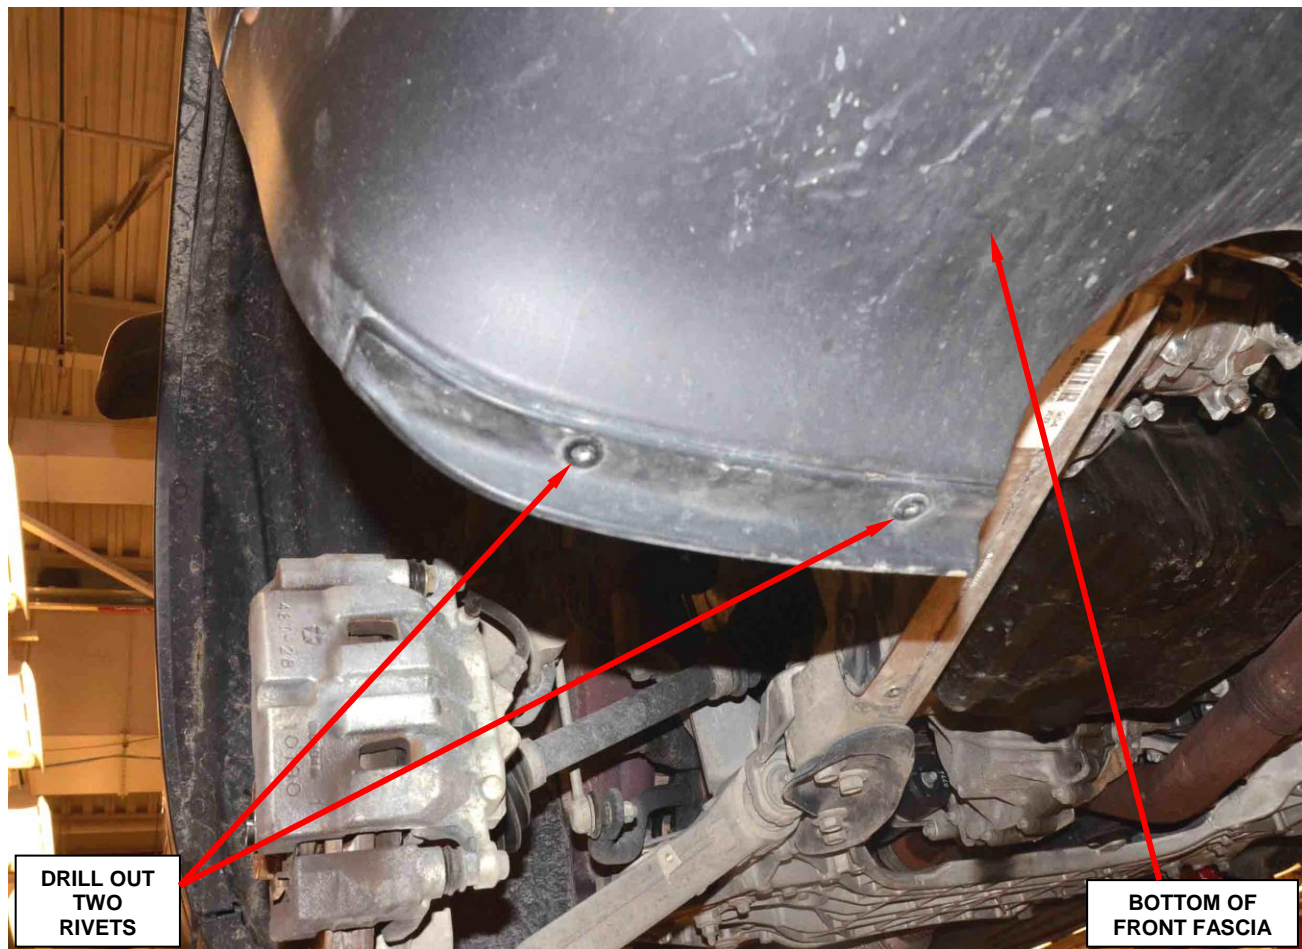
**Figure 5 – Drill Out Rivets on Right and Left Side  
(right side shown)**

3. Use the following procedure to remove the front fascia:
  - a. Raise the vehicle on the hoist.
  - b. Remove and save the right front wheel/tire assembly.
  - c. Remove and save the underbody splash shield.
  - d. Drill out the two outer rivets on the right and left side of the lower fascia (Figure 5).
  - e. Partially lower the vehicle from the hoist.

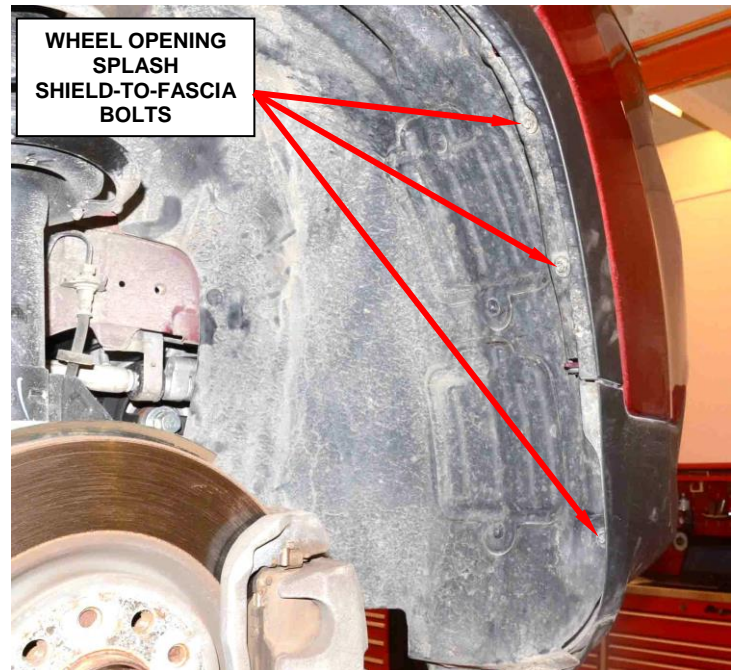
**Figure 6 – Wheel Opening Splash Shield-to-Fascia Bolts**

f. Remove and save the three right and left side wheel opening splash shield-to-fascia bolts (Figure 6).

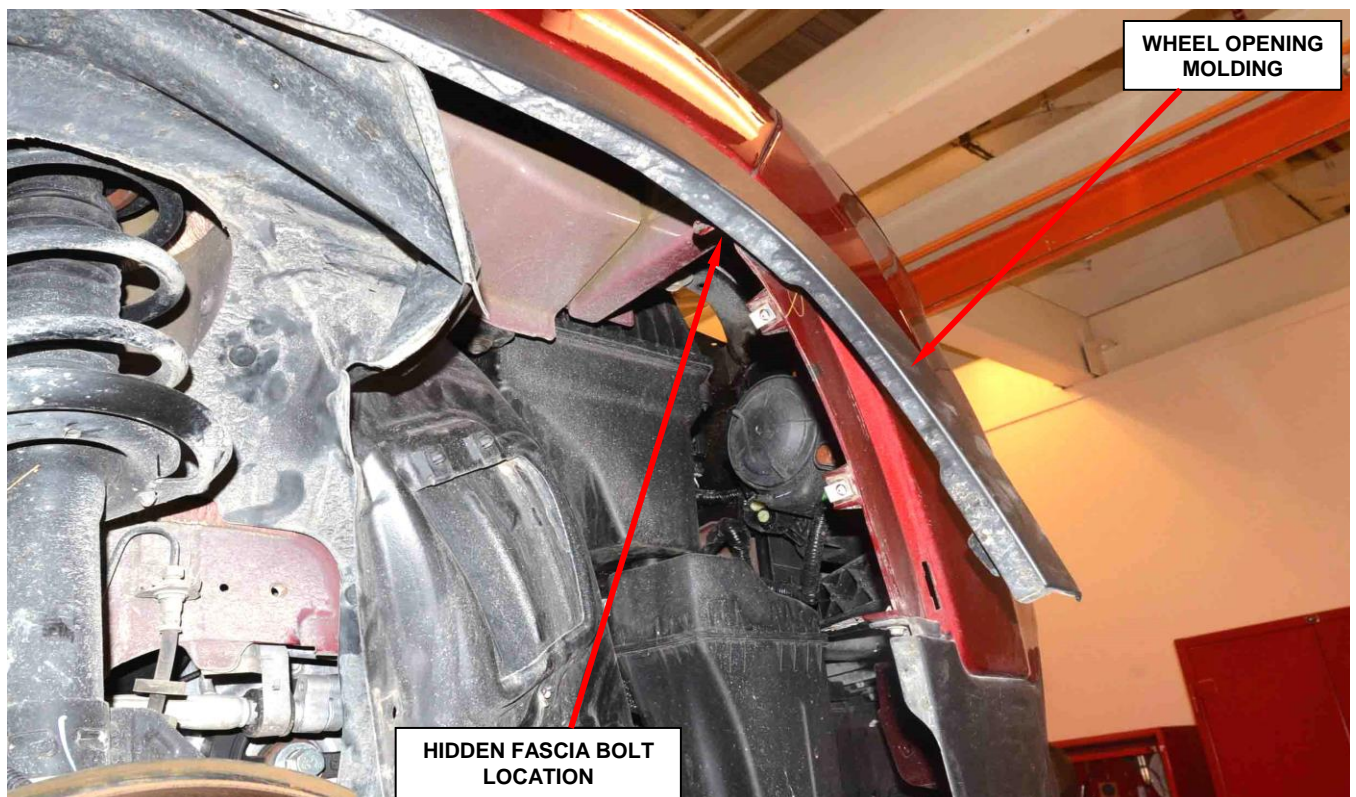
**Figure 7 – Hidden Fascia Bolt (right side shown)**

g. Remove and save the right and left side fascia bolts located behind the wheel opening splash shield (Figure 7).

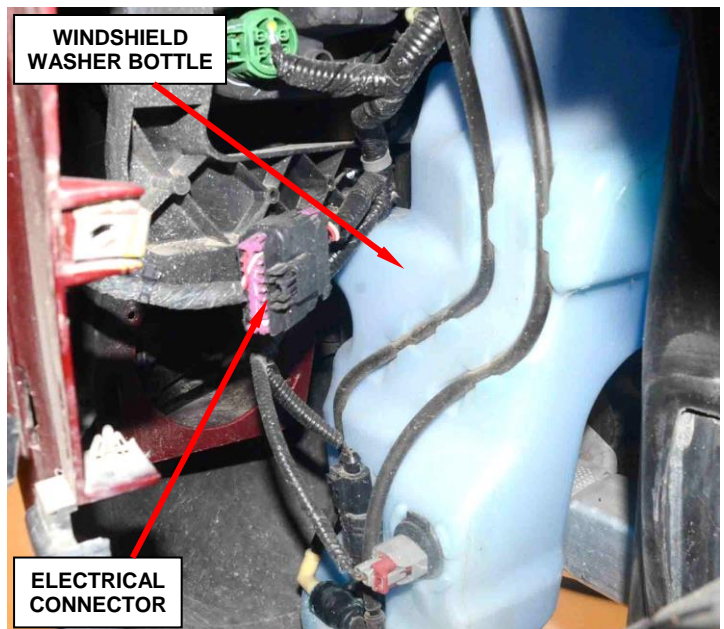
**Figure 8 – Electrical Connector Behind Left Wheel Opening Splash Shield**

- h. Disconnect the electrical connector located behind the left wheel opening splash shield (Figure 8).
- i. Lower the vehicle from the hoist.
- j. Partially unsnap the right and left side wheel opening molding (Figure 9).

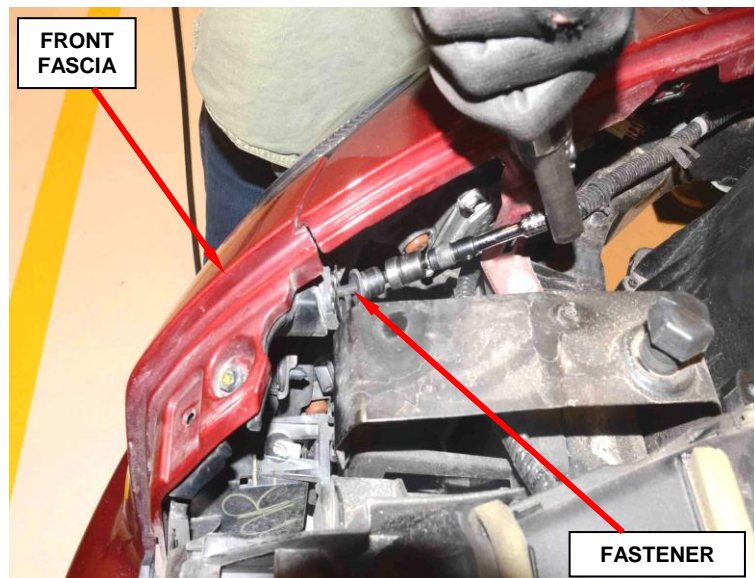
**Figure 10 – Three Right and Left Side Upper Fascia Retaining Bolts**

k. Remove and save the three right and left side upper fascia retaining bolts (Figure 10).

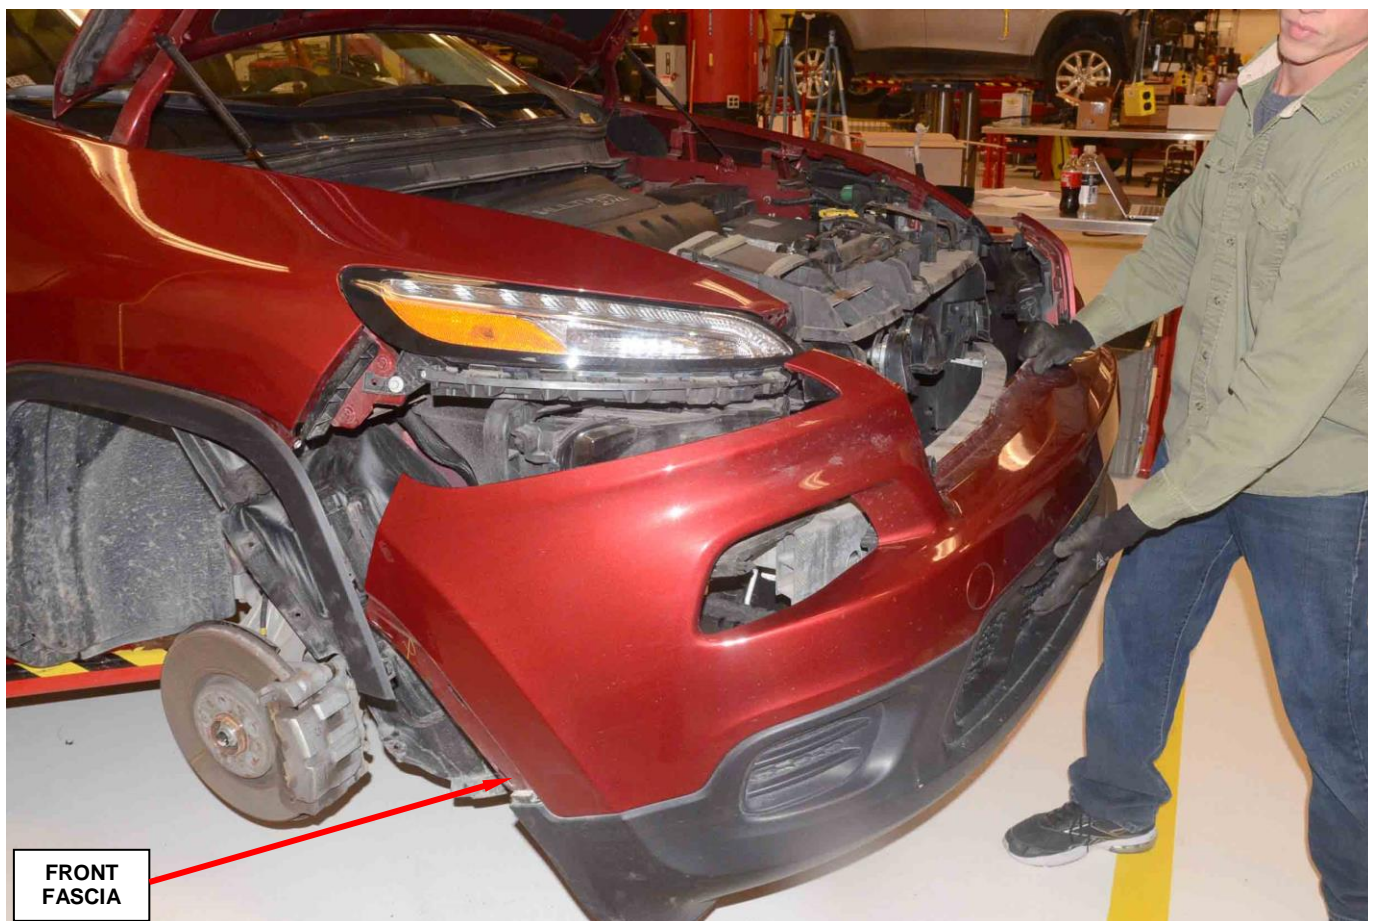
**Figure 11 - Remove Front Fascia Assembly**

l. Carefully unsnap the front fascia and remove the fascia from the vehicle (Figure 11).

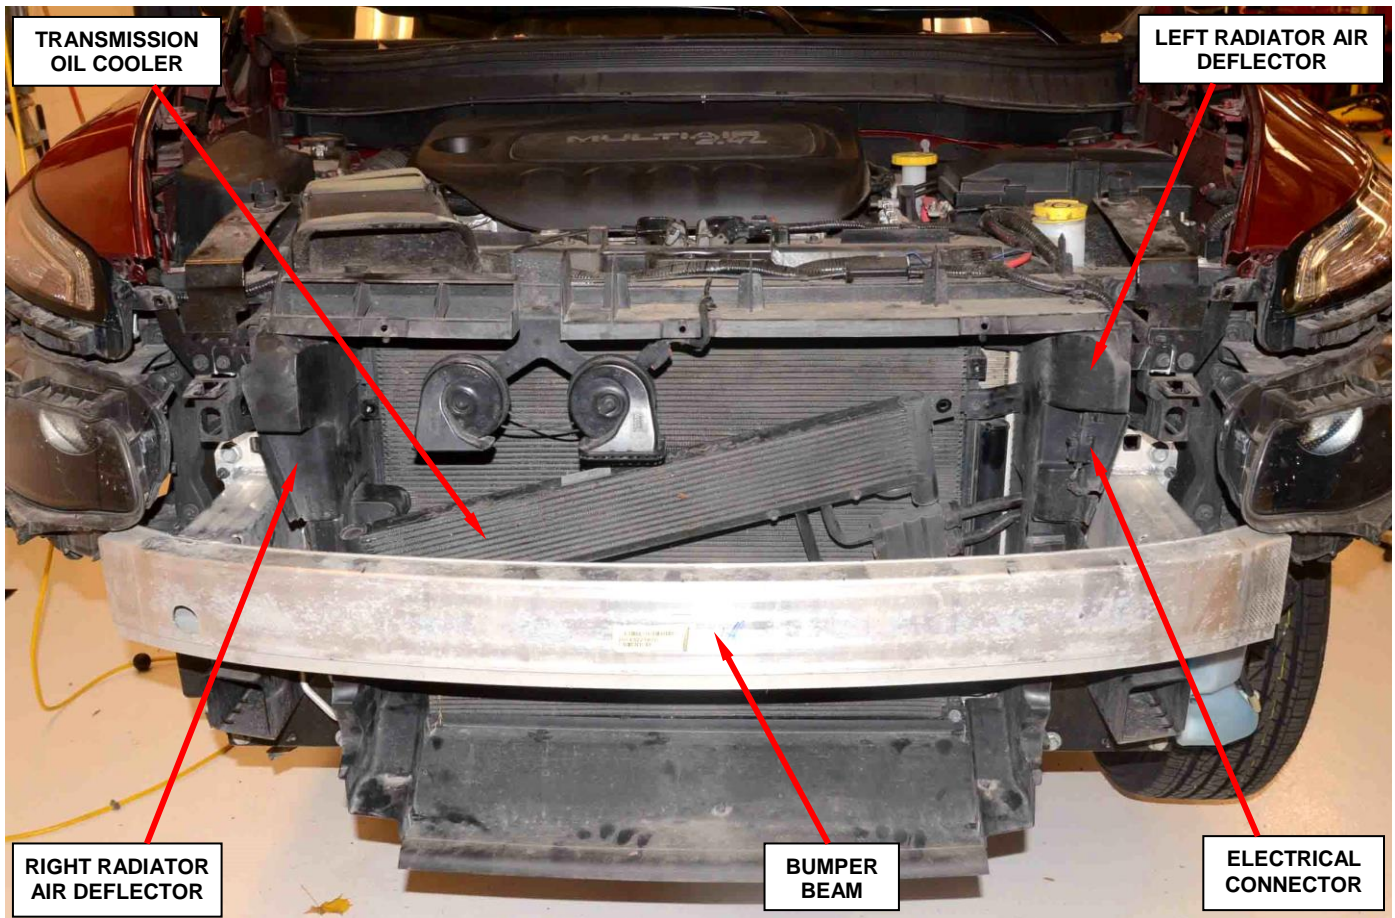
**Figure 12 – Transmission Oil Cooler and Bumper Beam**

3. Remove and save the transmission oil cooler and oil cooler tube bracket. Then carefully set the cooler aside (Figure 12).

4. Remove and save the aluminum bumper beam (Figure 12).
5. Disconnect the electrical connector at the left side radiator air deflector (Figure 12).
6. Remove and save the left and right radiator air deflector (Figure 12).
7. Remove and save remove the nut and the A/C discharge/liquid line manifold from the A/C condenser.
8. Remove and save the four A/C condenser mounting bolts.

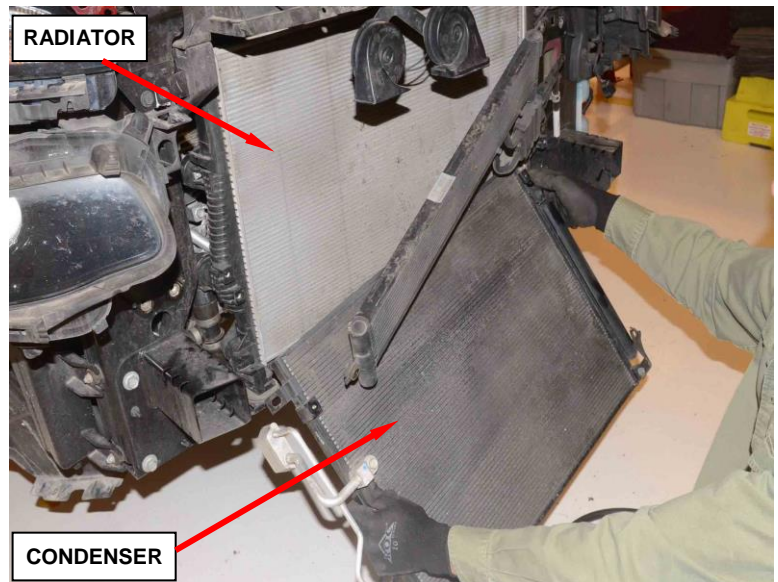
**Figure 13 – Remove Condenser**

9. Carefully remove the original A/C condenser (Figure 13).
10. Transfer the refrigerant jumper tubes from the original A/C condenser to the new A/C condenser (Figure 14). Tighten the jumper tube retaining bolts to 15 ft. lbs. (20 N·m).

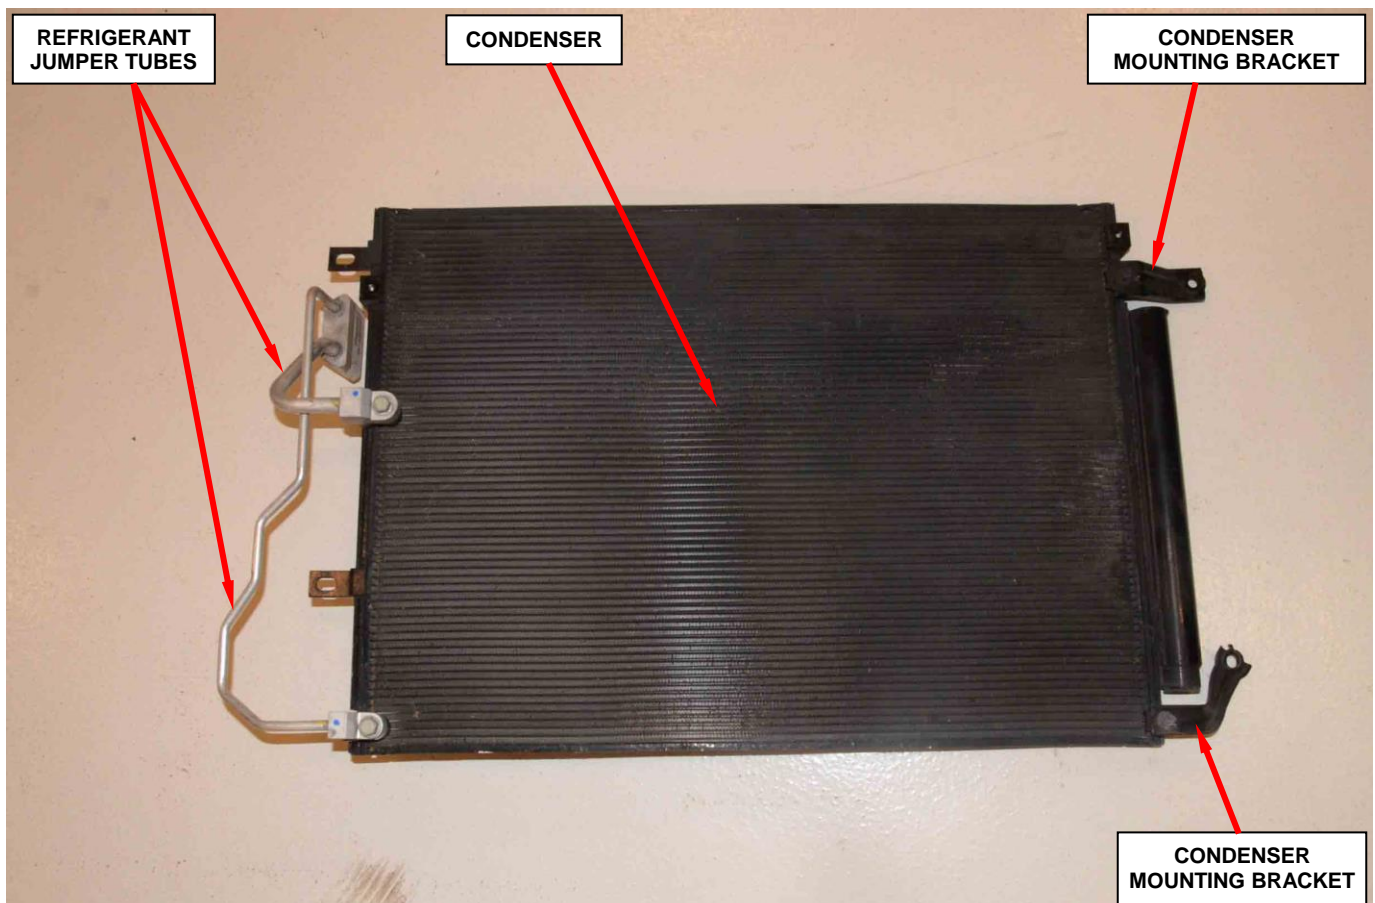
**Figure 14 – Transfer Refrigerant Jumper Tubes and Mounting Brackets**

11. Transfer the condenser mounting brackets from the original A/C condenser onto the new A/C condenser (Figure 14).

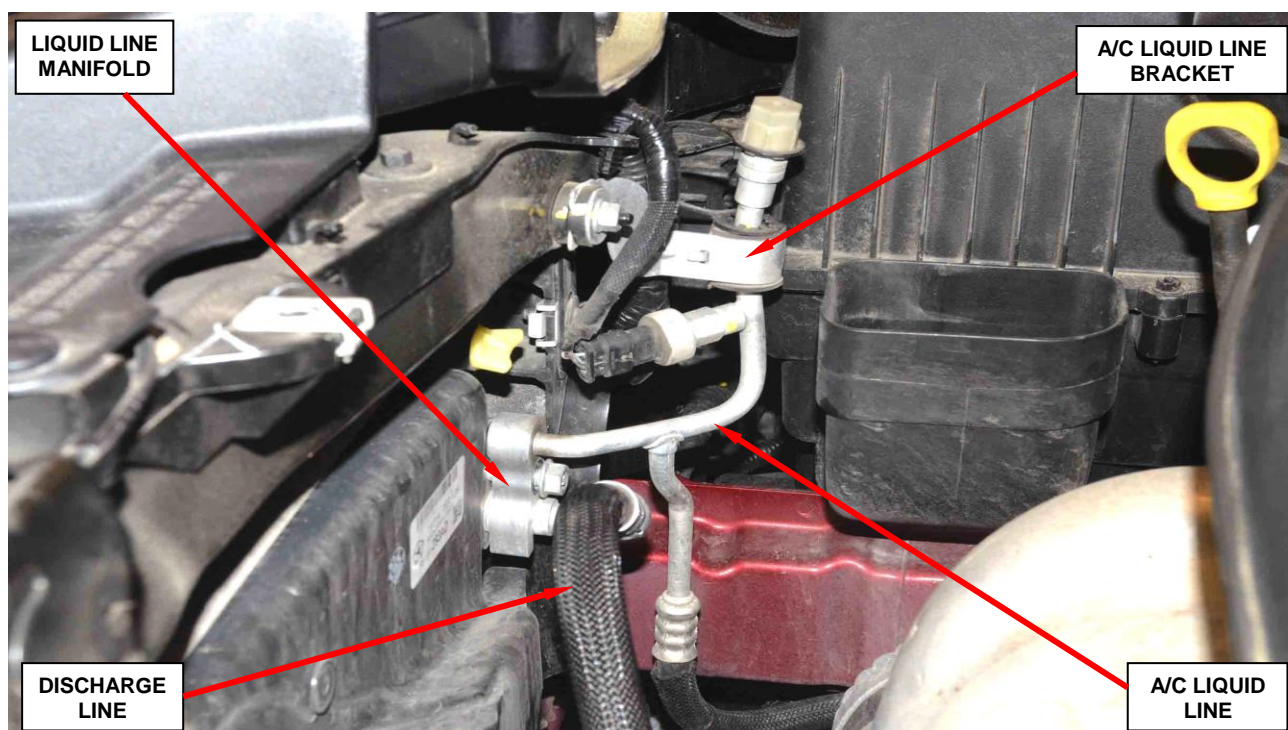
**Figure 15 – Refrigerant Lines at Condenser**

2. **For vehicles that did not have the condenser replaced**, use an appropriate air conditioning refrigerant recovery machine to recover the refrigerant from the air conditioning system.
3. **For vehicles that did not have the condenser replaced**, disconnect the A/C liquid line bracket (Figure 15).
4. **For vehicles that did not have the condenser replaced**, remove the nut and the A/C discharge/liquid line manifold from the A/C condenser (Figure 15).
5. Separate the discharge line from liquid line manifold (Figure 15).

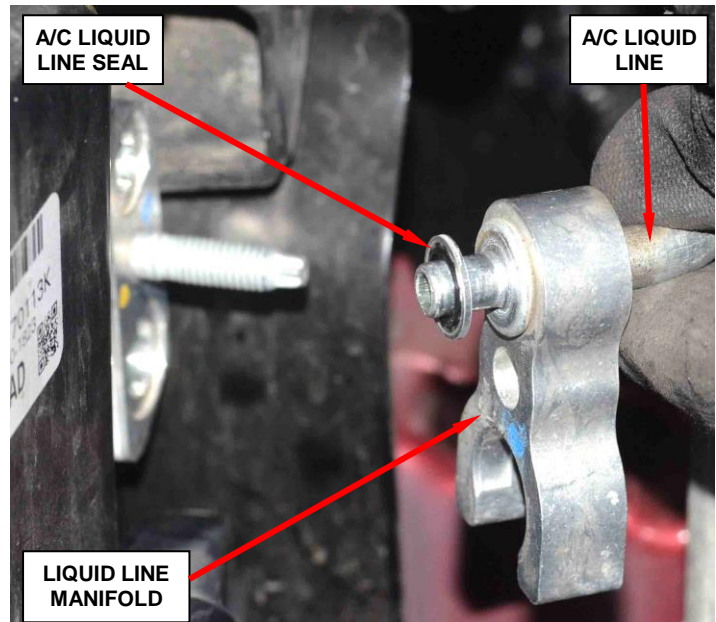
**Figure 16 – Condenser Liquid Line Seal**

6. Replace the seal on the A/C liquid line (Figure 16).
7. Remove and save the nut on the A/C suction/discharge manifold to the A/C compressor (Figure 17).
8. Install masking tape over the open refrigerant line fittings and the condenser and discharge tube ports.
9. Lift the vehicle on an appropriate hoist.
10. **For vehicles that did not have the condenser replaced**, remove and save the right front tire.

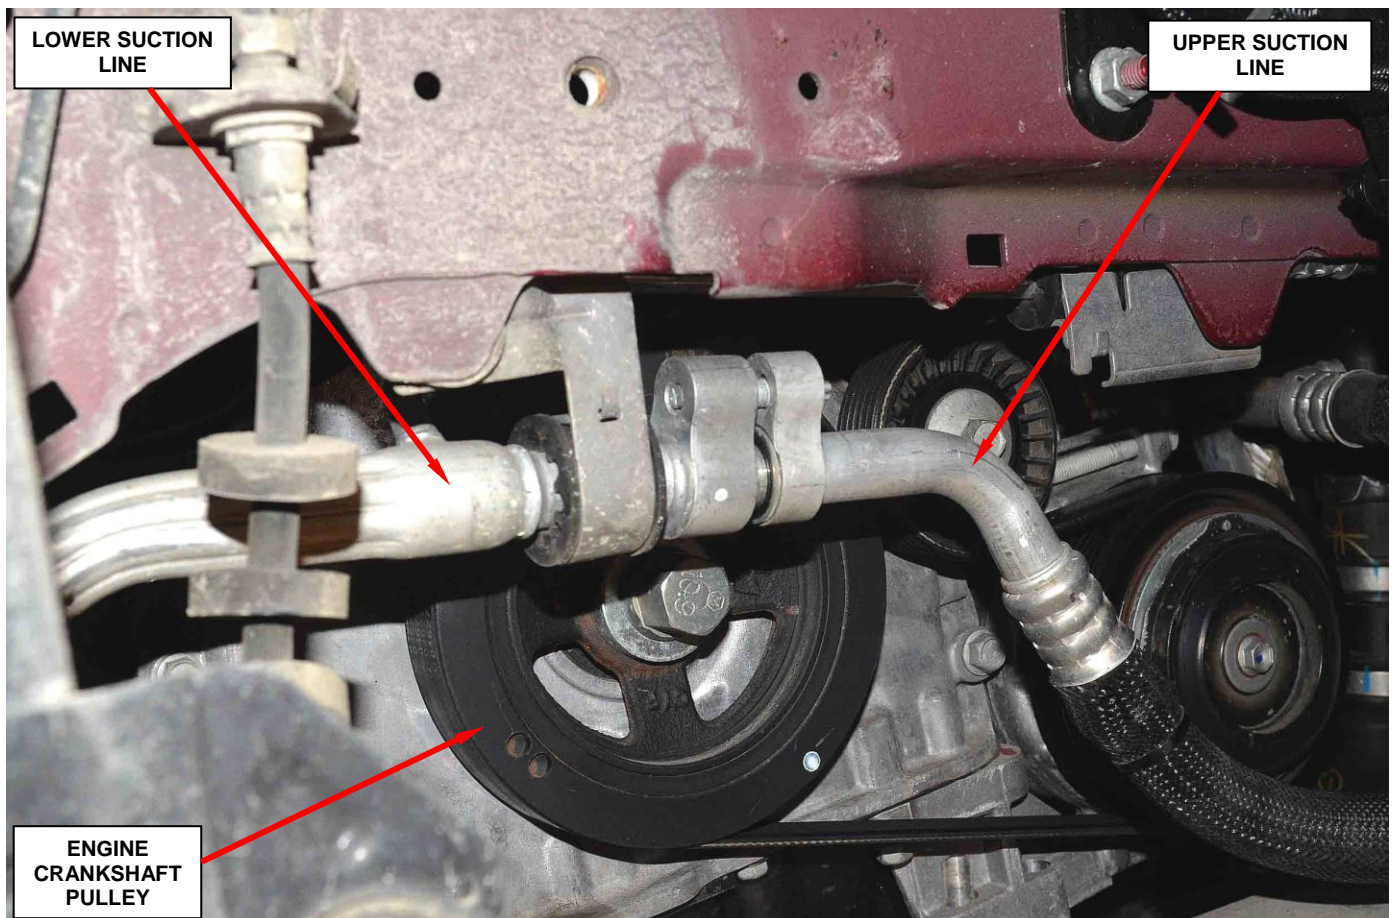
**Figure 18 – Disconnect the Lower Suction Line from Upper Suction Line**

11. **For vehicles that did not have the condenser replaced**, partially remove the right front wheel opening plastic liner to gain access to lower A/C suction line fitting (Figure 18).
12. Disconnect the lower A/C suction line from the upper A/C suction line (Figure 18).
13. Remove and discard the original A/C line.
14. Place the new A/C line into position.
15. Connect the lower A/C line to the new upper A/C suction line. Tighten the retaining nut to 15 ft. lbs. (20 N·m) (Figure 18).
16. Install the right plastic wheel liner.

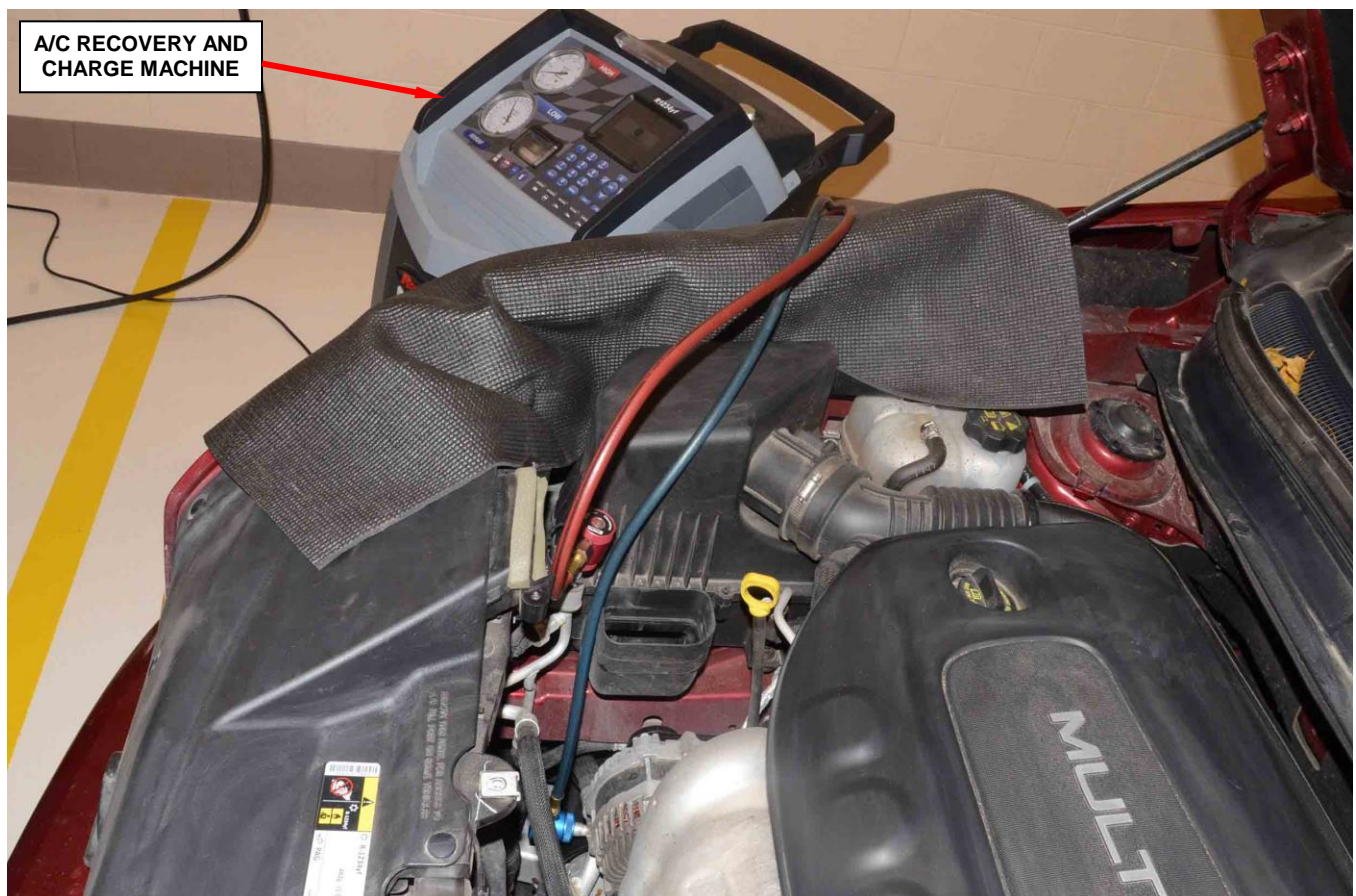
**Figure 19 – Typical A/C Recovery and Charge Machine**

27. Using an appropriate air conditioning refrigerant recovery machine, evacuate the refrigerant system (Figure 19).

28. Using an appropriate air conditioning refrigerant recovery machine, charge the A/C system with the proper refrigerant (Figure 19).
