TECHNICAL INSTRUCTIONS
FOR
SAFETY RECALL F2E (FLE)
PRE-COLLISION SYSTEM DISABLEMENT (INTERIM)
CERTAIN 2013 –2015 MODEL YEAR ES350 and ES300H

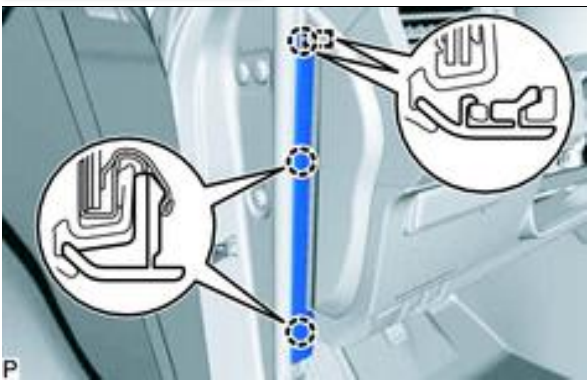
4. REMOVE THE FRONT DOOR OPENING TRIM COVER

Disengage the 3 claws as shown.

Note: Driver's side shown for reference to show where claws are located.

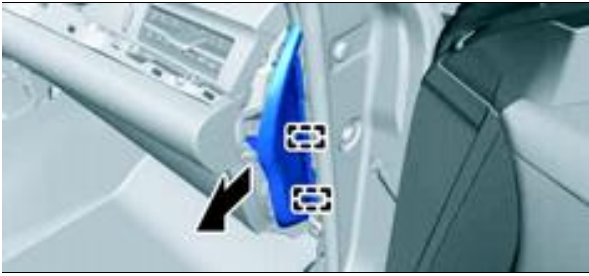
b) Disengage the 2 guides and remove the panel as shown.

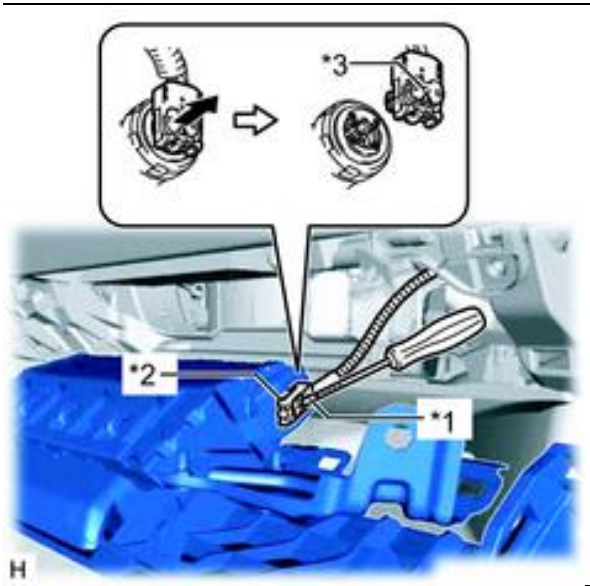
c) Using a taped screwdriver carefully release the airbag connector lock.

d) Disconnect the connector and remove the airbag.

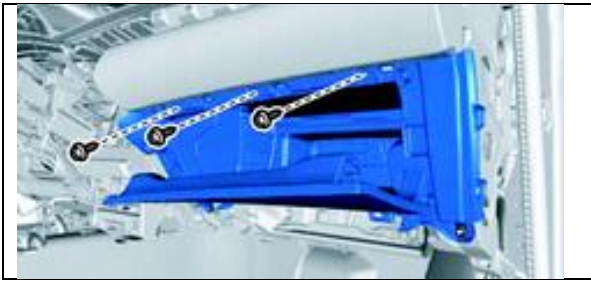
c) Remove the 3 screws.

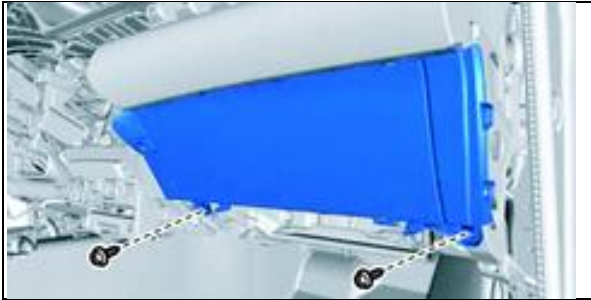
d) Close the glove box door to access and remove the 2 lower screws.

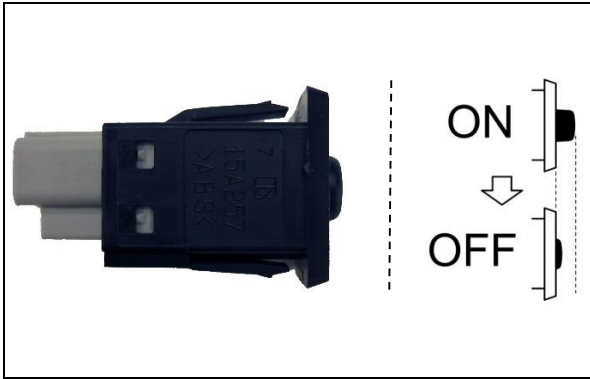
2. DISABLE THE PCS SYSTEM

- a) Reconnect the PCS switch to the harness.
- b) Confirm that the PCS Switch is in the "Off" position as shown.

NOTE: The button will protrude approximately:

OFF = 2mm

ON = 5 mm

While relocating the switch, ensure the switch remains in the "Off" position.

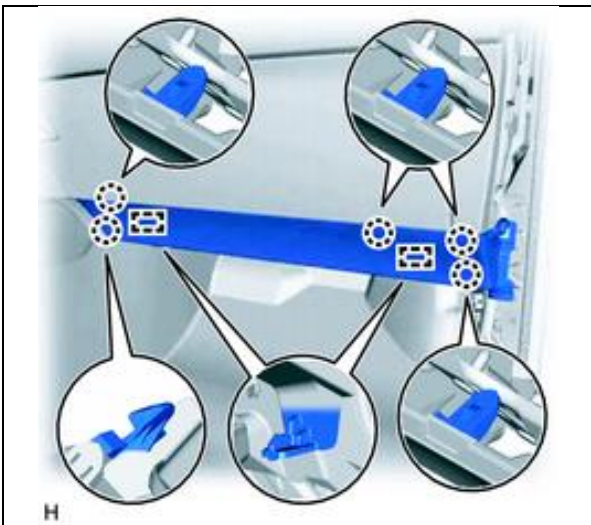
- b) Engage the 2 guides and 5 claws.

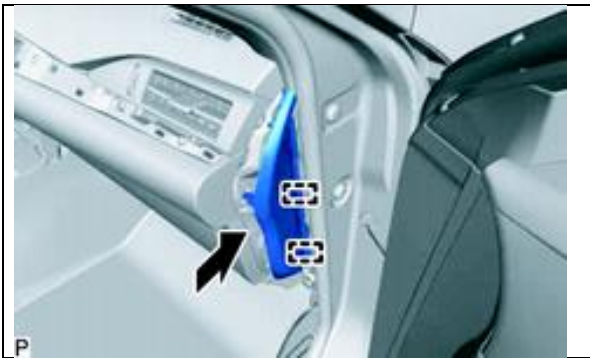
5. REINSTALL INSTRUMENT SIDE PANEL

- a) Engage the 2 guides as shown.

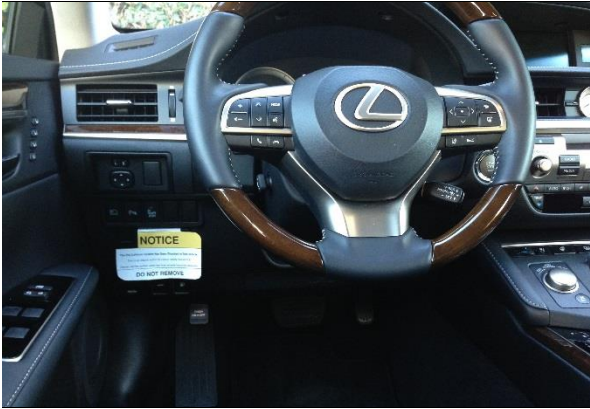
11. INSTALL THE WARNING TAG

- Install the notice tag on the driver's side storage tray.

Note: Early production notice tags will require you to cut out the upper left corner of the tag so that the customer will be able to access tray release button.
