**TECHNICAL INSTRUCTIONS**  
**FOR**  
**SAFETY RECALL F1V (F0V)**  
**PRE-COLLISION SYSTEM DISABLEMENT (INTERIM)**  
**CERTAIN 2013 –2015 MODEL YEAR AVALON**

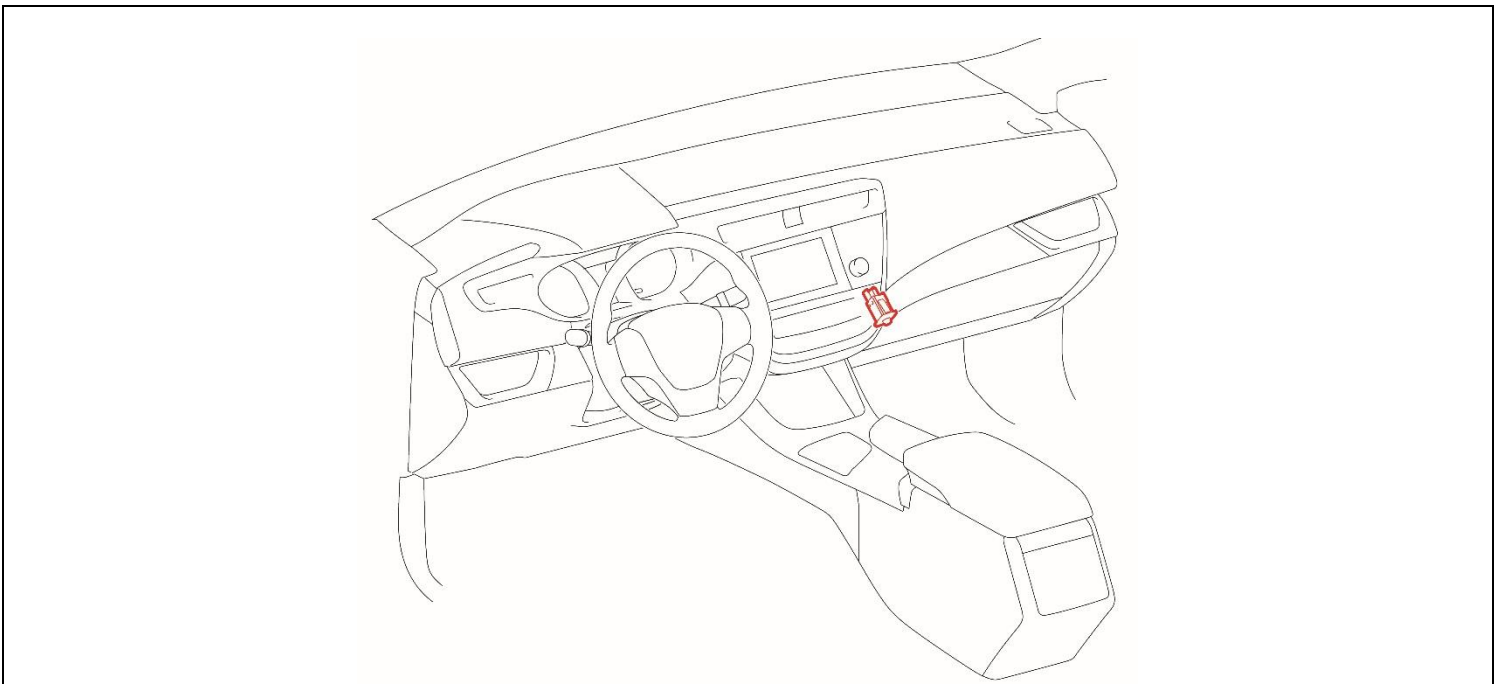
In certain driving situations, the optional Pre-Collision System (PCS), on the involved vehicles could interpret a steel road joint or steel plate in the road surface as an obstacle or vehicle in the path of travel and activate. When the system activates, the vehicle's brakes are applied automatically, the system activates Brake Assist mode, and the front seat belts may tighten. The driver will hear a warning buzzer, the PCS indicator lamp will illuminate, and a message will appear on the multi-information display.

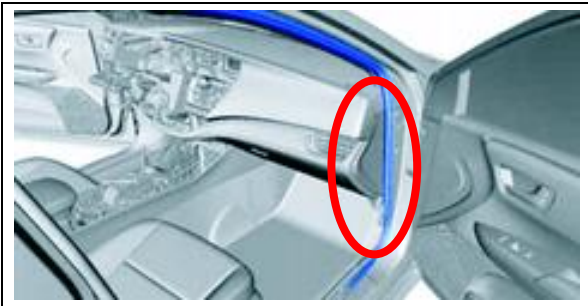
3. REMOVE THE FRONT PASSENGER DOOR SCUFF PLATE AND COWL SIDE TRIM PANEL

Note: Driver's side door scuff plate & cowl trim panel is shown for retention clip/claw locations.

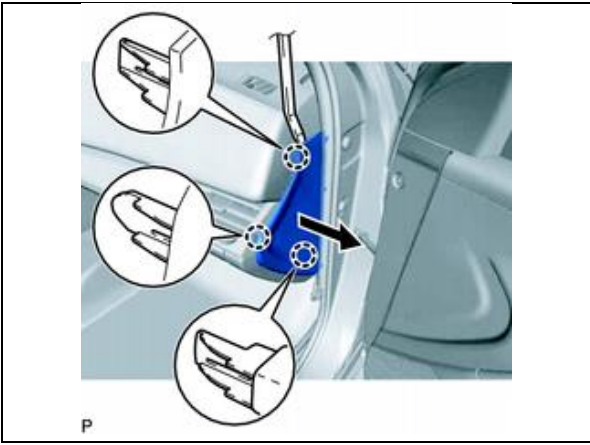
6. REMOVE INSTRUMENT SIDE PANEL

- a) Using a plastic molding remover, disengage the 3 claws.

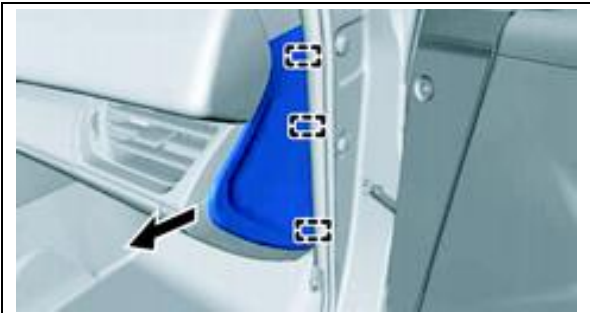
- b) Disengage the 3 guides and remove the panel as shown.

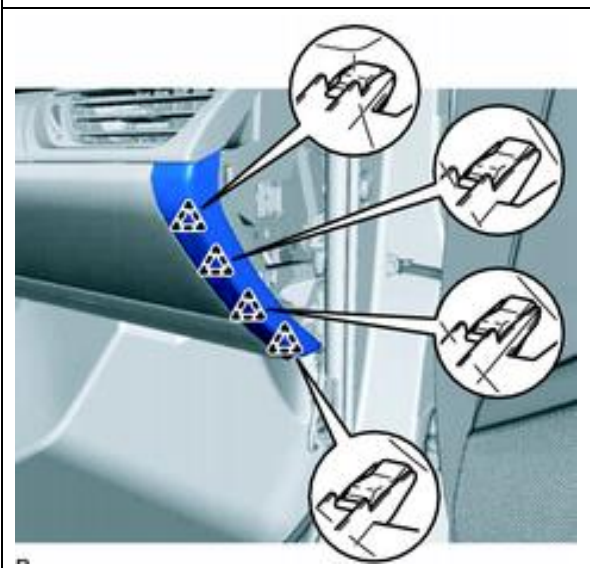
### 7. REMOVE GLOVE COMPARTMENT PLATE

- a) Disengage the 4 clips and remove the glove compartment plate.

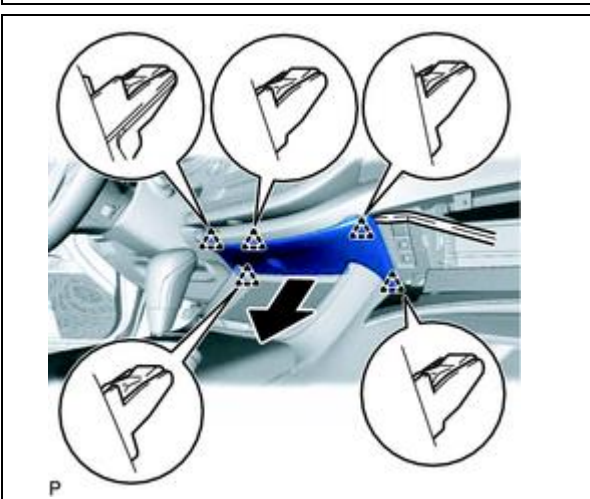
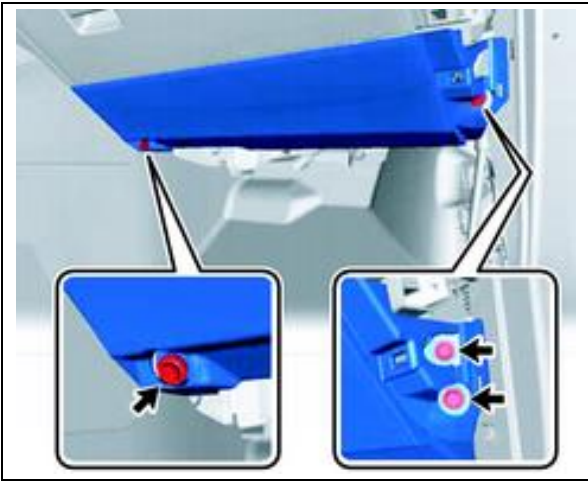
### 8. REMOVE LOWER CENTER INSTRUMENT PANEL FINISH PANEL

- a) Using a molding remover, disengage the 5 clips as shown in the illustration.
- b) Disconnect the connector and remove the lower center instrument panel finish panel.

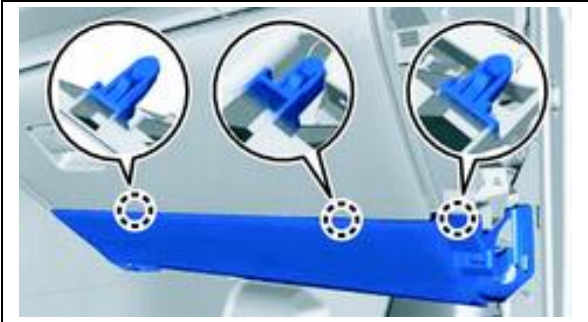
## 9. REMOVE PASSENGER KNEE AIRBAG

a) Remove the 3 bolts.

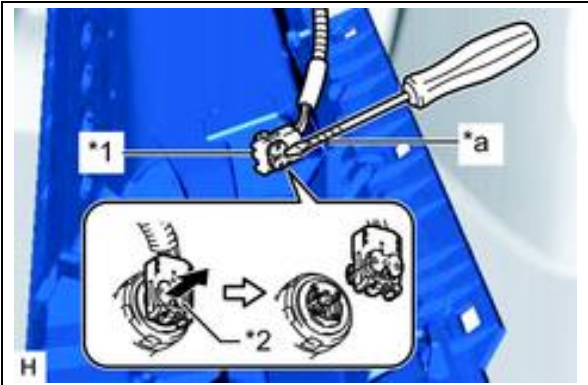
b) Disengage the 3 claws and separate the airbag from the instrument panel.

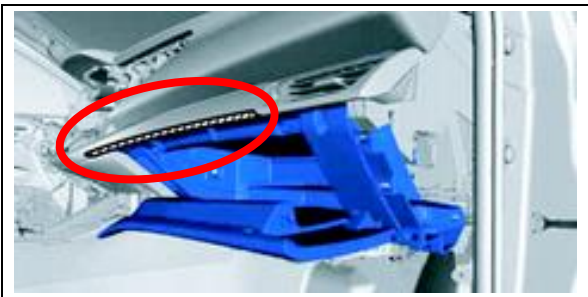
c) Using a taped screwdriver carefully release the airbag connector lock.

d) Disconnect the connector and remove the airbag.

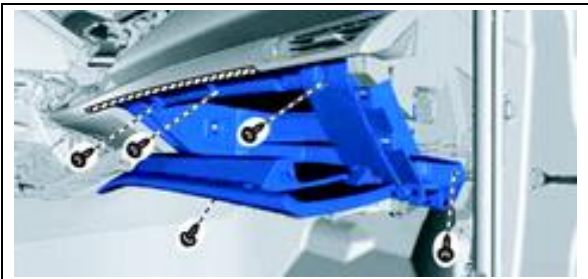
## 10. REMOVE GLOVE BOX

a) Apply protective tape to the instrument panel as shown to ensure the leather is not damaged during removal.

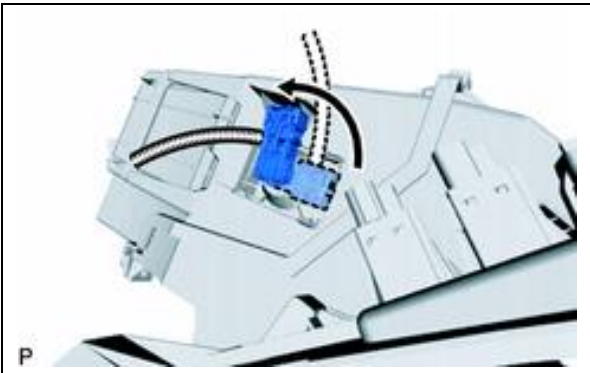
d) Remove the electrical connectors

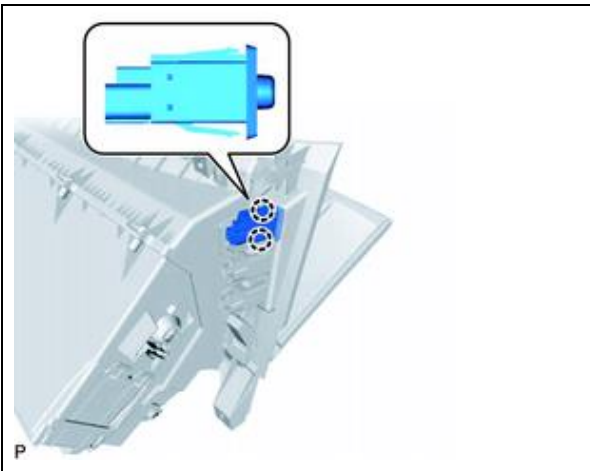
e) Remove the glove box light.

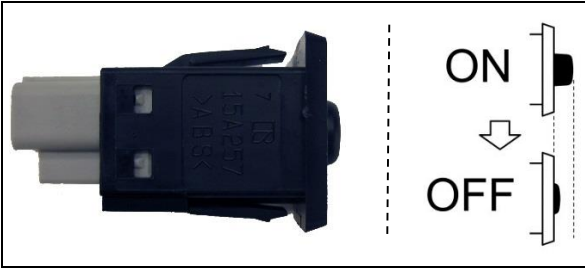
**11. REMOVE THE PCS SWITCH FROM THE GLOVE BOX ASSEMBLY**

- a) Confirm the PCS Switch to the “Off” position as shown.

**While relocating the switch always use caution to ensure the switch remains in the “Off” position.**

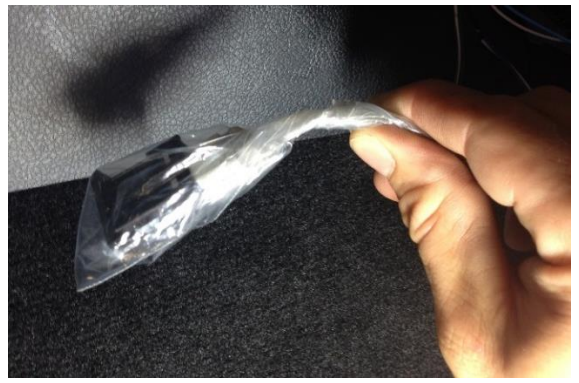
- a) Reconnect the PCS switch connector.
- b) Using the plastic bag that the glove box plastic cap is provided in, cover the PCS switch and wire harness as shown:

**Note: The plastic bag is required to protect the switch from tape adhesive when securing it to the wire harness.**

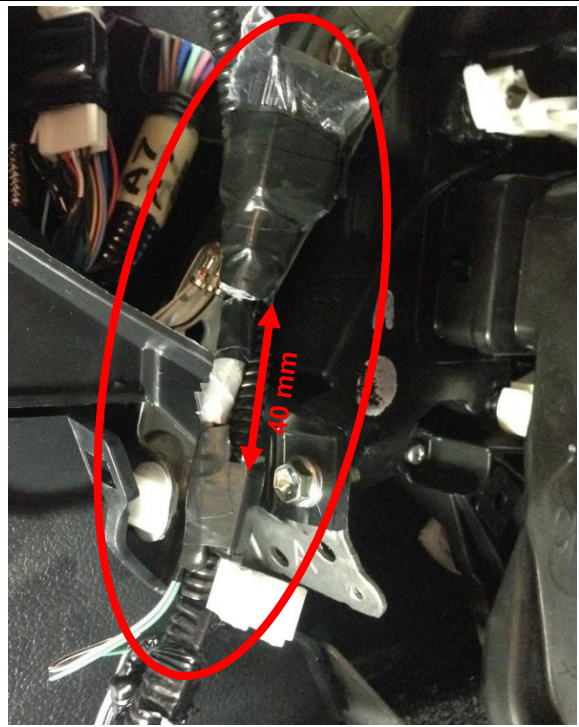
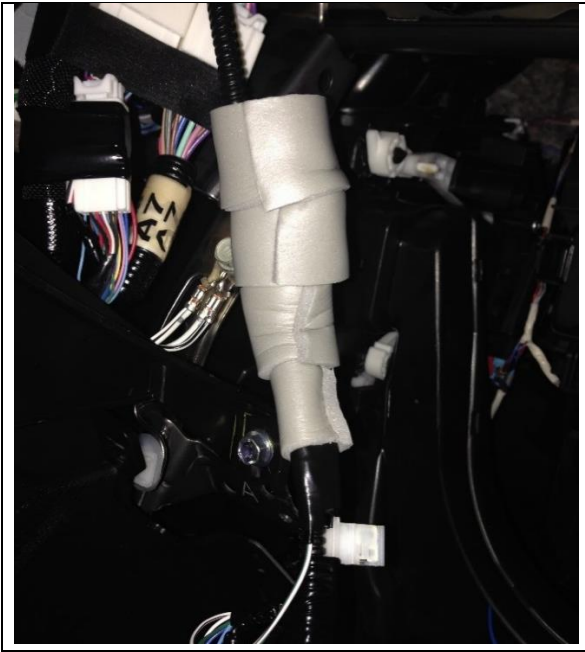
- c) Using electrical tape secure the PCS switch and plastic bag to the glove box wire harness as shown.
- d) The PCS switch should be attached approximately 40 mm above the white alligator clip housing as shown.

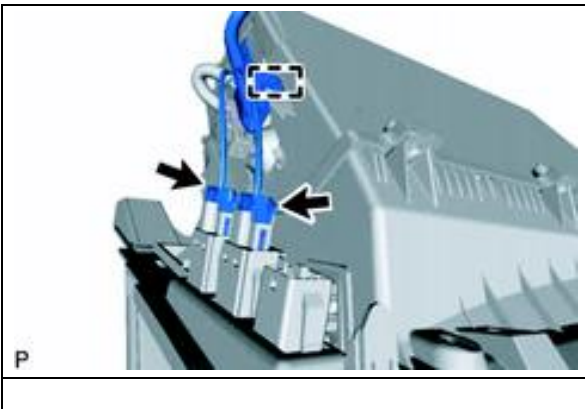
- a) Install the glove box light as shown.

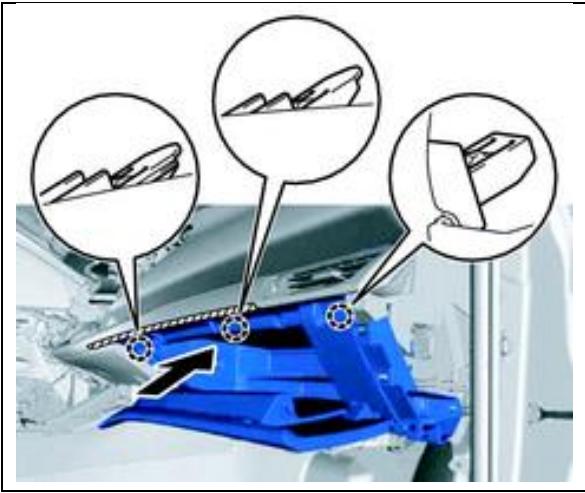
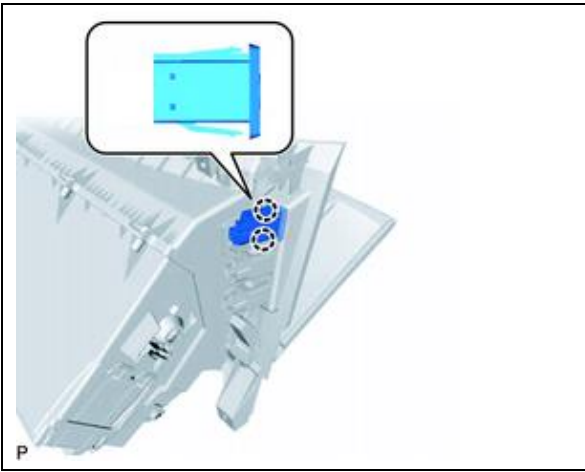
- b) Install the connectors as shown..

- c) Engage the 3 claws as shown.

d) Install the 5 screws as shown.

e) Install the switch blank where the PCS switch was previously installed and confirm both claws lock.

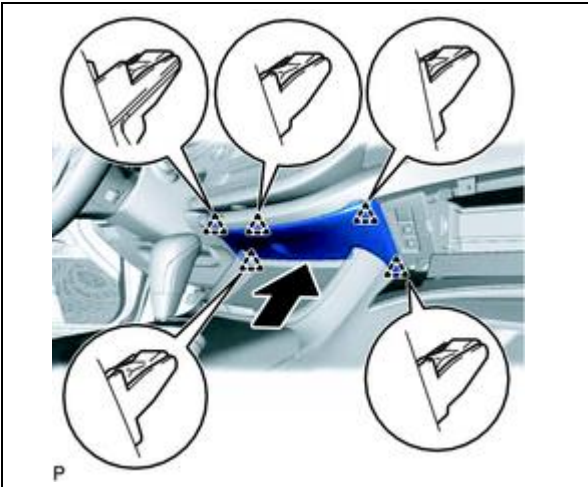
f) After installing the glove box ensure that the relocated PCS switch is still secured and that no wires are contacting the metal brackets located under the dash.

**Note: This picture was taken looking up from the passenger foot well.**

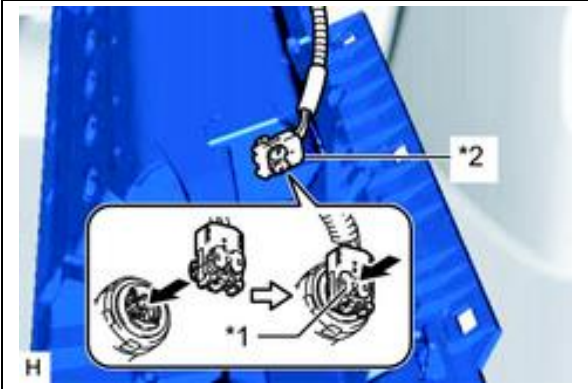
**2. REINSTALL LOWER CENTER INSTRUMENT PANEL FINISH PANEL**

- a) Connect connector.
- b) Engage the 5 clips as shown.

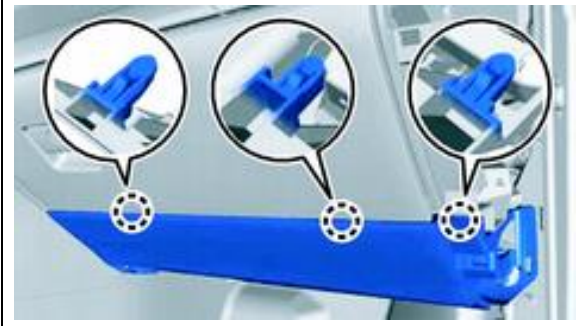
- a) Reinstall the knee airbag connector and lock the connector as shown.

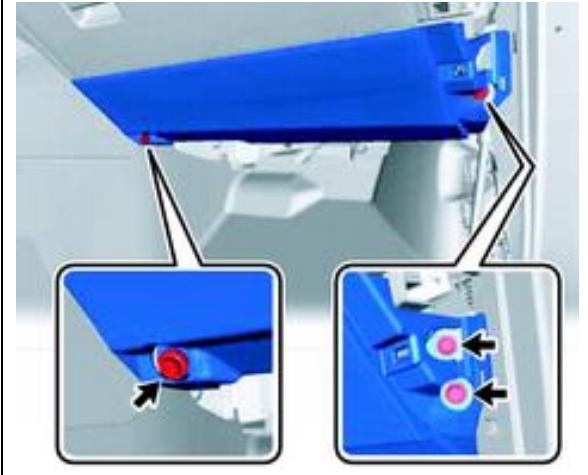
- b) Engage the 3 claws to temporarily install the knee airbag.

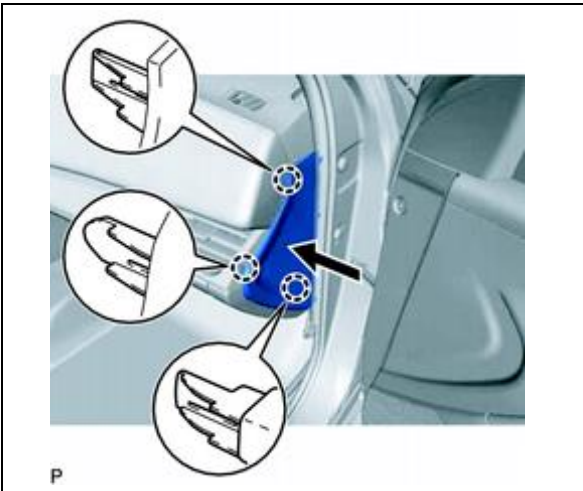
- a) Engage the 3 guides as shown.

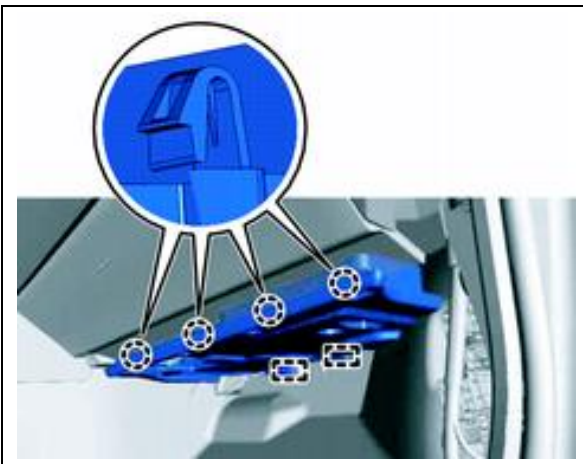
- b) Engage the 3 claws as shown.

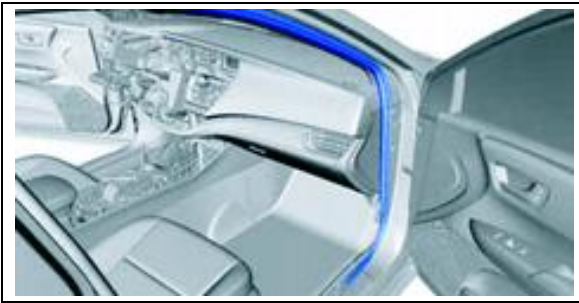
**6. REINSTALL THE NO. 2 INSTRUMENT PANEL UNDER COVER**

- a) Connect the connectors.
- b) Engage the 2 guides and 4 claws as shown.

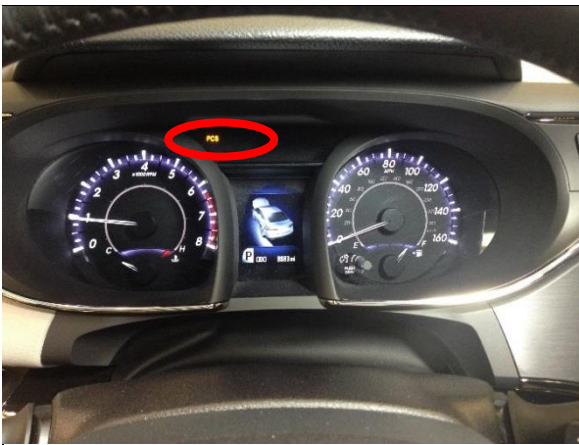
1. CONFIRM PCS LIGHT REMAINS ILLUMINATED AFTER BULB CHECK

If the PCS light does not remain this indicates that the switch did not remain in the “Off” position.

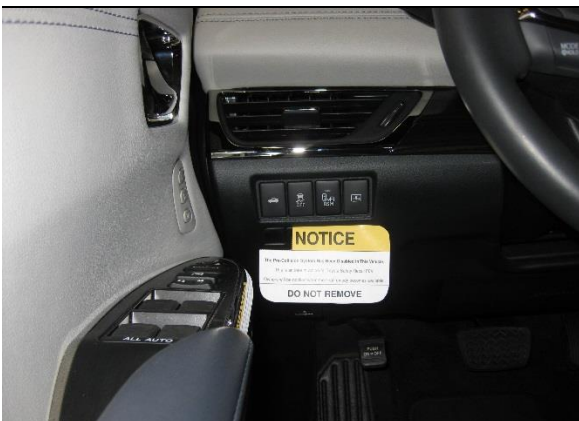
2. INSTALL THE NOTICE TAG

- a) Install the notice tag on the driver's side storage tray.

**Note:** Early production notice tags will require you to cut out the upper left corner of the tag so that the customer will be able to access tray release button.
