REFERENCE:	Nova Bus Manuals
SECTION:	17: Radio and accessories
RS N°:	MQR N/A
EFFECTIVE IN PROD.:	N/A
TC RECALL N°:	N/A
NHTSA RECALL N°:	15B-735

APPLICATION DEADLINE: N/A
REFERENCE NUMBER: SR-3493

SUBJECT:	Passenger counting sensor
JUSTIFICATION:	The passenger counting sensor may have a pinch point safety hazard which can result in injury.

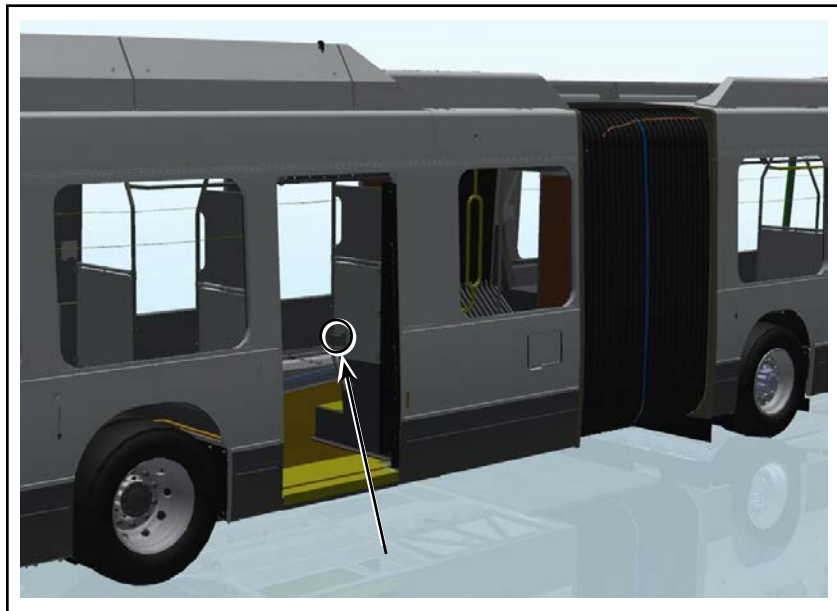
Figure 1 - Passenger Counting Sensor Location

- 1.1. Turn **OFF** the battery master disconnect switch in the vehicle's battery compartment.
- 1.2. Locate the passenger counting sensor on the partition of the rear passenger door. See Figure 1.

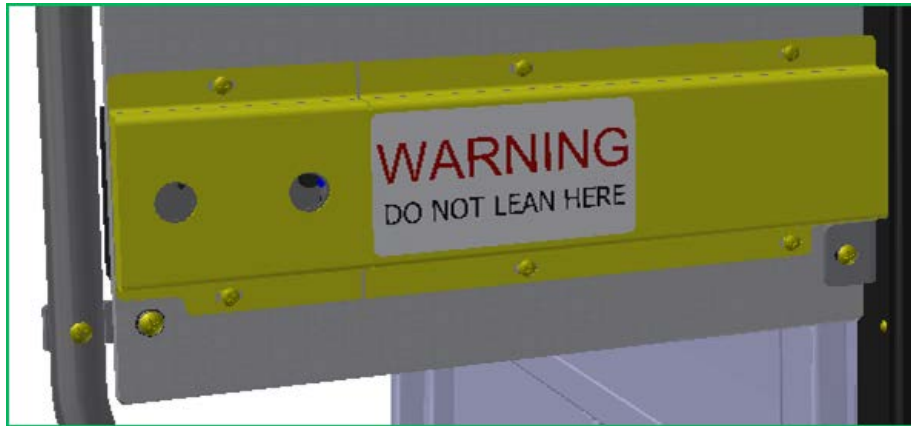
Figure 6 - Warning Decal Installation on N82084 (Partition Rear Side)

- 1.10. Clean the N81834 bracket installed on the rear side of the partition.
- 1.11. Apply the N82084 warning decal on the N81834 bracket installed on the rear side of the partition. See Figure 6.

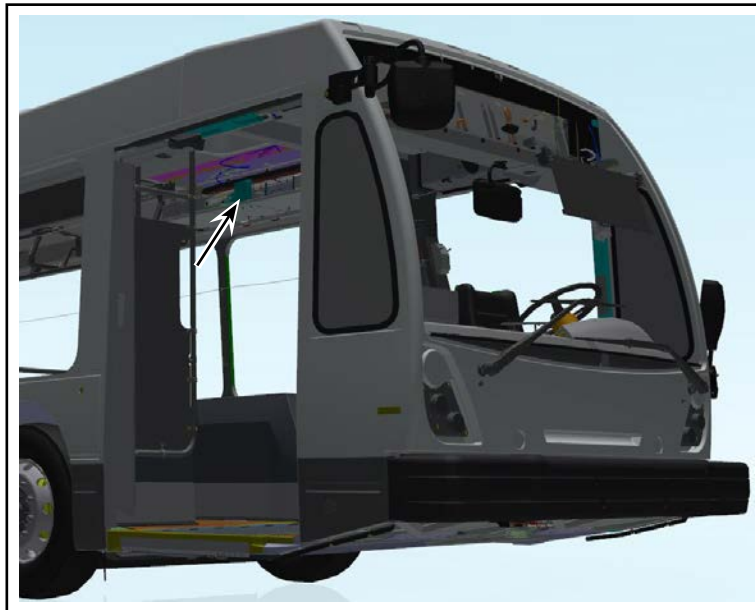
Figure 7 - Smart Sensor (CPU)/APC Analyzer Located in the ITS Tray

- 1.12. Turn **ON** the battery master disconnect switch in the battery compartment.
- 1.13. Open the ITS tray. See Figure 7.

- 1.14. Locate the smart sensor (CPU)/APC analyzer in the ITS tray. See Figure 7.
- 1.15. Verify for the proper operation of the passenger counting sensor.
- 1.16. Check that the **POWER LED** is **ON** and solid green through the translucent cover of the smart sensor (CPU)/APC analyzer. See Figure 8.
