Author: J. Juse L. Cervera	Field Modification Instruction Knuckle Link Arm Replacement	FMI 751-071 10/27/15 Rev: A
----------------------------------	---	--

Field Modification Instructions for Project:
 Knuckle Link Arm Inspection and Replacement
 For Recall Number 15E-068

Subject: Recall Number 15E-068 – Occurrence of Fatigue Cracks in certain S-Series Wheelchair Lifts

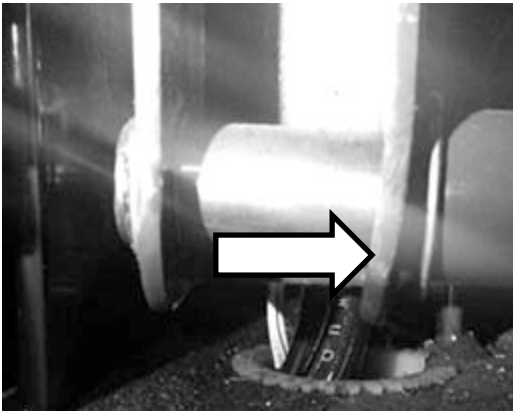
Figure 1A (Bent Knuckle Link Arm)

1. The Knuckle Link Arm is bent. Reference Figure 1A.
2. The DU bearings on the Knuckle Link arm have fallen out of the hole. Reference Figure 1B.

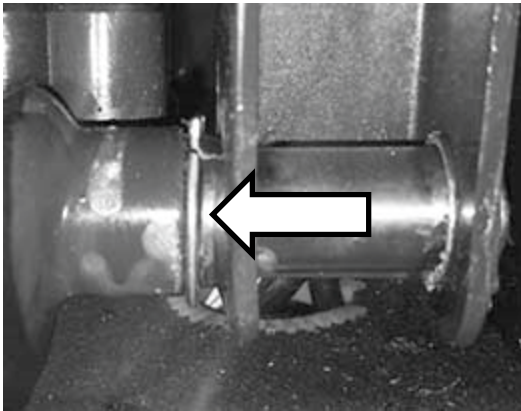
Figure 1B (DU Bearing Separation)

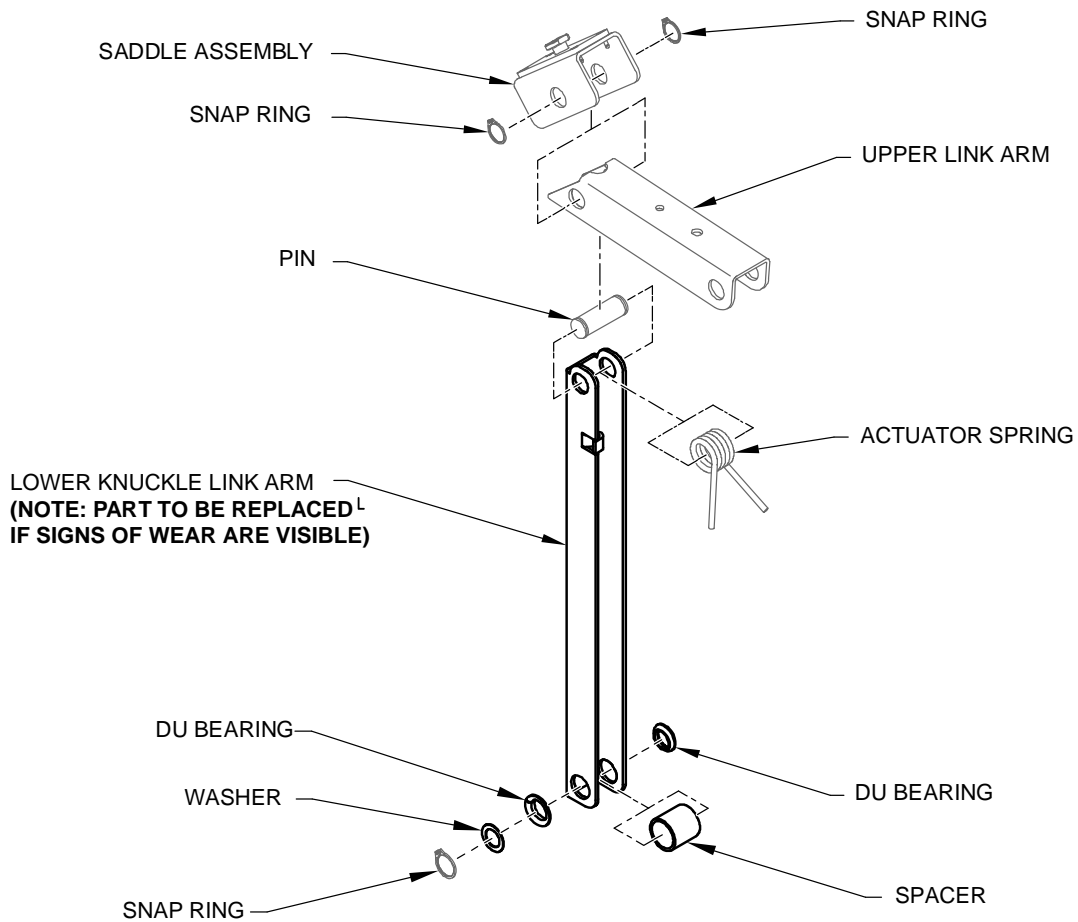
RSM0071600

Figure 2. Left Hand Knuckle Link Arm Assembly (Shown)

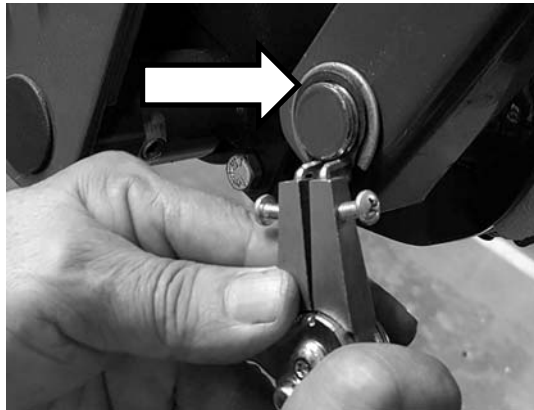
Figure 3. Lower Knuckle Link Arm Snap Ring, Bottom

1. Refer to **Figure 3**. Locate Lower Knuckle Link Arm Snap Ring, bottom then remove Snap Ring. Retain Snap Ring for re-installation.

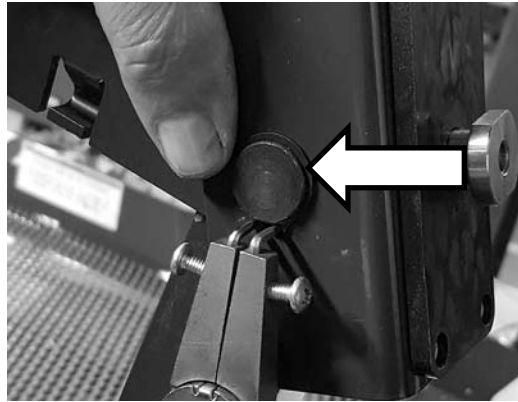
Figure 4. Lower Knuckle Link Arm Snap Ring, Top

2. Refer to **Figure 4**. Locate Upper/Lower Link Arm joint then remove Snap Ring. Retain Snap Ring for re-installation.

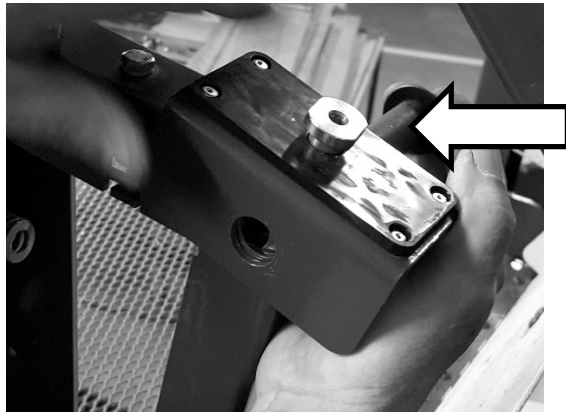
Figure 5. Saddle Pin

3. Refer to **Figure 5**. Remove pin from Link Arm/Saddle Assembly.

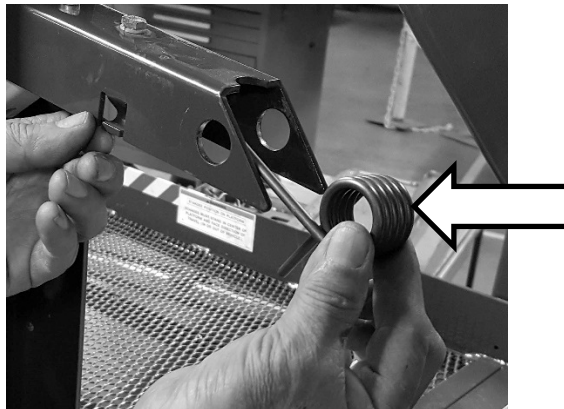
Figure 6. Actuator Spring

4. Refer to **Figure 6**. Remove and retain actuator spring for reuse.

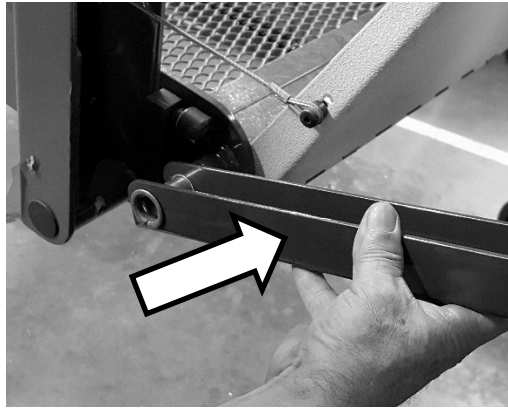
Figure 7. Lower Knuckle Link Arm

5. Remove Lower Knuckle Link Arm from platform pivot pin.

1. Refer to **Figure 7**. Slide lower portion of Knuckle Link Arm onto platform pivot.

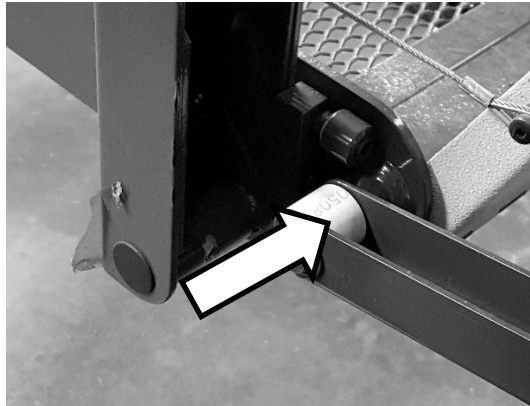
Figure 8. Ensure Bushing Installs Correctly

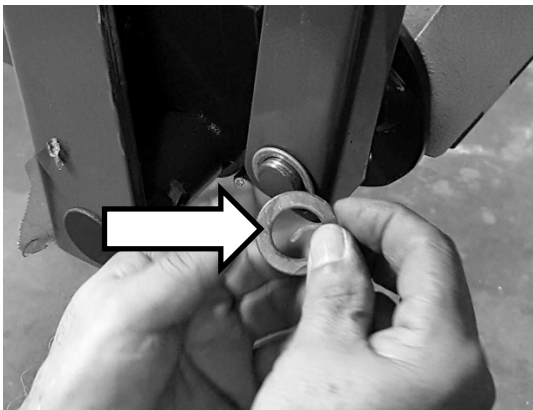
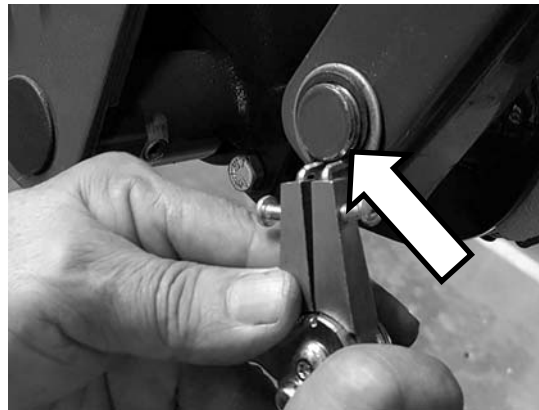
Figure 9. Install Washer and Snap Ring

2. Re-install one (1) 3/4" flat washer over platform pivot and re-install snap ring.

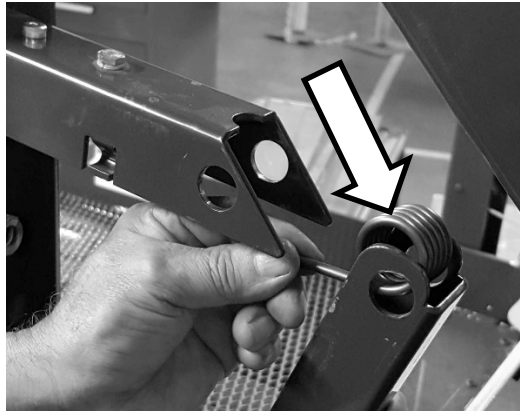
Figure 10. Install Actuator Spring

3. Re-install actuator spring on upper portion of Link Arm.
