RECALL CAMPAIGN BULLETIN

NTB16-004

VOLUNTARY RECALL CAMPAIGN 2015 ROGUE SHIFT SELECTOR KNOB

CAMPAIGN ID #: PC415**APPLIED VEHICLE:** 2015 Rogue (T32)**Check Service COMM to confirm campaign eligibility.**

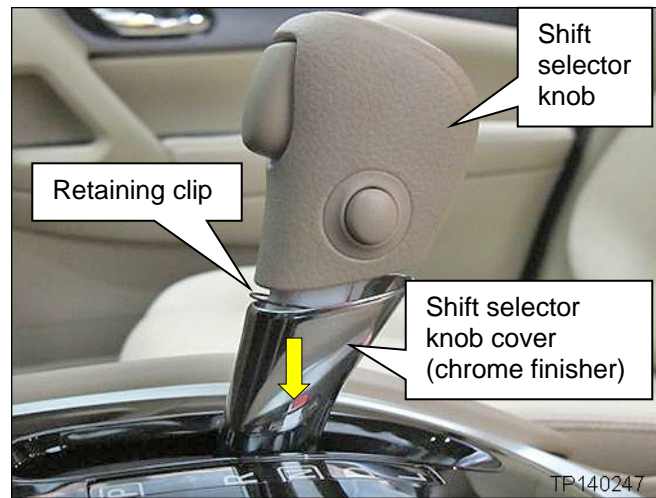
Figure 1

1. Apply the parking brake.
2. Pull DOWN the shift selector knob cover (chrome finisher).
3. Remove the retaining clip using a suitable tool.
4. Pull the shift selector knob UP to remove it.

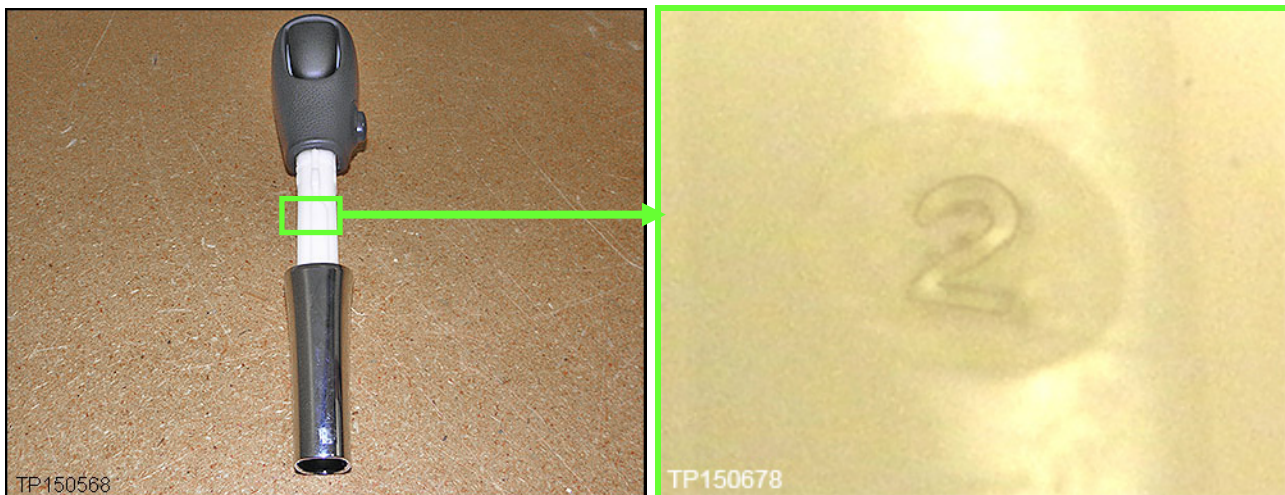
Figure 2

5. Inspect the front of the shift selector knob shaft for the number "2" (Figure 2).
NOTE: The number is very small and hard to see. A magnifying glass may be helpful.
6. Is the number 2 present?
 - No: Replace the shift selector knob with new part.
 - Yes: Inspection is complete and no replacement is required.

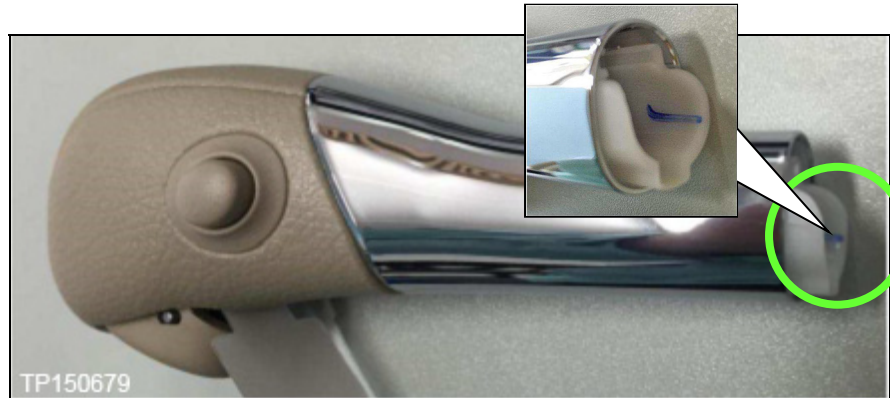
1. Confirm that the new part has the blue mark shown in Figure 3 and/or the black mark shown in Figure 4.

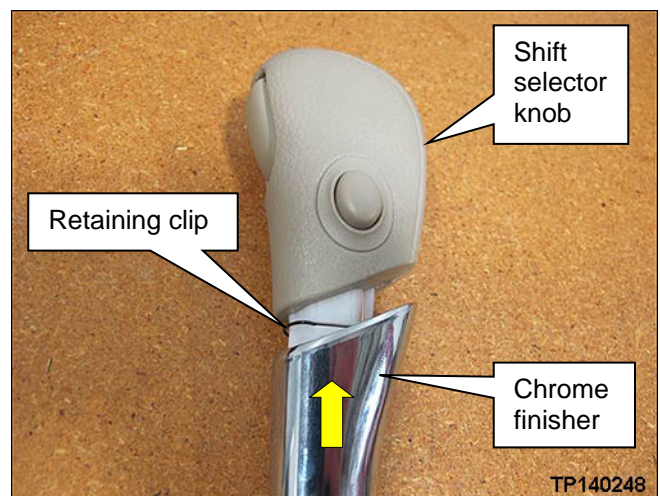
Figure 5

2. Make sure the retaining clip is installed on the shift selector knob.
3. Slide the chrome finisher up and snap in place.

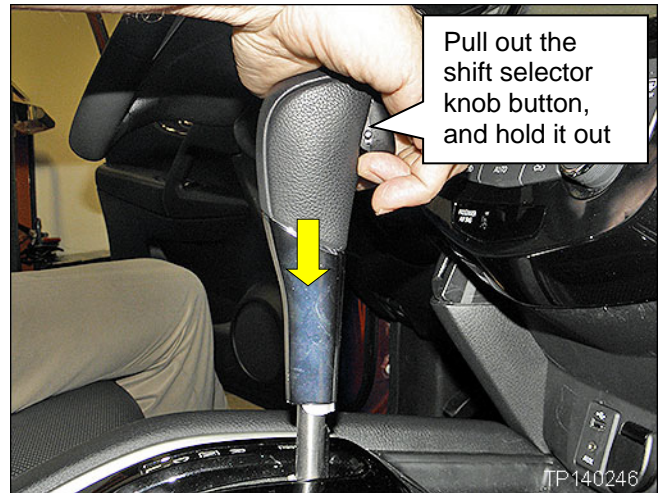
Figure 6

4. Use a pick tool to pull out the shift selector knob button, and hold it out.
5. While holding the button out, slide the shift selector knob onto the shift shaft until you feel it click into place.
6. Release the shift selector knob button.
7. Pull UP on the shift selector knob to make sure it is locked in place, and does not come off.

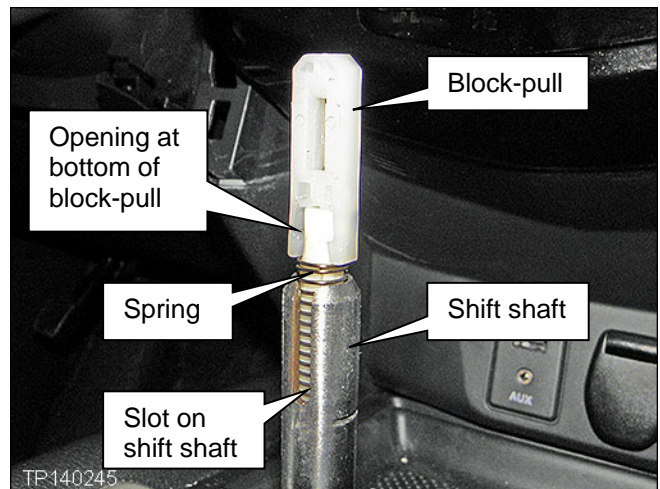
Figure 7

- **DO NOT** replace the entire shifter assembly if the block-pull and spring have been removed.
- Make sure they are reinstalled correctly, as shown in Figure 7.
- The opening at the bottom of the block-pull must be aligned with the slot on the shift shaft as shown in Figure 7.
- Figure 8 shows the block-pull and spring removed.

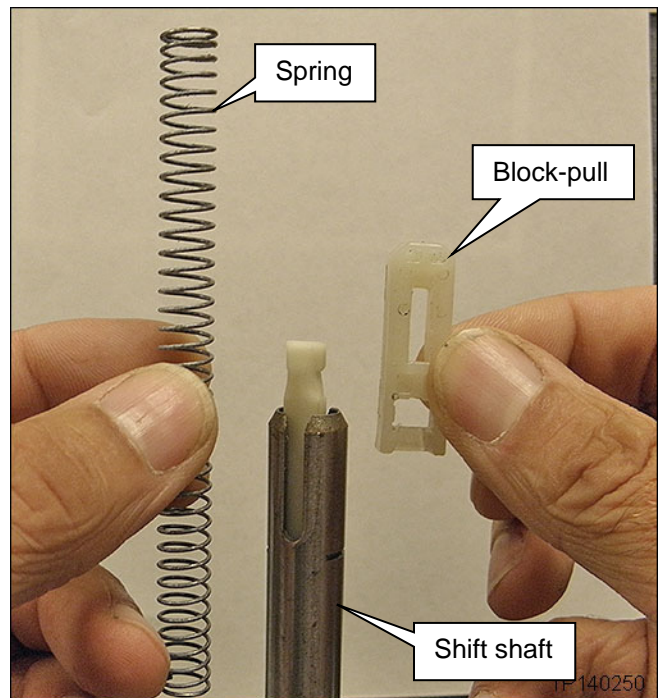
Figure 8

If for any reason the block-pull and spring are removed as shown in Figure 8:

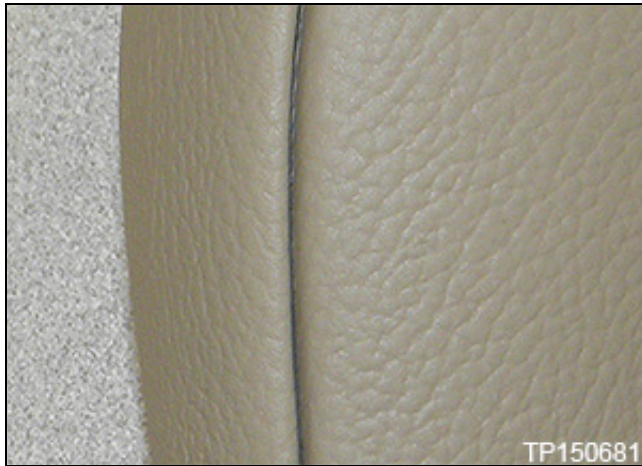
Figure 9

(1) Leather shift selector knob shown in Figure 9.

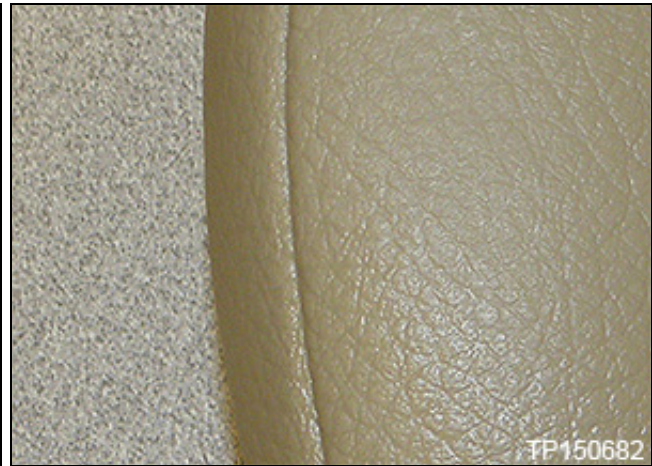
(2) Vinyl shift selector knob shown in Figure 10 with simulated seam.
