# Safety Recall

## Code: 74D1

<b>Subject</b>	<b>Passenger Occupant Detection System (PODS)</b>
<b>Release Date</b>	February 4, 2016
<b>Affected Vehicles</b>	<b>U.S.A.: 2012-2013 MY Audi A6 and A7 with heated/cooled seats</b> <i>Check Campaigns/Actions screen in Elsa on the day of repair to verify that a VIN qualifies for repair under this action. Elsa is the <u>only</u> valid campaign inquiry &amp; verification source.</i> <ul style="list-style-type: none"><li>✓ Campaign status must show "open."</li><li>✓ If Elsa shows other open action(s), inform your customer so that the work can also be completed at the same time the vehicle is in the workshop for this campaign.</li></ul>
<b>Problem Description</b>	In affected vehicles with climate control seats (heated/cooled), the Passenger Occupant Detection System (PODS) control module can malfunction due to stress/wear factors affecting an internal connector and/or a body-sensing mat in the seat. Should a malfunction occur, vehicle occupants will be alerted of a PODS system problem by illumination of the airbag monitoring light and by the status of the Passenger Airbag OFF indicator light. In this situation, a front passenger seat occupan

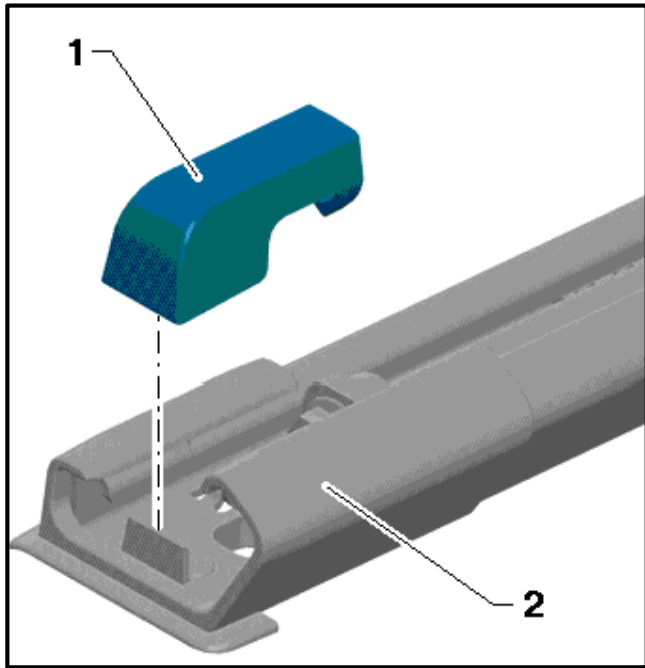
- Push the headrest into the lowest position.
- Move the passenger front seat to the full-rearward position.
- Move the passenger front seat height adjustment to the fully-raised position.
- Pry off the front spindle cover <1> from the seat rail cover <2> and the forward/back adjustment spindle using the Trim Removal Wedge 3409 (or equivalent).

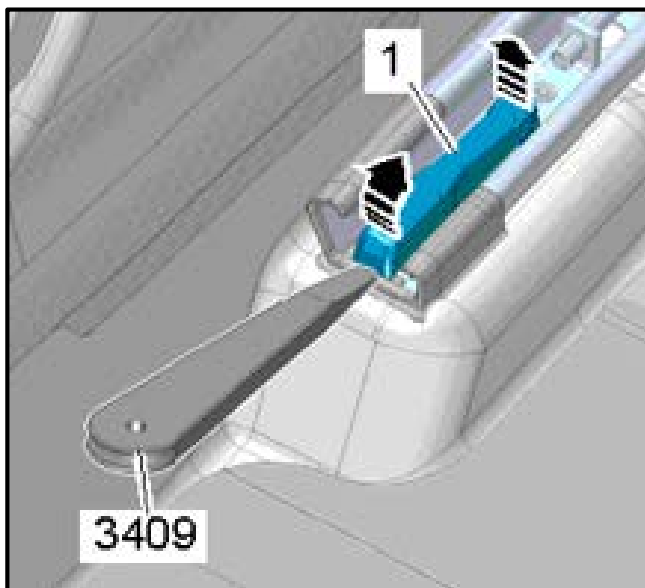
- Move the seat to the full-forward position.
- Using the Trim Removal Wedge (or equivalent), Pry the rear spindle cover <1> off the seat rail cover and the seat rail bolt as shown <arrows>.

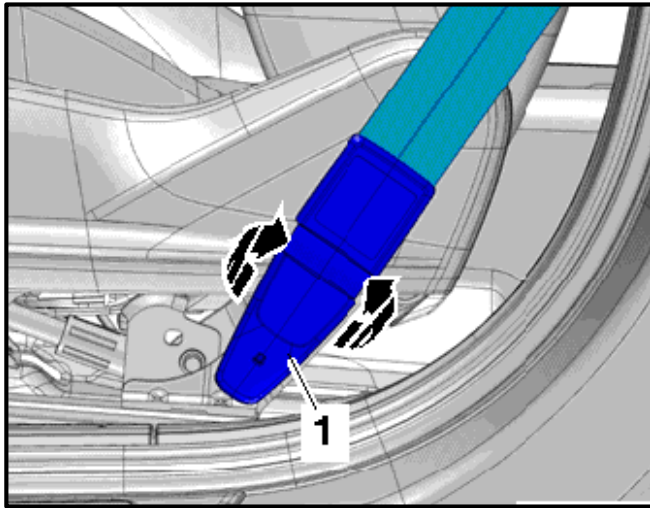
- Unclip the cover <1> on the belt relay <arrows> and fold it upward.

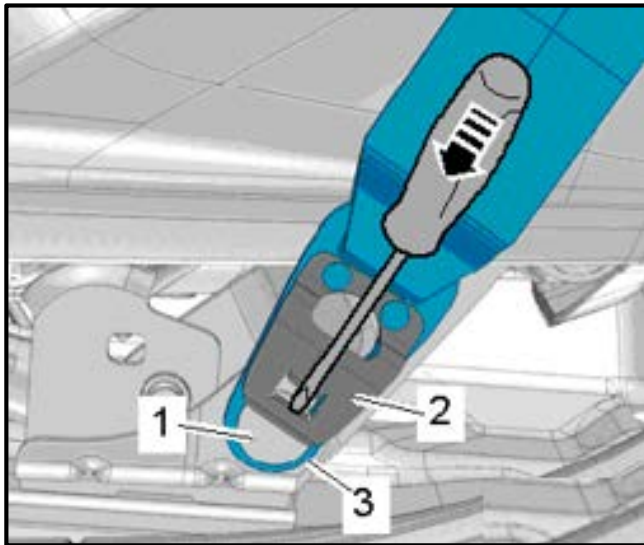
- Release the spring catches <2> by inserting a small screwdriver in the opening in the spring <arrow>.
- Slide the belt end fitting <3> downward and disengage at the pin <1>.

- The spring <2> can bend if removed incorrectly. Replace the three-point seat belt if the spring is bent or distorted. Damage to the seat belt is not covered under this action.
- Only move the spring <2> far enough to unlock the tab on the spring. Do not overextend the spring.

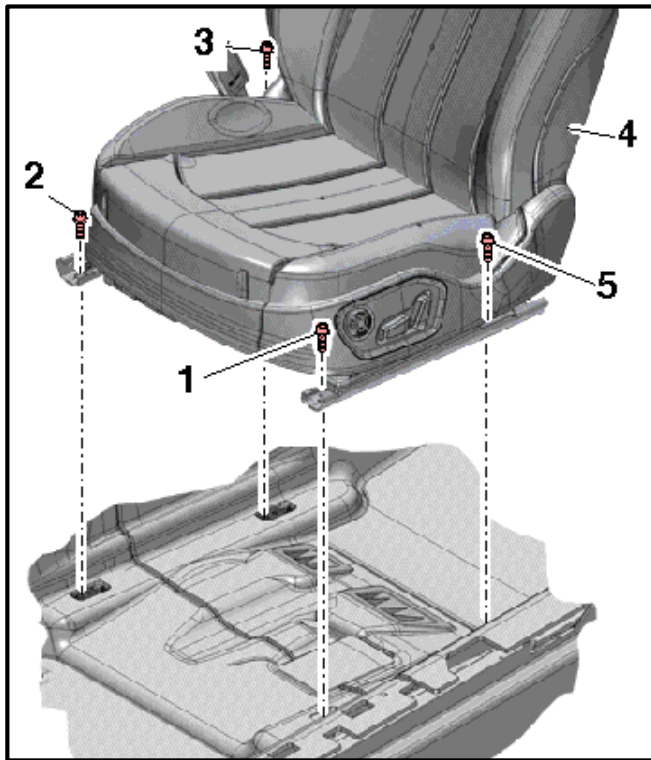
- Remove the bolts <3 and 5> from the rear of each seat rail.
- Move the seat <4> to the full rearward, fully raised position.
- Remove the bolts <1 and 2> from the front of each seat rail.

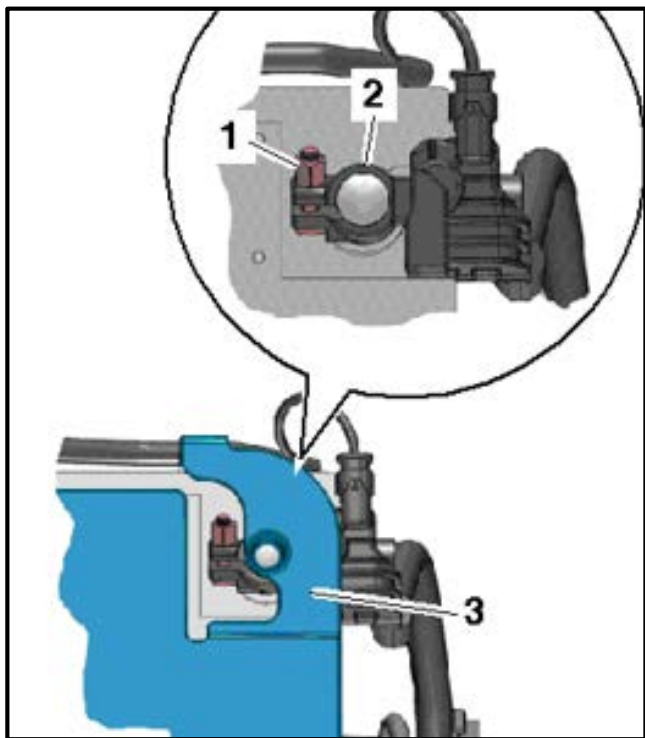
- Switch the ignition ON.
- Open the trunk lid.
- Lift the luggage compartment floor covering by the handle and fold it forward.
- If equipped, remove the vehicle tool kit and spare tire.
- Open the cover <3> above the negative battery connection.
- Loosen the nut <1> and remove the battery ground cable terminal <2> from the battery terminal.

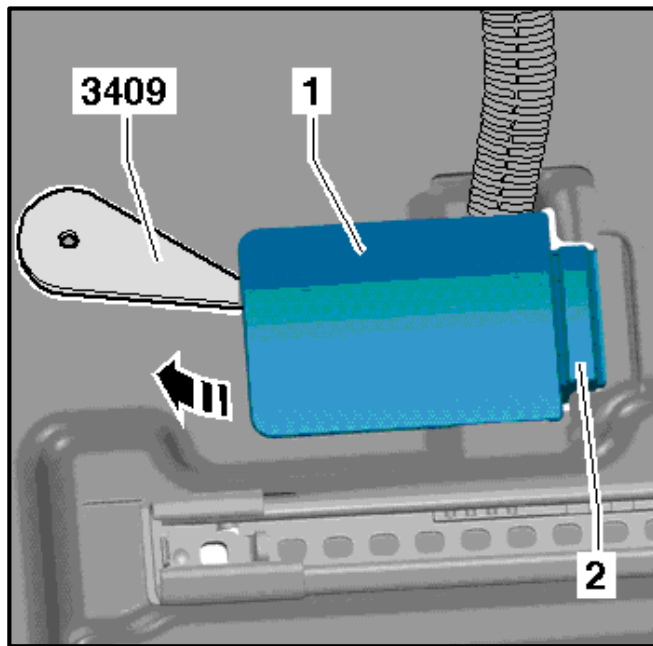
- Using Trim Removal Wedge 3409 (or equivalent), release the front of the cover <1> and remove it as shown <direction of arrow>.

The connector station shown here is located in the vehicle floor under the front passenger seat.

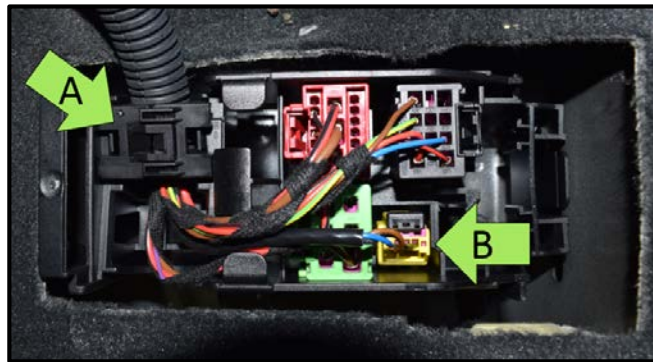
- Release the retaining tabs and remove the wiring bracket <arrow A> from the connector station.
- Release the retaining tabs and remove the side airbag electrical harness connector <arrow B>.
- Disconnect any remaining electrical connectors.

The number of connectors present in the connector station will vary based on vehicle equipment.

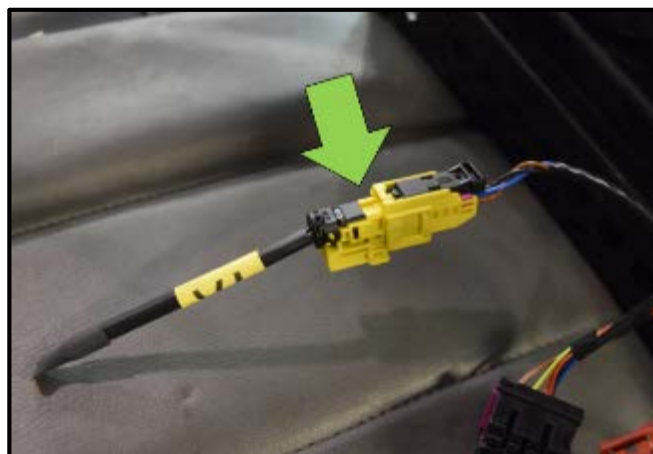
- Connect the Airbag Lockout Adapter VAS6282 to the side airbag connector as shown <arrow>.

The Airbag Lockout Adapter VAS6282 must stay connected to the airbag wiring harness until the seat is reinstalled in the vehicle.

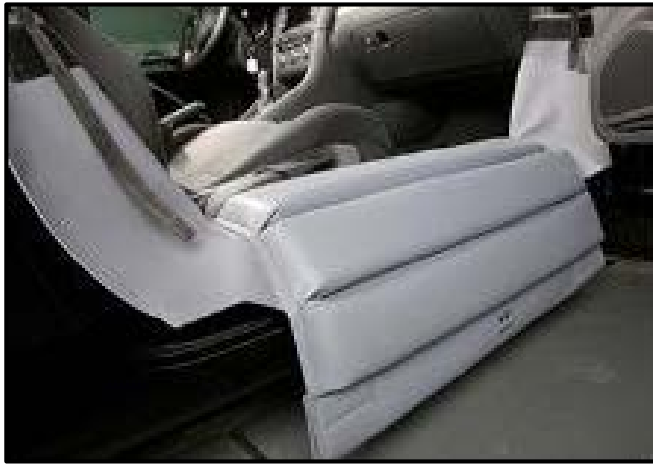
- To protect the sill panel before removing the front seat, install the Universal Vehicle Protector VAS871 001 <as shown>.
- Carefully remove the front seat from the vehicle.

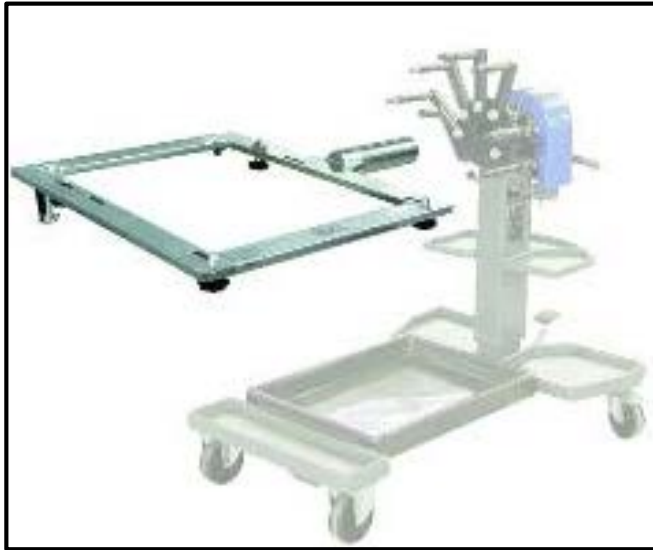
- Attach the Seat Repair Fixture VAS6136 to the Engine and Transmission Holder VAS6095.
- Fasten the front seat onto the Seat Repair Fixture VAS6136.

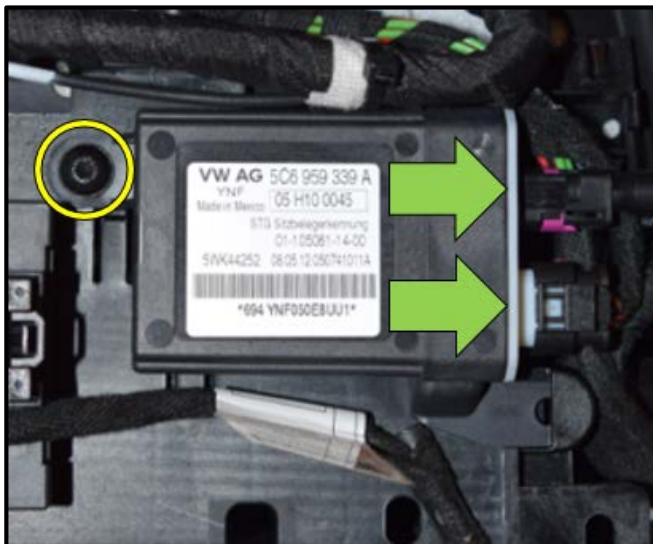
- Disconnect the connectors <arrows> from the PODS control module.
- Remove the mounting bolt <circle>.
- Remove the PODS control module.

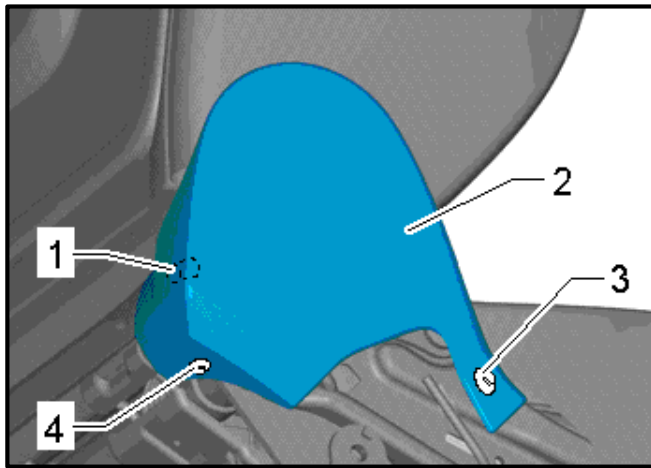
- Remove the expanding rivets <3 and 4>.
- Disengage and remove the tunnel-side trim <2> from the seat back hinge.

Use caution during removal of the trim. The mounting tab <1> may break if not properly disengaged. Damage to the trim is not covered by this action.

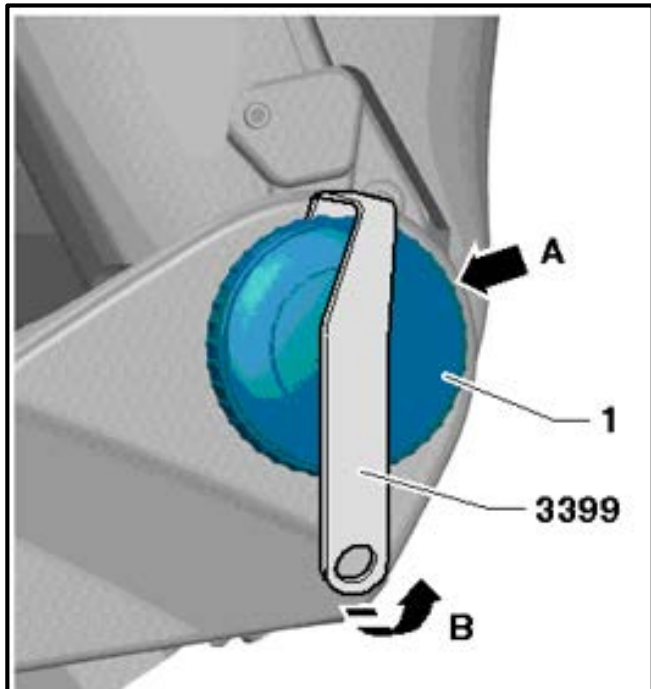
- Turn the seat back adjustment wheel <1> until one catch is visible from behind <arrow A>. Use a flashlight if necessary.
- Using the Assembly Tool 3399, carefully pry the adjustment wheel off the seat <direction of arrow B>.
- Turn the seat back adjustment wheel 120° further and repeat the process.
- Remove the seat back adjustment wheel.

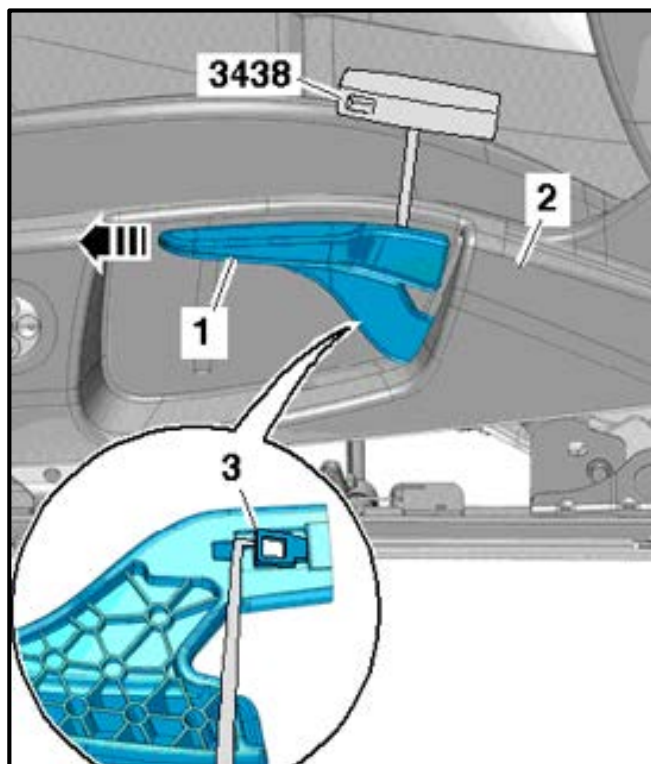
- Pull the seat height adjustment handle <1> upward and hold it in the fully-raised position.
- Carefully pull the seat height adjustment handle away from the seat.
- Guide the T-Handle Hook 3438 between the seat height adjustment handle and the seat trim <2>.
- Using the T-Handle Hook 3438, release the fastening tab <3>.
- With the fastening tab released, remove the seat adjustment handle from the lever <direction of arrow>.

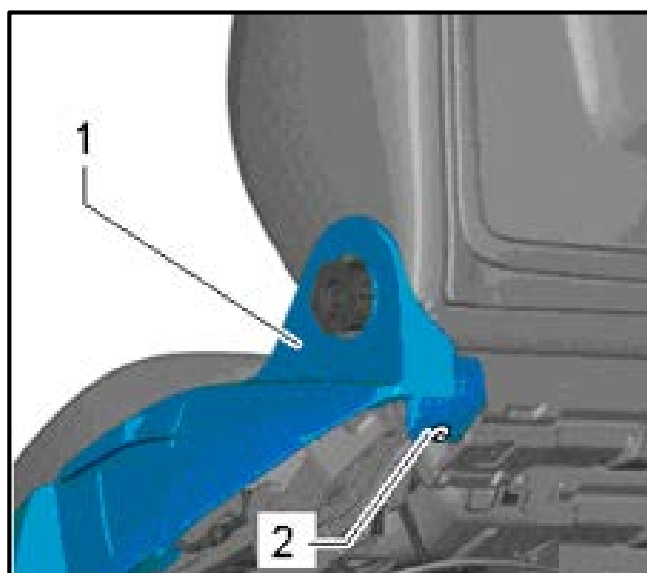
- Remove the expanding rivet <2> from the sill-side seat trim <1>.

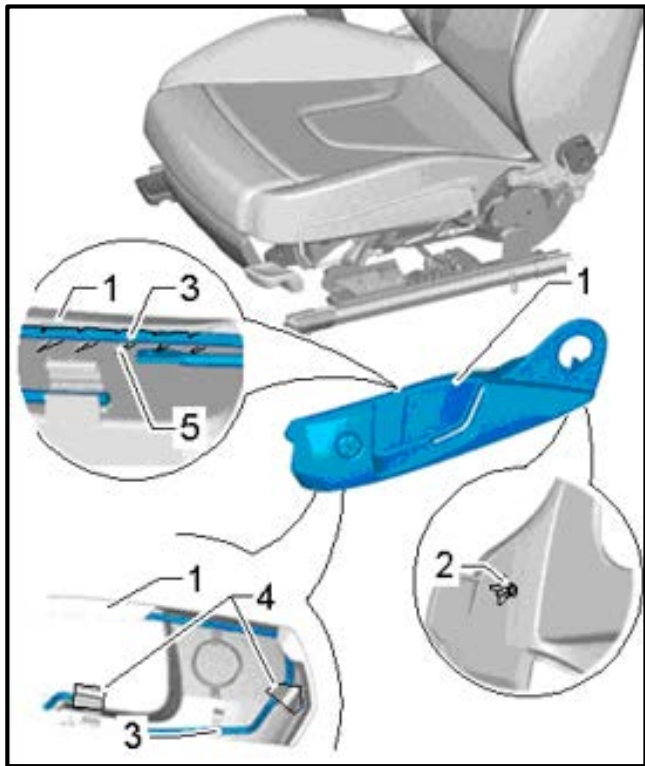
- Open the mounting clips <4> on the seat trim.
- Unclip the bracket <3> and, if present, release the wiring harness from the sill-side trim.
- Pull the trim <1> slightly forward off the bracket and remove it in an upward direction.

Use caution during removal of the trim. The mount <5> and the tab <2> may break if not properly disengaged. Damage to the trim is not covered by this action.

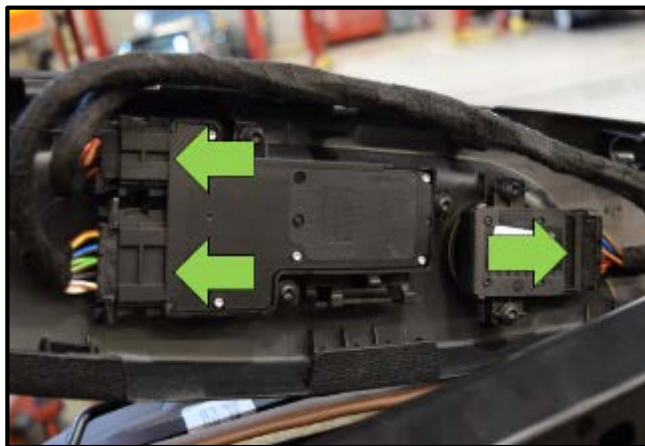
- Disconnect the electrical connectors <arrows> between the seat trim and the seat itself.
- Remove the seat trim panel.

The harness connections shown here may not be present on all vehicles.

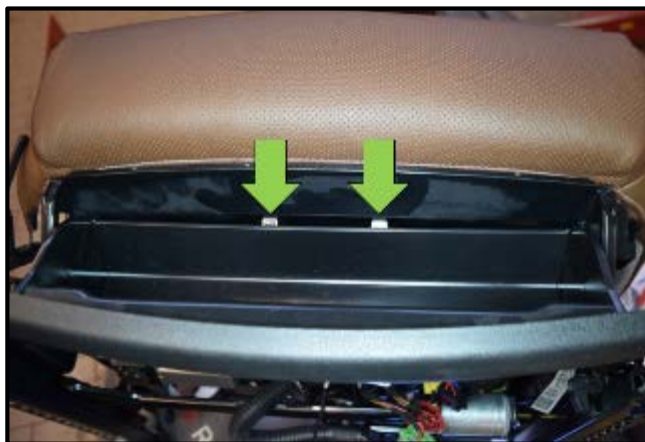
- Open the storage compartment located on the lower front portion of the seat.
- Release the two tabs <arrows> and fully open the storage compartment.

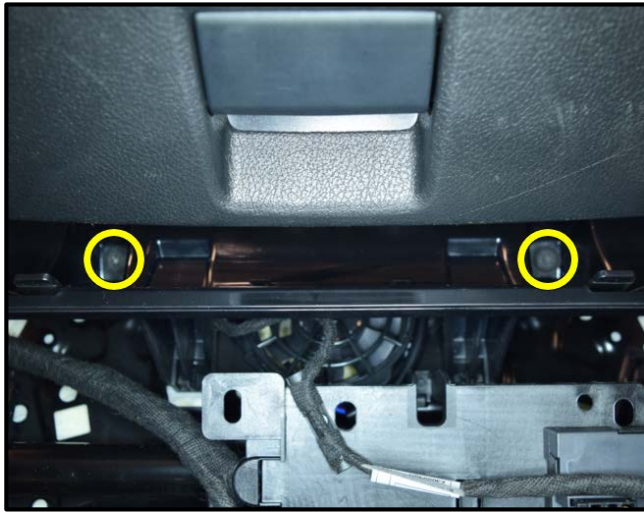
- Hold the storage compartment in the full-open position, and remove the mounting screws <circles>.
- Remove the storage compartment from the seat.

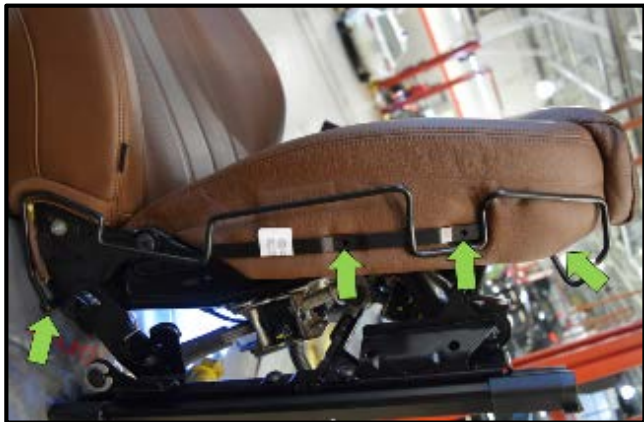
- Remove the four fastening screws <arrows> from the mounting bracket.
- Remove the mounting bracket from the seat.

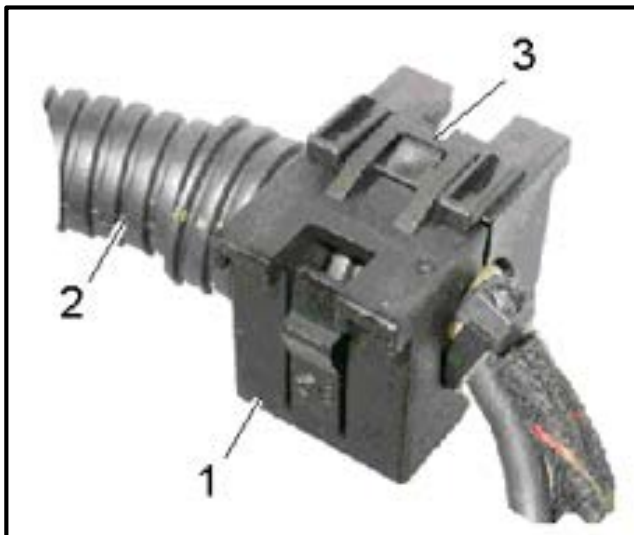
- Using the Trim Removal Wedge 3409 (or equivalent), release the retainer <3> and open the front cable holder <1>.
- Remove the wiring bracket from the corrugated tube <2>.

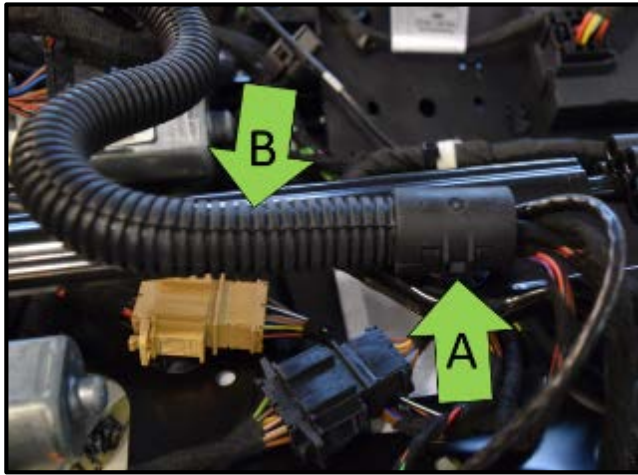
- Using a small, flat-blade screwdriver (or equivalent), open the rear wiring bracket <arrow A> for modular wire routing on the seat pan lower frame.
- Remove the corrugated tube <arrow B> from the bracket.
- Remove the outer corrugated tube from the wiring harness.

- There are two corrugated tubes installed over this wiring harness. It is only necessary to remove the outer tube during this procedure.
- To aid in proper reassembly, the wiring harness should be marked with a paint pen, masking tape, etc. to mark the position of the corrugated tube.

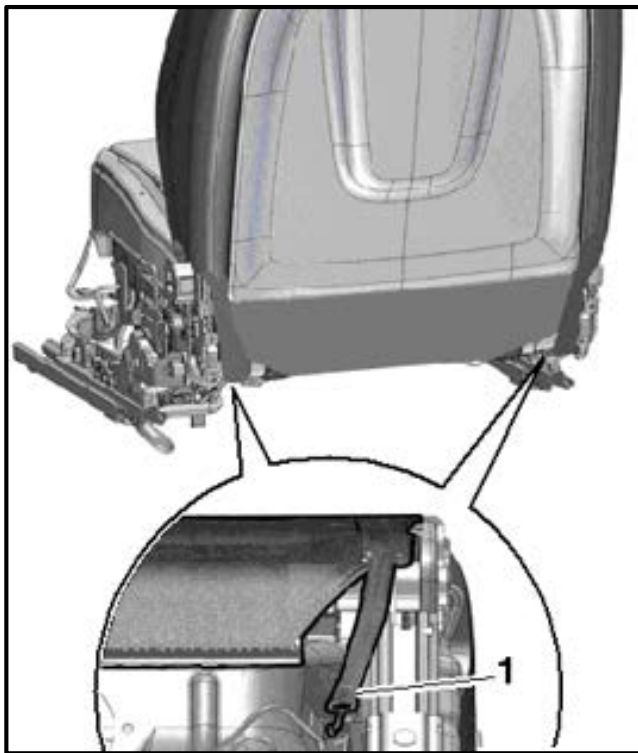
- Detach the rubber strap <1> from the left and right side at the bottom of the seat pan.

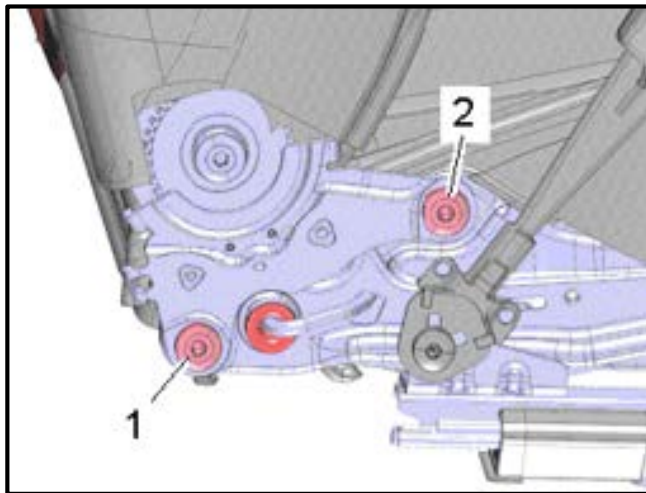
- Remove the mounting bolts <1 and 2> from the seat back hinge.
- Repeat the bolt removal on the opposite side seat back hinge.
- Carefully remove the seat back from the base of the seat.
- During removal, re-route the wiring harness for the seat mounted airbag – it must be removed with the seat back.

The wiring harness for the side airbag is continuous from the floor connector to the airbag igniter itself. There is no intermediate connection between the base and the back of the seat.

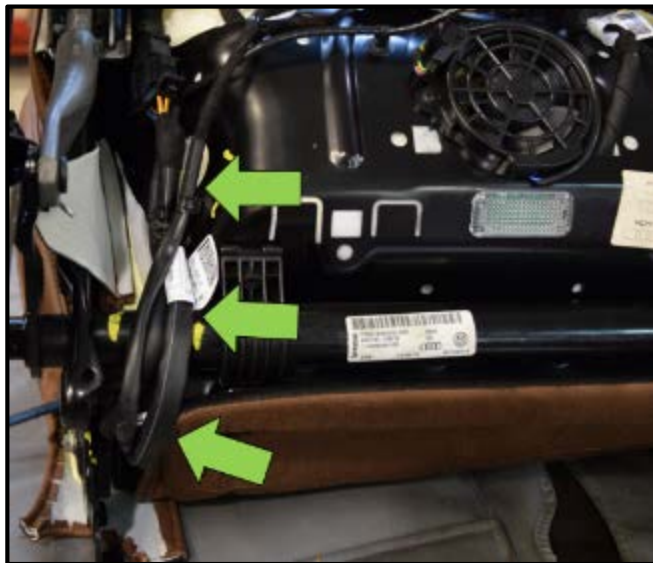
- Depending on vehicle options, additional wiring harness components <arrows> may be present between the seat back and the seat base.
- Disconnect and re-route the wiring as necessary to avoid wiring damage during disassembly of the seat.

To aid in proper reassembly, the wiring harness routing should be marked with a paint pen, masking tape, or by taking pictures during disassembly. Pay careful attention to the wire harness location and routing, as they **MUST** be reinstalled in the same location. Damage to the seat wiring is not covered under this action.

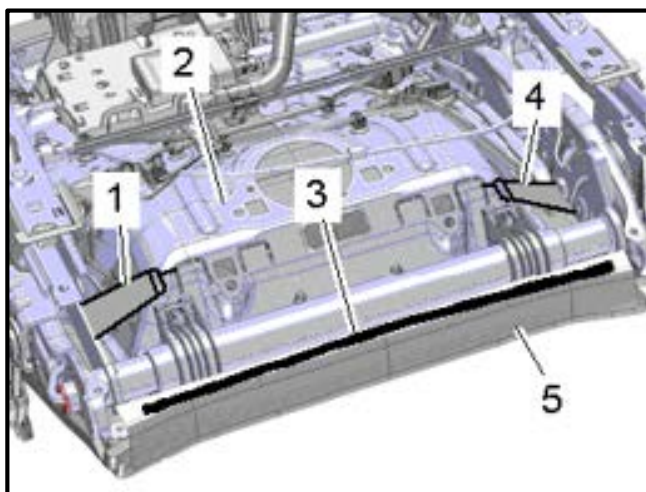
- Release the hooks <1 and 4> from the lower seat frame <2>.
- Disconnect and free up any wiring connectors that are present.
- Using Seat back Panel Tool 3370, detach the molding <3> of the seat cover <5> in the rear of the seat.

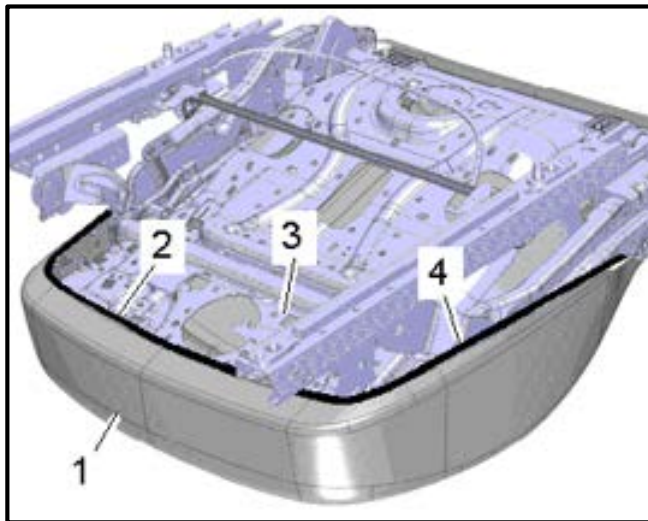
- Using Seat back Panel Tool 3370, detach the molding <2 and 4> of the seat cover in the front and side areas.
- Remove the seat cover <1> with the seat cushion from the lower seat frame <3>.
- During seat cover and cushion removal, free up the wiring harness for the seat heating and PODS unit.

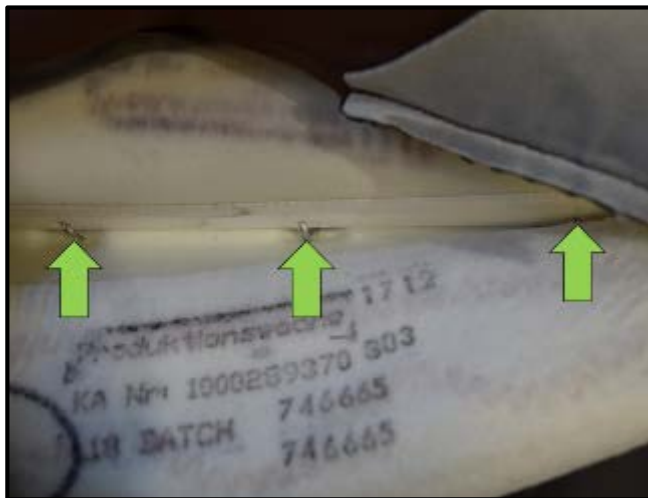
- The seat cover is fastened to the seat cushion using wire upholstery clips.
- Carefully peel the seat cover back to expose the clips <arrows>.
- With the seat cover pulled back, cut the upholstery clips <arrows> using appropriate side-cutting pliers.
- Fully remove the seat cover from the seat cushion.

The seat cover will have approximately 20 upholstery clips installed. While cutting these clips, some fragments may remain attached to the seat cover. **ALL** fragments of the old clips **MUST** be removed from the seat cover prior to reassembling the seat.

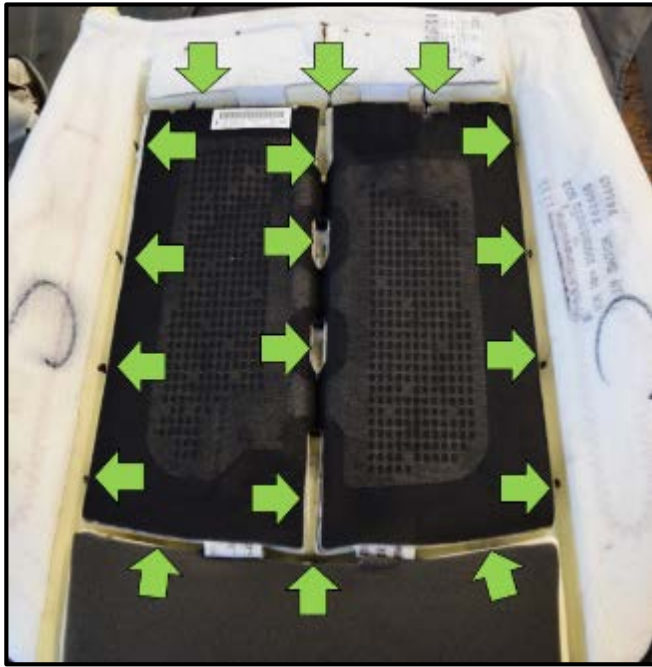
- When looking at the seat cushion from the top down, the upholstery clips are located approximately where shown <arrows>.
- During disassembly, start cutting the clips along the outside perimeter, then work inward until all the clips have been removed.

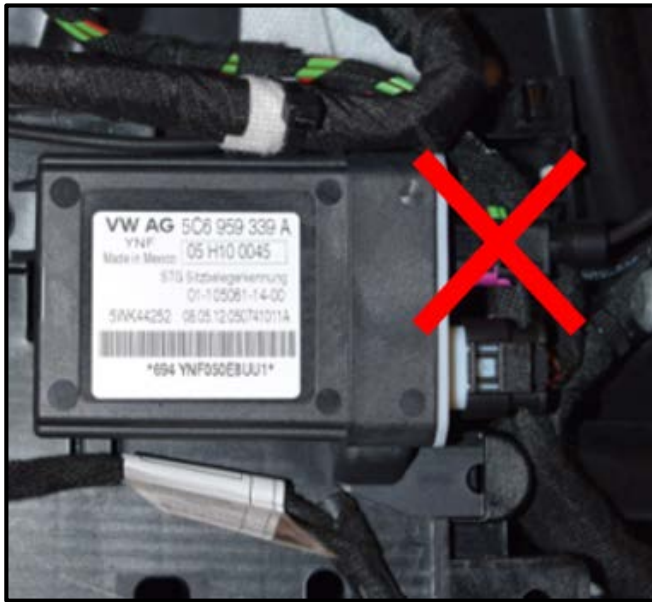
The PODS module and the PODS mat are calibrated by the manufacturer. Therefore, the PODS module will be connected to the PODS sensor wiring harness on the replacement PODS kit. This connector **MUST NOT** be disconnected from the PODS module itself.

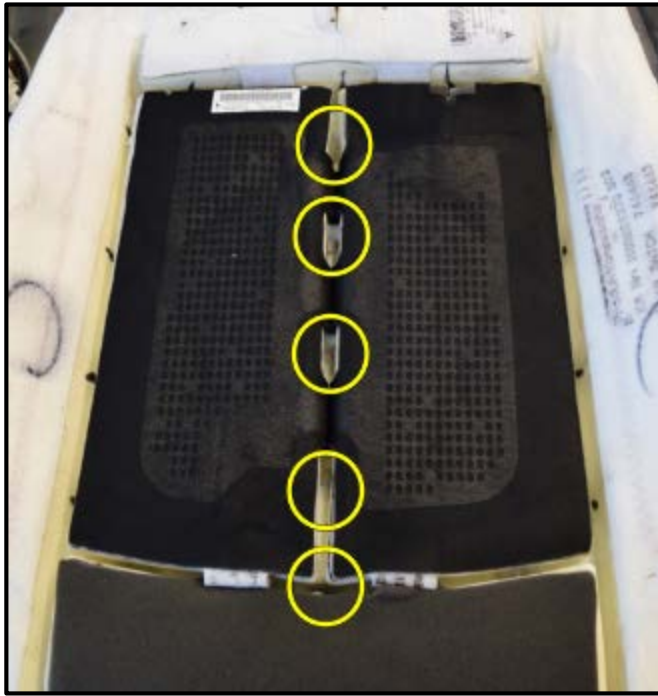
- Position the seat cover onto the replacement seat cushion/PODS mat assembly.
- Starting at the center row of the seat cushion, install and fasten the upholstery clips where shown <circles> using upholstery clip pliers VAG1634 (or equivalent).

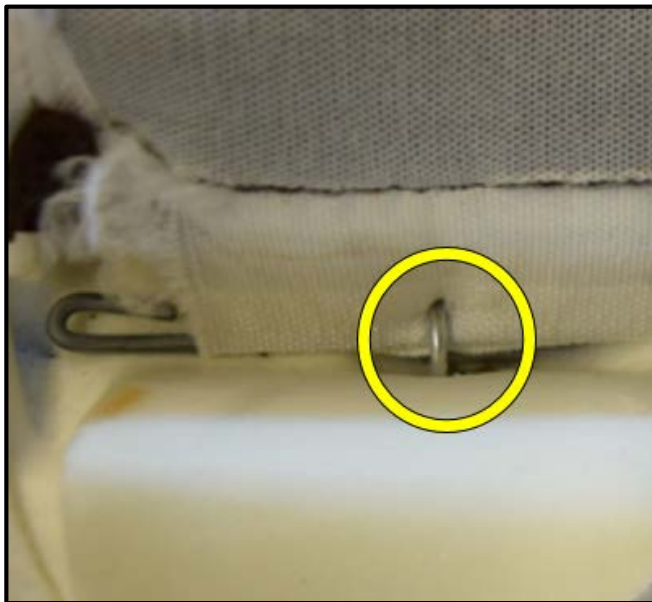
- Prior to fully clamping the upholstery clips closed, be sure each upholstery clip engages BOTH the webbing on the bottom side of the seat cover AND the fastening wire molded into the seat cushion as shown <circle>.

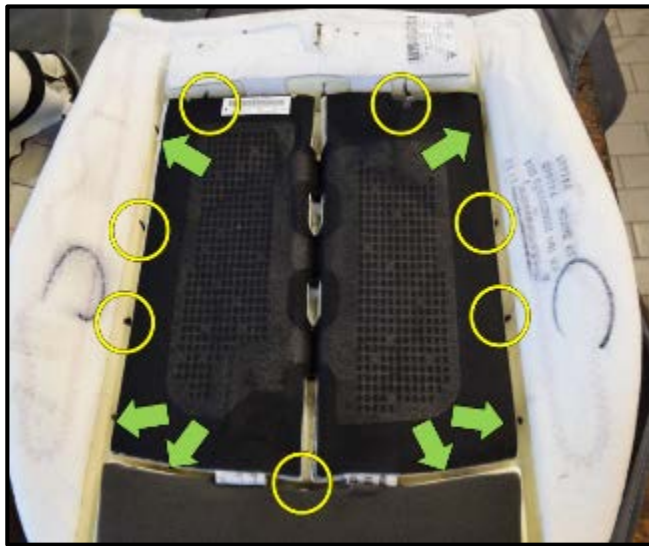
- Install additional remaining upholstery clips around the perimeter of the seat cushion where shown <circles>.
- Install the corner upholstery clips <arrows> last. This allows additional accessibility for installing the inboard upholstery clips.

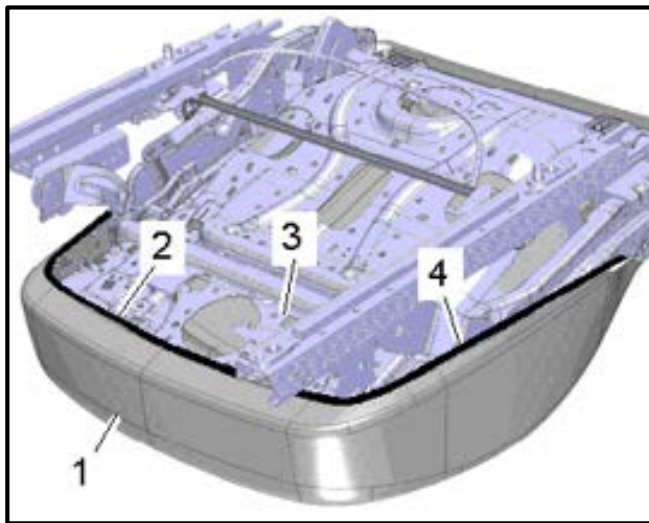
- Inspect the seat cover position on the seat cushion to ensure it appears properly centered.
- Route the wiring harness for the seat heating element and the PODS unit through its original location at the rear center of the seat cushion.
- Reinstall the seat cover <1> with the seat cushion onto the lower seat frame <3>.
- Reattach the molding of the seat cover <2 and 4> onto the front and sides of the lower seat pan as shown.

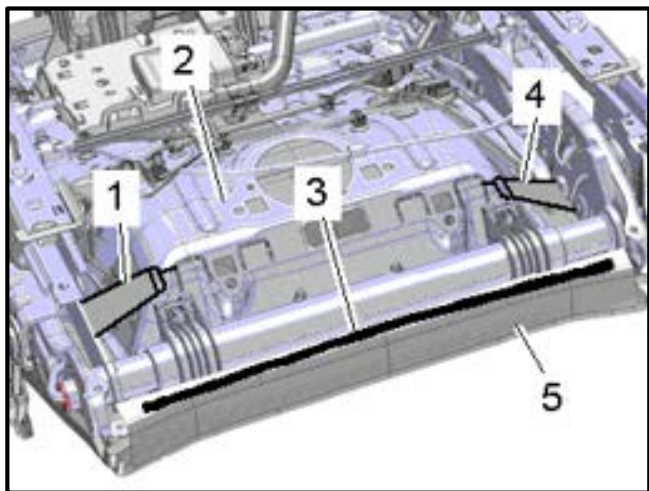
- Reattach the molding <3> of the seat cover <5> onto the rear of the seat.
- Reconnect the hooks <1 and 4> onto the lower seat frame <2>.

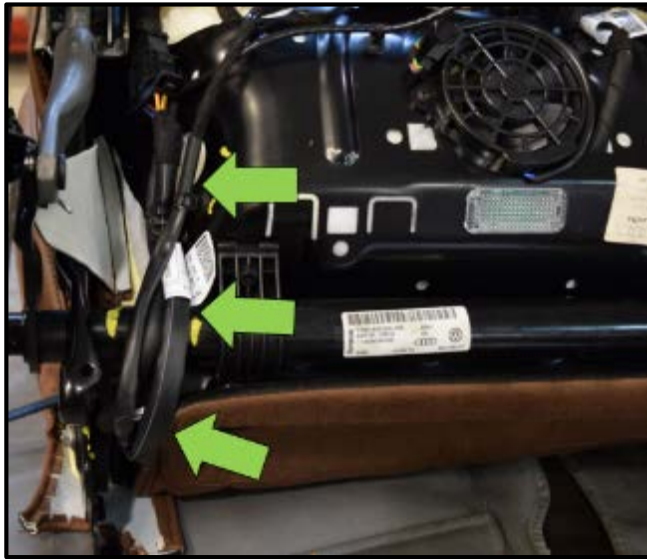
- Position the seat back on/near the seat bottom and prepare for reassembly.
- Reroute and reconnect the wiring as necessary <arrows>.

The wiring must be routed in its original location and orientation to avoid damage. Damage to the seat wiring is not covered under this action.

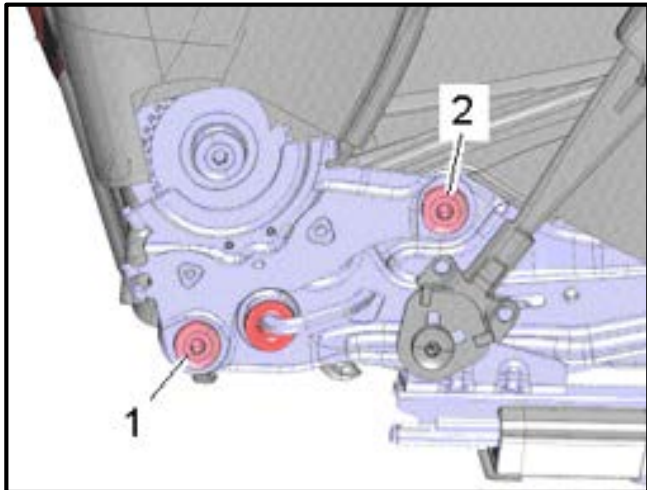
- Install the seat back onto the base of the seat.
- During installation, if not already performed, route the airbag wiring harness through its original location and under the base of the seat.
- Clean the threaded holes for seat back mounting bolts <1 and 2> with an appropriate thread tap.
- Apply an appropriate medium-strength thread locking compound onto the seat back mounting bolt threads.
- Reinstall the mounting bolts <1 and 2>, into the seat back hinge.
- Repeat the bolt installation on the opposite side seat back hinge.
- Torque all four seat back mounting bolts to **34.5Nm**.

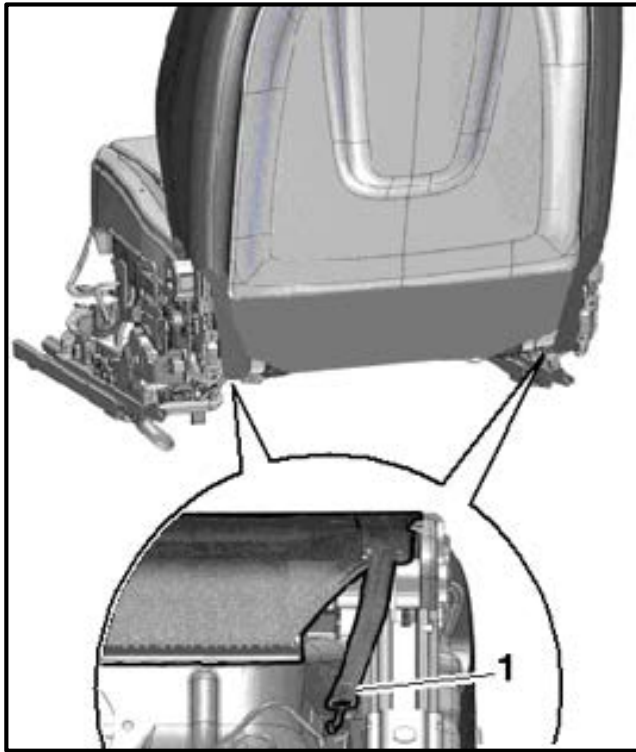
- Reattach the rubber straps <1> to the seat pan.

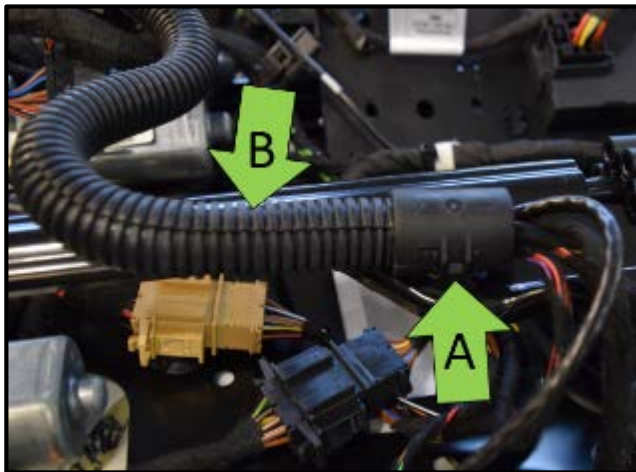
- Reinstall the airbag wiring harness, and any other wiring that was removed, into the corrugated tube.
- Reinstall the outer corrugated tube <arrow B> into its original position.
- Refasten the rear wiring bracket <arrow A> over the end of the corrugated tube as shown.

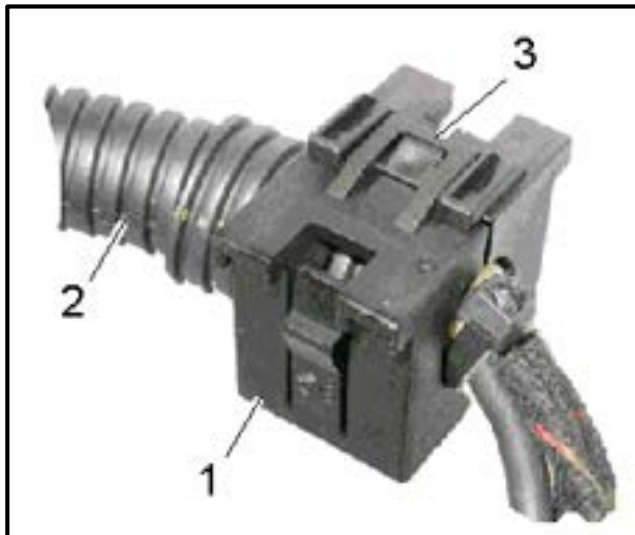
- Reinstall the front cable holder <1> onto the corrugated tube <2> in its original location.
- Refasten the retaining clip <3>.

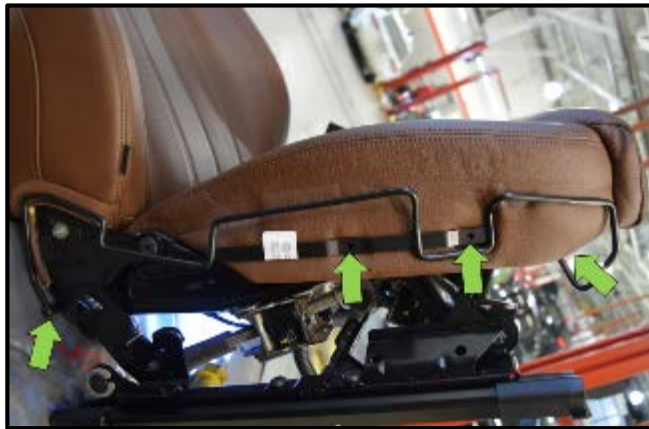
- Reinstall the mounting bracket onto the seat in its original location as shown.
- Reinstall the four fastening screws <arrows> into the mounting bracket and torque to **8Nm**.

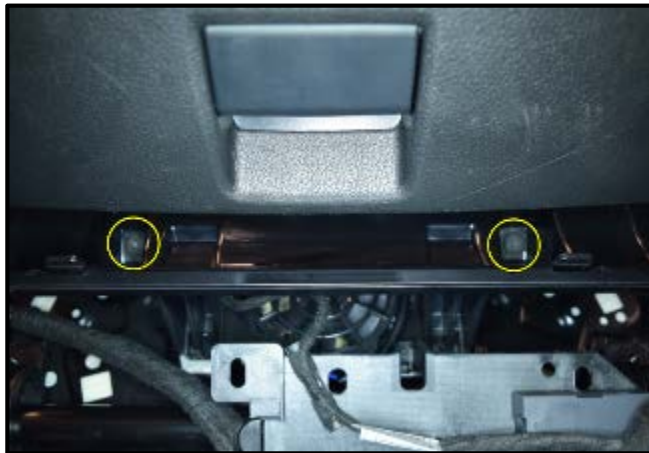
- Reinstall the storage compartment onto the front of the seat pan.
- Reinstall the mounting screws <circles> and torque to **3Nm**.
- Close the storage compartment.

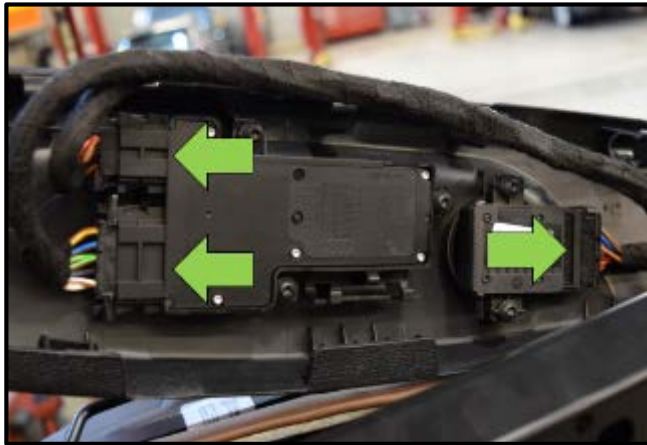
- Reconnect the electrical connectors <arrows> between the seat trim and the seat itself.

The harness connections shown here may not be present on all vehicles.

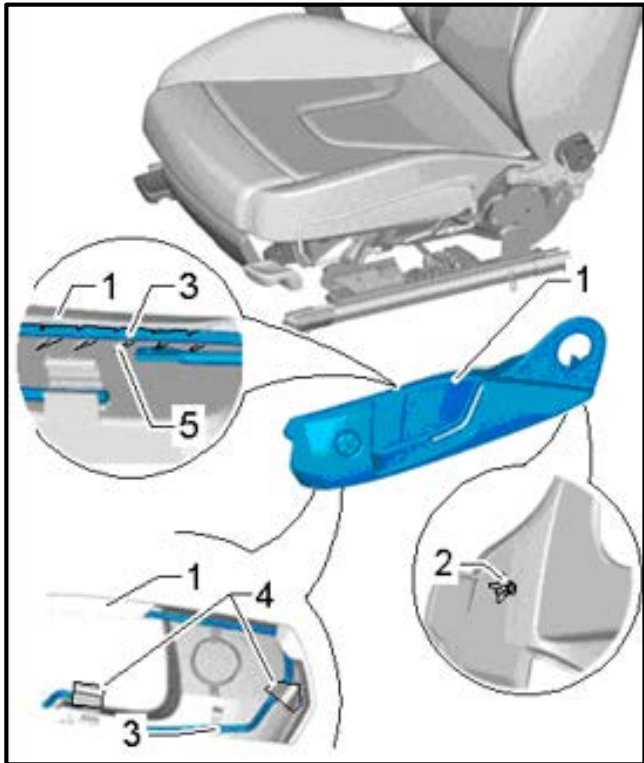
- Reinstall the seat trim <1> onto the mounting bracket <3>.
- Refasten the mounting clips <4>, and any wiring harness retainers that were previously removed.

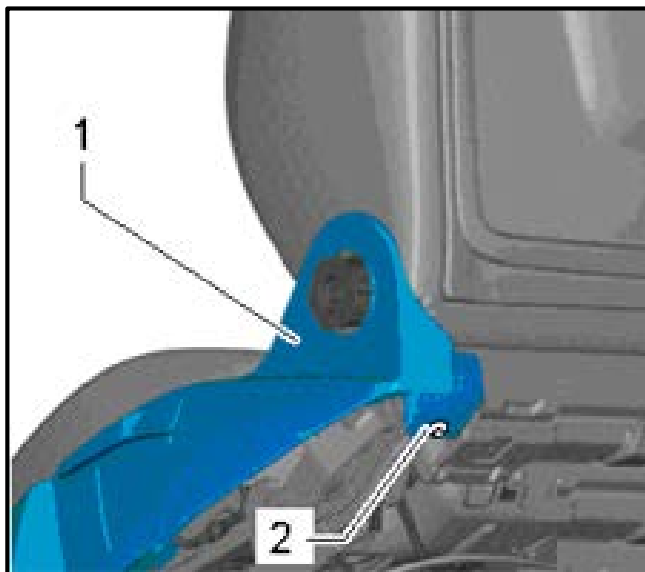
- Reinstall all remaining trim and fasteners that were previously removed from the seat (i.e. items 1 and 2).

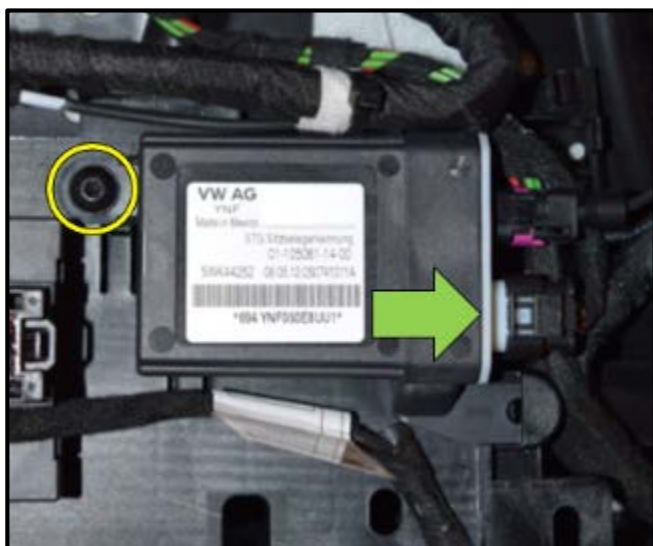
- Install the PODS module into the mounting bracket as shown.
- Reconnect the electrical connector <arrow> to the PODS module.
- Reinstall and hand tighten the mounting bolt <circle>.

The PODS module and the PODS mat are calibrated by the manufacturer. Therefore, the PODS module will be connected to the PODS sensor wiring harness on the replacement PODS kit. This connector **MUST NOT** be disconnected from the PODS module itself.

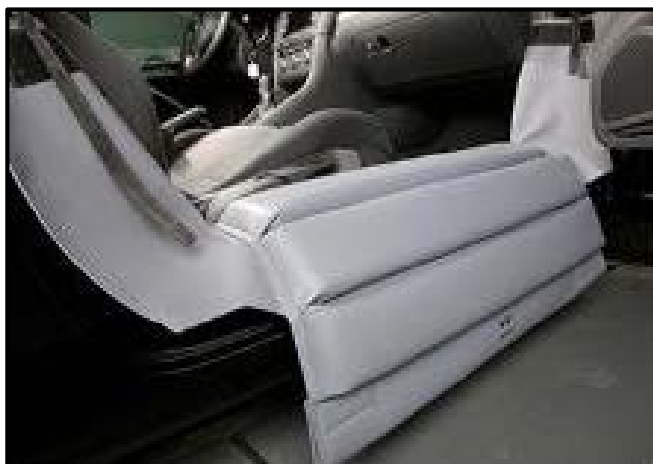
- To protect the sill panel before reinstalling the front seat, install the Universal Vehicle Protector VAS871 001 <as shown>.
- Carefully reinstall the front seat into the vehicle.

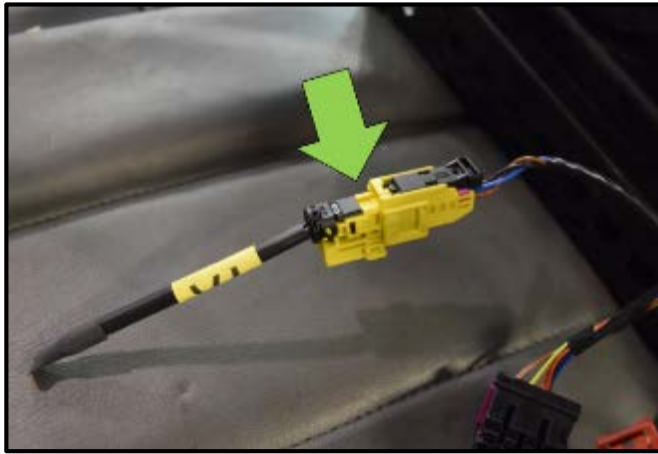
- Disconnect the Airbag Lockout Adapter VAS6282 from the side airbag connector <arrow>.

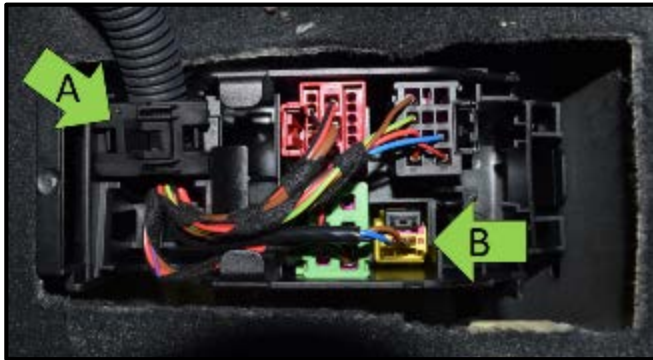
- Reinstall the wiring bracket <arrow A> and refasten the retaining tabs on the connector station.
- Reinstall the side airbag electrical harness connector <arrow B>.
- Reconnect any remaining electrical connectors.
- Reinstall the connector station cover.

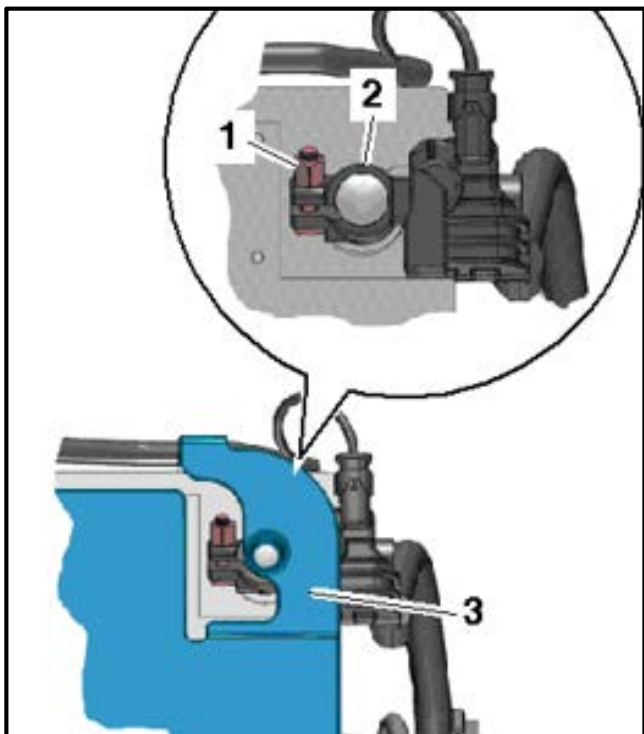
- Reconnect the battery cable <2> and tighten the fastener <1>.
- Close the cover <3>.
- If previously removed, reinstall the vehicle tool kit and spare tire.
- Close the luggage compartment floor covering.

Ignition must be on when connecting battery. If pyrotechnic components (for example, airbag, belt tensioner) are not repaired correctly, they may deploy unintentionally after connecting battery. There must not be anyone inside the vehicle when connecting the battery.
