# Safety Recall

## Code: 74D1

<b>Subject</b>	<b>Passenger Occupant Detection System (PODS)</b>
<b>Release Date</b>	February 4, 2016
<b>Affected Vehicles</b>	<b>U.S.A.: 2012-2013 MY Audi A6 and A7 with heated/cooled seats</b> <i>Check Campaigns/Actions screen in Elsa on the day of repair to verify that a VIN qualifies for repair under this action. Elsa is the <u>only</u> valid campaign inquiry &amp; verification source.</i> <ul style="list-style-type: none"><li>✓ Campaign status must show "open."</li><li>✓ If Elsa shows other open action(s), inform your customer so that the work can also be completed at the same time the vehicle is in the workshop for this campaign.</li></ul>
<b>Problem Description</b>	In affected vehicles with climate control seats (heated/cooled), the Passenger Occupant Detection System (PODS) control module can malfunction due to stress/wear factors affecting an internal connector and/or a body-sensing mat in the seat. Should a malfunction occur, vehicle occupants will be alerted of a PODS system problem by illumination of the airbag monitoring light and by the status of the Passenger Airbag OFF indicator light. In this situation, a front passenger seat occupan

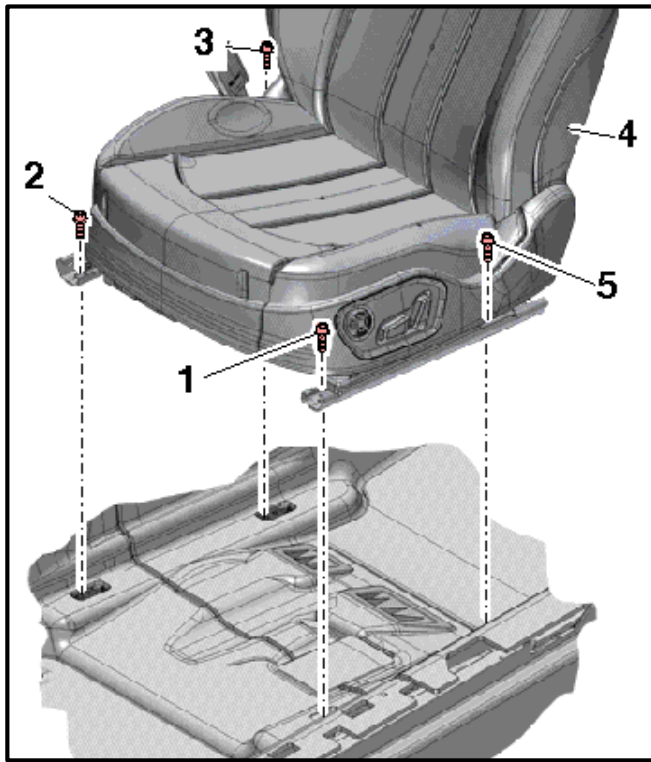
- Reinstall the bolts <1 and 2> into the front of each seat rail.
- Move the seat <4> to the full forward, fully raised position.
- Reinstall the bolts <3 and 5> into the rear of each seat rail.
- Torque all four seat mounting bolts to **50Nm**.
- Reinstall all 4 spindle covers onto the seat rails.

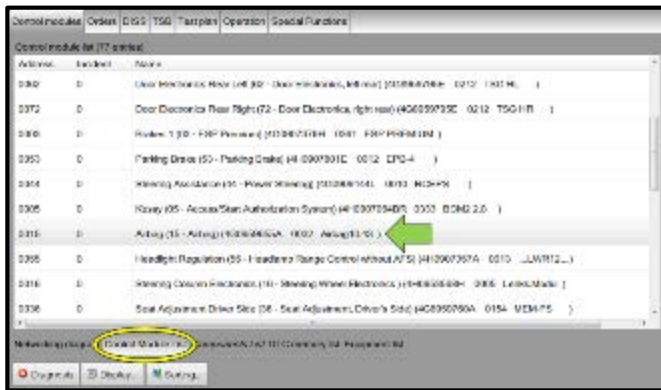
- Switch the ignition ON.
- Connect the VAS tester to the vehicle.
- Using ODIS, perform a complete GFF scan of the vehicle.
- From the “Control Module List” screen <circle>, right click on the Airbag Control Module <arrow>.
- When the drop down list is displayed, select “Guided Functions”.

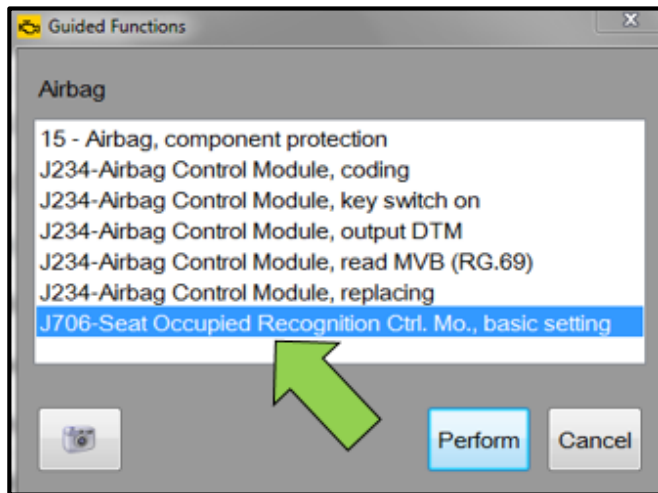
- From the “Guided Functions” list, select “J706 – Seat Occupied Recognition Ctrl. Mo., basic setting” <arrow>.
- Follow the on-screen directions to complete the PODS system basic settings.

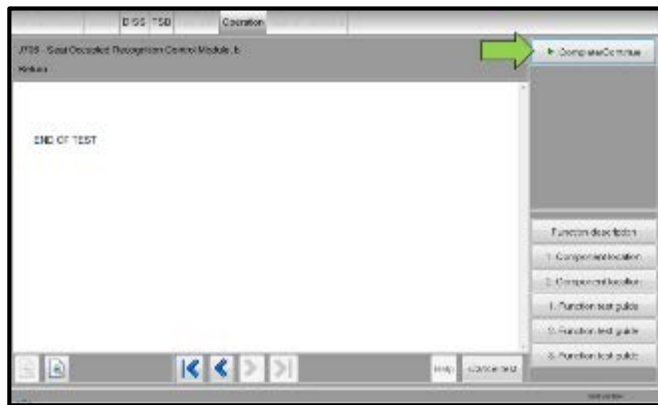
- When the message “END OF TEST” is displayed, select “Complete/Continue” <arrow>.
- Clear all DTCs.
- Reset customer convenience basic settings (i.e. clock, one-touch windows, seat position).
- Disconnect the VAS scan tool.
