Service Bulletin No. 430

MODEL J4500 Series	TYPE Field Change Program	SECTION/GROUP 3-Body	DATE Jan. 11, 2016
SUBJECT KIEL PASSENGER SEAT			
CONDITIONS

Ref. MCI NHTSA Recall No.:15V-862

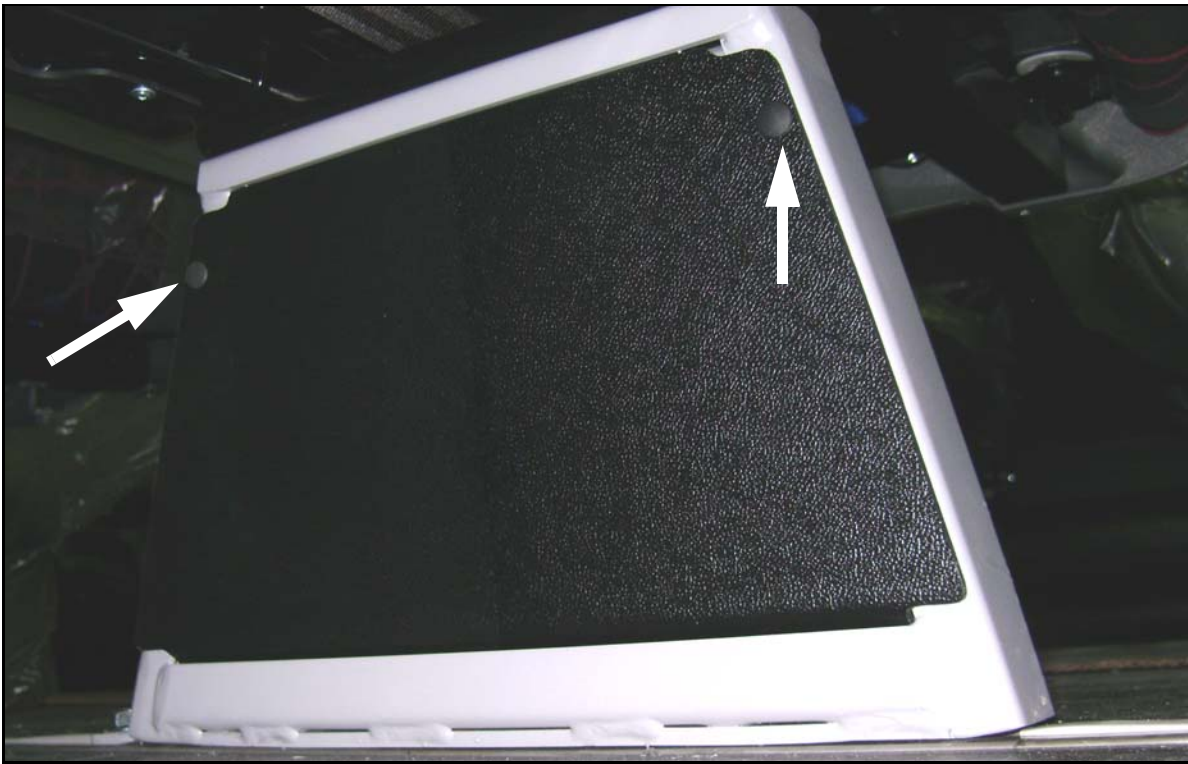
Figure 1. Passenger seat base cover panel.

5. Carefully pull to remove the two (2) snap fasteners utilized to secure the cover panel shown in Figure 1. Remove and retain the cover panel to be re-installed at a later step in this procedure. Discard the existing snap fasteners.
6. Repeat Step 5 to the remaining fixed, non-sliding passenger seat bases.

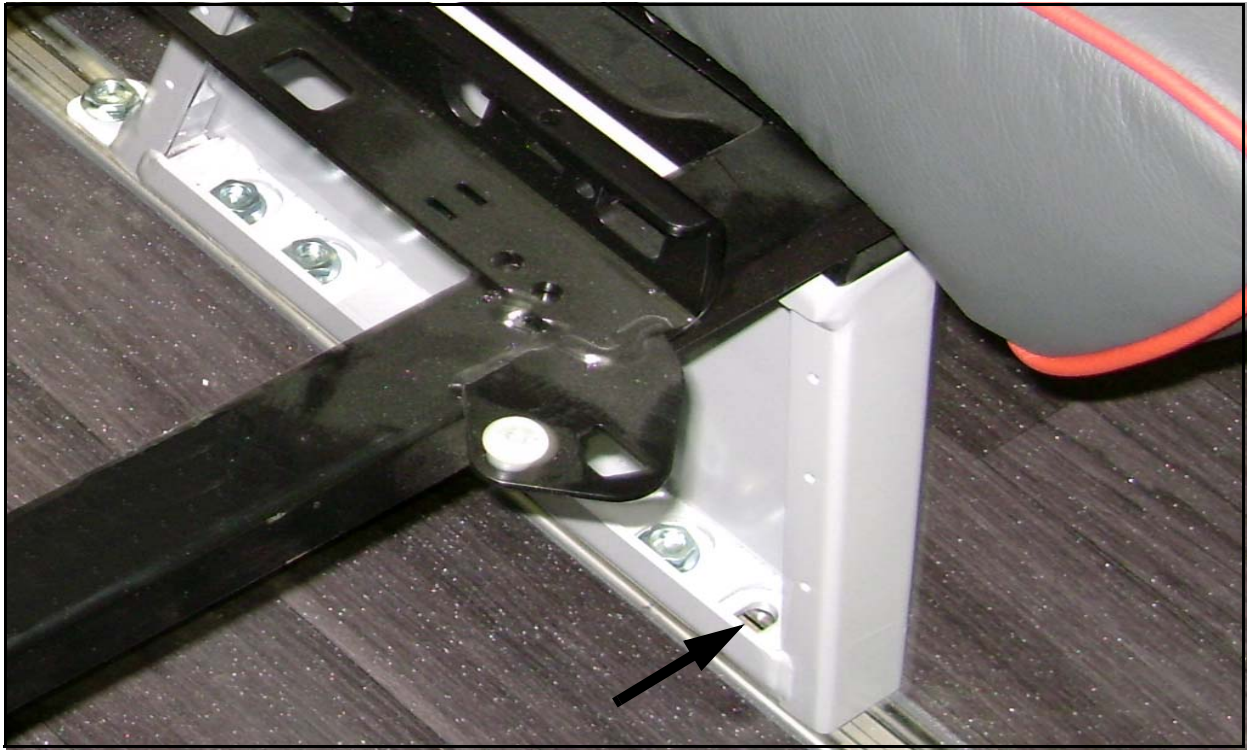
Figure 2. Correct installation of mounting hardware.

If the mounting hardware is installed correctly as shown in Figure 2, no further action required. Re-install the cover panel to the seat base using the two (2) snap fasteners, p/n 19-05-0304.

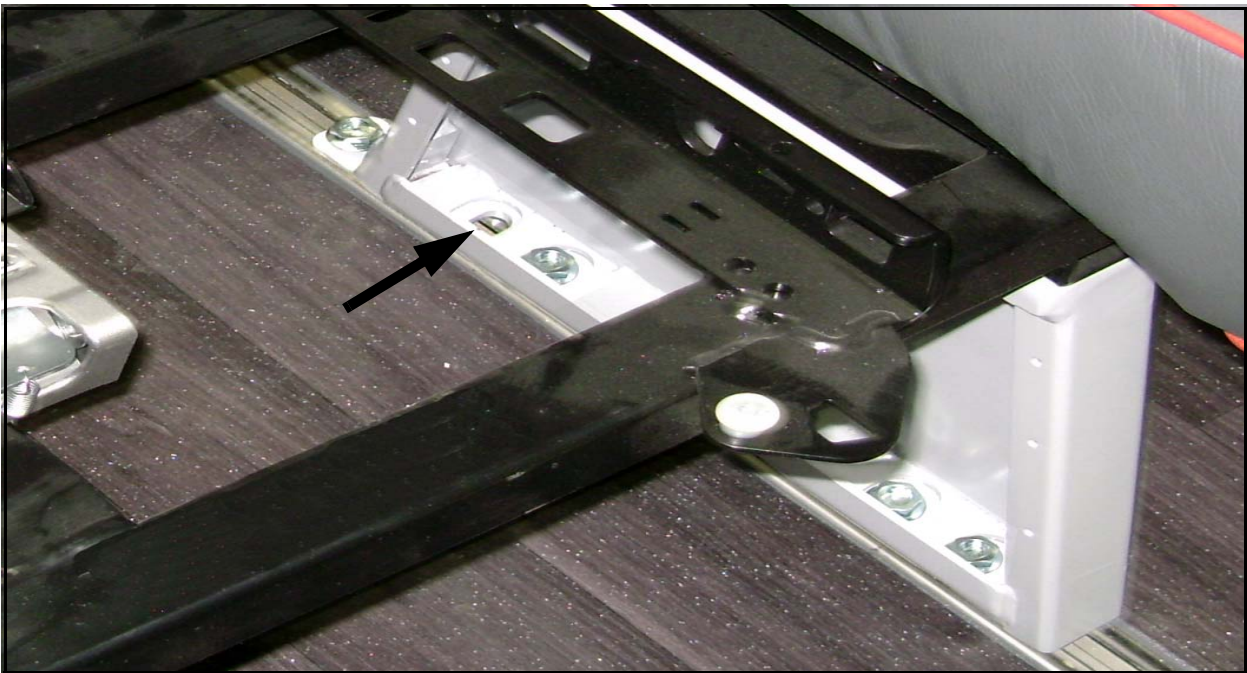
Figure 3. Incorrect installation of mounting hardware.

Motor Coach Industries ("MCI") has become aware that a bolt fastening the seat pedestal to the seat track on the J4500 coaches listed below may have been installed in the incorrect location.

Incorrect mounting fastener location at the production plant.

If the mounting hardware is installed incorrectly as shown in Figure 3, proceed to Step 7.

8. Locate the passenger seat mounting hardware on the coach sidewall. Remove and discard the nuts from the mounting t-bolts (refer to Figure 7).
9. Locate the passenger seat mounting hardware on the seat base (refer to Figure 3). Remove and discard the nuts from the mounting t-bolts.

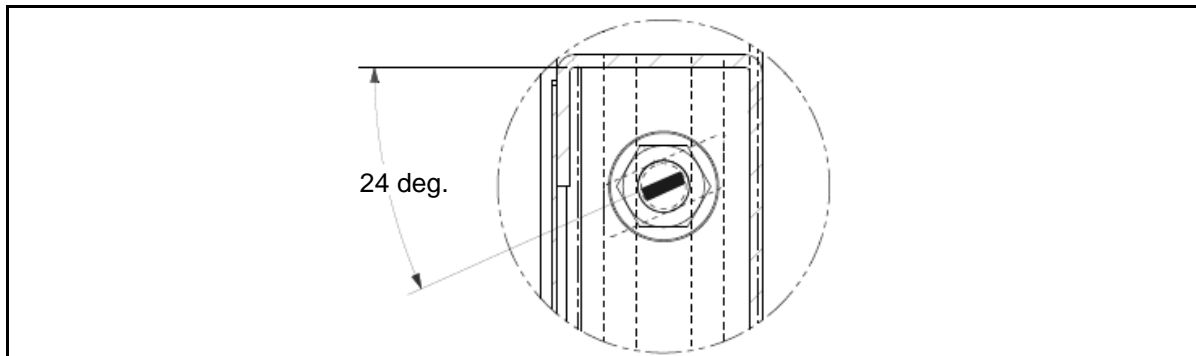
Figure 4. Floor track t-bolt locked angle.

13. Orient and align the four (4) new t-bolts, p/n 3R-11-32, in the floor track. Slide under the seat pedestal until the t-bolt is aligned with the seat pedestal hole at the four (4) locations shown in Figure 5. Rotate the t-bolt to lock into the floor track. The notch on top of the t-bolt should be at 24 degrees when locked in place (refer to Figure 4).

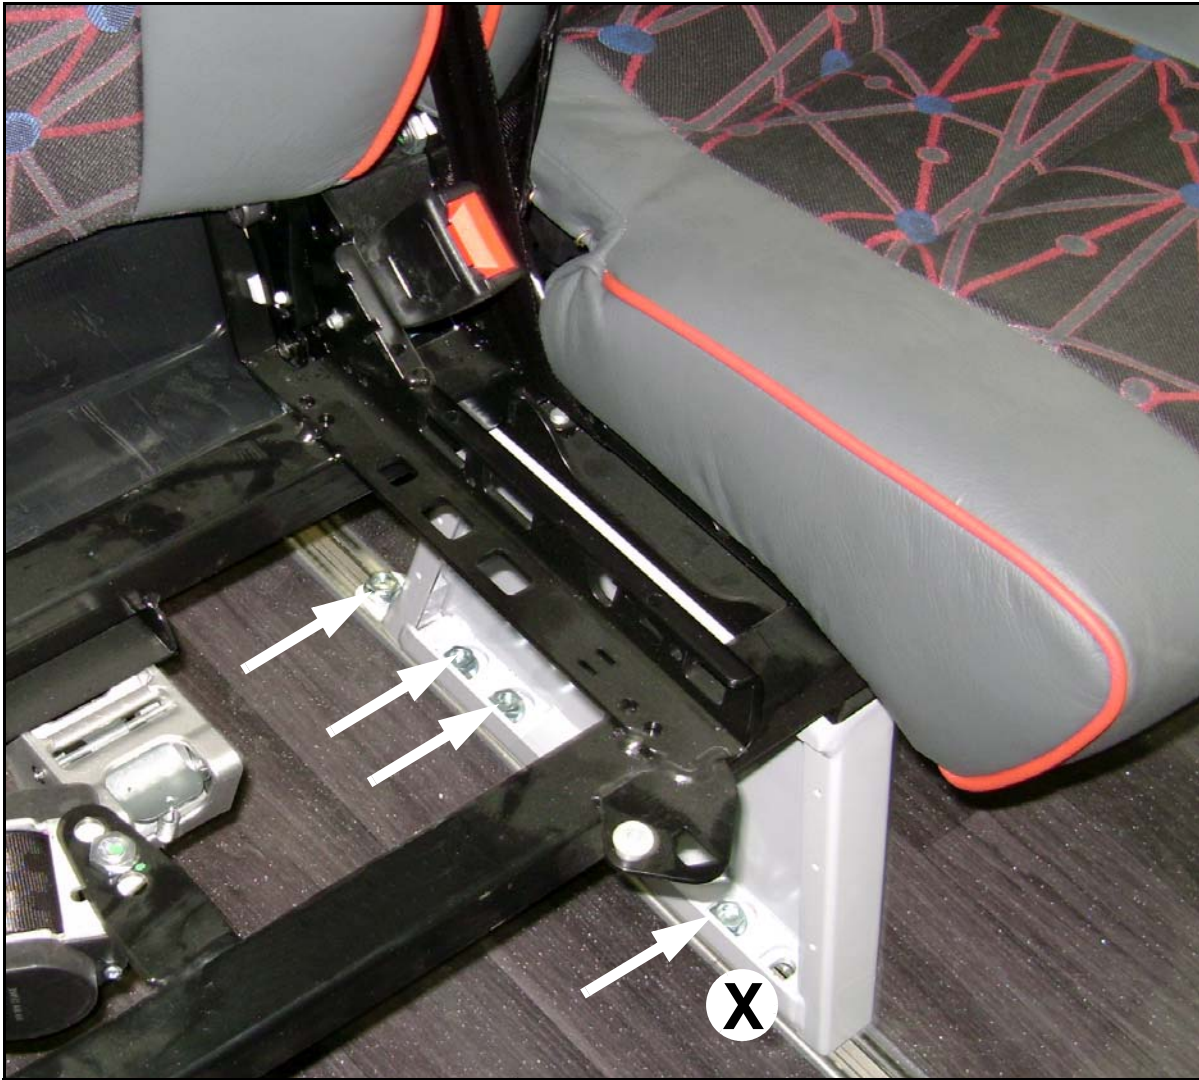
Figure 5. Correct floor track t-bolt location.

For proper installation, do not install a t-bolt at the location marked with an X in Figure 5.

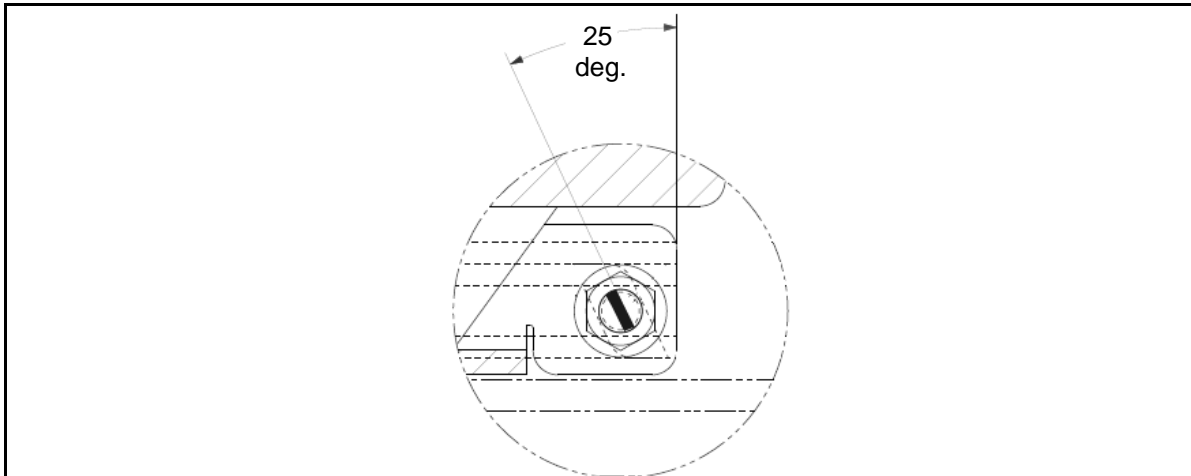
Figure 6. Sidewall track t-bolt locked angle.

14. Orient and align three (3) new t-bolts, p/n 3R-11-24, with the marks made on the sidewall track. Rotate the t-bolt to lock into the sidewall track. The notch on top of the t-bolt should be at 25 degrees when locked in place as shown in Figure 6.

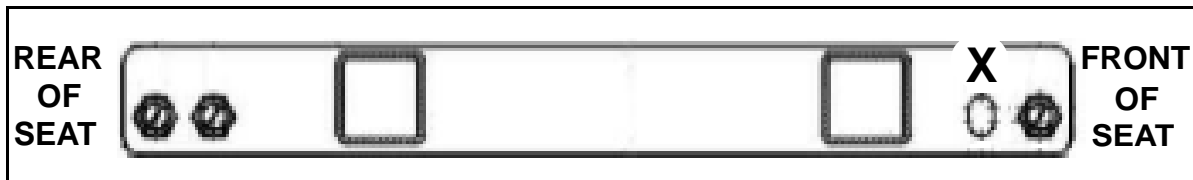
Figure 7. Coach sidewall t-bolt location.

For proper installation, do not install a t-bolt at the location marked with an X in Figure 7.
