HYUNDAI NEW THINKING. NEW POSSIBILITIES. Technical Service Bulletin	GROUP	NUMBER
	CAMPAIGN	16-01-006
	DATE	MODEL(S)
	FEBRUARY 2016	2015 GENESIS SEDAN (DH)
SUBJECT: 2015MY GENESIS SEDAN (DH) TIRE REPLACEMENT (RECALL 138)

Description: On certain 2015MY Genesis sedan (DH) vehicles the original equipment tires (Hankook Ventus S1 Noble 2) may exhibit uneven tread wear; and/or cracks along the sidewall(s). The cracks in the sidewall of a tire could result in air loss and a loss of vehicle control, increasing the risk of a vehicle crash.

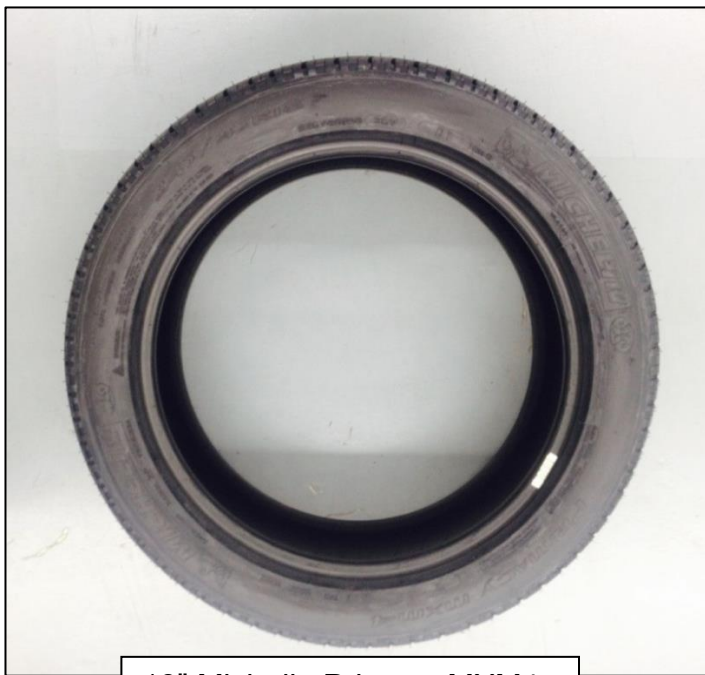
18” Michelin Primacy MXM4

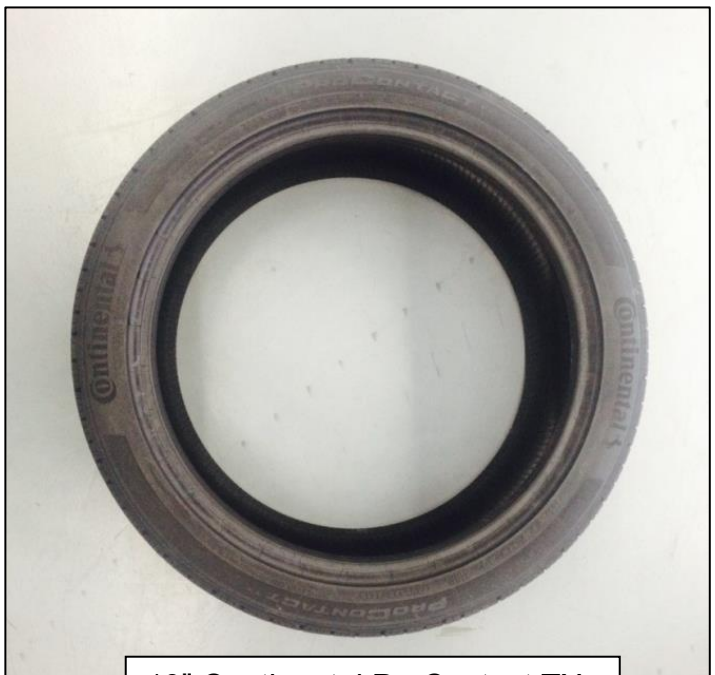
19” Continental ProContact TX

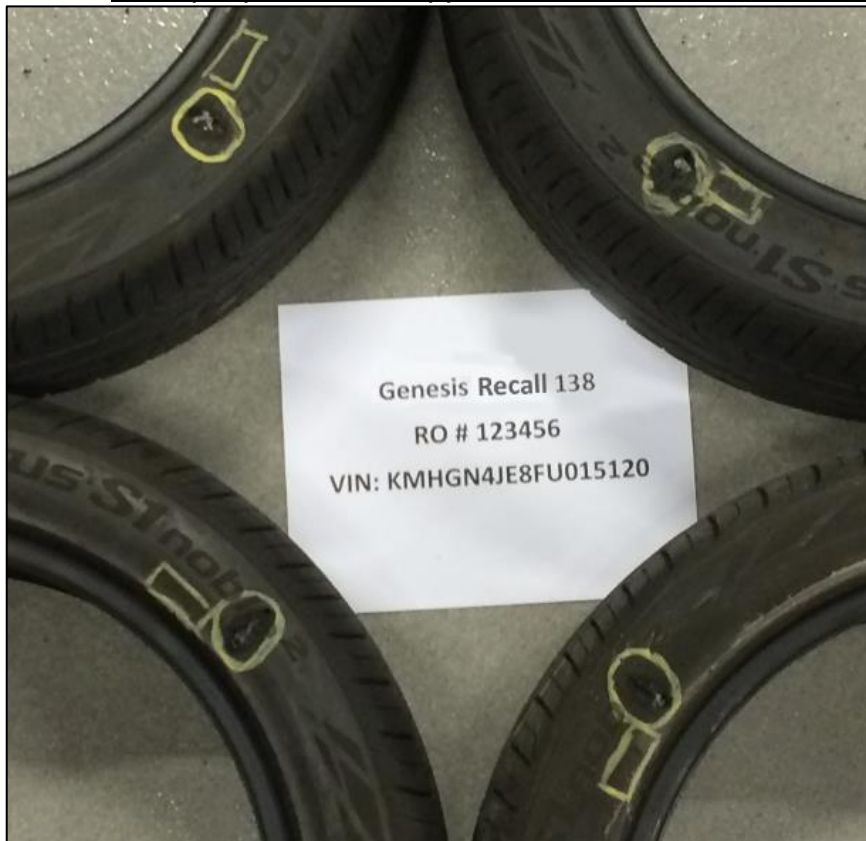
Example photo of scrapped tires and RO/VIN number

- Drill a hole into the sidewall of each tire next to the DOT number. This hole must be made using a uni-bit until the bit goes completely through the tire.
- Arrange all replaced tires from the same vehicle so that the DOT number and the newly drilled holes are visible for all replaced tires.
- In large and legible writing, write the RO and/or VIN number on a piece of paper, and place the paper in the center of the arranged tire(s). See example photo below.
- Take a photo of the arranged tire(s) and paper and review the photo to make sure that the DOT number, the newly drilled hole(s), and the RO and/or VIN number are clearly visible for all tire(s). See example photo below.

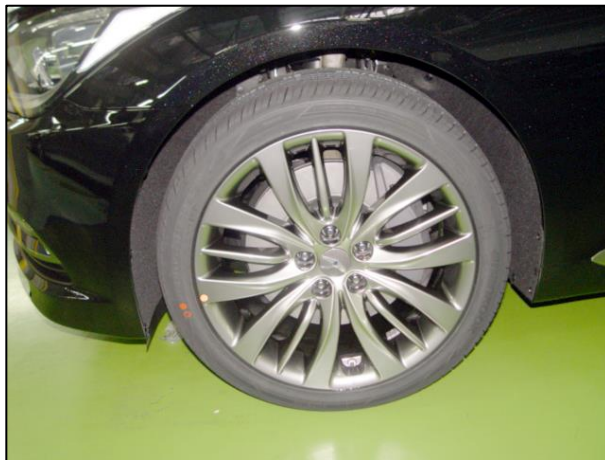
1. Lift the vehicle on a hoist, remove the wheel lug nuts, and remove the wheel and tire assemblies.

Tightening torque: 65.1~79.6 lb-ft (88.3~107.9 Nm, 9.0~11.0 kgf.m)

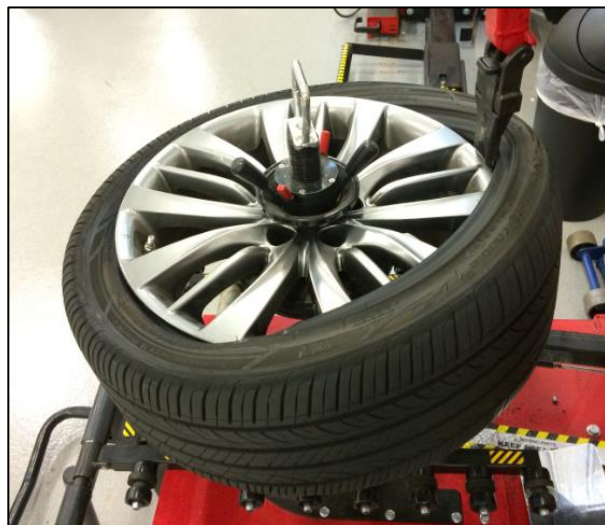
2. Separate the tires from the wheels and install the new tires.

Take care to not damage the TPMS sensor.

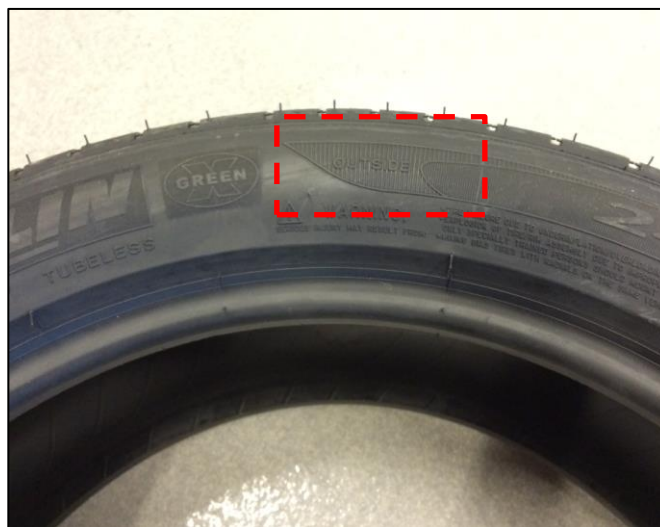
The 18" Michelin tires need to be mounted with the "OUTSIDE" label facing the outside of the vehicle.

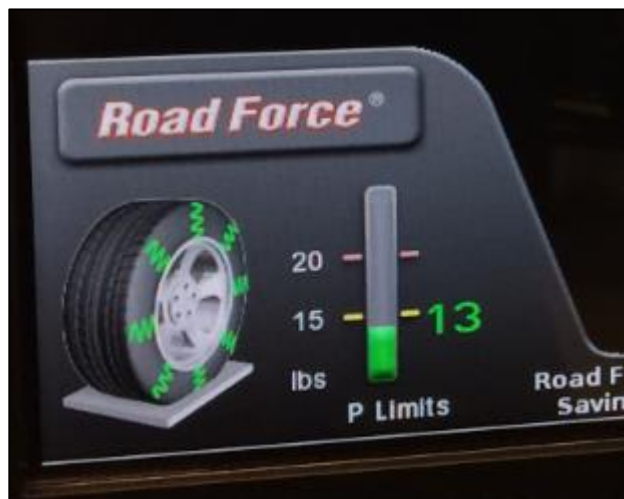
3. Balance the wheel/tire assemblies, and check road force variation (RFV).

Record the RFV value of each assembly on the worksheet at the end of this TSB.

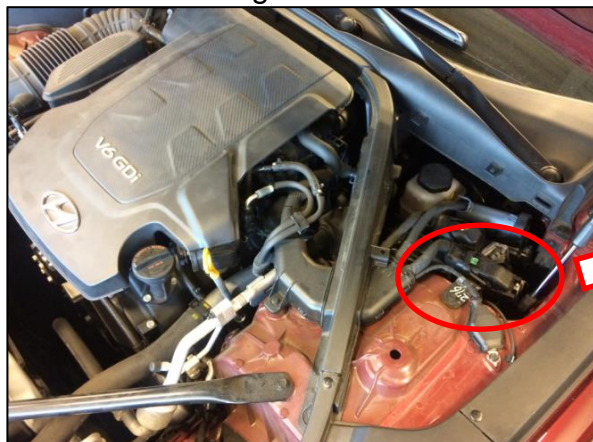
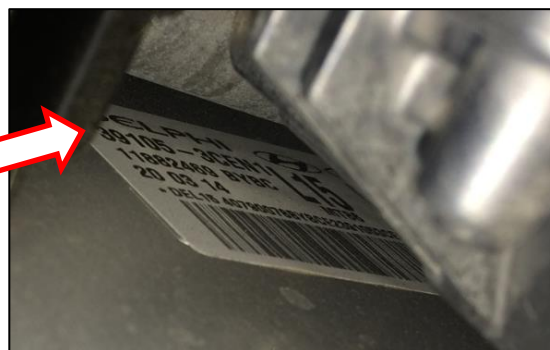
- 1) To verify the vehicle is affected, check the version of the ROM ID according to the ROM ID Information Table, below.
 - a. ECU part number can be checked by the sticker located on the ECU case, as shown in the images below.

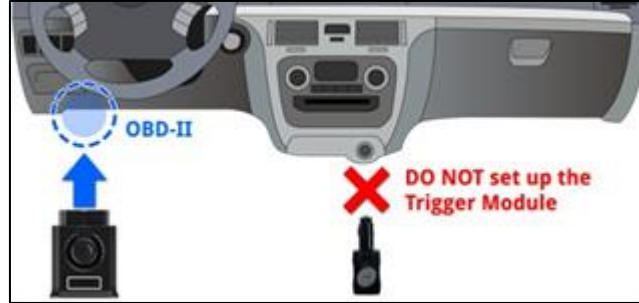
1. Connect the VCI-II into the vehicle's DLC connector under the driver side instrument panel and check to ensure the VCI-II is powered on.
