SUBJECT: RECALL R15YH
Vision Wiper Motor Electrical Connector

IMPORTANT SAFETY RECALL NOTICE

**NHTSA RECALL NO. 15V-691 SCHOOL BUS
NHTSA RECALL NO. 15V-696 NON-SCHOOL BUS**

Vision Wiper Motor Electrical Connector

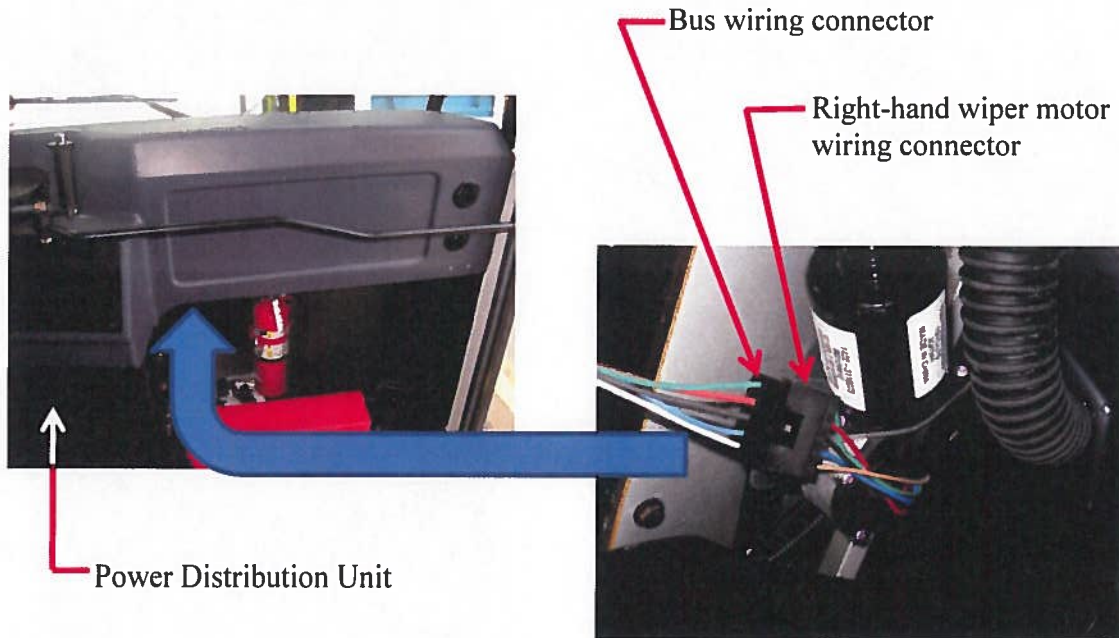
1. Park bus, turn off ignition and remove the keys.
2. Locate the wiper motors and inspect and repair if necessary, per attached instructions pages 1-5.
3. The right-hand wiper motor is located to the right side of Power Distribution Unit.

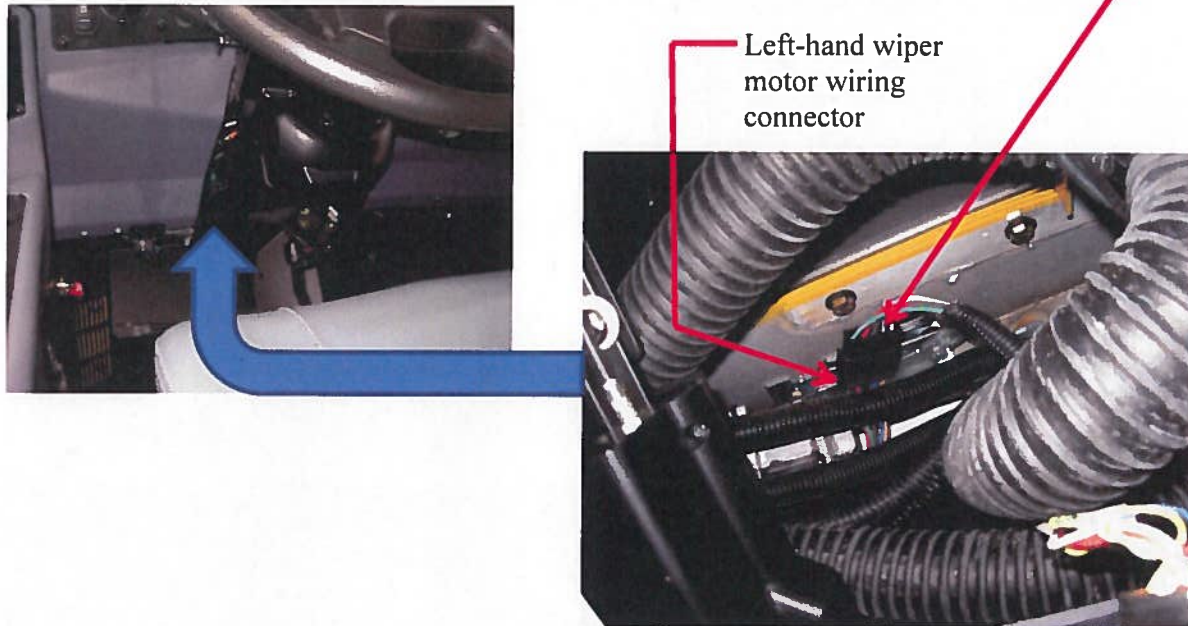
4. The left-hand wiper motor is located on the left-side of the steering column.

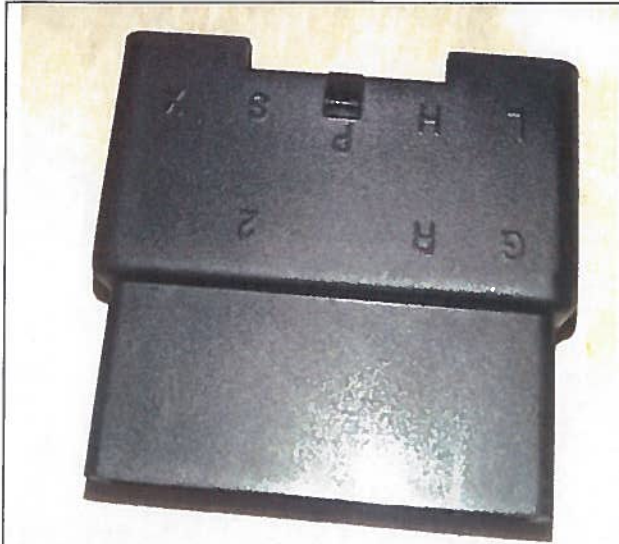
1. Inspect the connector body for damage.

If any damage to the connector body is found please see Work Instruction "105715 Connector Replacement Instructions".

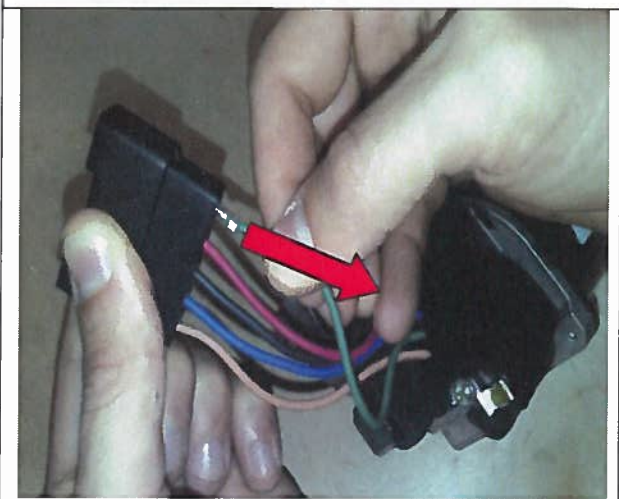
2. Pull on each wire of the motor connector and try remove the terminals, any terminals which will not pull out are inserted securely.

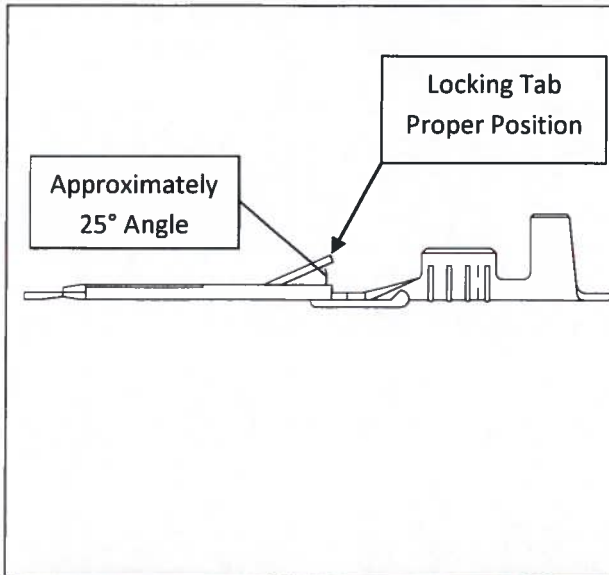
3. Examine each loose terminal for proper locking tab position, if the terminal does not match the picture shown perform step 4. If the terminal has the locking tab in the correct position move on to step 5.

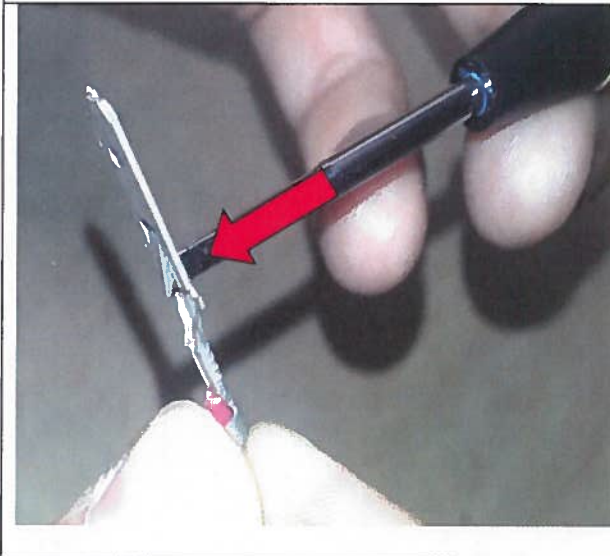
4. Using the miniature screwdriver push the locking tab outwards until it matches the image shown in step 3.

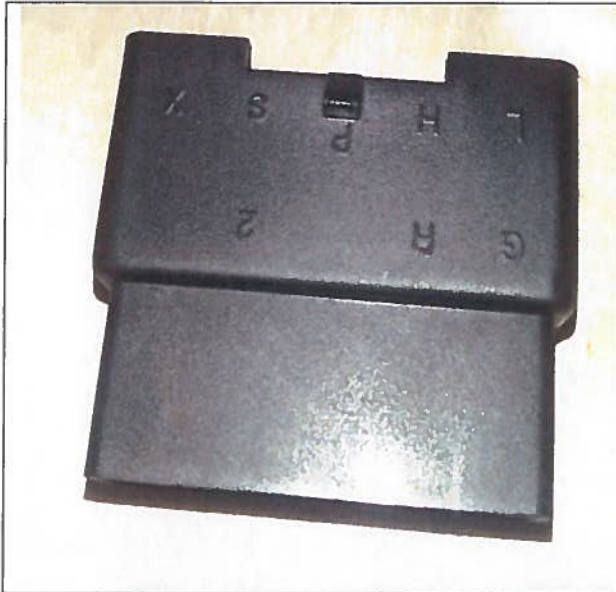
5. The motor connector has labeled cavities corresponding to the correct wire color.

- L – Green
- H – Red
- P – Black
- S – Blue
- X – Brown

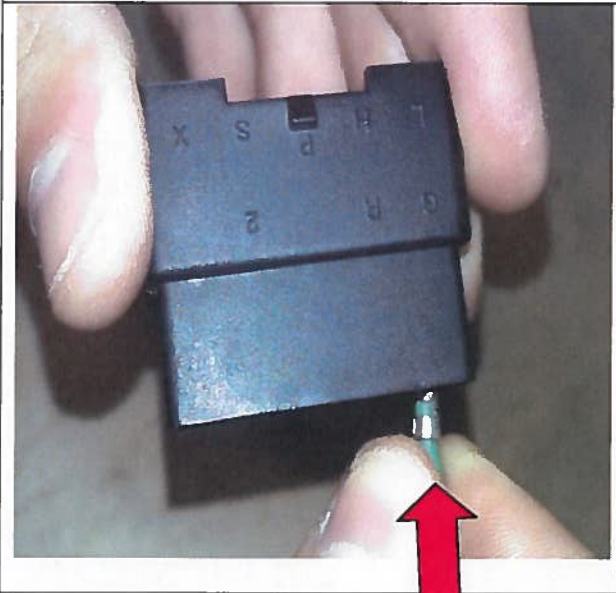
Insert the terminals into the connector until a “clicking” sound can be heard, this is the locking tab engaging with the connector body.

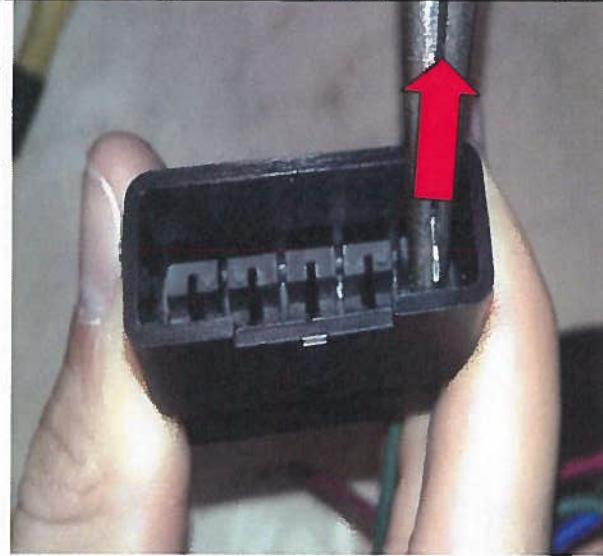
If no clicking sound can be heard gently pull on the terminal with the miniature pliers until a “click” is heard. Insure that the terminal is not pulled through the connector.

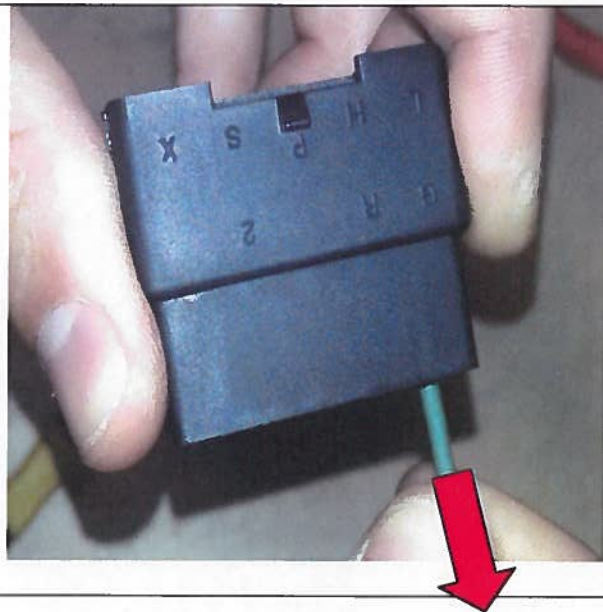
6. Try to pull each terminal out of the connector to verify proper installation. If the terminal moves freely repeat steps 3 – 6.

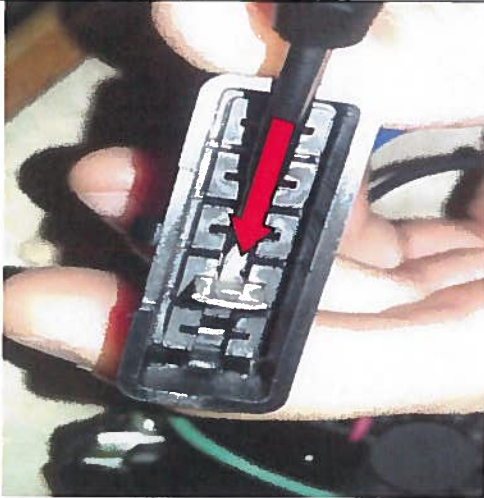
1. To remove the wires from the damaged connector locate the terminal locking tabs as shown.
2. Use the miniature screwdriver to push in the locking tab while also pulling on the wire until the terminal slides free from the connector. Loose wires will not require pushing in the locking tab. Repeat this step for all terminals remaining in the connector.

Discard the damaged connector.

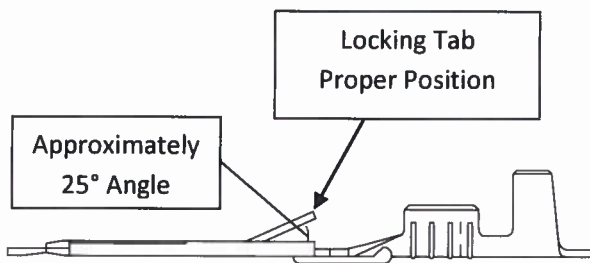
3. Examine each loose terminal for proper locking tab position. If the terminal does not match the picture shown move on to step 4. If the terminal has the locking tab in the correct position move on to step 5.

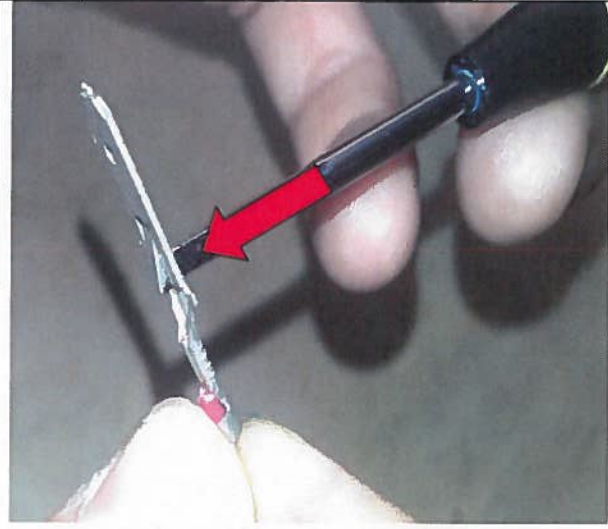
- Using the miniature screwdriver push the locking tab outwards until it matches the image shown in step 3.

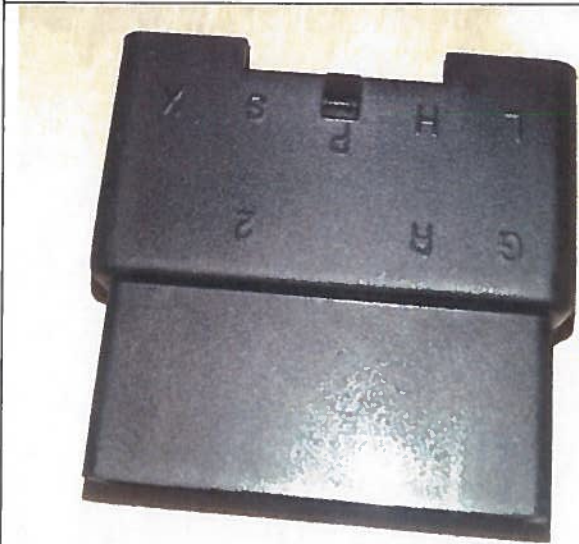
- The 400121 connector has labeled cavities corresponding to the correct wire color.

L – Green
H – Red
P – Black
S – Blue
X – Brown

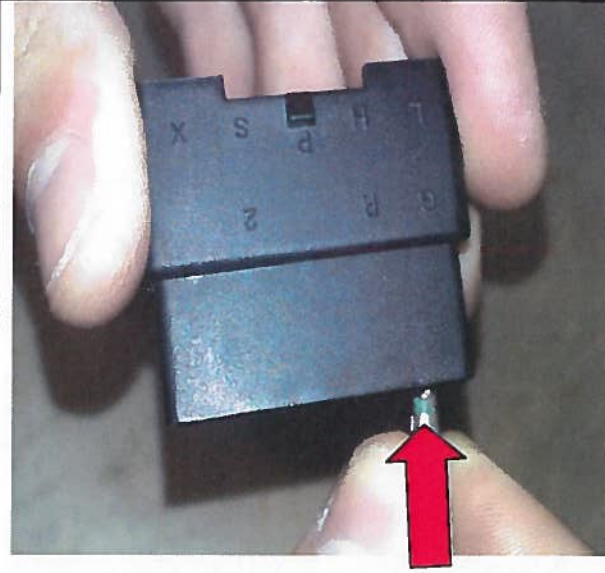
Insert the terminals into a new 400121 connector until a “clicking” sound can be heard, this is the locking tab engaging with the connector body.

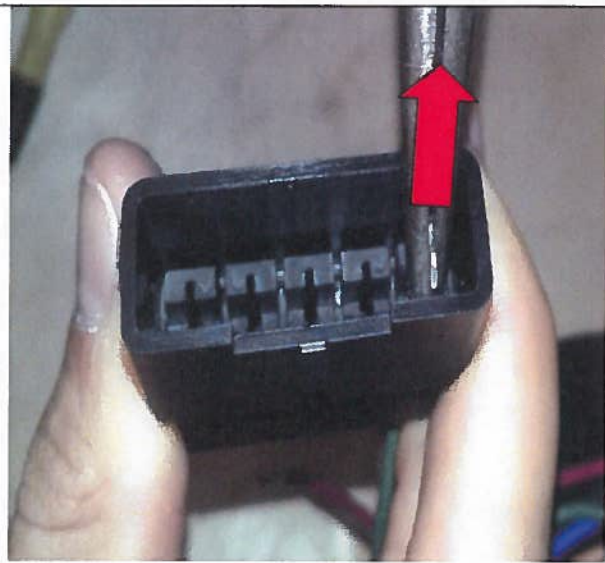
If no clicking sound can be heard gently pull on the terminal with the miniature pliers until a “click” is heard. Insure that the terminal is not pulled through the connector.

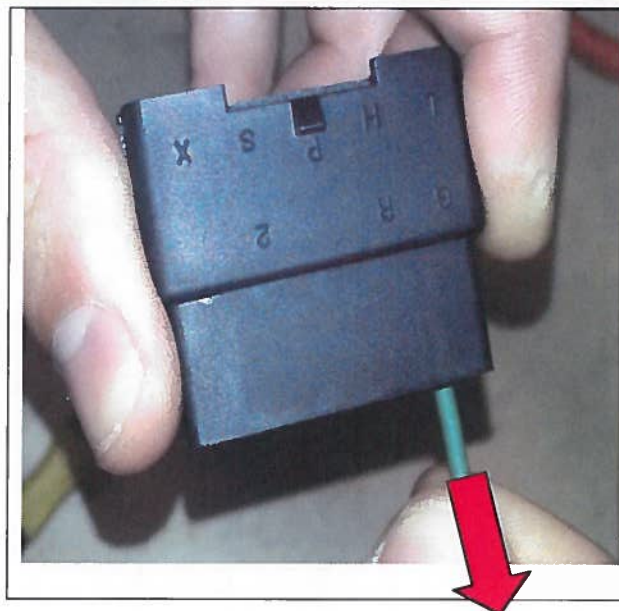
6. Try to pull each terminal out of the connector to verify proper installation. If the terminal moves freely repeat steps 3 – 6.
