Bulletin No.: 15166B  
Date: April 2015

# Recall Bulletin

**SUBJECT:** Rim Size Missing on Certification Label

**MODELS:** 2015 Buick Encore  
2015 Chevrolet Trax

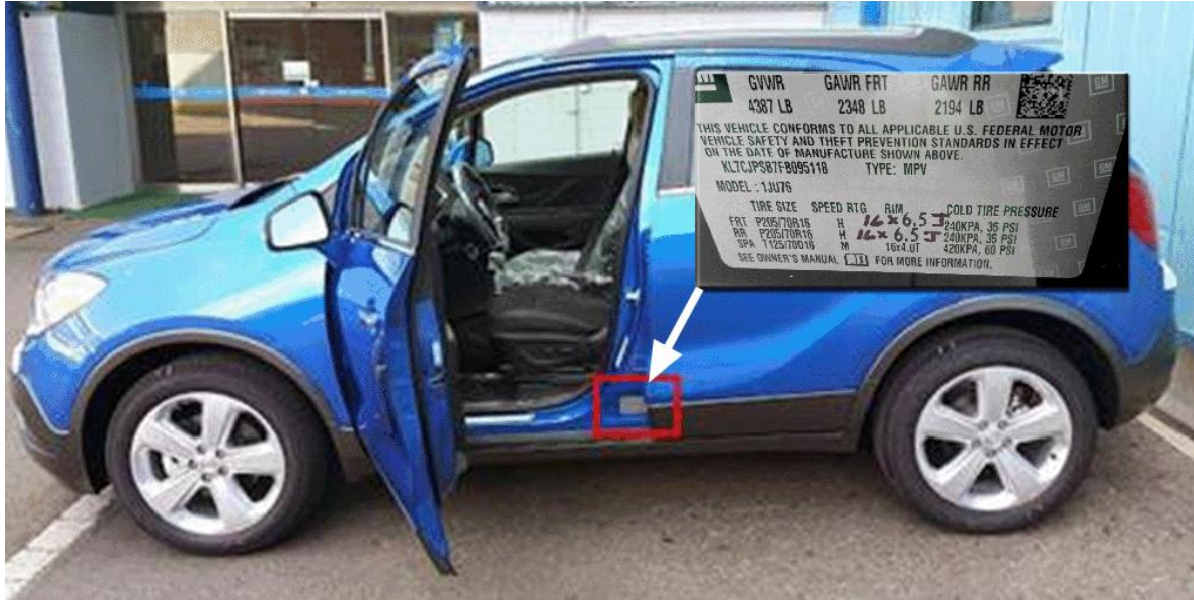
4122076

1. Open the driver's door.

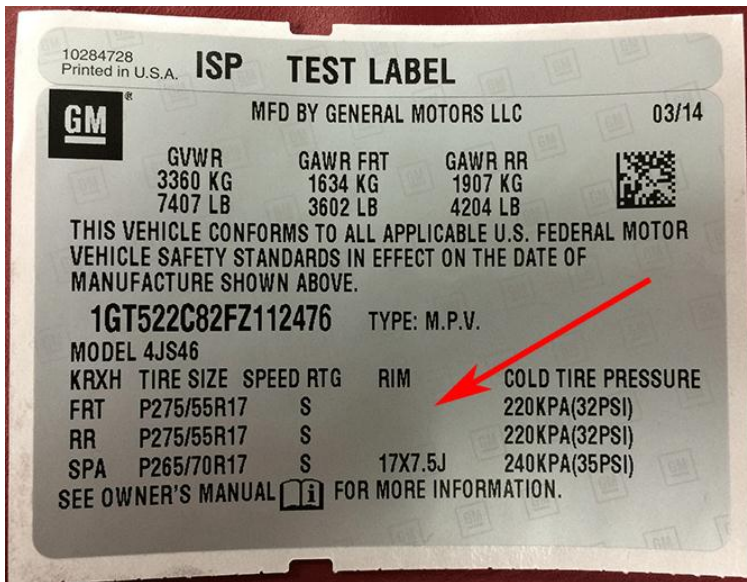
4152238

2. Locate the Vehicle Certification Label on the lower section of the driver's door jamb as illustrated above.

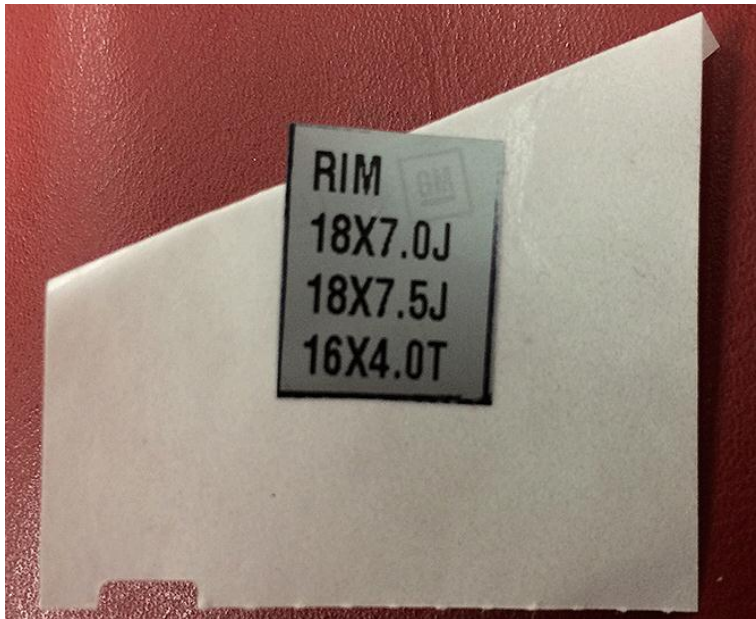
4152227

3. The original label may be blank under the "RIM" column, or have information hand written in. If the label is hand written, you may remove the writing with isopropyl alcohol (rubbing alcohol) before applying the overlay.
4. The original label must be clean and dry before installing the overlay label.

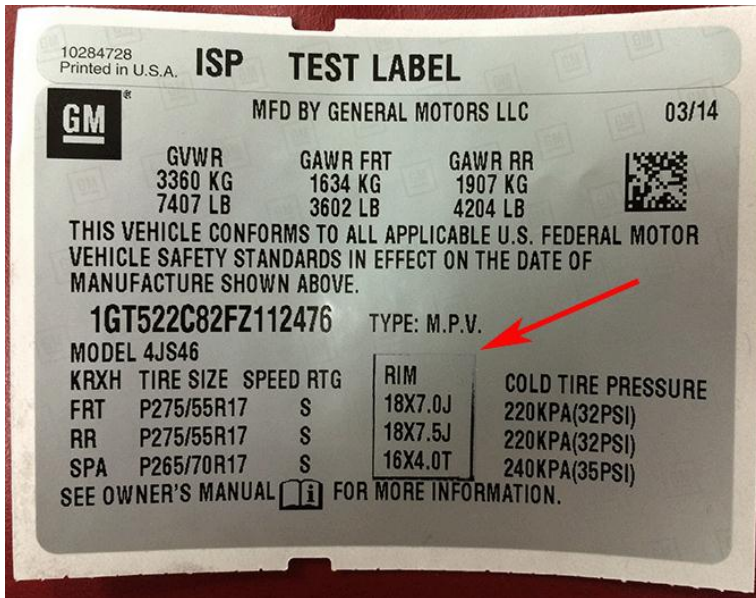
4152349

5. Locate the overlay label included with these instructions. Remove the label from the backing by folding the backing paper as shown above.

6. Apply the overlay label in the location shown above. Assure the label is properly positioned before allowing contact with the original label. The adhesive used is very aggressive and will not allow repositioning once the label is applied.
7. Close the driver's door.

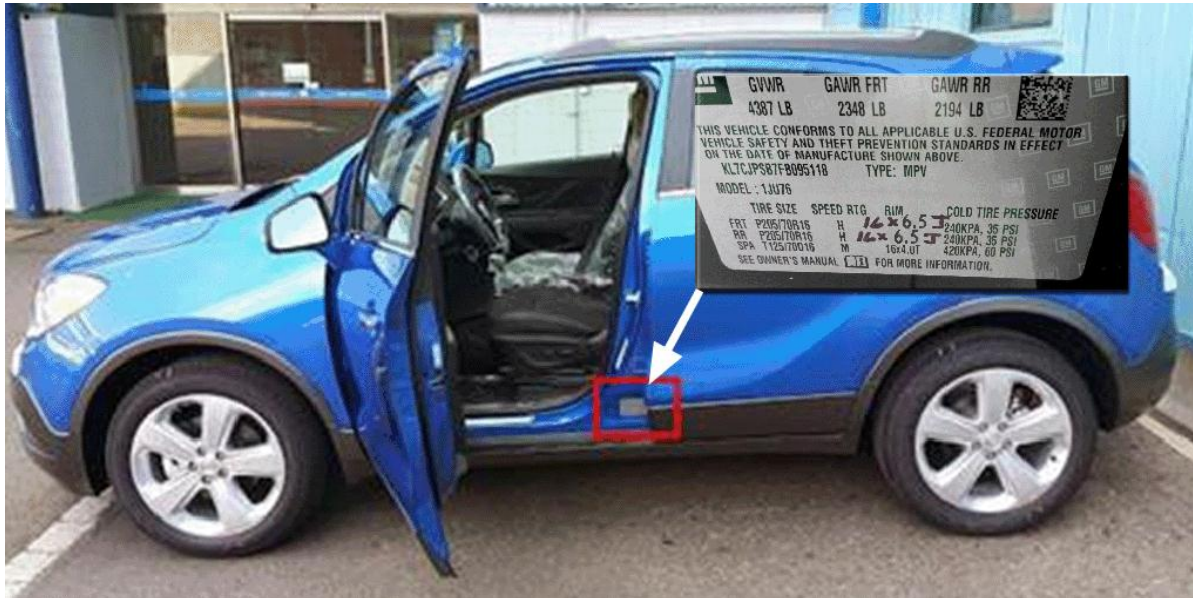
4122076

1. Open the driver's door.

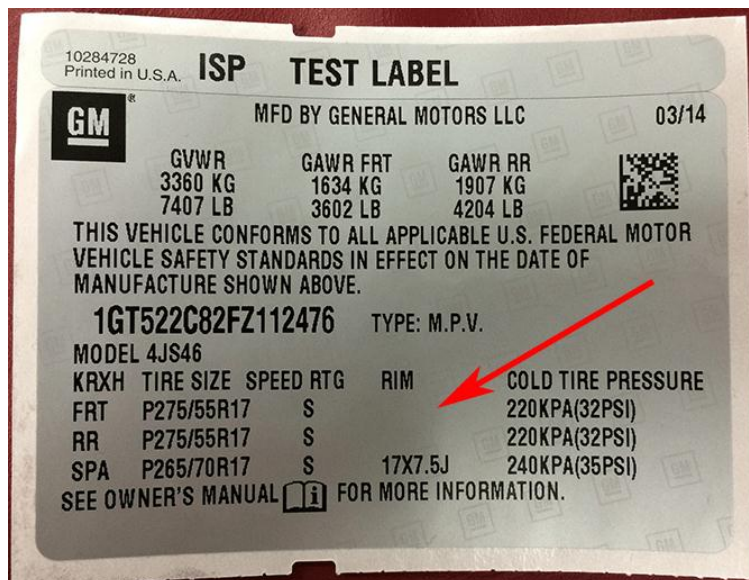
4152238

2. Locate the Vehicle Certification Label on the lower section of the driver's door jamb as illustrated above.

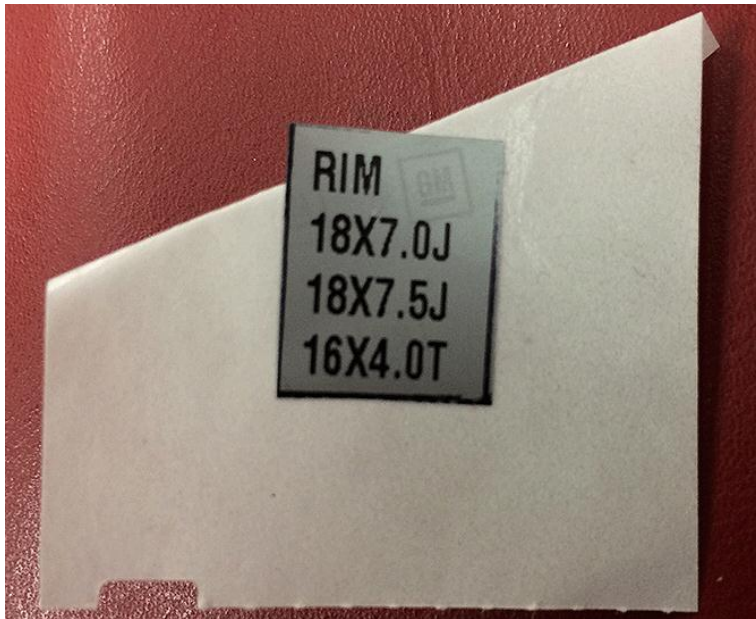
4152227

3. The original label may be blank under the "RIM" column, or have information hand written in. If the label is hand written, you may remove the writing with isopropyl alcohol (rubbing alcohol).
4. The original label must be clean and dry before installing the overlay label.

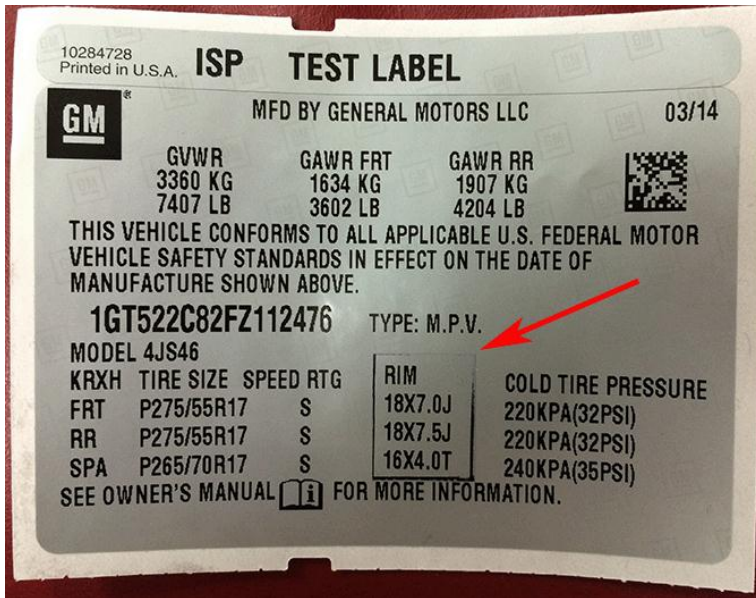
4152349

5. Locate the overlay label included with these instructions. Remove the label from the backing by folding the backing paper as shown above.

6. Apply the overlay label in the location shown above. Assure the label is properly positioned before allowing contact with the original label. The adhesive used is very aggressive and will not allow repositioning once the label is applied.
7. Close the driver's door.
