# Product Safety Recall

## 15438 Front Passenger Air Bag Inflator

**Reference Number:** N15043800

**Release Date:** August 2021

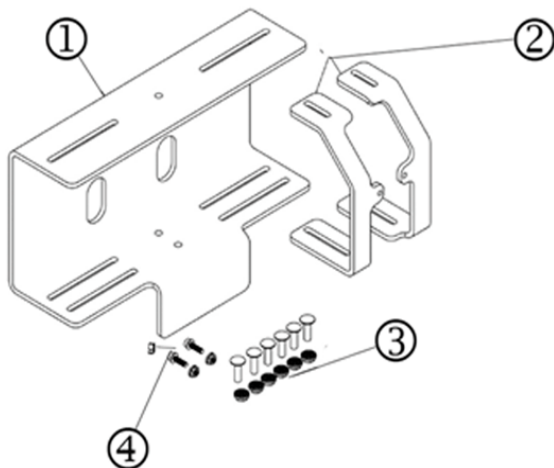
4006668

(1) Mounting Bracket (2) Support Bars (3) Support Bar Hardware (4) Air bag Mounting Hardware.

All U.S. dealers have been shipped the required air bag mounting bracket, shown below, to replace the front passenger air bag inflator module. These brackets were provided to dealers by General Motors through Bosch Automotive Service Solutions in late 2015. The Bosch tool number is EL-51377. If your dealership does not have the air bag mounting bracket, do not attempt to perform this service procedure and immediately contact Bosch at 1-800-GM-TOOLS for assistance. Attempting to replace the front passenger air bag inflator module without using the bracket poses a safety risk for the technician and anyone else in the area.

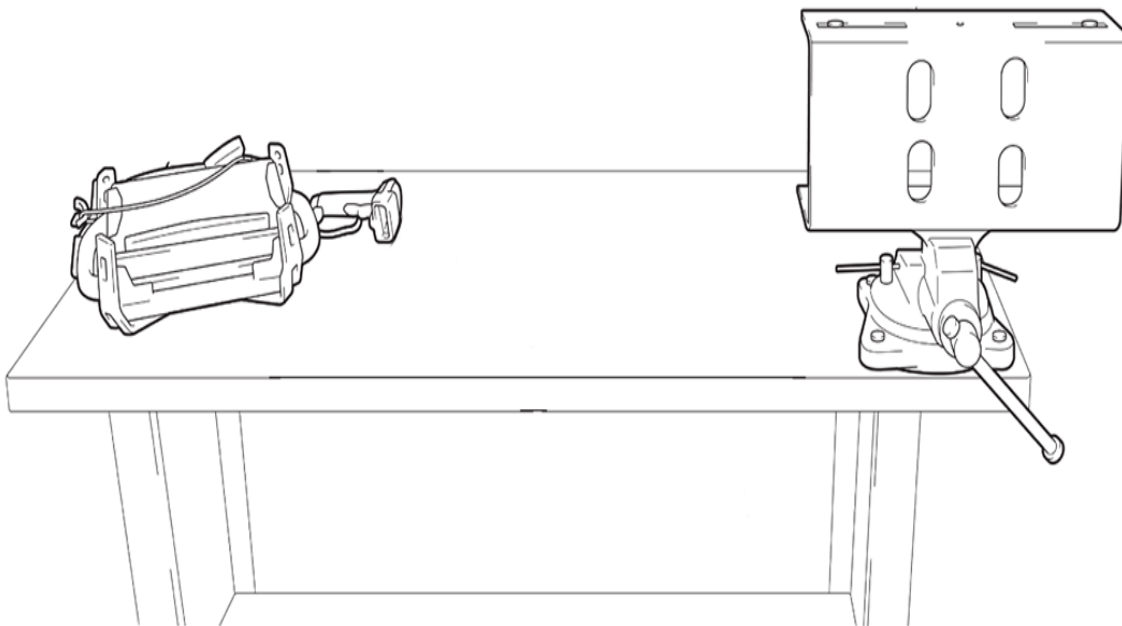
3607819

**Danger:** To avoid personal injury or death, it is critical to use an air bag module bracket when replacing an inflator module. Carefully read and follow the instructions below:

1. Confirm the bracket assembly is installed securely in the vice.
2. Confirm there are no loose objects or people exposed to the back side of the bracket for safety in the unlikely event of air bag deployment due to improper work procedures. The air bag is NOT being replaced due to an inadvertent deployment concern.
3. Confirm that no objects, tools or people are within 3 feet (1 meter) of the back side of the bracket.
4. Confirm that no objects, tools or people are within 2 feet (0.6 meters) of the sides of the bracket.

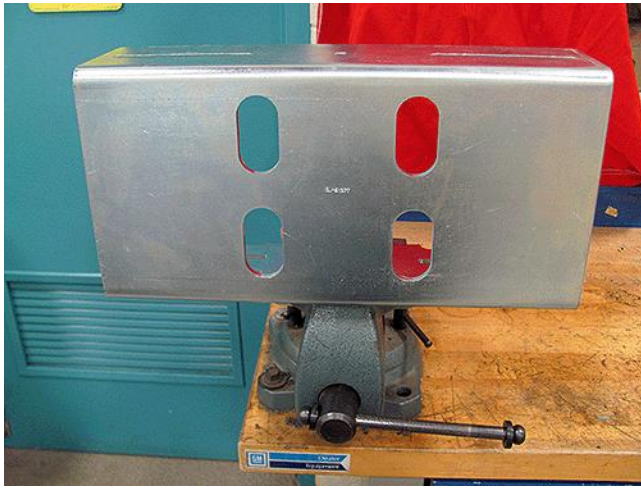
4664047

1. Mount the air bag module bracket securely in a vice.

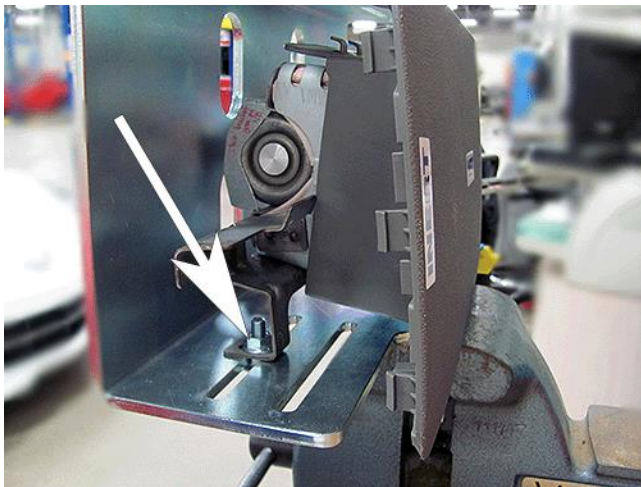
4664048

2. Using the hardware kit supplied with the module bracket, loosely mount the airbag assembly to the bracket using two nuts and bolts.

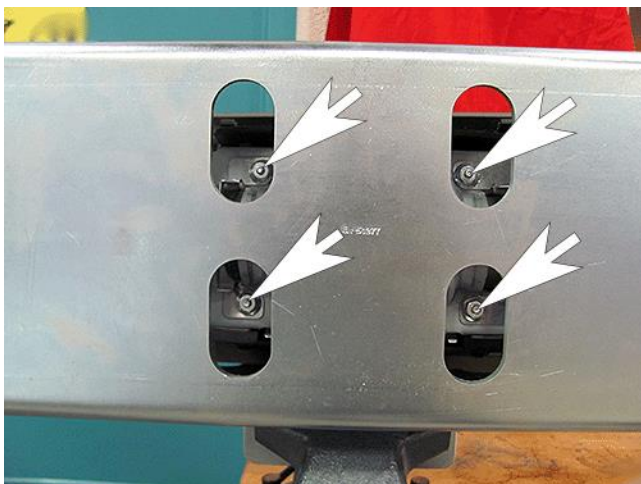
4664049

3. Position the air bag so that all four stopper plate nuts can be removed through the access holes.

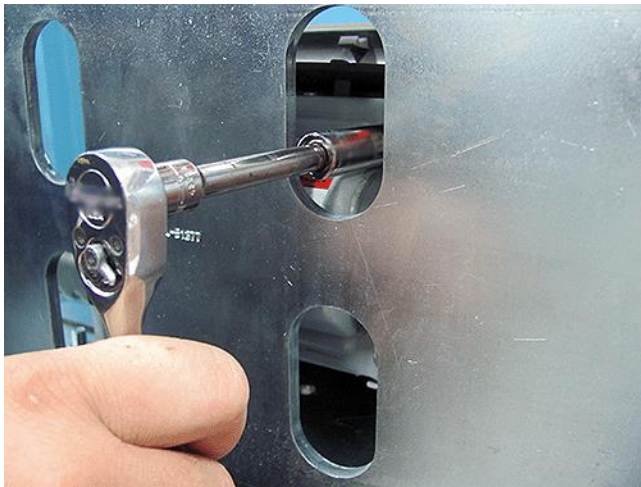
4664052

7. Use the access holes in the bracket to loosen and remove the four self-locking nuts. Discard the nuts, they will not be reused.
8. Remove the two stopper plates.

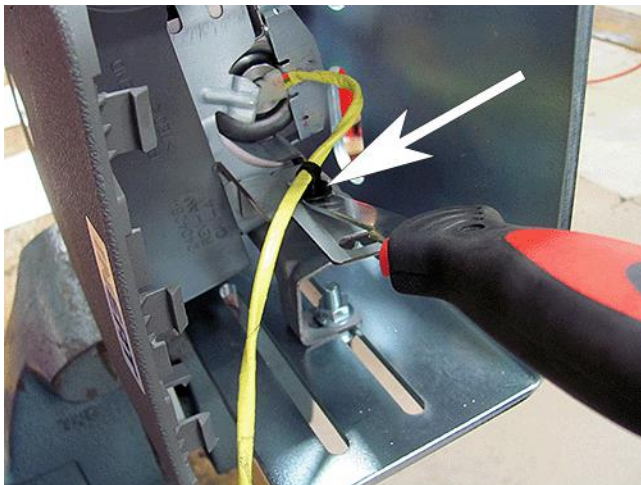
4664053

9. Disengage the wire harness locator from the housing.

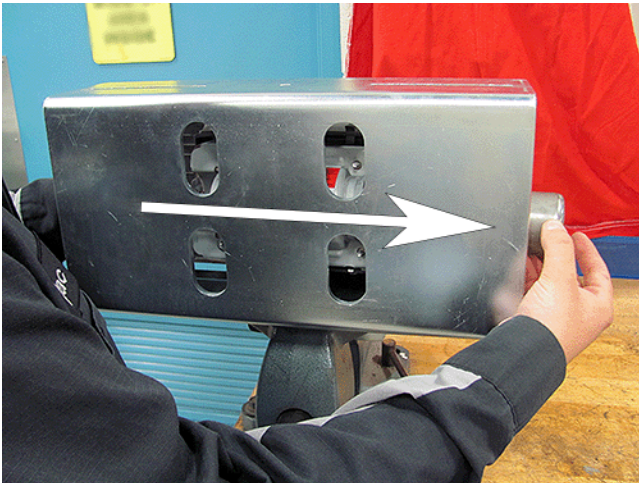
4664060

11. Remove the inflator from the housing, slide the inflator away from the harness side.

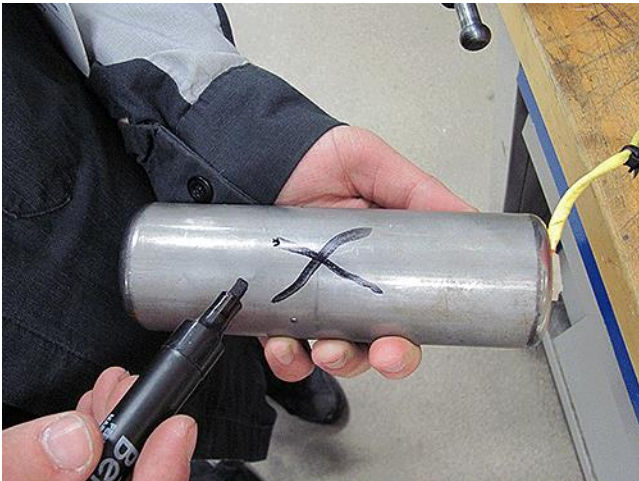
4664063

12. Put a mark on the removed inflator and store it in the provided replacement part box. Refer to the packaging instructions that were included with the new inflator module kit.

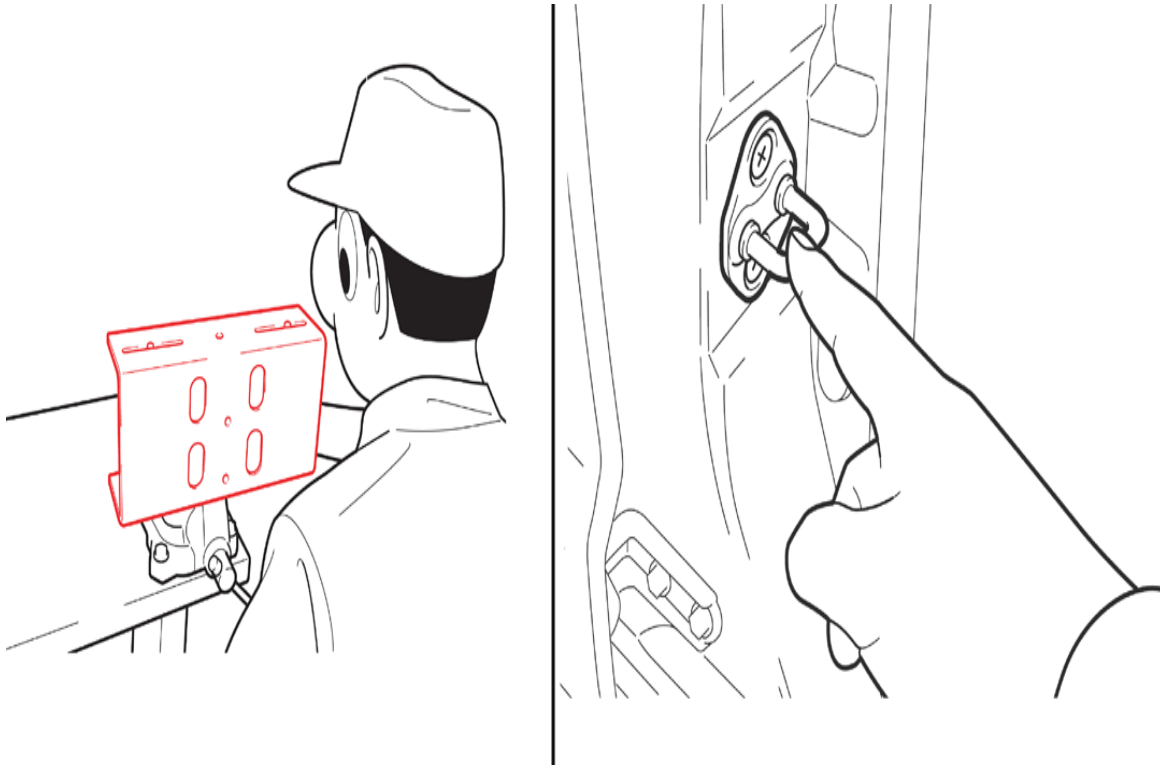
3607909

**Danger:** To avoid personal injury, **ALWAYS** keep as much of your body as possible in front of the bracket when working on the airbag assembly. Remember to periodically touch a metallic part of the vehicle or work bench to discharge static electricity in the body. **DO NOT** use power tools when performing the inflator removal/reinstallation steps.

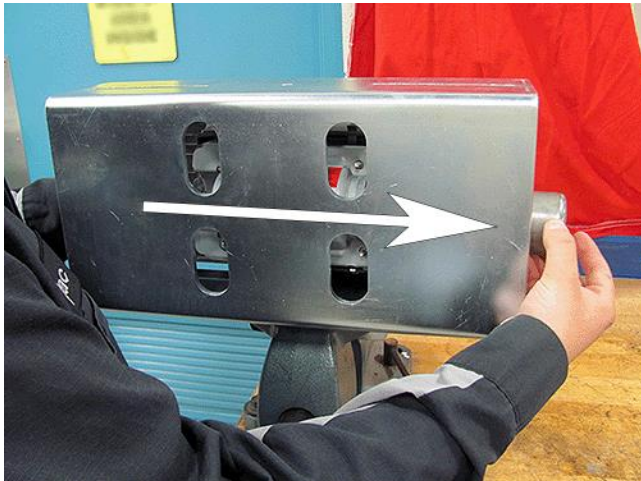
4664060

5. Remove the inflator from the housing, slide the inflator away from the harness side.

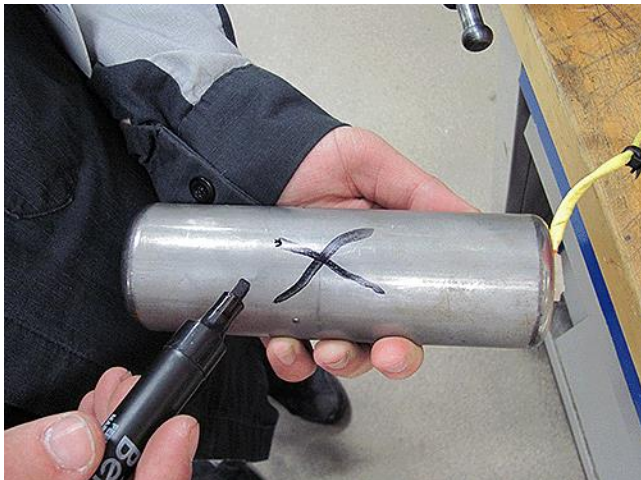
4664063

6. Put a mark on the removed inflator and store it in the replacement part box.

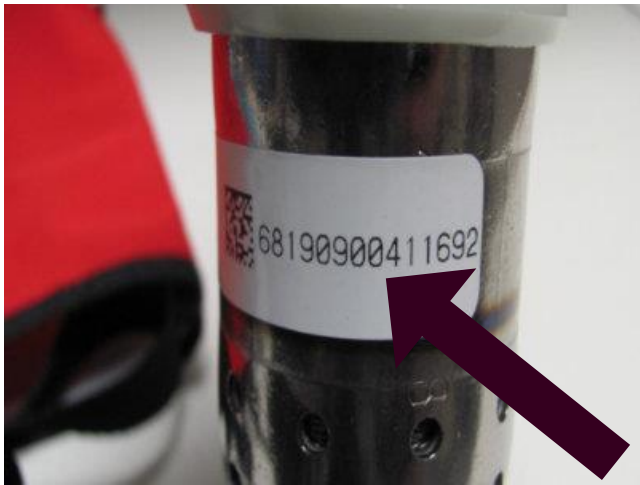
5838265

- Record the serial number of the new inflator from the service kit on the job card.

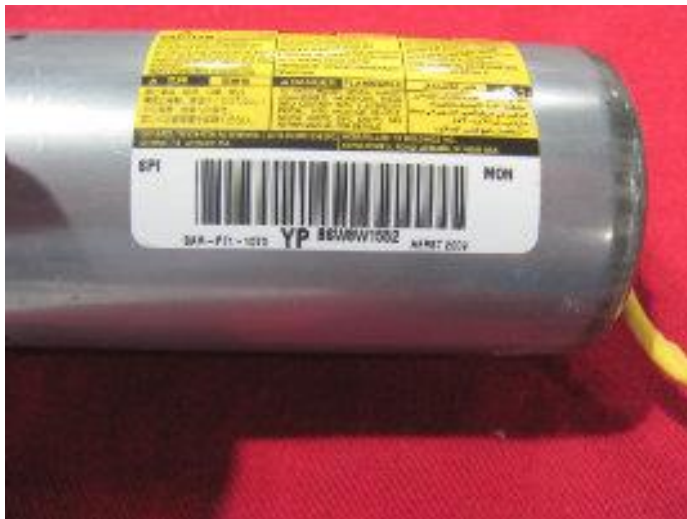
5844318

- Record the serial number of the used inflator that is being returned on the job card.
- Inspect the new inflator for the following two conditions:

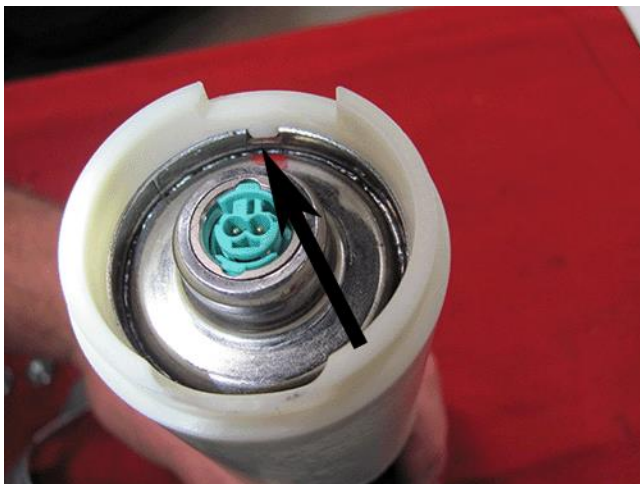
5680402

- Ensure the tab on the white end cap is aligned with the notch in the inflator.

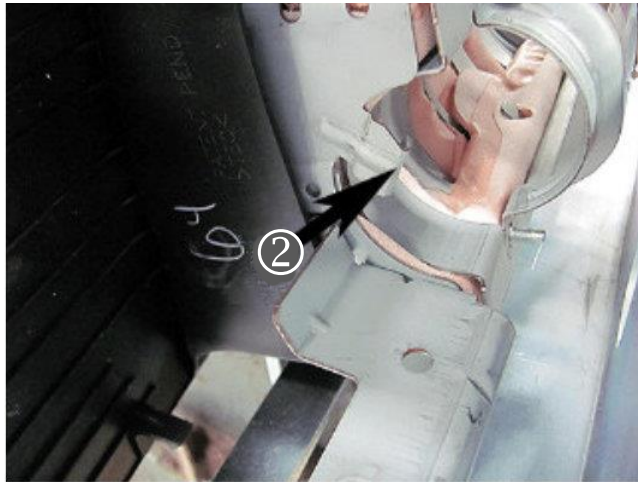
5735686

10. Using a small pair of slip joint pliers, bend the alignment tab on the airbag inward from a 90 Deg. angle (1) to a 45 Deg. angle (2).

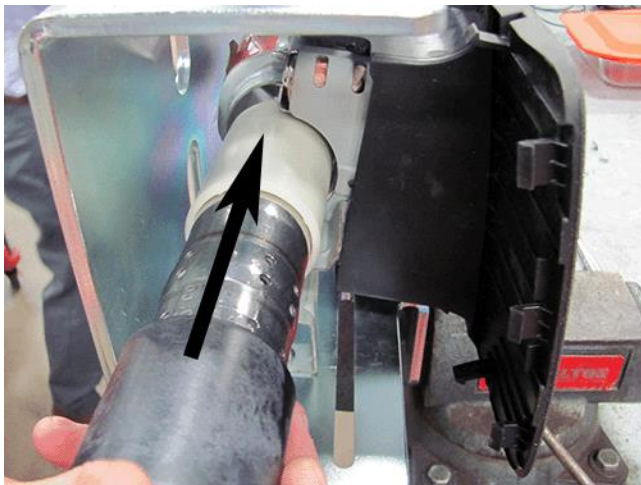
5680409

11. Carefully slide the new inflator into the airbag assembly. Ensure the inflator is installed with the harness (white end cap) end first.

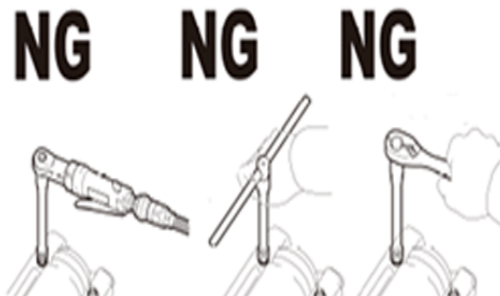
3610416

17. Tighten four (4) **NEW** plate nuts evenly in several increments in the order shown in the illustration using a 10-mm socket driver while pushing the inflator. You will encounter some resistance during tightening because these nuts are self-locking nuts. **Torque Specification: 6.5 Nm (57 in-lb).**

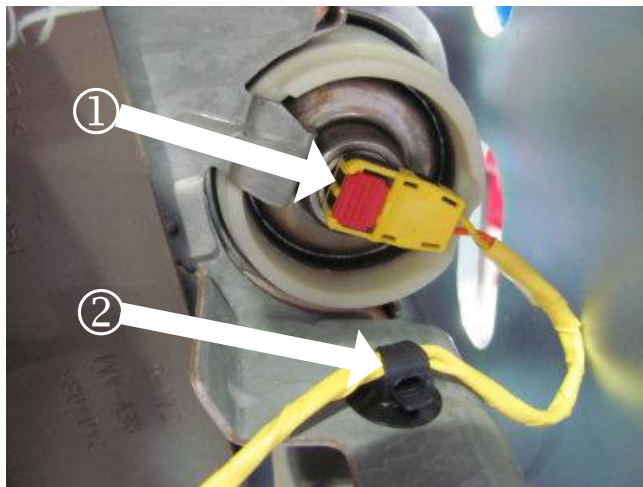
18. Connect the new yellow wiring harness to the airbag inflator, fully engage the CPA (1).
19. Install the wire harness locator to the housing (2).
20. Remove the airbag assembly from the bracket by removing the two bolts and the airbag assembly.
21. Reinstall the instrument panel passenger airbag assembly. Refer to *Airbag Instrument Panel Module Replacement* in SI.
22. The box that the new passenger air bag inflator was shipped in must be utilized to return the used inflator. The box contains special instructions for the packaging and shipment of the used inflator. The instructions must be followed without exception. If the original box is not available or you have questions about the special shipping instructions, please contact your District Service Manager- Aftersales for assistance. **DO NOT DEPLOY ANY INFLATOR.**
