# Product Safety Recall

## 15817 Front Passenger Air Bag Inflator

**Reference Number:** N150817000

| <b>Condition</b> | General Motors has decided that a defect which relates to motor vehicle safety exists in all 2007-2008 model year Chevrolet Silverado and GMC Sierra 2500/3500 series heavy duty pickup trucks. Some of the front passenger air bag inflators in these vehicles may experience an alteration over time, which could lead to overaggressive combustion in the event of an air bag deployment. This condition could create excessive internal pressure when the air bag is deployed, which could result in the body of the inflator rupturing upon deployment. In the event of an inflator rupture, metal fragments could pass through the air bag cushion material, which may result in injury or death to vehicle occupants. |

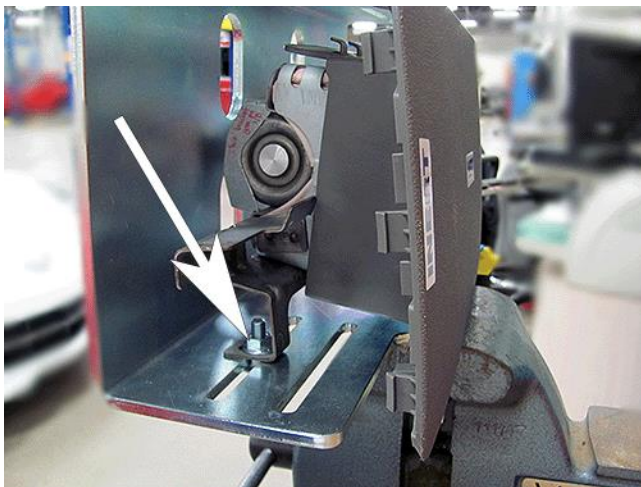
4664048

2. Using the hardware kit supplied with the module bracket, loosely mount the airbag assembly to the bracket using two nuts and bolts.

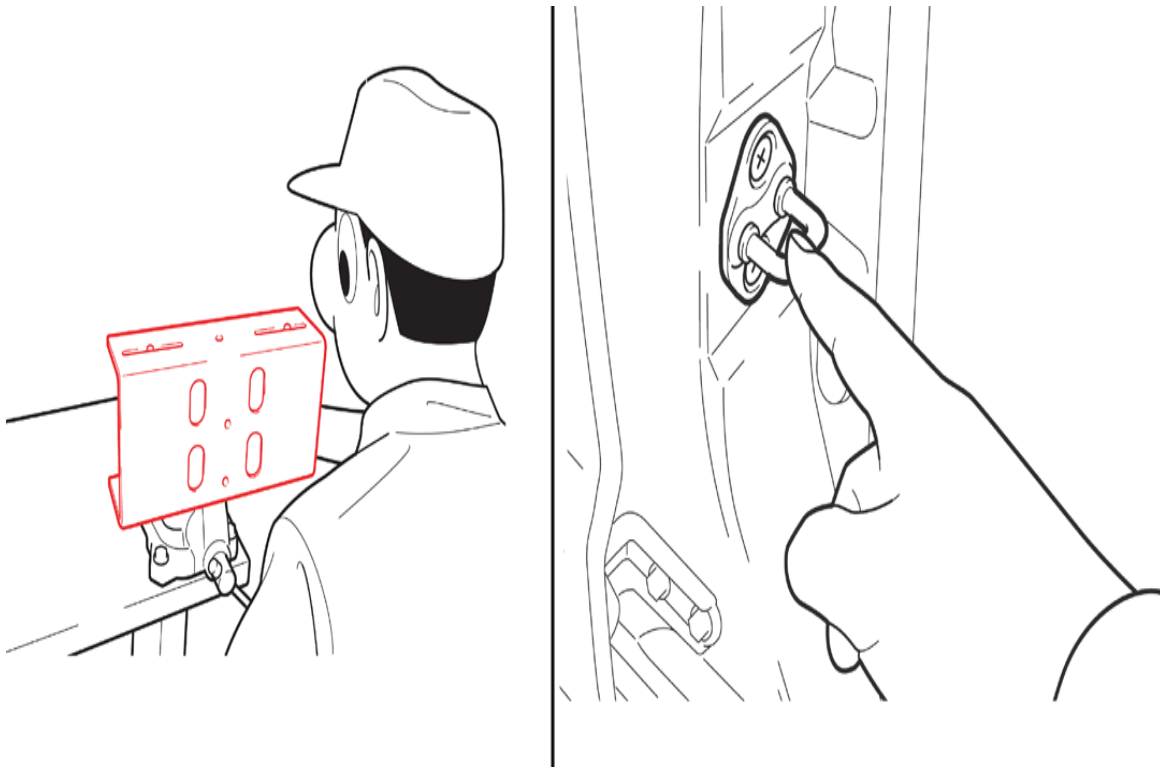
3607909

**Danger:** To avoid personal injury, *ALWAYS* keep as much of your body as possible in front of the bracket when working on the air bag assembly. Remember to periodically touch a metallic part of the vehicle or work bench to discharge static electricity in the body. **DO NOT** use power tools when performing the inflator removal/reinstallation steps.

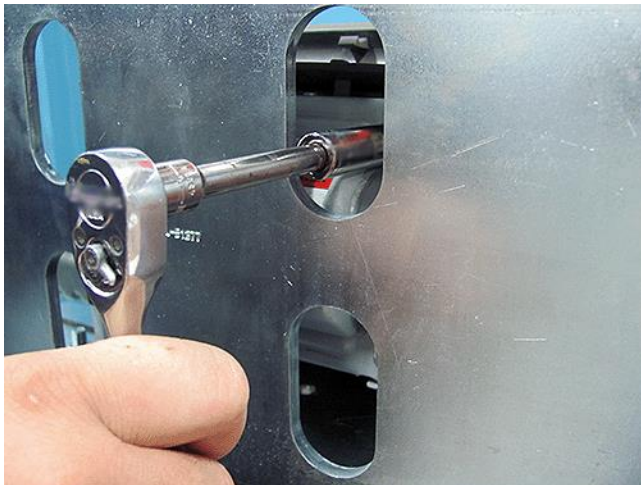
4664052

7. Use the access holes in the bracket to loosen and remove the four self-locking nuts. Discard the nuts, they will not be reused.
8. Remove the two stopper plates.

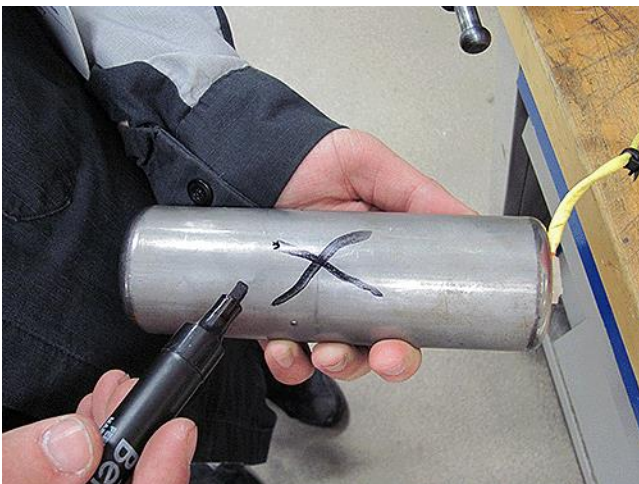
4664063

12. Put a mark on the removed inflator and store it in the provided replacement part box. Refer to the packaging instructions that were included with the new inflator module kit.

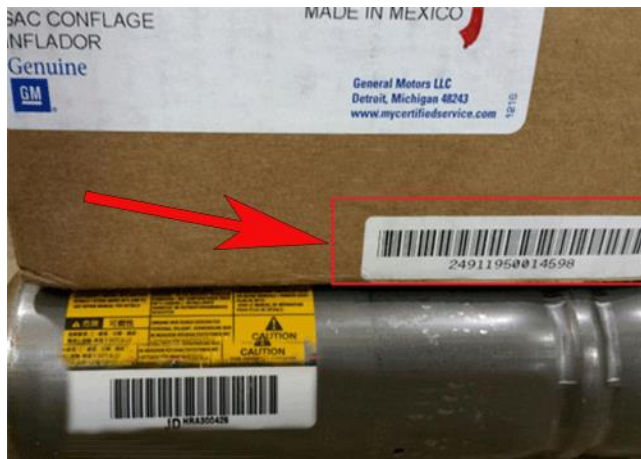
4664074

13. Record the serial number from the service inflator kit on the repair order.

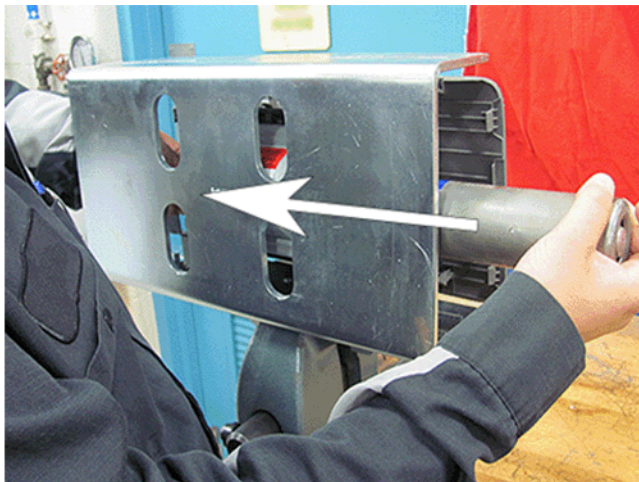
4664064

14. Carefully slide the new inflator into the air bag assembly. Ensure the inflator is installed with the harness end first.

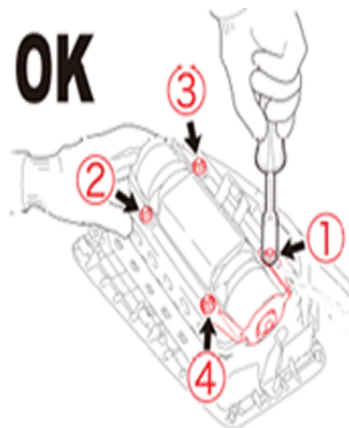
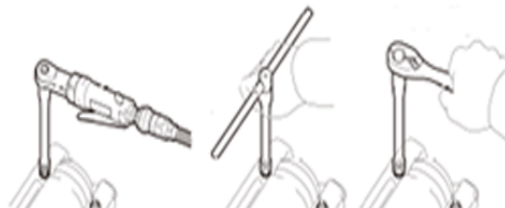
3610416

**NG NG NG**

19. Tighten four (4) **NEW** plate nuts evenly in several increments in the order shown in the illustration using a 10 mm socket driver while pushing the inflator. You will encounter some resistance during tightening because these nuts are self-locking nuts. **Torque Specification: 6.5 Nm (57.53 in-lb)**

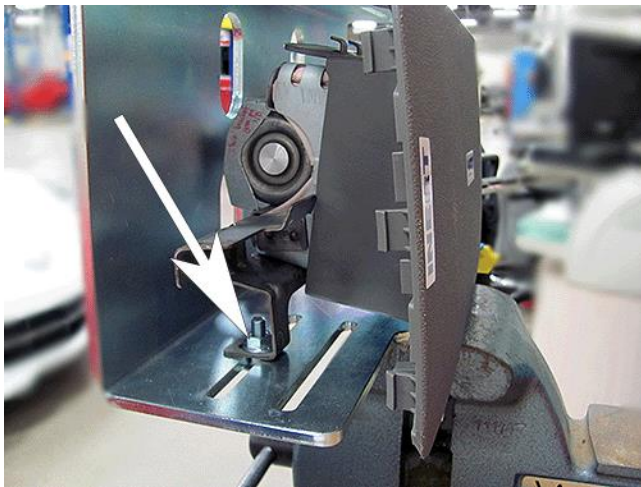
4664048

2. Using the hardware kit supplied with the module bracket, loosely mount the airbag assembly to the bracket using two nuts and bolts.

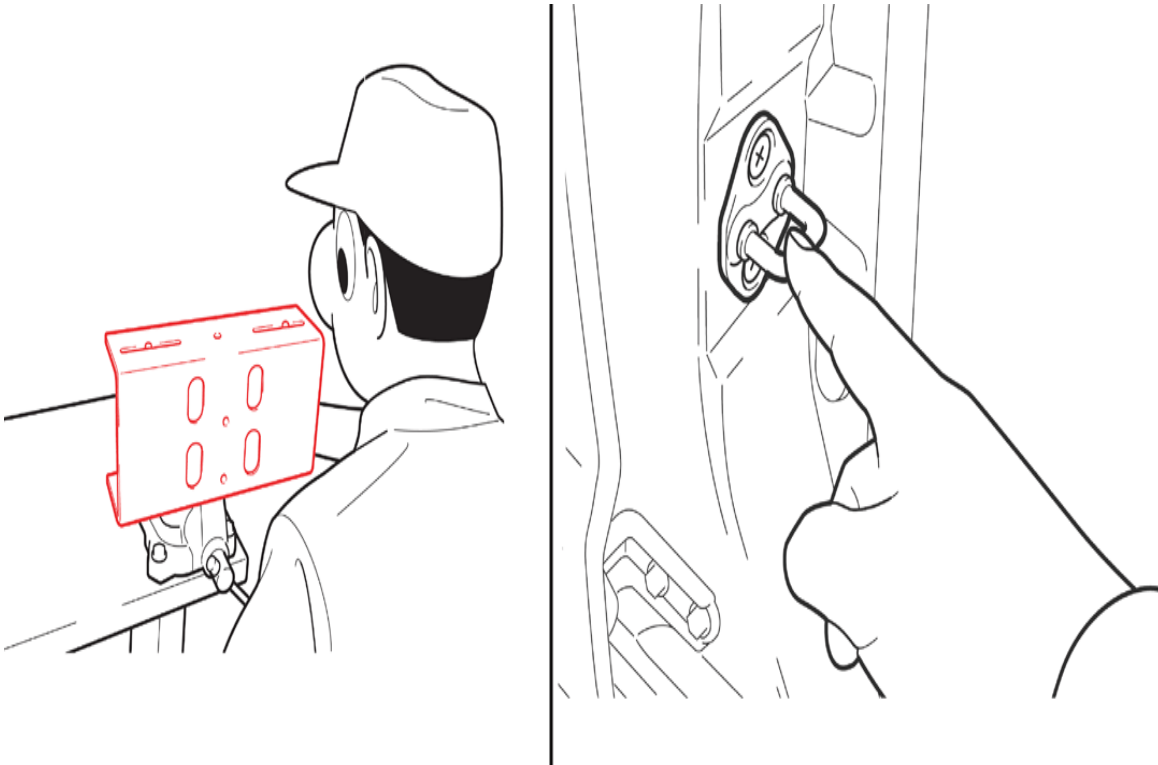
3607909

**Danger:** To avoid personal injury, **ALWAYS** keep as much of your body as possible in front of the bracket when working on the airbag assembly. Remember to periodically touch a metallic part of the vehicle or work bench to discharge static electricity in the body. **DO NOT** use power tools when performing the inflator removal/reinstallation steps.

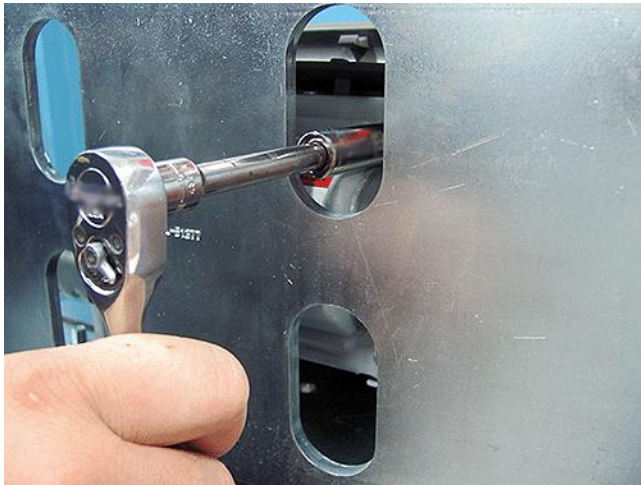
4664052

1. Use the access holes in the bracket to loosen and remove the four self-locking nuts, **do not use power tools to remove the nuts**. Discard the nuts, they will not be reused.

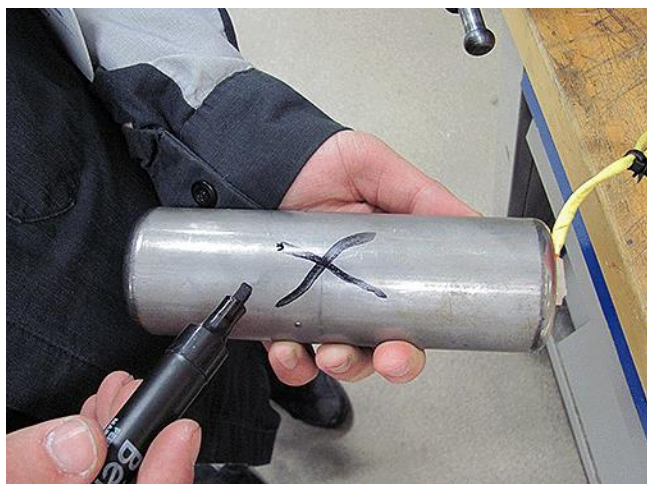
4664063

6. Put a mark on the removed inflator and store it in the replacement part box.

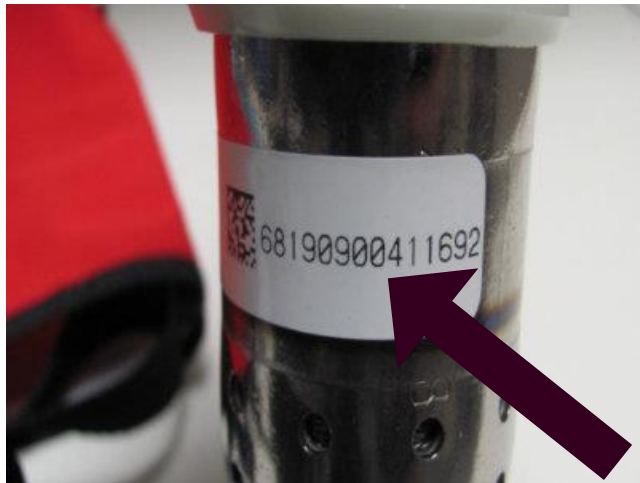
5838265

- Record the serial number of the new inflator from the service kit on the job card.

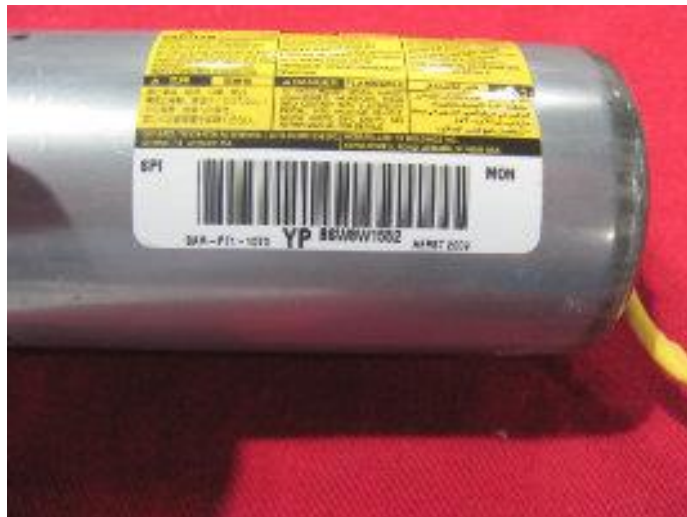
5844318

- Record the serial number of the used inflator that is being returned on the job card.
- Inspect the new inflator for the following two conditions:

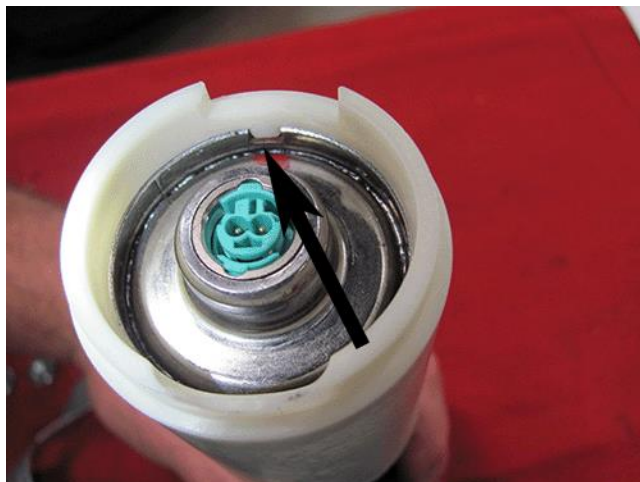
5680402

- Ensure the tab on the white end cap is aligned with the notch in the inflator.

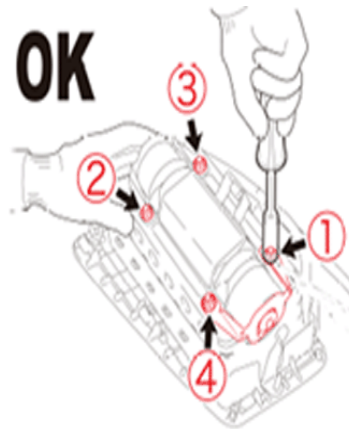
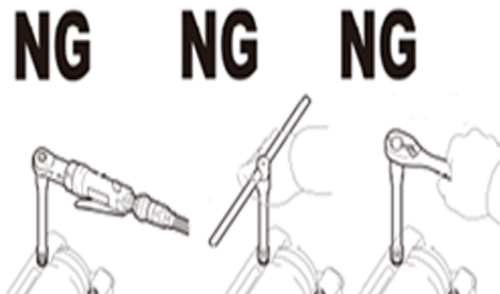
3610416

17. Tighten four (4) **NEW** plate nuts evenly in several increments in the order shown in the illustration using a 10-mm socket driver while pushing the inflator. You will encounter some resistance during tightening because these nuts are self-locking nuts. **Torque Specification: 6.5 Nm (57 in-lb).**
