Product Safety Recall

15438 Front Passenger Air Bag Inflator

Reference Number: N15043800

Release Date: January 2017

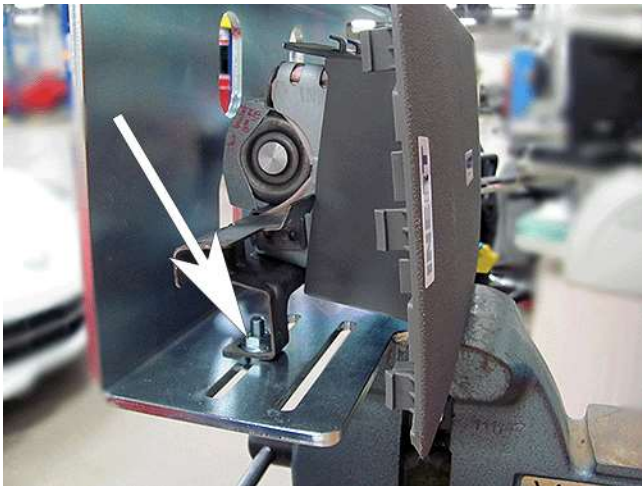
4664048

2. Using the hardware kit supplied with the module bracket, loosely mount the airbag assembly to the bracket using two nuts and bolts.

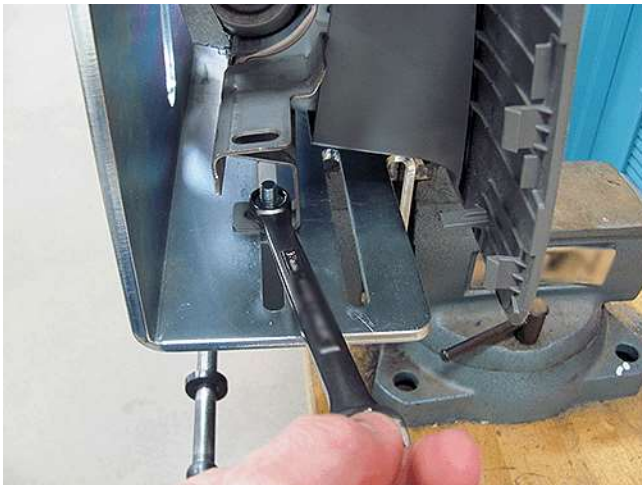
4664050

4. Tighten the two fasteners that attach the airbag to the module bracket.
5. Confirm the following steps have been completed BEFORE proceeding to the next step:
 - The mounting bracket is secure in the vise.
 - The air bag module is secured to the bracket.

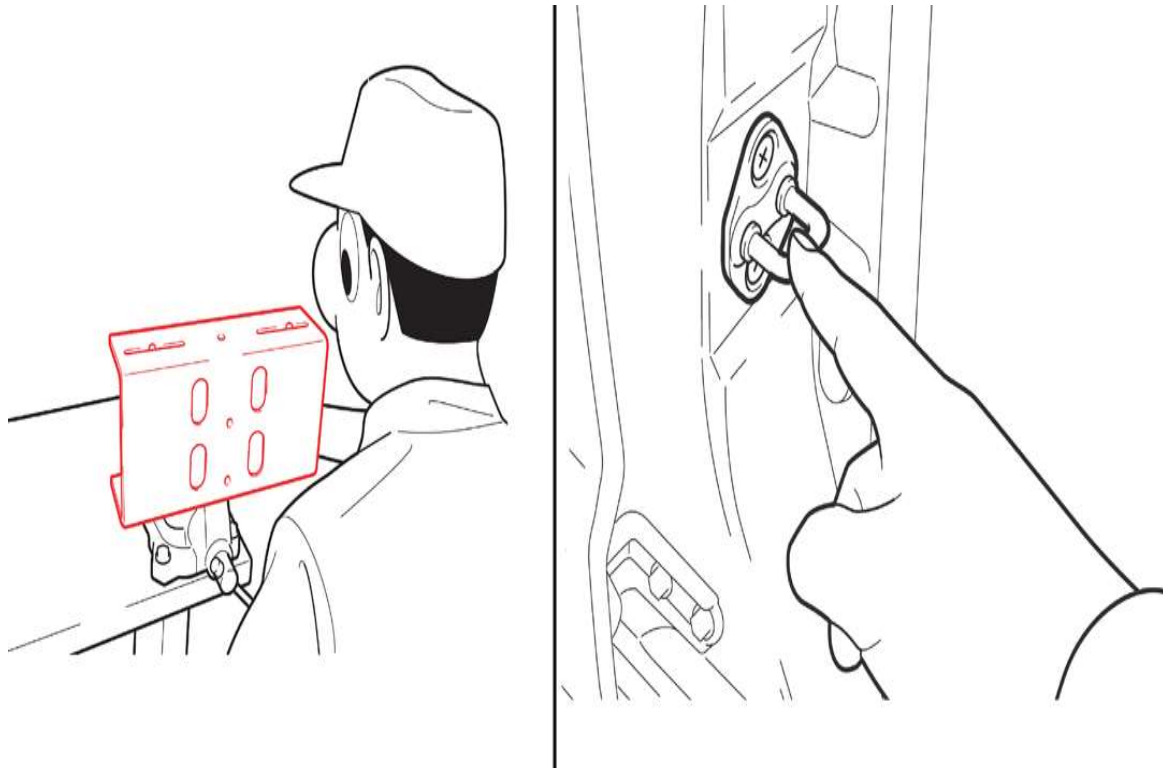
3607909

Danger: To avoid personal injury, *ALWAYS* keep as much of your body as possible in front of the bracket when working on the air bag assembly. Remember to periodically touch a metallic part of the vehicle or work bench to discharge static electricity in the body. **DO NOT** use power tools when performing the inflator removal/reinstallation steps.

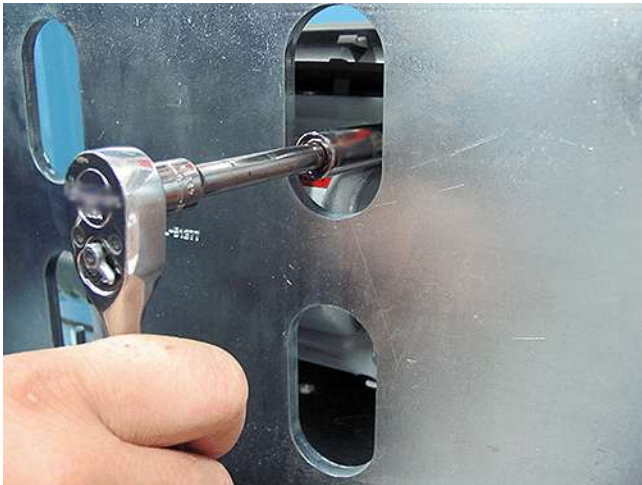
4664052

7. Use the access holes in the bracket to loosen and remove the four self-locking nuts. Discard the nuts, they will not be reused.
8. Remove the two stopper plates.

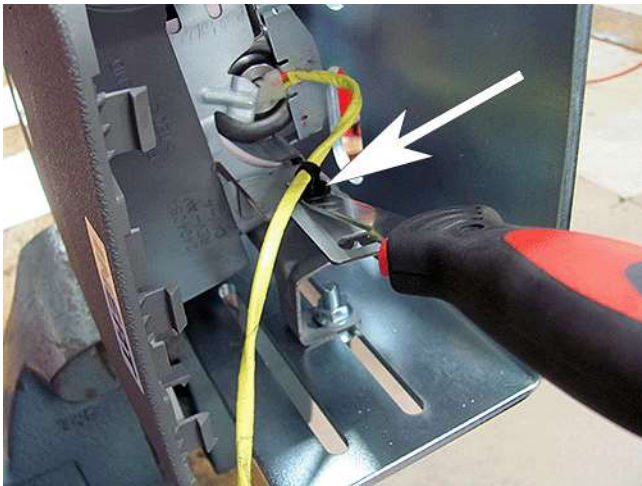
4664053

9. Disengage the wire harness locator from the housing.

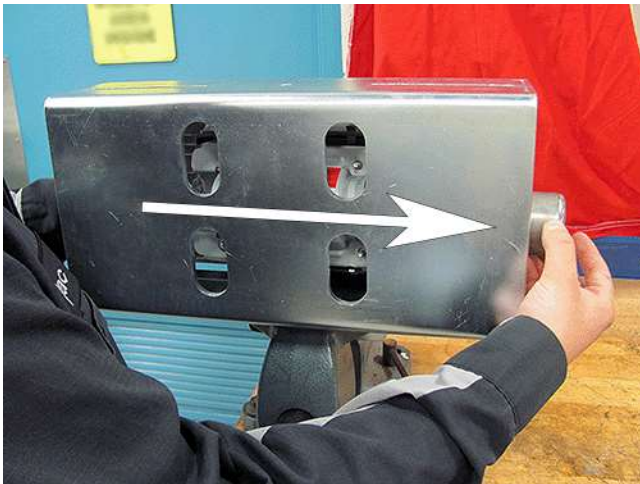
4664060

11. Remove the inflator from the housing, slide the inflator away from the harness side.

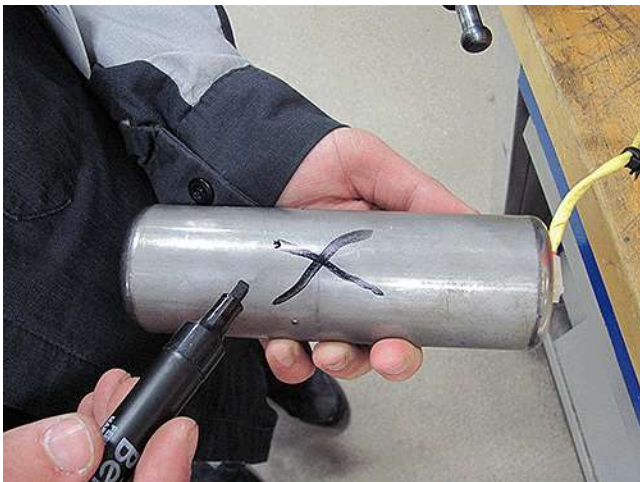
4664063

12. Put a mark on the removed inflator and store it in the provided replacement part box. Refer to the packaging instructions that were included with the new inflator module kit.

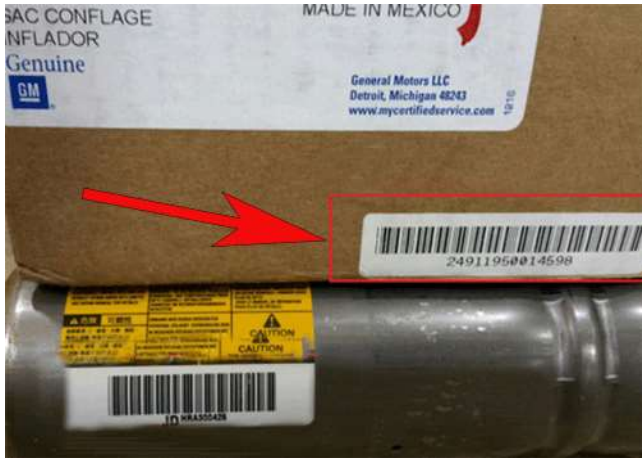
4664074

13. Record the serial number from the service inflator kit on the repair order.

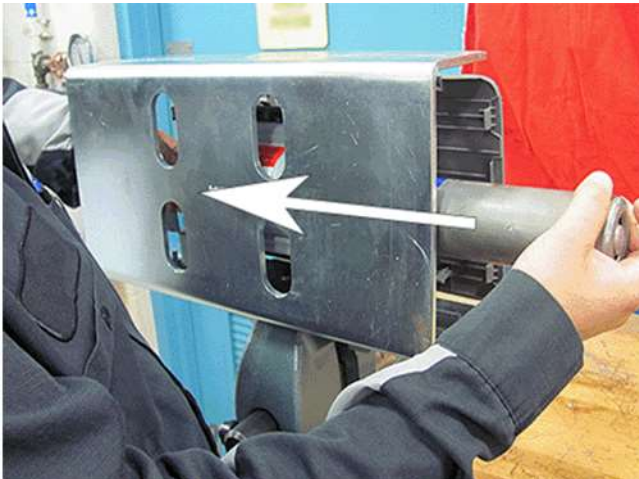
4664064

14. Carefully slide the new inflator into the air bag assembly. Ensure the inflator is installed with the harness end first.
