Upcoming Product Safety Recall 15168

INSPECTION PROCEDURE

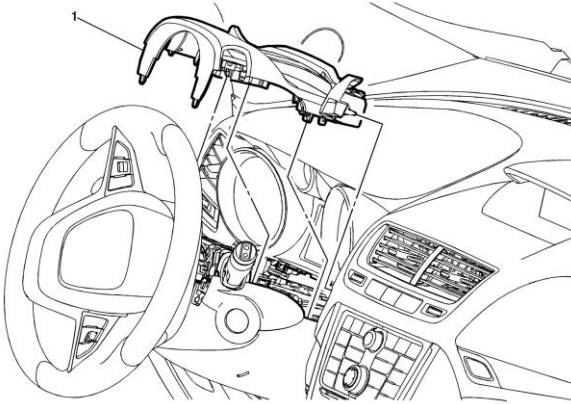
2784015

1. Unclip the steering column upper trim cover (1) from the steering column lower trim cover.
2. Disengage the steering column upper trim cover flexible part from instrument cluster.
3. Carefully pull plastic part rearward from instrument cluster.

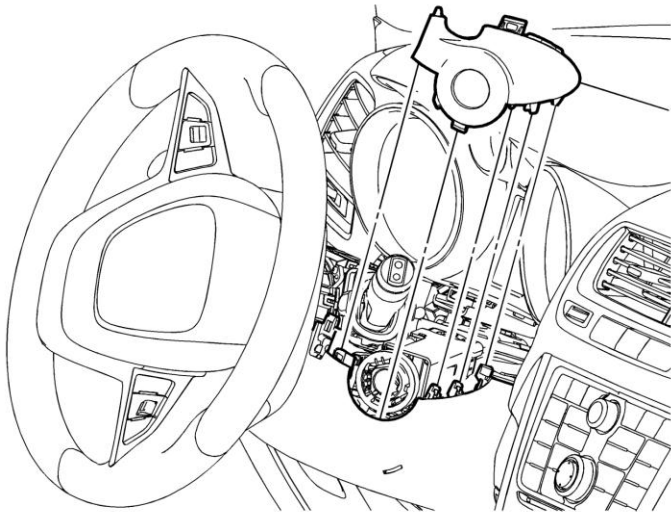
2780180

4. Unclip the ignition lock cylinder opening cover (1) from the steering column lower trim cover.
5. Remove the ignition lock cylinder opening cover.

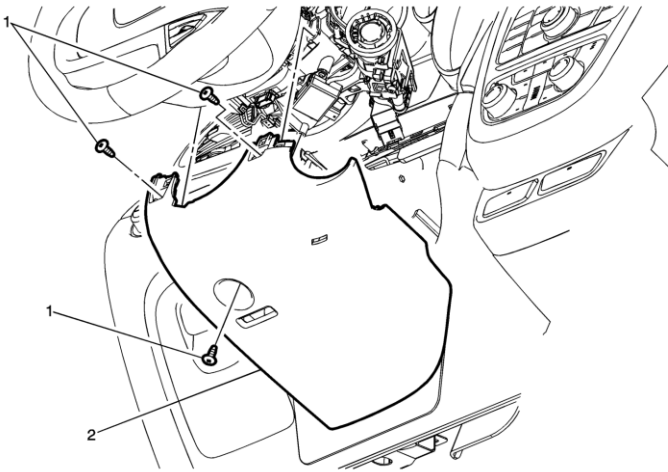
2784018

- 6. Remove the fasteners (1) from the steering column lower trim cover (2).
- 7. Remove the steering column lower trim cover for column inspection.

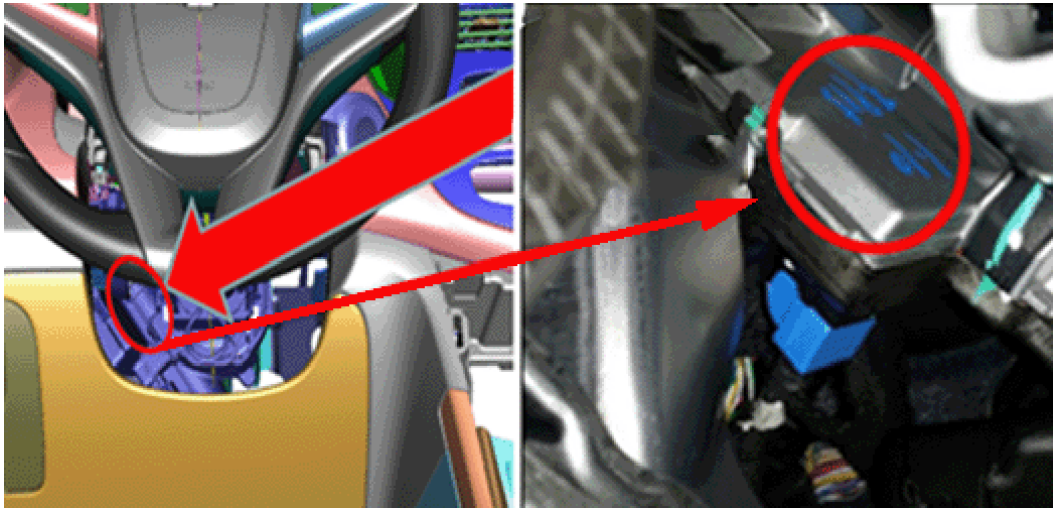
4109043

Location of steering column lot number

- 8. Check the housing LOT number.

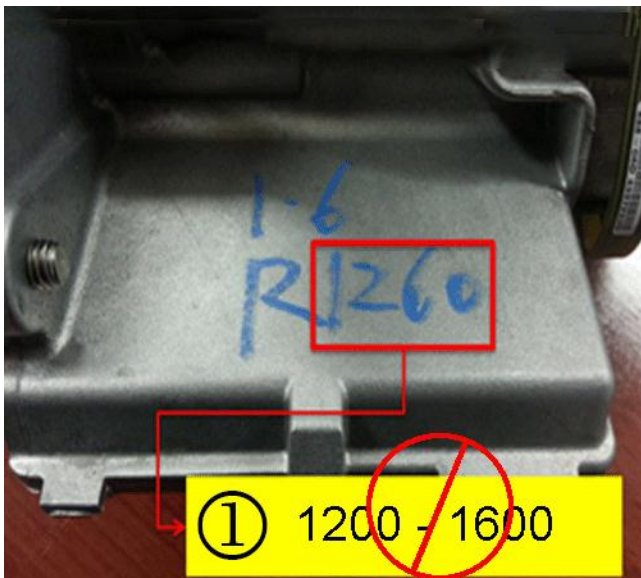
NOTE: If the LOT number is illegible, or not readable, the vehicle must be held for steering column replacement.

- 9. A part with a LOT number (1) above 1200 **(including 1200, and up to and including 1600) is *not* OK. The vehicle must be held for steering column replacement.**
- 10. If the LOT number is less than 1199, then the part is OK and the vehicle has passed inspection. Re-assemble parts in reverse order.
- 11. **If the steering column has failed inspection, the vehicle must be held for steering column replacement.**
