# SAFETY RECALL NOTICE

## Re: Can-Am Spyder Coast-to-Coast Accessory Passenger Seat Does Not Activate Pillion Switch

# PAC BULLETIN SAFETY CAMPAIGN

Subject: **Coast-to-Coast Accessory Passenger Seat Does Not Activate Pillion Switch**

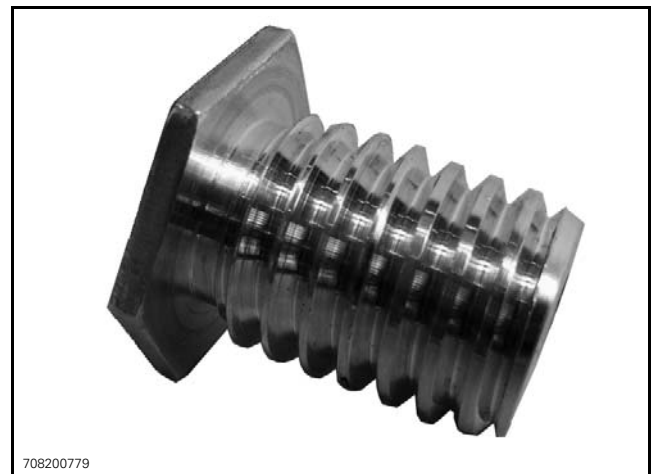
DESCRIPTION	PART NUMBER	QUANTITY
Activation stud	708200779	1

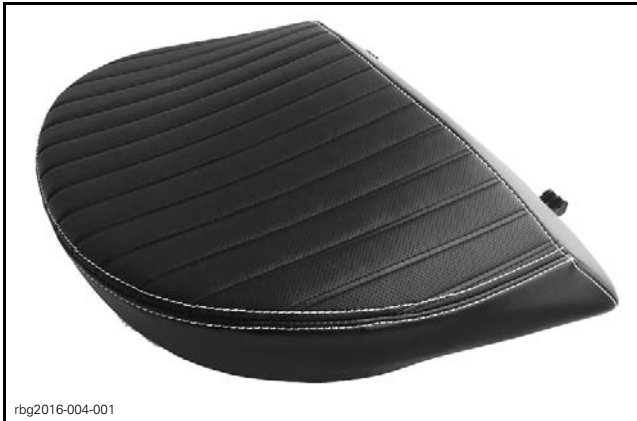
1. Remove the passenger seat.

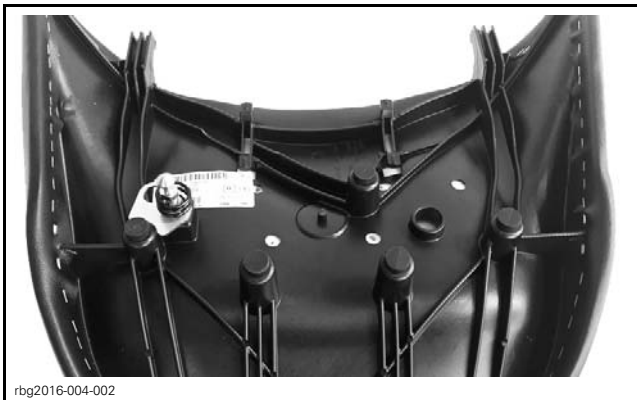
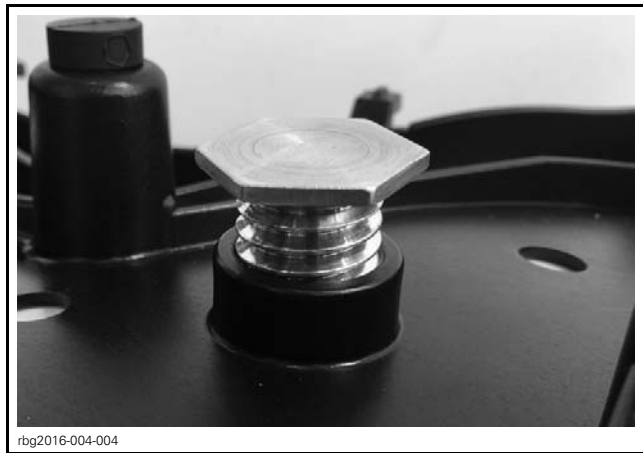
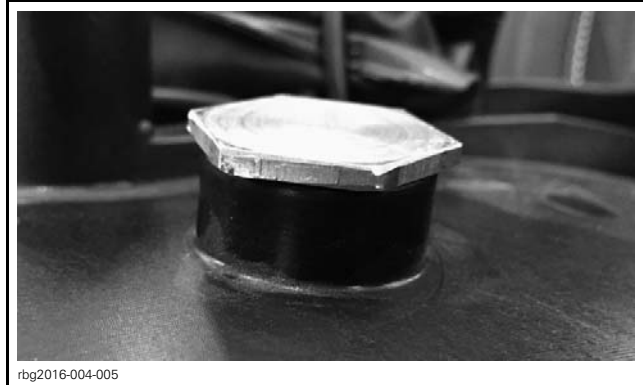
2. Install the stud in the seat base.

3. Tighten to specification.

**NOTICE** Do not overtighten the plug. It would make the seat base to crack or to strip.

TIGHTENING TORQUE	
Activation stud	3.5 N•m ± 0.5 N•m (31 lbf•in ± 4 lbf•in)

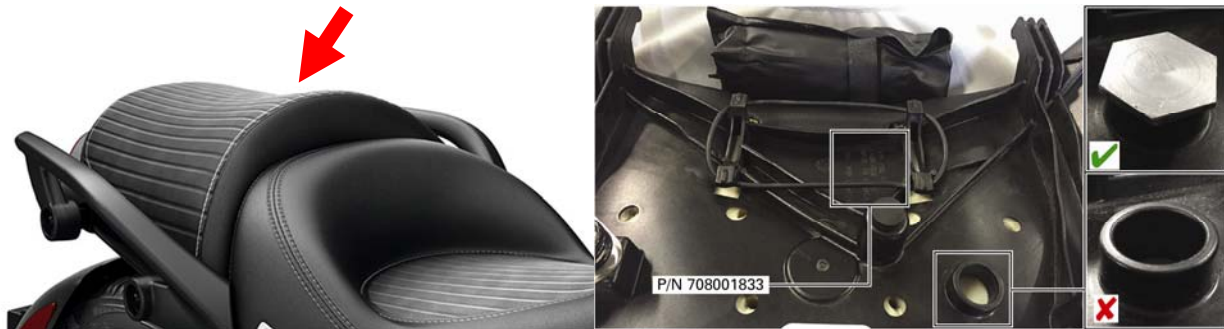
1. Remove the seat and locate the part number under the seat. The part recalled is 708001833.
2. Check to see if the updated stud was installed (see picture). If you do not see this additional stud, your seat is included in the recall.
3. If the seat is included in the recall, visit an authorized Can-Am Spyder dealership to have the seat modified at no charge.
4. In the meantime, if you want to continue riding with a passenger, use the production passenger seat rather than the Coast-to-Coast passenger seat.

**X: Must be modified**
