| RE: <b>Recall Campaign 2017030012</b><br><b>Update Notification</b><br><b>MY07-MY14 906 (Sprinter)</b><br><b>Replace Takata Driver-side Airbag</b> | DATE: January 12, 2018 |

Campaign No. 2017030012, January 2018  
Revision C

SUBJECT: **Model 906, Model Years 2007-2014**  
**Replace Driver's Side Airbag**

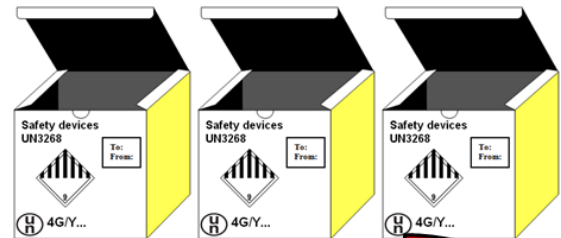
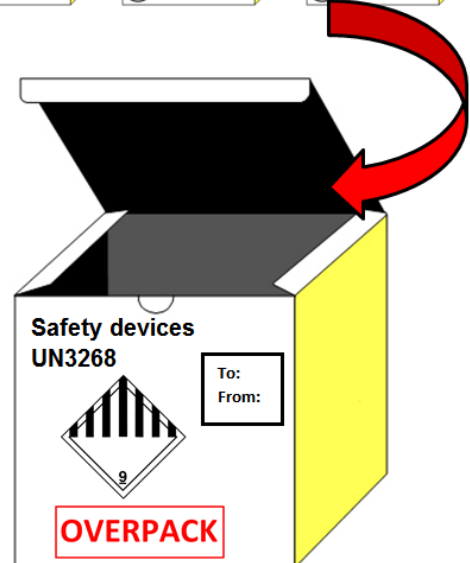
### Package example:

- Package each airbag in a separate UN spec box prepared with the labels/markings described above.
- Place each individual airbag box inside a larger non-UN spec box to keep the shipment together.
- This larger box is called an "OVERPACK."
- The OVERPACK must have the identical markings and label as the boxes contained inside.

- The OVERPACK must have the "OVERPACK" statement on the same face as the hazard markings and labels.
