Dealer Service Instructions for:

## **Safety Recall S14 / NHTSA 16V-077 Driver Airbag Module**

**2007-2009 (VB) Dodge Sprinter**

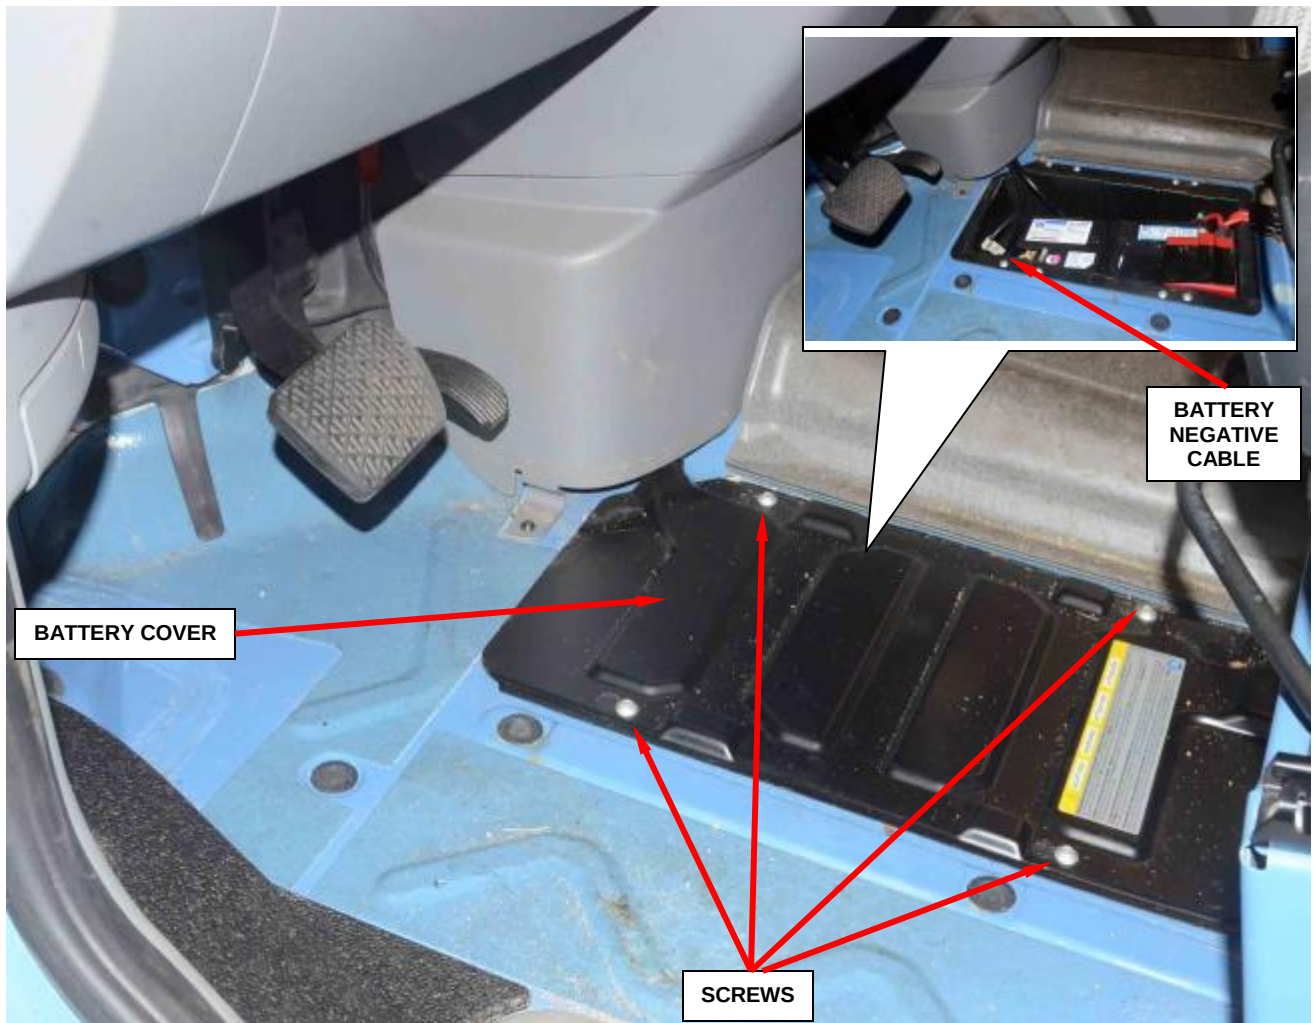
**Figure 2 – Battery Location**

- c. Remove and save the four screws from the battery cover and remove the battery cover (Figure 2).
- d. Disconnect and isolate the battery negative cable(s). Wait two minutes for the system capacitor to discharge before further service (Figure 2).

- 22. Install the battery cover and the four screws then tighten securely.
- 23. Install the rubber mat.
- 24. Install the door sill scuff plate and the three screws then tighten securely.
- 25. Return the original inflator as described in the Parts Return section.
- 26. Return the vehicle to the customer.

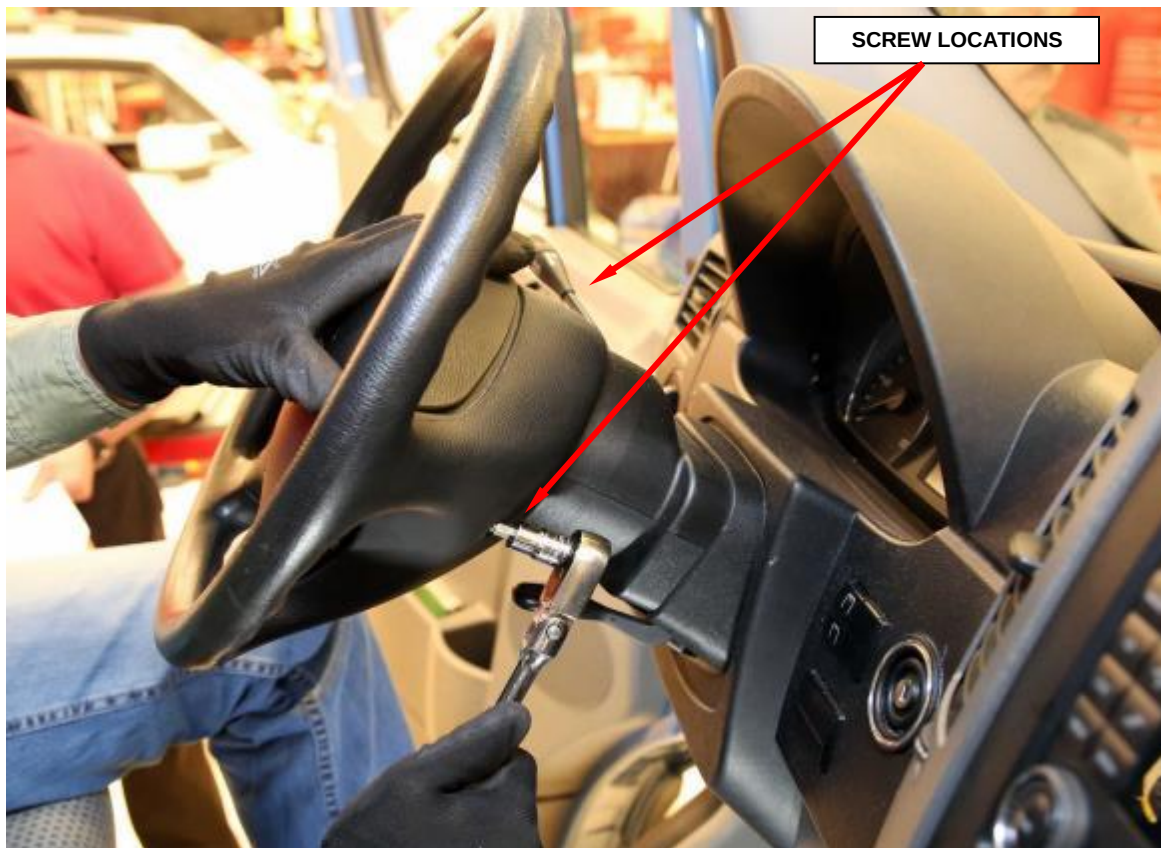
**Figure 3 - Driver Airbag Screws**

2. From the underside of the steering wheel, remove the two screws that secure the driver airbag to the steering wheel armature (Figure 3).

3. Pull the driver airbag away from the steering wheel far enough to access the electrical connections at the back of the airbag housing.

19. From the underside of the steering wheel, install and tighten the two screws that secure the driver airbag to the steering wheel armature. Tighten the screws to 53 in. lbs. (6 N·m).
20. **Do not connect the battery negative cable at this time.** The supplemental restraint system verification test procedure should be performed following service of any supplemental restraint system component.

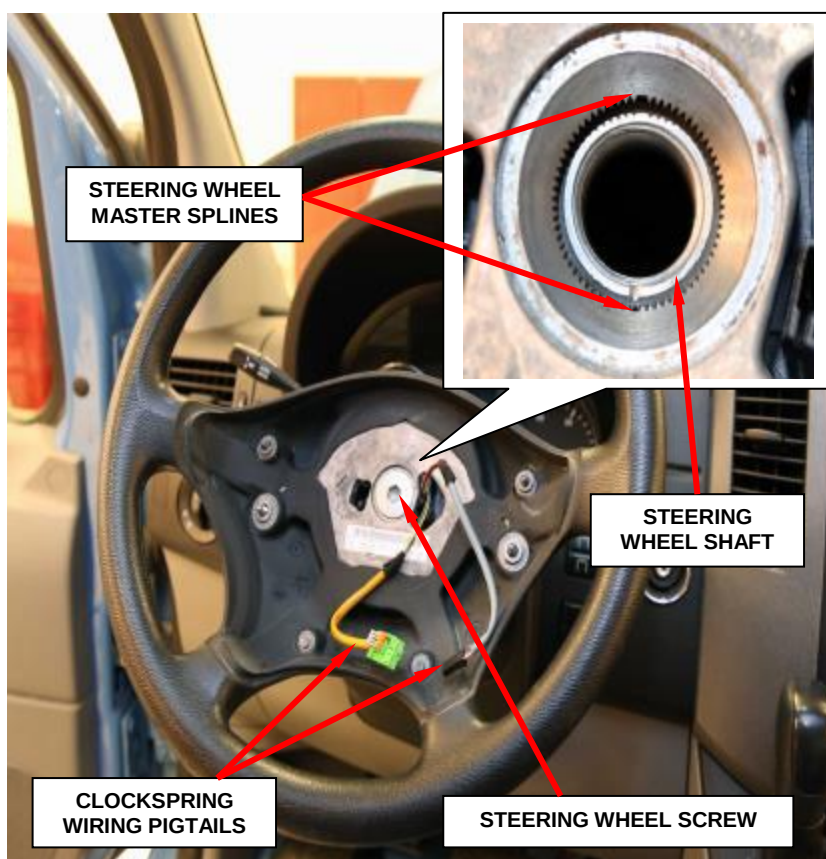
Figure 5 – Steering Wheel

7. Using DealerCONNECT under Single VIN Inquiry look up the vehicle Build Date.
  - For 2007 MY vehicles continue with **Step 8** to replace the steering wheel.
  - For 2008 MY vehicles **built up to and including** 09/22/2007 continue with **Step 8** to replace the steering wheel.
  - For 2008 MY vehicles **built on or after** 09/23/2007 continue with **Step 14. Steering wheel replacement is NOT REQUIRED.**
  - For 2009 MY vehicles continue with **Step 14. Steering wheel replacement is NOT REQUIRED.**
8. Turn the steering wheel until the front tires are in the straight ahead position and lock the steering wheel in the straight ahead position.
9. Remove and **discard** the steering wheel screw (Figure 5).

**NOTE:** The steering wheel has master splines but the steering shaft does not. The steering wheel must be marked prior to removal or the wheel can be reinstalled wrong in any position.
10. Mark the steering wheel and steering column shaft with a paint pen for reference to ensure the proper orientation when installing.

12. Route the clockspring wiring pigtails through the **NEW** steering wheel and install the **NEW** steering wheel onto the column (Figure 5).
13. Install the **NEW** steering wheel screw. Tighten to 80 N·m (59 ft. lbs.).
