Revision (2) July 2022

Dealer Service Instructions for:

Safety Recall S14 / NHTSA 16V-077 Driver Airbag Module

2007-2009 (VB) Dodge Sprinter

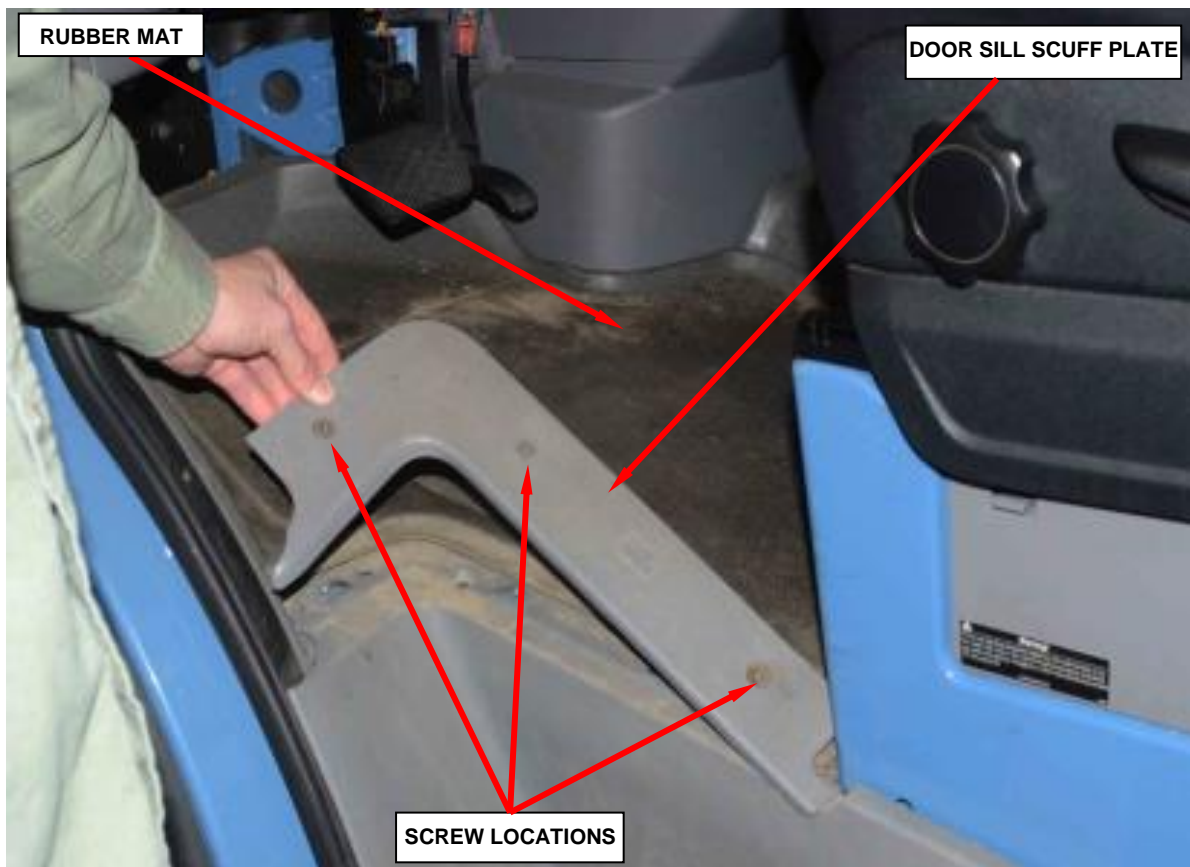
Figure 1 – Door Sill Scuff Plate

- a. Remove and save the three screws from the door sill scuff plate and remove the door sill scuff plate (Figure 1).
- b. Remove the rubber mat (Figure 1).

22. Install the battery cover and the four screws then tighten securely.
23. Install the rubber mat.
24. Install the door sill scuff plate and the three screws then tighten securely.
25. Return the original inflator as described in the Parts Return section.
26. Return the vehicle to the customer.

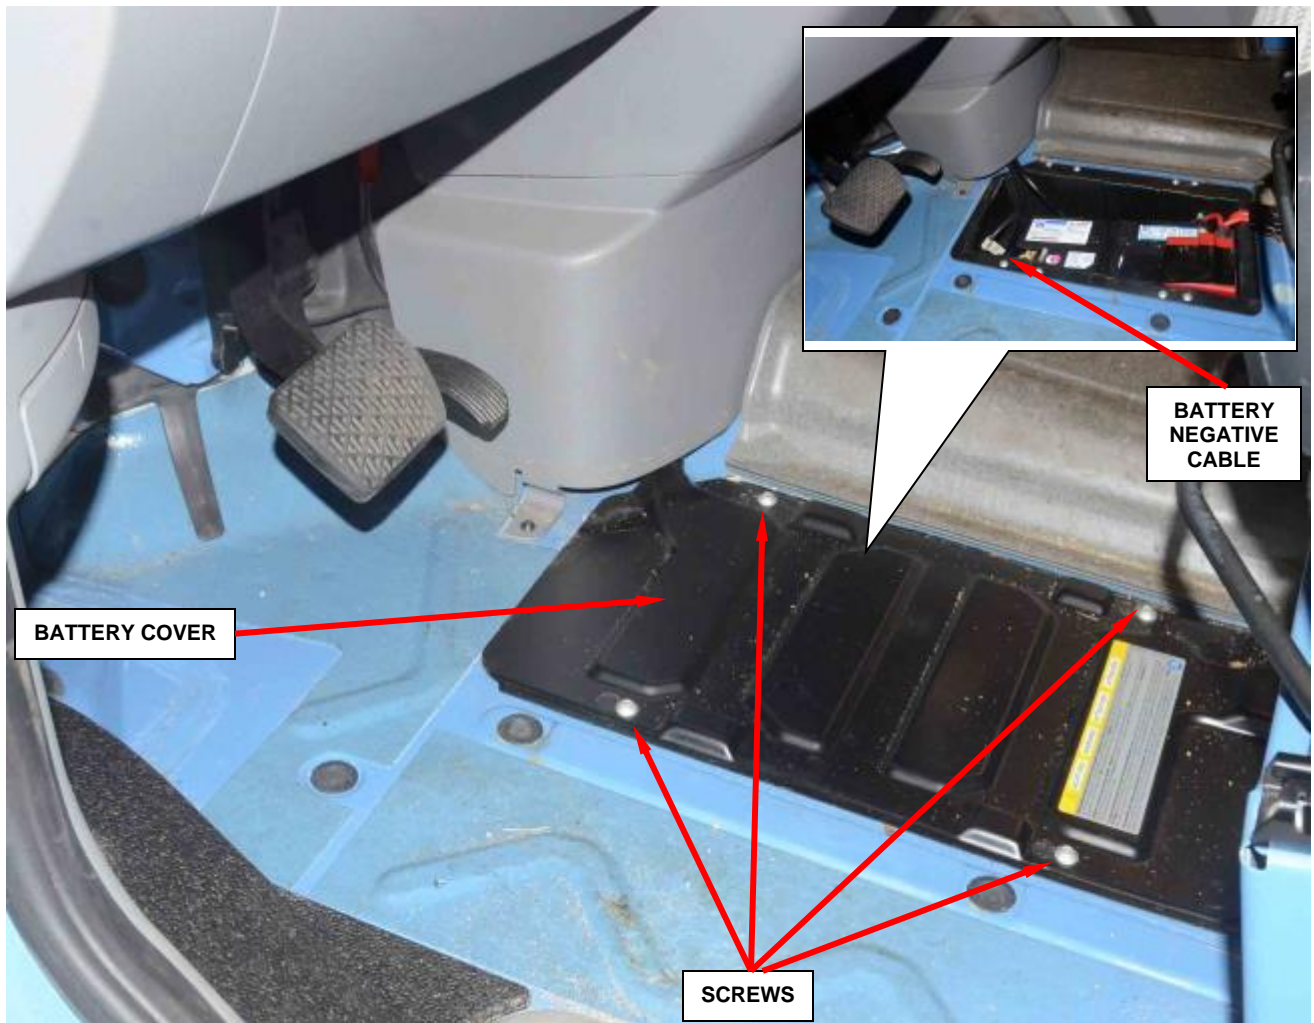
Figure 2 – Battery Location

- c. Remove and save the four screws from the battery cover and remove the battery cover (Figure 2).

- d. Disconnect and isolate the battery negative cable(s). Wait two minutes for the system capacitor to discharge before further service (Figure 2).

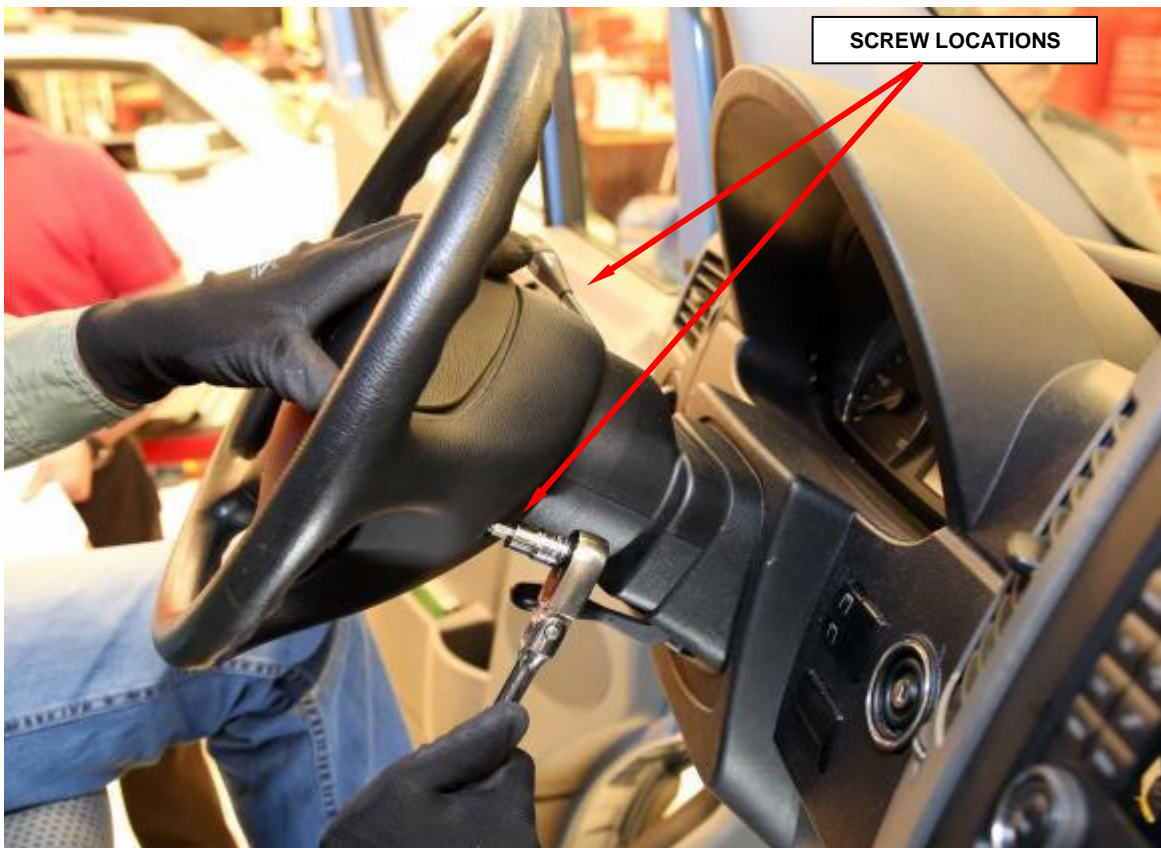
Figure 3 - Driver Airbag Screws

2. From the underside of the steering wheel, remove the two screws that secure the driver airbag to the steering wheel armature (Figure 3).

3. Pull the driver airbag away from the steering wheel far enough to access the electrical connections at the back of the airbag housing.

19. From the underside of the steering wheel, install and tighten the two screws that secure the driver airbag to the steering wheel armature. Tighten the screws to 53 in. lbs. (6 N·m).
20. **Do not connect the battery negative cable at this time.** The supplemental restraint system verification test procedure should be performed following service of any supplemental restraint system component.

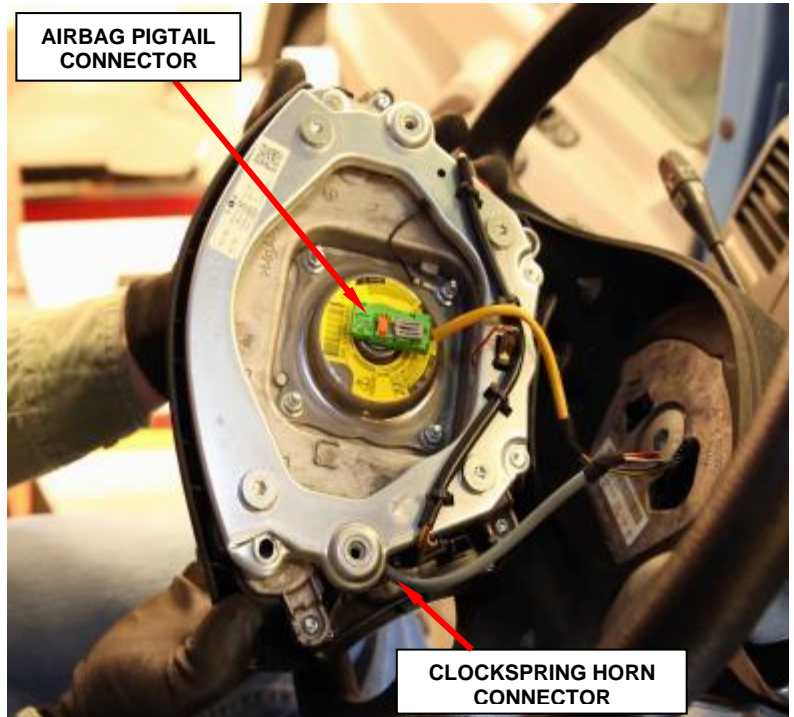
Figure 4 – Electrical Connectors

4. Disconnect the clockspring horn and steering wheel switch pigtail wire harness connector from the receptacle on the back of the driver airbag housing (Figure 4).

5. Disconnect the clockspring driver airbag pigtail wire harness connector from the airbag inflator connector receptacle, which is located on the back of the driver airbag housing (Figure 4). To disconnect the connector:

- a. Slide the orange Connector Position Assurance (CPA) lock on the connector toward the top of the connector.
- b. Depress the connector latch tab and pull the connector straight away from the inflator initiator.

15. Position the **NEW** driver airbag close enough to the steering wheel to connect the electrical connections on the back of the airbag housing.
16. Connect the clockspring driver airbag pigtail wire harness connector to the airbag inflator connector receptacle, which is located on the back of the driver airbag housing. Be certain that the latch on the connector and the orange Connector Position Assurance (CPA) lock are each fully engaged.
17. Connect the clockspring horn and steering wheel switch pigtail wire harness connector to the receptacle on the back of the driver airbag housing.
18. Carefully position the **NEW** driver airbag in the steering wheel. Be certain that the clockspring pigtail wires in the steering wheel hub area are not pinched between the driver airbag and the steering wheel armature.

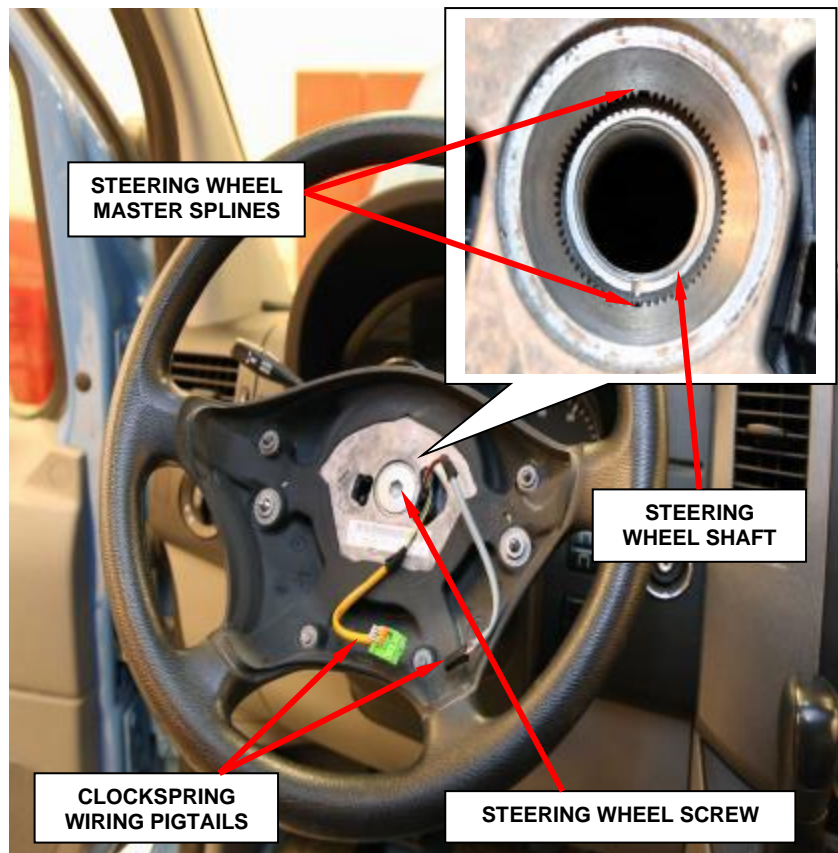
Figure 5 – Steering Wheel

9. Remove and **discard** the steering wheel screw (Figure 5).

NOTE: The steering wheel has master splines but the steering shaft does not. The steering wheel must be marked prior to removal or the wheel can be reinstalled wrong in any position.

10. Mark the steering wheel and steering column shaft with a paint pen for reference to ensure the proper orientation when installing.

12. Route the clockspring wiring pigtails through the **NEW** steering wheel and install the **NEW** steering wheel onto the column (Figure 5).
13. Install the **NEW** steering wheel screw. Tighten to 80 N·m (59 ft. lbs.).

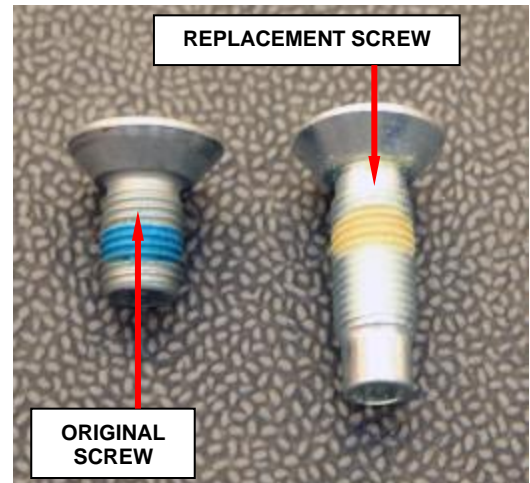
Figure 6 – Steering Wheel Screw

NOTE: The original steering wheel screw may have been superseded by a longer screw (Figure 6). Use the provided screw.

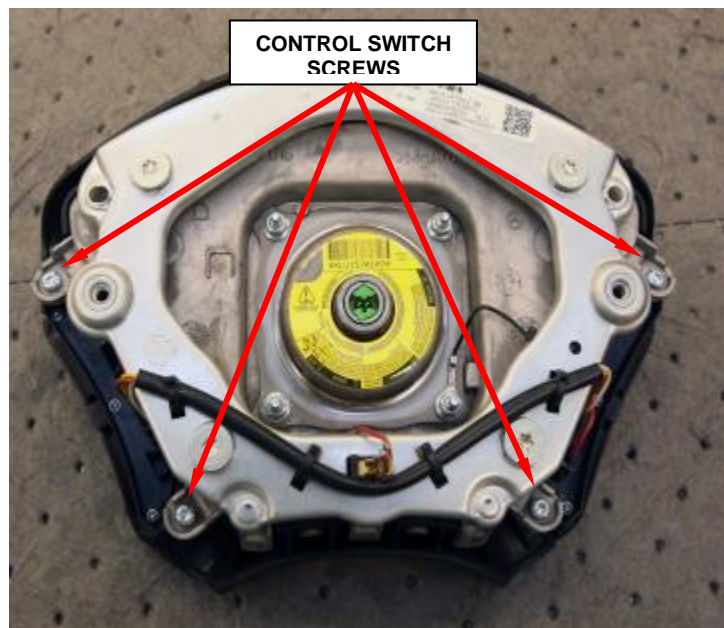
Figure 7 – Steering Wheel Control Switch Screws

14. For vehicles equipped with steering wheel controls, transfer the switches from the original driver airbag to the **NEW** driver airbag.
 - a. Remove the four steering wheel control switch mounting screws from the back side of the original driver airbag and position the switches away from the driver airbag (Figure 7).

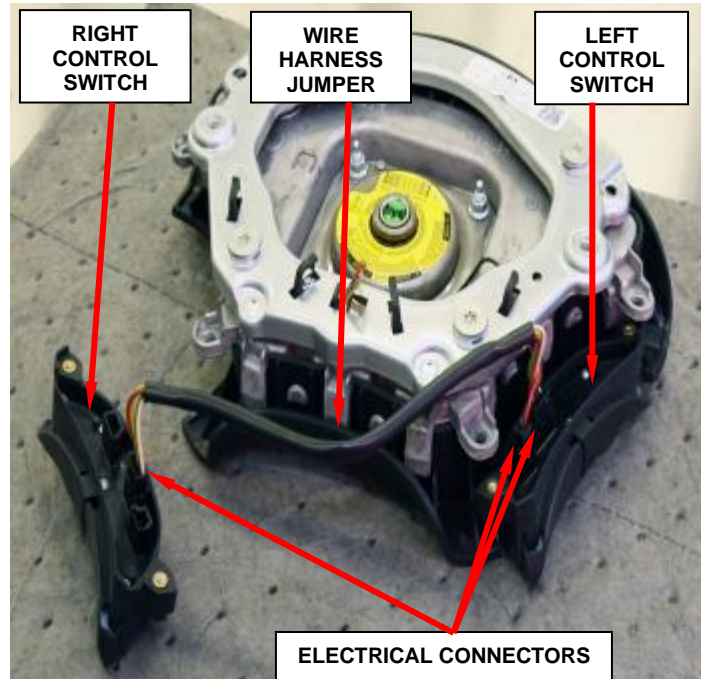
**Figure 8 – Control Switch Removal**

- b. Disconnect the wire harness jumper electrical connectors from both control switches (Figure 8).
- c. Discard the wire harness jumper if removed from the housing clips, a **NEW** wire harness jumper is provided with the **NEW** driver airbag.
- d. Position the control switches to the **NEW** driver airbag, connect the electrical connectors.
- e. Position the control switches to the **NEW** driver airbag, install the four screws and tighten securely.
