## newschannel update

| RE: <b>Recall Campaign Launch Notification</b><br><b>2018120012</b><br><b>Takata – Priority Group 5 Phase 2 All Zones</b><br><b>Replace Driver-side Airbags –</b><br>Certain MY11 W212 (E-Class Sedan), MY10 W/X164(ML-Class, GL-Class) and W251 (R-Class) vehicles | DATE: December 14, 2018 |

# RECALL CAMPAIGN LAUNCH

SUBJECT: **Model 164, 251 and 212**  
**Model Years 2010 - 2011**  
**Replace Driver-Side Airbag**

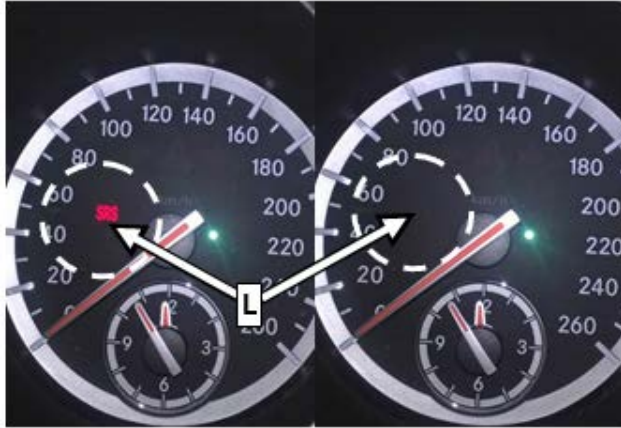
**Figure 1**

- Ensure that smart phone is held parallel to barcode label (**Figure 1**) when scanning VIN bar code.
- In the event the VIN barcode cannot be scanned when pressing the "Scan-Barcode" button or the vehicle does not have a VIN bar code; scan using the "Text recognition" button and letter/number combination of the VIN (**Figure 1**).
- The VIN can also be entered manually if required.
- After scanning, compare the vehicle identification number that has been read off in the app and manually correct any scanning errors.
- All required data can also be entered manually if required.

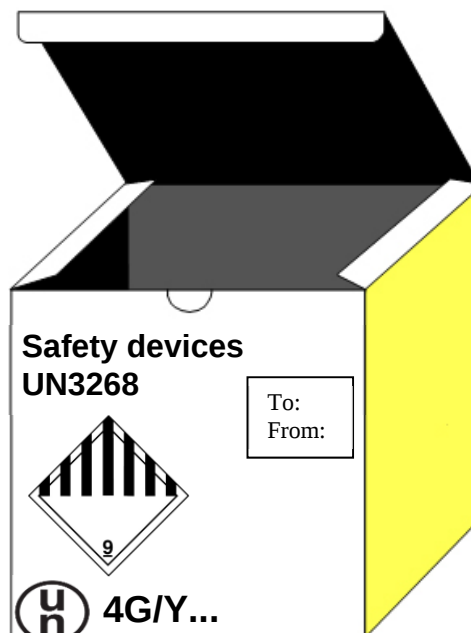
- The following words ("marking") must also be clearly visible on the same side of the box as the Class 9 label:  
**Safety devices**  
**UN3268** (font size must be  $\geq \frac{1}{2}$  inch)
- Affix "To/From" address label to same or adjacent packaging face as the hazardous markings/labels.
- The UN 4G code preprinted near the bottom edge of the box must also be clearly visible.

- Note:** The Packing Group and the EX# are no longer required to be printed on the HAZMAT bill of lading.
- Package example:**
