| RE: <b>Takata Recall Campaign UPDATE</b><br><b>2019060004 Takata PG6 DRIVER AIRBAG – Non-A Zones</b><br>Certain MY 10-11 212 (E-Class Sedan) vehicles | DATE: September 23 <sup>rd</sup> , 2019 |

### IMPORTANT UPDATED TAKATA RECALL CAMPAIGN INFORMATION

SUBJECT: **Model 164, 251, 212**  
**Model Years 2010 - 2012**  
**Replace Driver-Side Airbag**

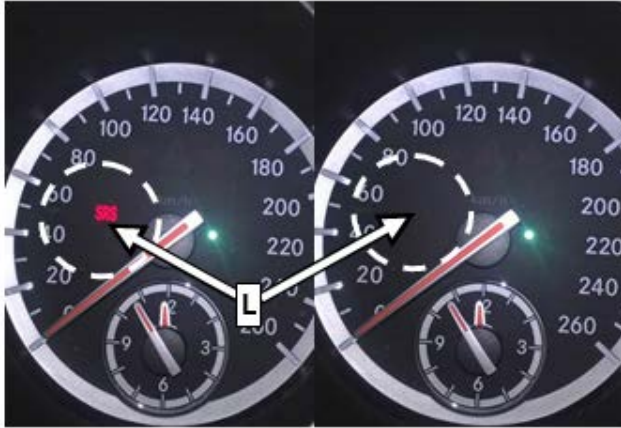
**Figure 1**

Start engine and check whether Supplemental Restraint System (SRS) indicator lamp (**Figure 1**) goes out after a few seconds.

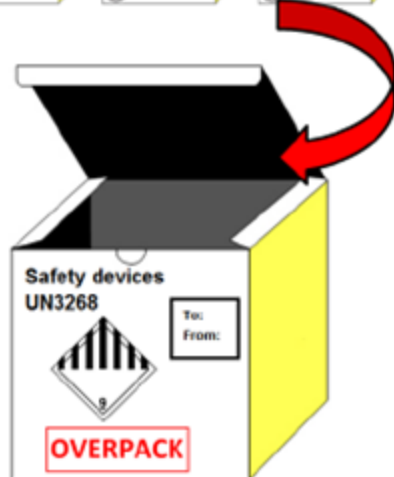
- Package each airbag in a separate UN spec box prepared with the labels/markings described above.
- Place each individual airbag box inside a larger non-UN spec box to keep the shipment together.
- This larger box is called an "OVERPACK."

- The OVERPACK must have the identical markings and label as the boxes contained inside.
- The OVERPACK must have the "OVERPACK" statement on the same face as the hazard markings and labels. Package example:
