| RE: <b>Recall Campaign 2018070014 Takata- Priority Group 4++ Ever-Registered in Zone A Replace Driver-side Airbags – Certain MY08-09 W204 (C-Class)</b> | DATE: August 28, 2018 |

# RECALL CAMPAIGN LAUNCH

SUBJECT: **Model 204 Model Years 2008 and 2009**  
**Replace Driver-Side and Front Passenger-side Airbag**

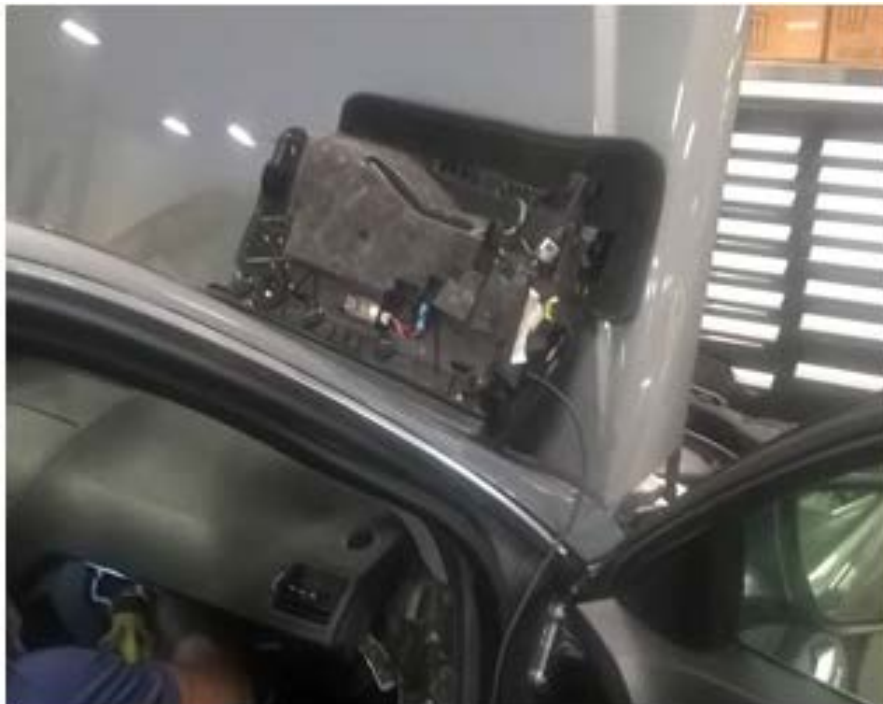
Figure 4

**i** Pull out the iPod cable as far as possible and set down glove box housing on the windshield **with** exterior iPod cable connected (**figure 4**).

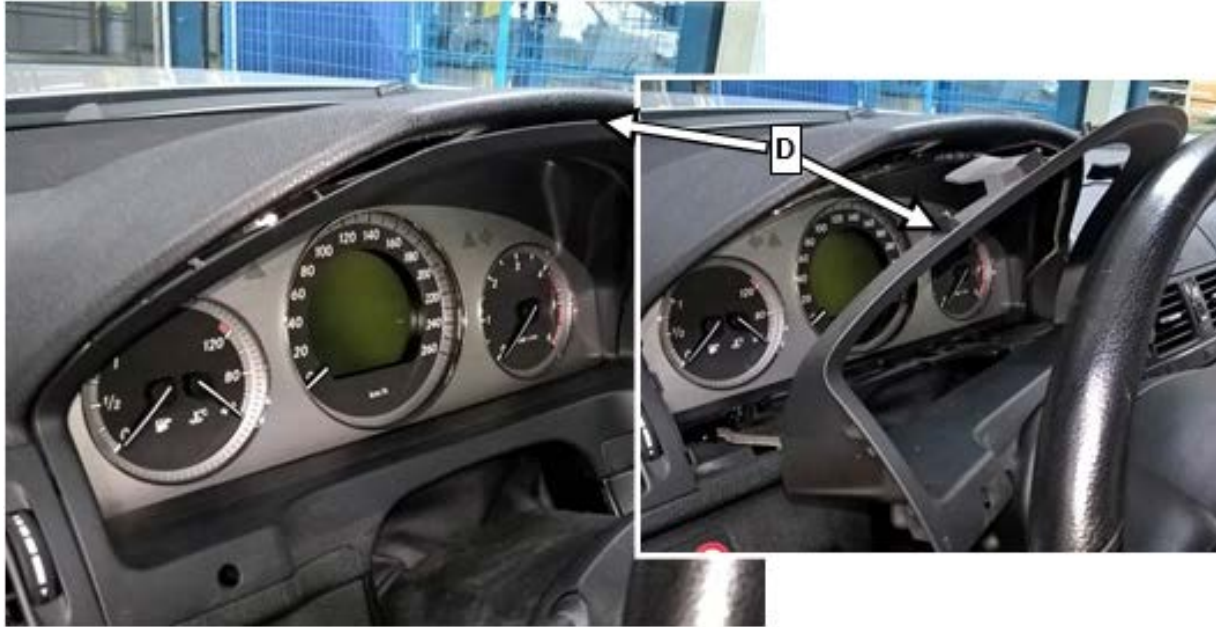
Figure 7

7. Remove center console (**AR68.20-P-2000CW**).
8. Remove automatic climate control and operating unit (**AR83.40-P-6350CW**).
9. Remove trim (**D**, **figure 7**) around the instrument cluster.

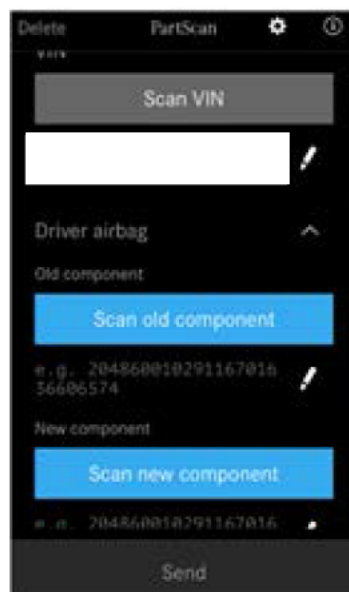
Figure 13

16. Scan barcodes of the removed driver airbag using the button "Scan old component" (figure 13).
  -
